**Land to the North of Conging Street,
Horncastle, Lincs.**

Archaeological Watching Brief

**Report prepared
for
Bell and Shinn**

LAS Report No. 593

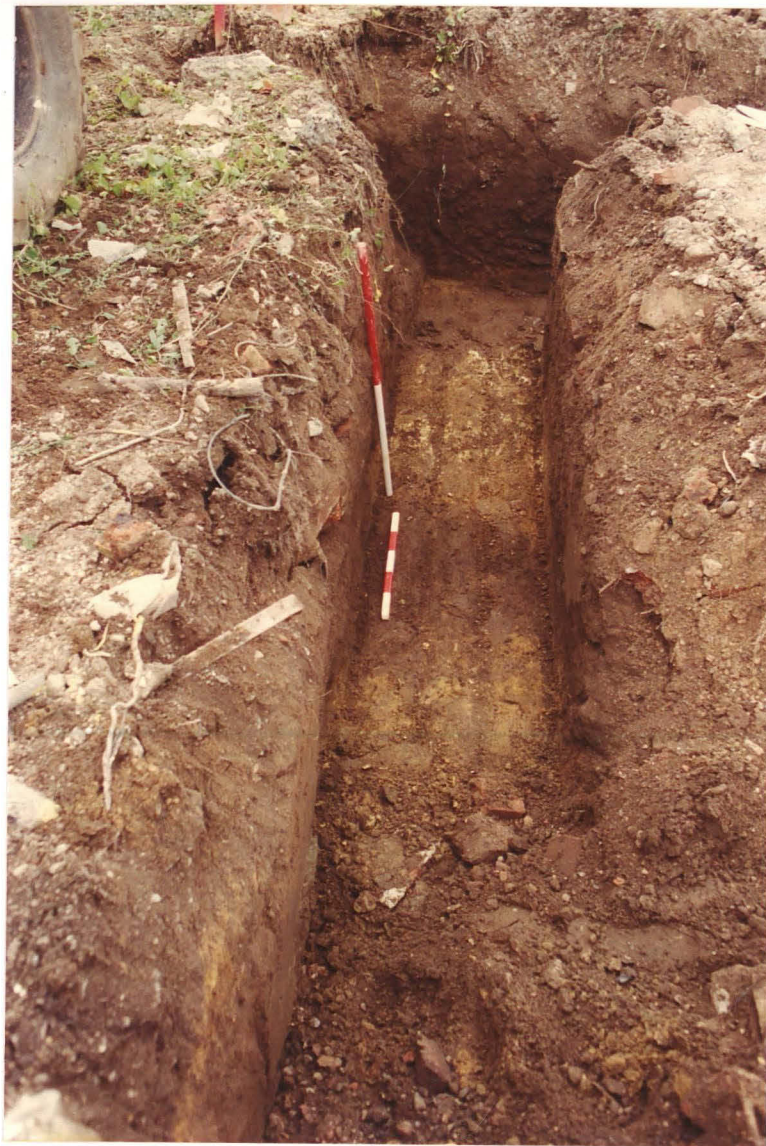
An east - west gully, **511**, 0.70m wide, 0.15m deep, was noted in the west side of the plot, 1.90m from the north west corner (Pls. 3 and 4). Its fill, **512**, was a brown sand clay containing a few flints. A gully, **513**, of a similar width and alignment to **511**, and with a similar fill, was noted in the north western corner of the plot (Pl. 3). They were dug through the natural yellow sands and gravels **501**, revealed at a depth of 0.95m below modern ground surface. There were no finds from either of these features. The backfill of Trial Trench 4, excavated in September 2000, was observed in the trench forming the boundary between house plots 1 and 2. It is likely that gullies **511** and **513** are the same as those recorded as gullies **403** and **405** in the trial trench. A brick lined well, **510** (Pl. 5), 1.08m diameter, was noted 1m west of the backfilled trial trench in the north side of the cross wall trench.

Pl. 3 Plot 1, ditches 511 and 513. Looking north. Vertical scale 1m, horizontal scale 0.50m.

The watching brief revealed a series of east - west gullies and ditches, **503**, **511**, **513**, **525** and **527**. Only one ditch, **527**, contained medieval pottery of 13-14th century date. They probably represent the subdivision of land within the medieval open fields. **523** was the only surviving area of undisturbed medieval ground surface.

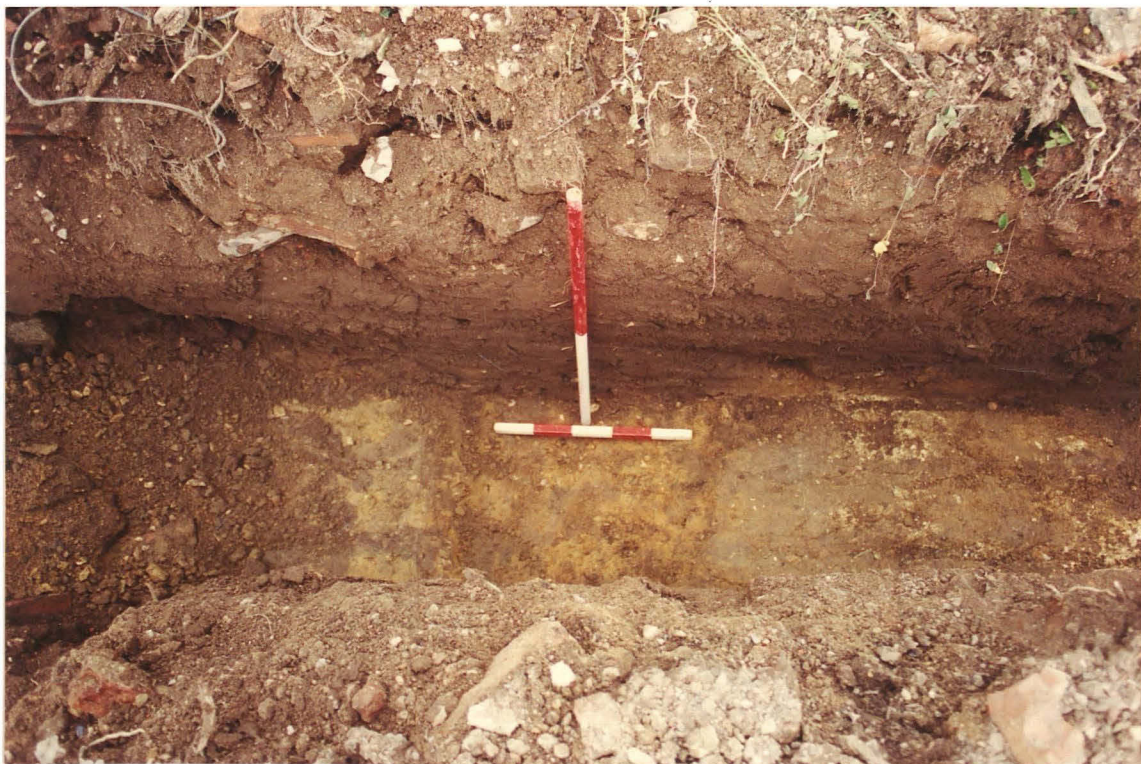
Pl. 4 Plot 1, ditch 511 after excavation. Vertical scale 1m, horizontal scale 0.50m.

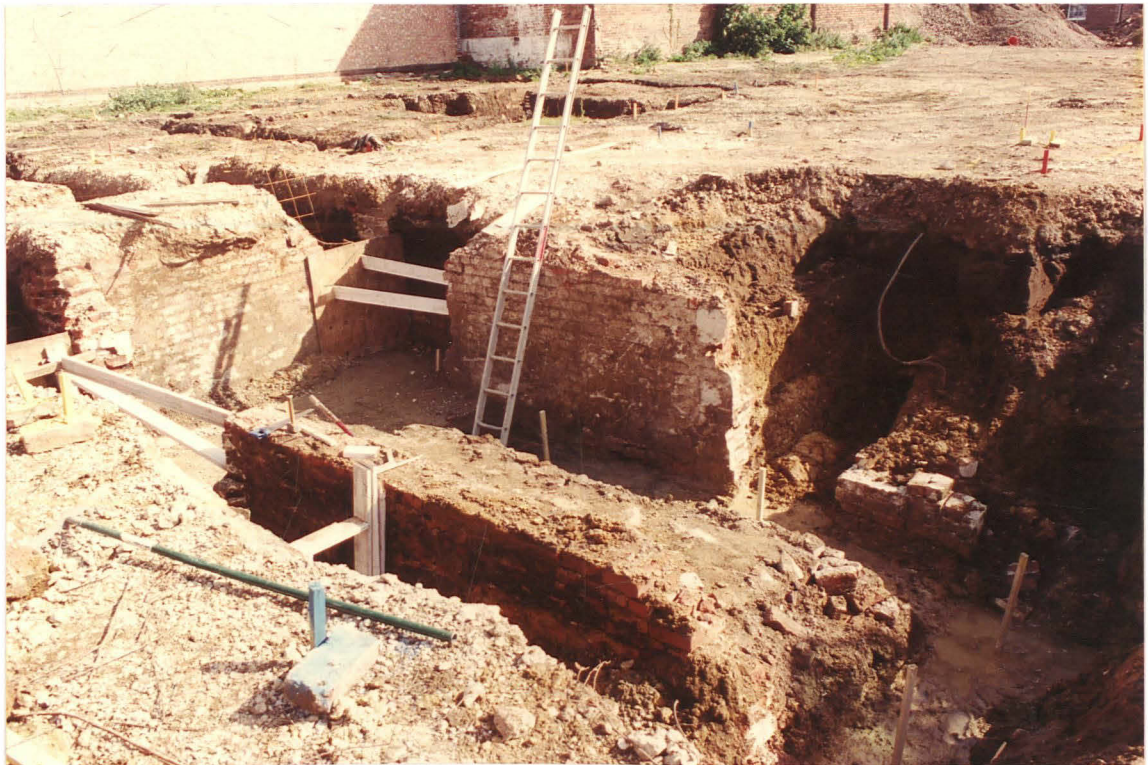
A rubble-filled cellar, **505** (Pl. 6), 6.2m x 2.4m in area, was observed in north east corner of this plot, continuing into plot 4. Sixteen courses of brick with a cream mortar bonding were visible. The cellar walls were 0.35m thick and lime whitewashed. The bricks measured 22.8cm x 11cm x 7.4cm.

Pl. 6 Plots 3 and 4, cellar 505. Looking south east.

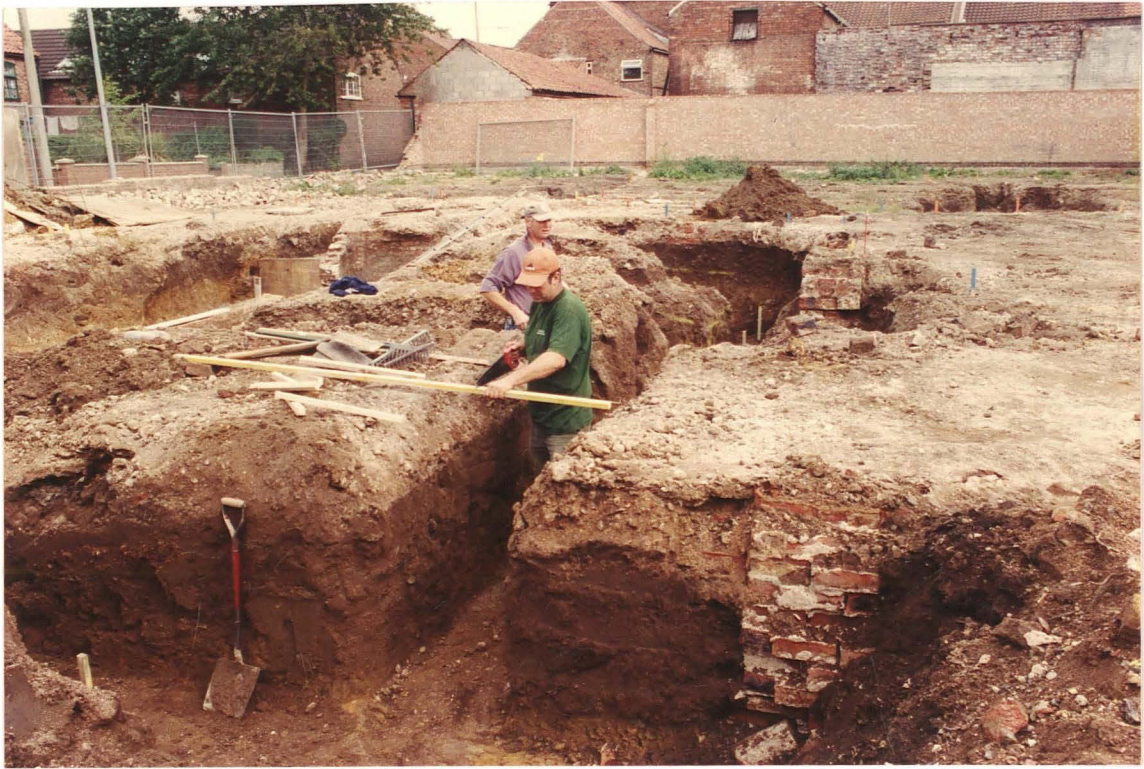
Excavation of the single porch for plot 1 and the double porch for plots 2 and 3 cut through the brick foundations of the south wall of Paddock House, which was demolished in about 1980 by East Lindsey District Council when the site was converted into a depot (Pl. 7). This wall was probably also recorded in the trial trench 4 as wall **412**.

Pl. 7 Plots 3 and 4, south wall foundations of Paddock House.

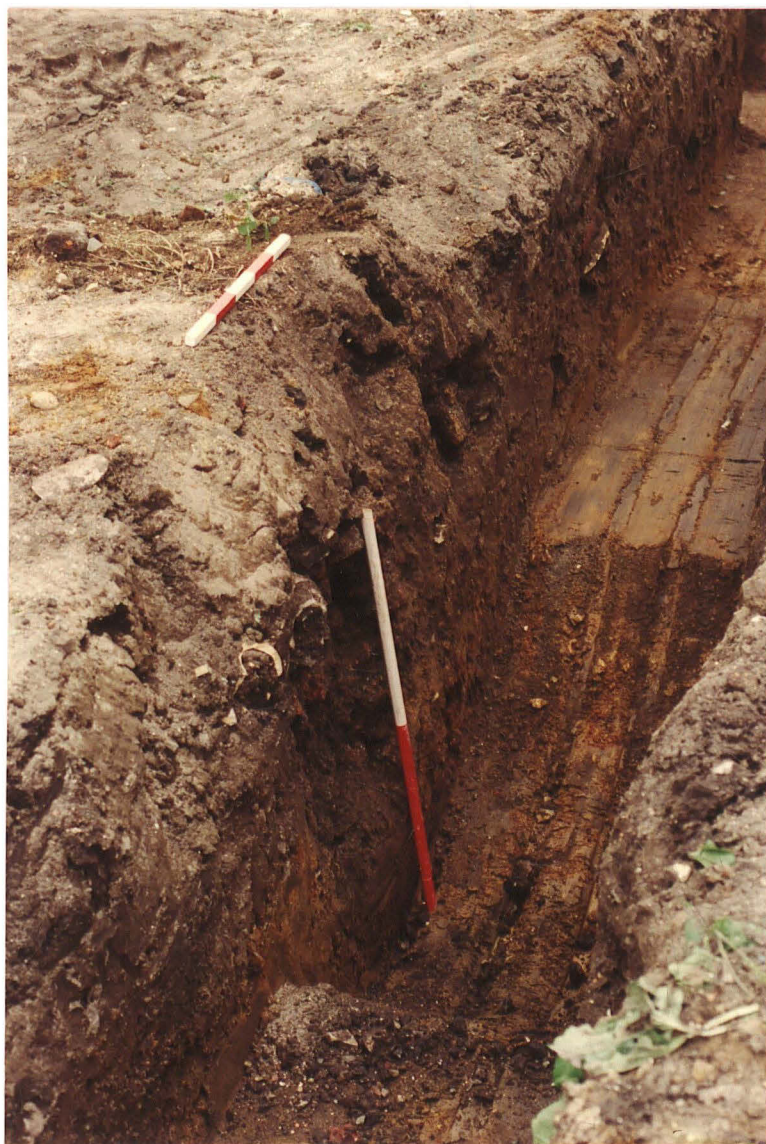
A 0.50m thick layer of brown clay sand, **509** (Pl. 10), was noted extending across plots 5 -7 and sealing **501**. A brick inspection chamber was noted south of the foundation trench crossing Plot 5 from west to east. Ceramic pipes ran from its north side diagonally across the plot and were cut through by the north foundation trench. East of the inspection chamber was a 1.50m wide, 'U' shaped trench, **503**, 4.20m south of the north east corner of the plot. It contained a ceramic sewer pipe and was filled with a dark brown sand clay with coal ash and brick rubble (Pl. 9).

Pl. 9 Plot 5, pipe trench 503, looking south east. Vertical scale 1m, horizontal scale 0.50m.

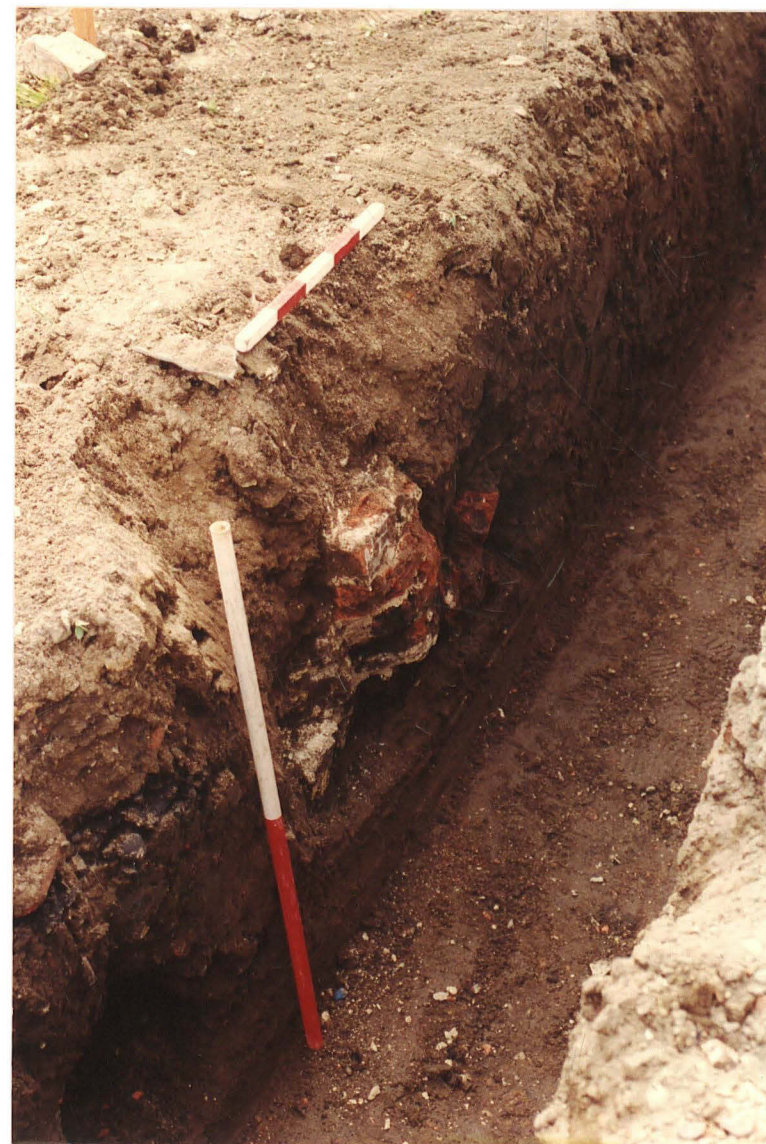
Brick foundations, **502** were observed in all three plots **5-7** running north-south close to the centre of the house plot, with perpendicular walls running eastwards in plots 6 and 7 (Pl. 10). Between five and ten courses of brickwork survived. All the bricks were handmade. These foundations belonged to a west-facing building, aligned north-south, which had already been demolished by the time of the OS survey in 1888.

Pl. 10 Footings 502 in east side of Plot 6. Vertical scale 1m, horizontal scale 0.50m.

The watching brief also established that the site had been disturbed by modern services along the Conging Street frontage and land drains. The foundations, **502**, observed in plots 5 - 7 belonged to a building or buildings pre-dating those standing in 2000 but not present on the O.S. map of 1880 (Fig.2). The bricks were hand made and it is possible that the building was 18th or even 17th century in date. The watching brief established that the north end of the site was heavily disturbed by cellars and 19th century building foundations. Cellar **505** and the foundations observed along the southern edge of plots 1-4 belonged to 'Paddock House', the building demolished in 1980 and replaced by a garage when the site became a depot for the local council.

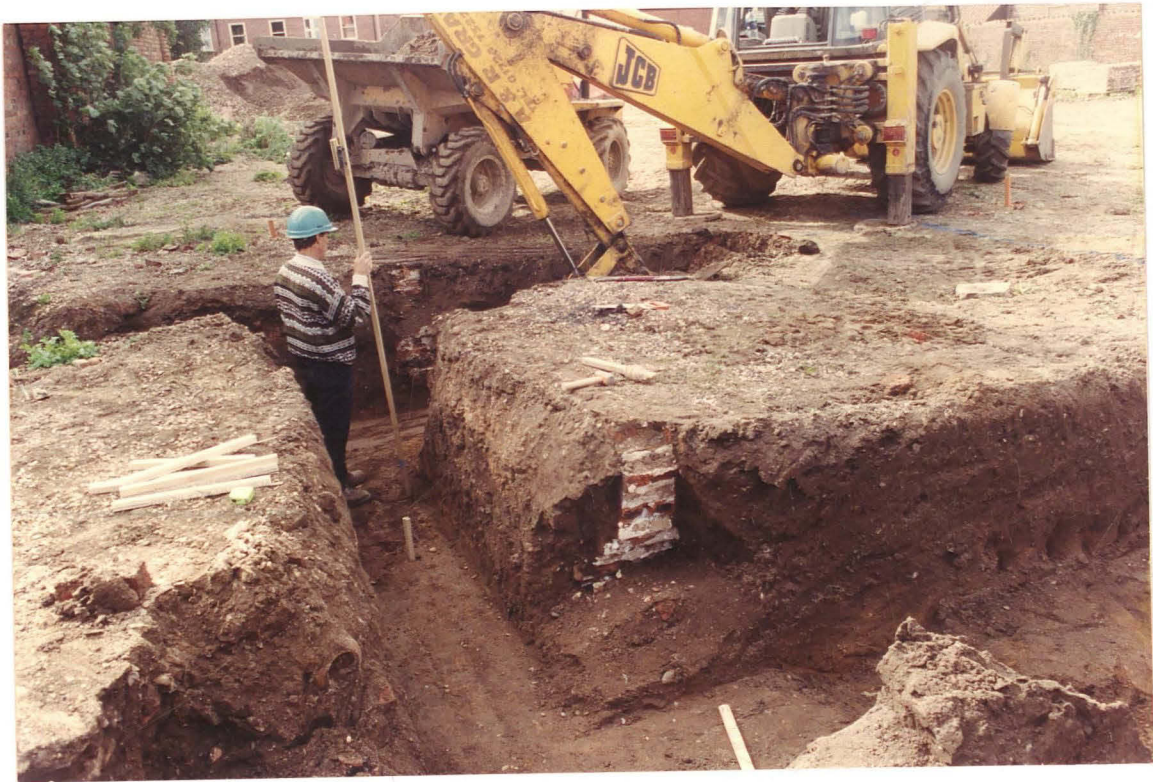
Brick foundations, **502**, running east from the front of the building were also noted within the plot (Pl.11). A brick lined well, **504**, 1.45m in diameter, was observed in the new porch area and continued into Plot 7 (Pl. 12).

Pl. 11 Footings 502 seen in Plot 7. Looking south.

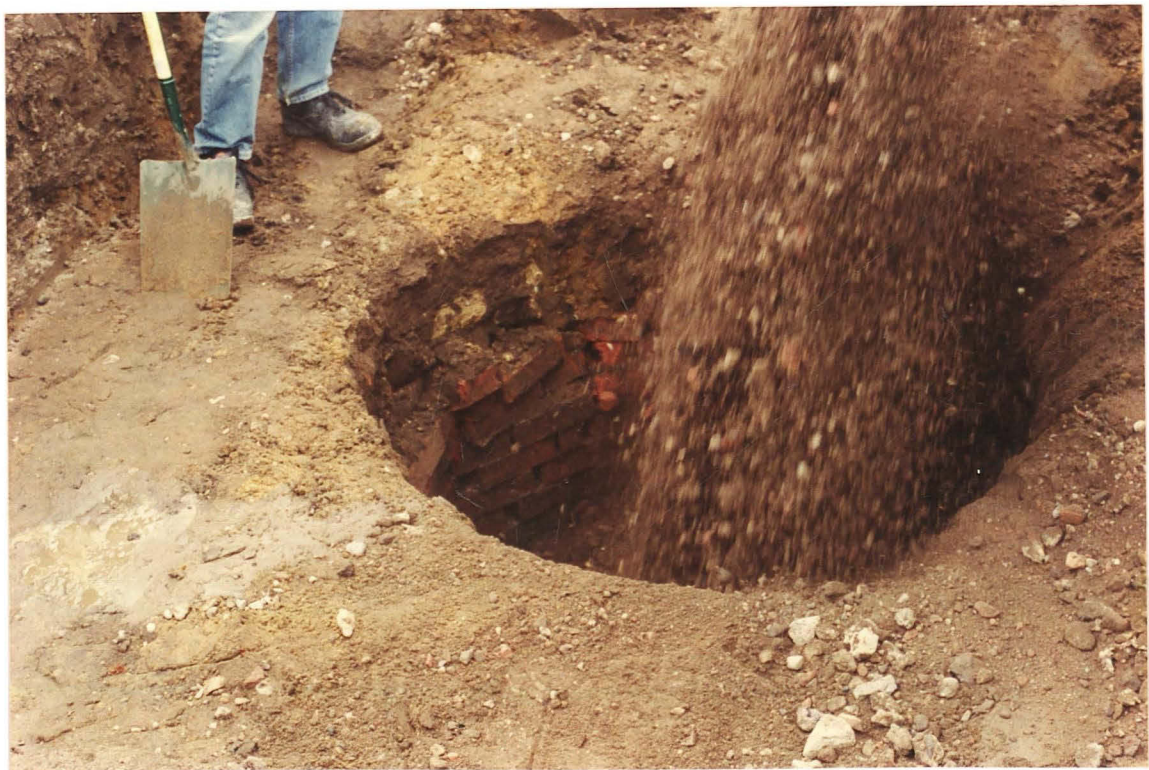
Pl. 12 Plot 6/7, well 504 being backfilled.

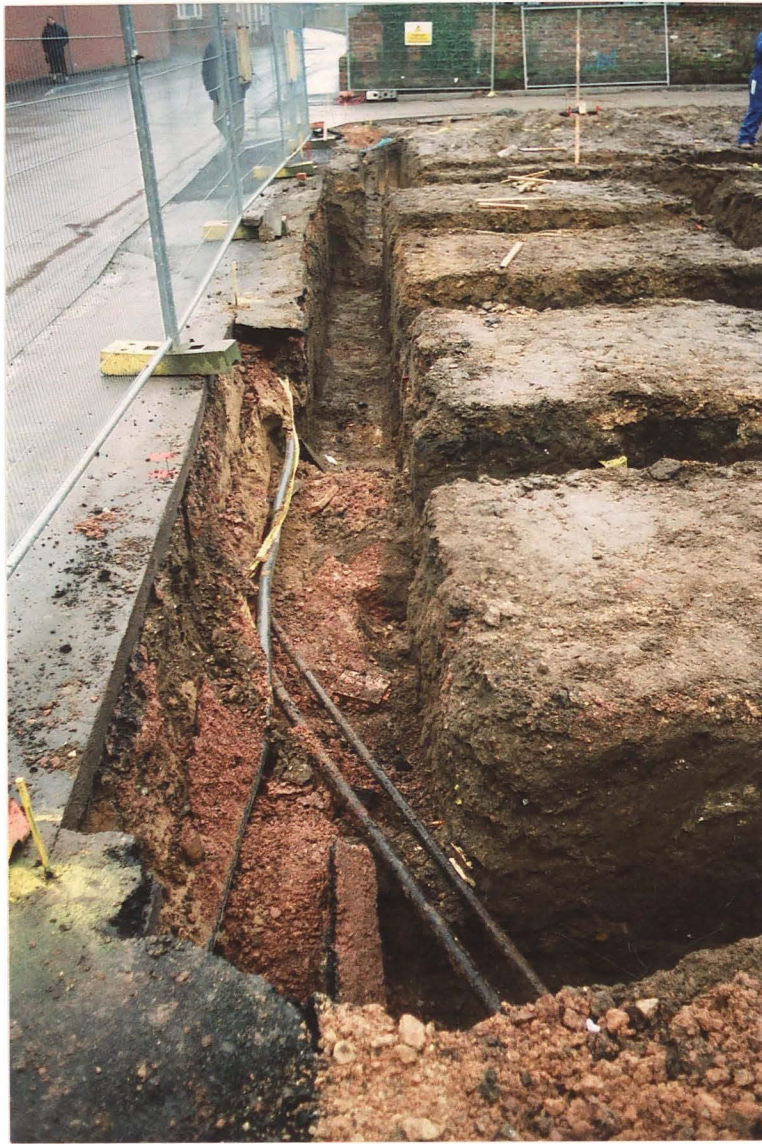
No archaeological features were observed, but a substantial modern service trench (Pl. 18) was recorded running the entire length of plots 12 - 14, parallel with Conging Street. It had a width of 2.50m and a depth of c.1m. There was a distinct layer of modern make-up **600**, overlying a dark grey brown topsoil and subsoil **601**, sealing the natural mid orange brown sandy clay natural **602** (Pl. 19).

Pl. 18 Service trench running through Plots 12 - 14.

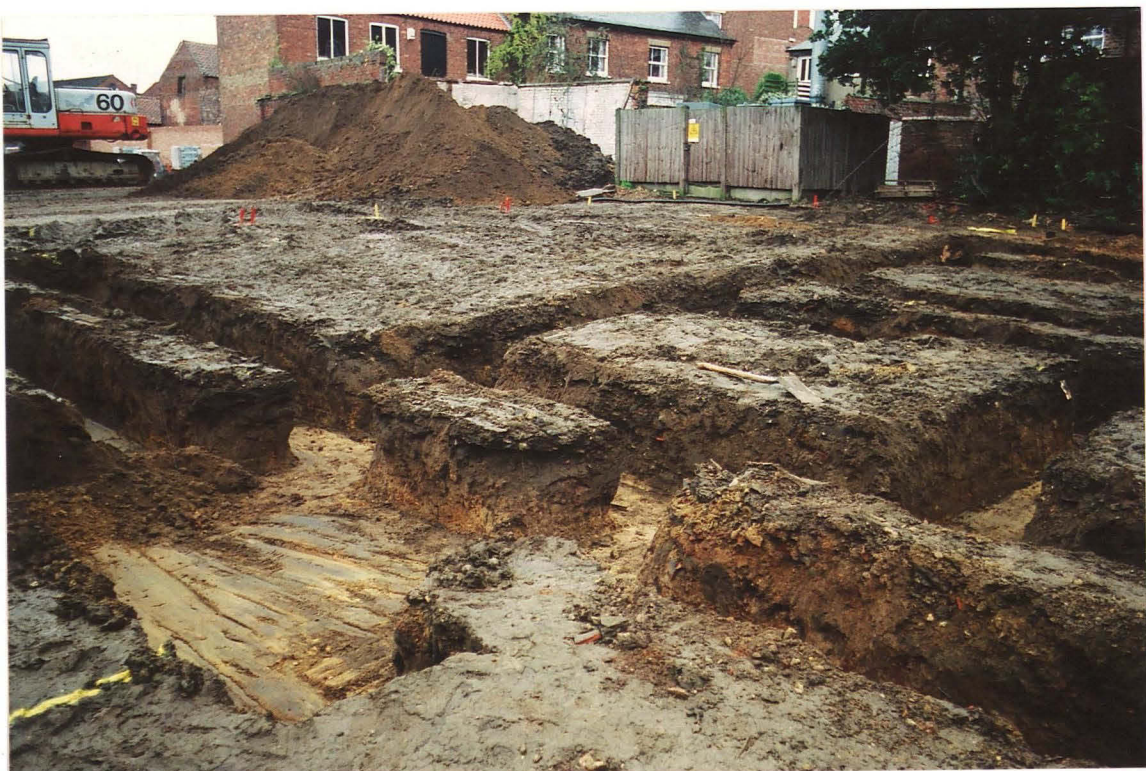
Pl. 19 Plots 11-14, looking north east, showing disturbed nature of deposits.
