Doughty's Mill, Melville Street, Lincoln

Archaeological Watching Brief

LAS Report No. 599

July 2002

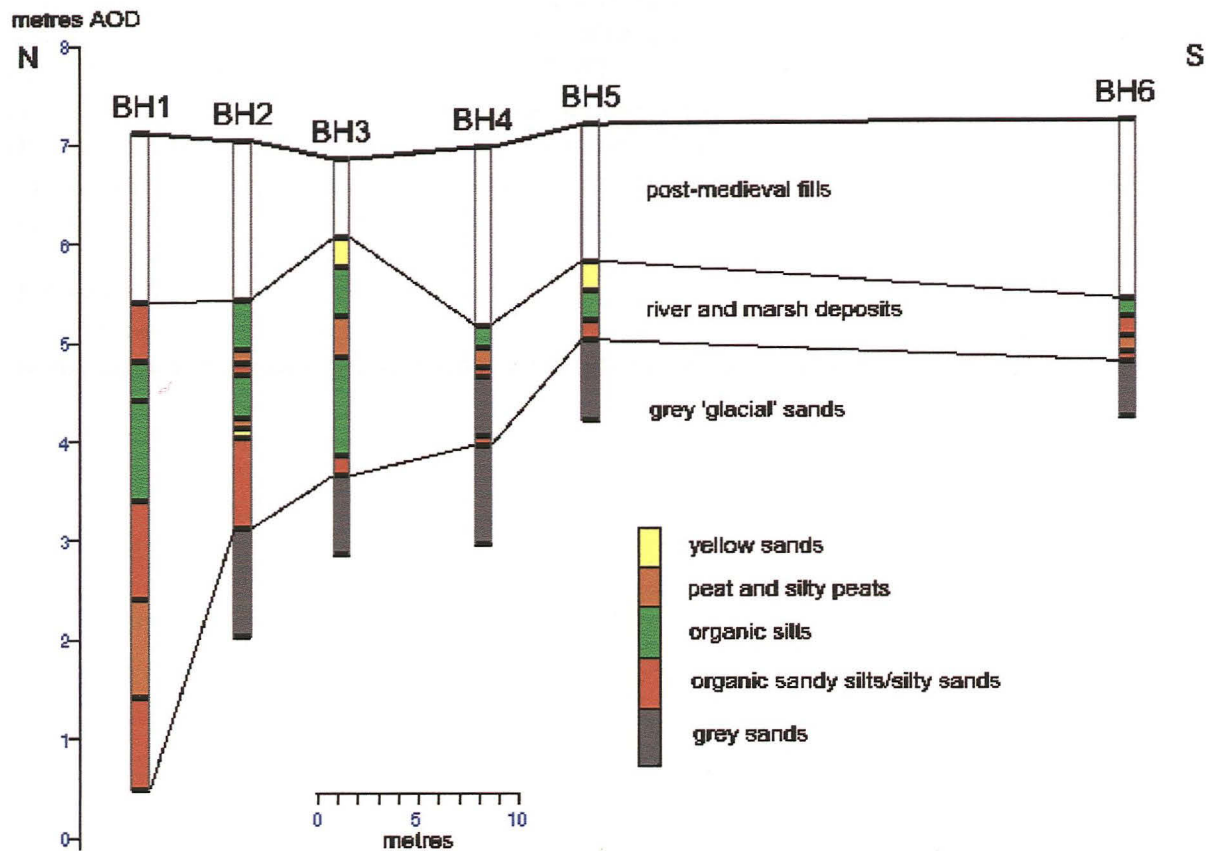
Figure 2. Simplified profile of the borehole data

The results from the six boreholes are presented in a summary diagrammatic section in Fig. 2 and the on-site descriptions are appended to this report.

The first borehole was sunk 15m from the present revetted south bank of the River Witham. Fig. 2 clearly shows that the ancient bank of the river underlies the phase 4B development plot. The underlying grey sands rise up over two metres across the five metres between BH1 and BH2, a further half metre over the next five metres, and 1.25 metres over the next twelve metres. After BH5 the underlying grey sands level off and in fact drop slightly southwards to BH6.

The upper levels of all six boreholes comprised recent and post-medieval fill. The deposits contained brick, coal, cinder, glass and other debris in a sandy and sandy silt matrix. The only structural evidence was encountered at the first location for BH4 where the auger was obstructed and a large brick foundation was exposed by machine and the borehole location moved two metres south. Beneath this overburden all the sequences were naturally formed sediments although with occasional inclusions of archaeological debris such as brick/tile, mussel shell fragments and coal. This lower stratigraphy could not confidently be linked between boreholes. The deposits can be classified within three main groups, sandy silts and silty sands, often with organic lenses or patches of organic rich material; organic silts, often with freshwater shell fragments and occasional visible fragments of wood and twigs; and peats and silty peats. The deposits grade between these with occasional sand lenses, and in BH4 a horizon of grey sands separated from the glacial sands below by a thin deposit of organic silt may be downslope slippage of the bank to the south.

The chronology for the sediments is in part conjectural but the following sequence can be suggested. The basal deposits in BH1 may be of prehistoric date but peats were forming in the Brayford Pool at (or above allowing for compression) 2.6m OD in the Roman period (Rackham 2001b), 2.2m OD during the Saxon period (Rackham 2001a) and 2.7m in the medieval period (Rackham 2001b) and the peat deposit in BH1 at 1.5-2.5m OD may be contemporary with any of these. The brick/tile fragments in the sediments immediately above at approximately 4.5m depth indicates that these deposits must at least be Roman or later. The bulk of the organic silts and sandy silts are therefore likely to be of Saxon and medieval date with the upper organic sediments possibly still forming into the post-medieval period. The earliest occupation of the site may not have been until the 18th or 19th century.

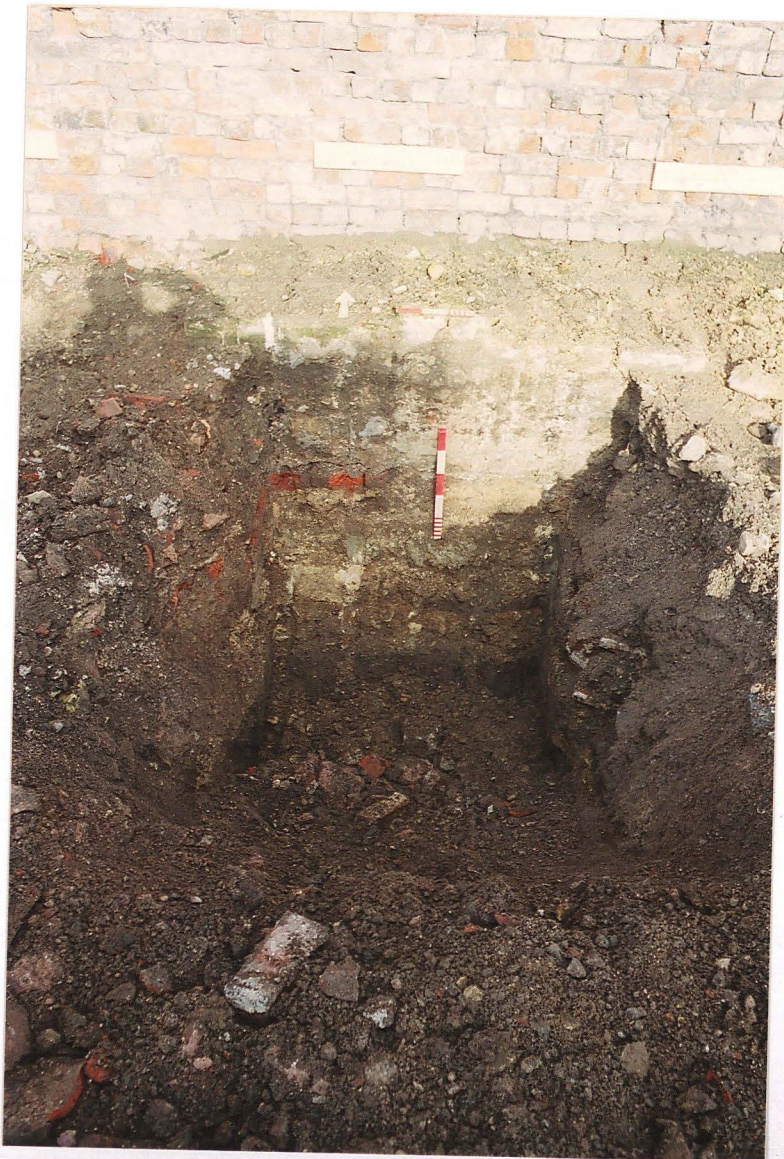
Pl.16 Trench BB, north facing section. Vertical scales 0.50m, horizontal scale 0.30m.

In Trenches BB, CC and EE a light brown silt, up to 0.40m deep, with brick and limestone fragments, **215** (Pl. 16), lay below **200**. A cream coloured mortar deposit, **221**, 0.85m deep was recorded in Trench EE. These were the only modern deposits below the level of the backfilled cellars.

Stratigraphy in the southern monitored area was similar to that in the north with the exception of **217** and **219** (Pl. 16). **217**, 0.20m deep, was in Trench BB, which had the same matrix as **210** but contained mortar and charcoal flecks. **219** was noted in Trench AA, it contained limestone fragments. It lay below **218**, which had a sandier content and above **208** (Pl. 15), which had a thickness of 0.20m. **208** was noted as **114** in the 2002 evaluation trench.

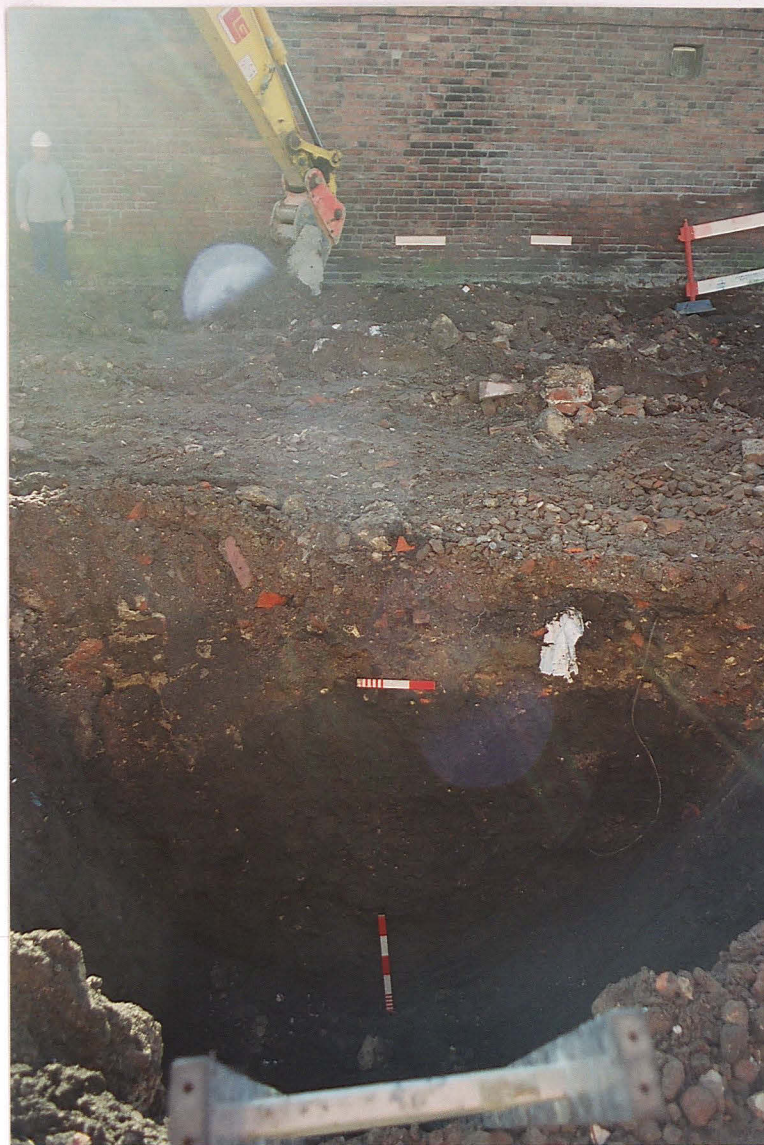
Pl.17 Trench FF, south facing section. Scale 0.50m.

Backfilled cellars were noted in Trenches FF (Pl. 17) and GG. In Trench FF the backfill, **204**, was over 2m deep.
