**St John' Road, Lincoln,
Archaeological Watching Brief.
Planning Application No. 2001/0255/F
NGR: SK97779 72578
Site code: LJR02
LCNCC Accession No. : 2002.258**

**Report for
Mr S. Gregory.**

**July 2002
Report no 600**

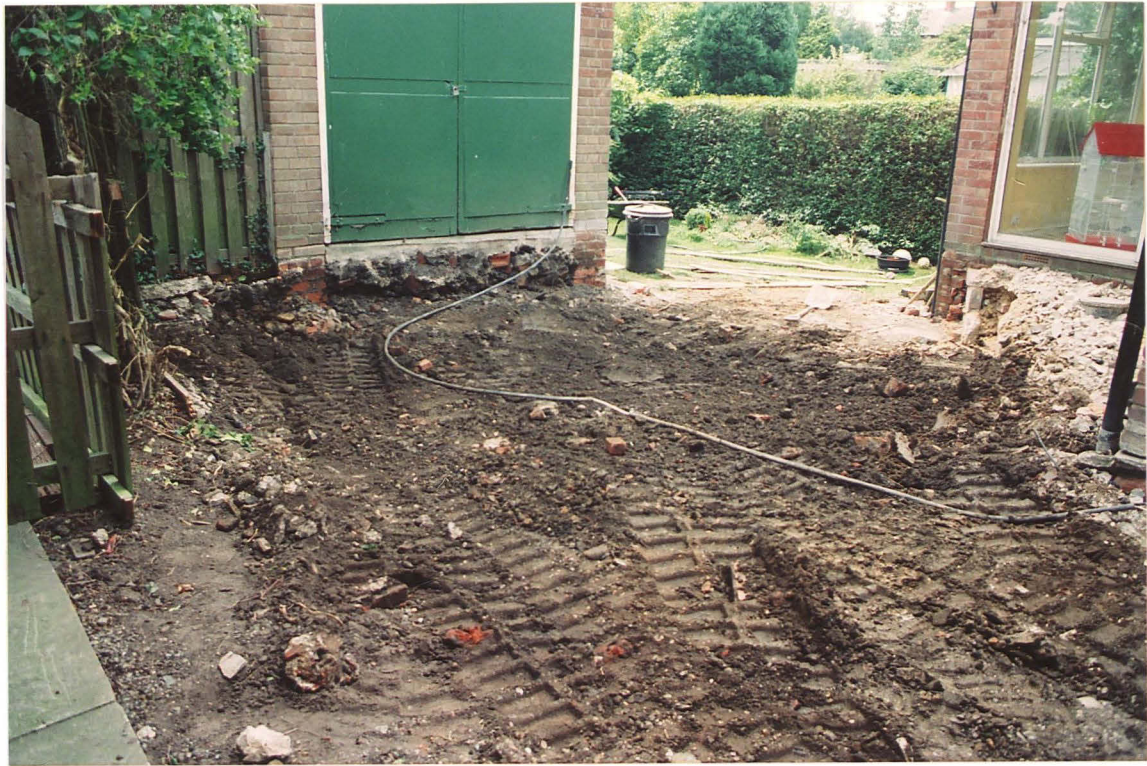
Pl. 1. General view of the southern part of the site after the removal of the concrete surfaces and limestone make-up.

Pl. 1. General shot of the southern part of the site after the removal of the concrete surfaces and limestone make-up.

The site was covered in a layer of concrete and limestone rubble (105) of between 0.10 and 0.30m thick along the driveway and over the entrance area to the rear of the property. This was machined away before the digging of the foundation trenches began in an attempt to minimize the total depth of the trenches. Four separate trenches were excavated over a period of approximately one week, due to the instability of the deposits being machined. Each length of trench was machined, quickly recorded, and the concrete footings laid before any section collapses occurred.

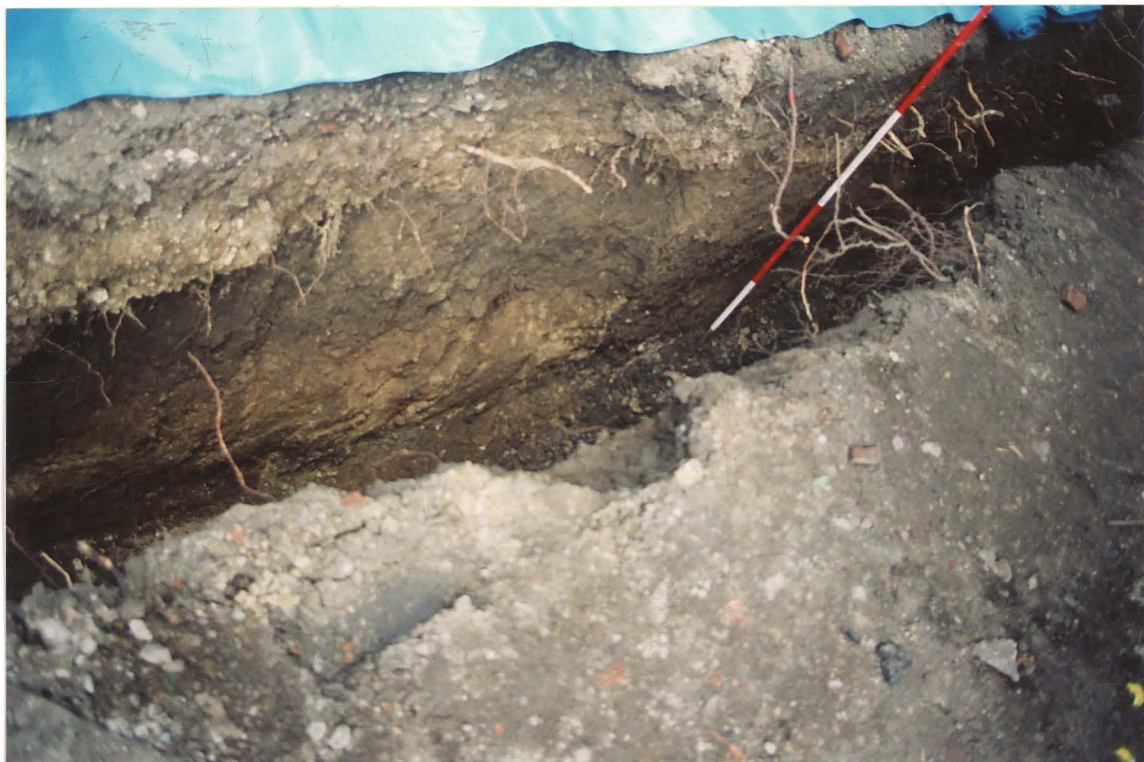
Pl. 2. South facing section of trench 1, taken from the south west , showing the dark fill of the cut of the possible ditch.

Pl. 2. Photograph of the south facing section of trench 1, taken from the south west, showing the dark fill of the cut of the possible ditch.

construction of the present building. Context (102), thought to be the original topsoil, was indistinguishable from any subsoil levels. This existed over the whole extent of the trench and also appeared to be the fill of a cut into the limestone brash / cream clay beneath. This cut, (103), appeared to be the western edge of a substantial ditch of north / south alignment and measured at least 0.70m in depth and, assuming the eastern edge of this ditch to be out of the trench, at least 2.5m in width. The limestone brash / cream clay (105) at the base of this feature was extensively weathered.

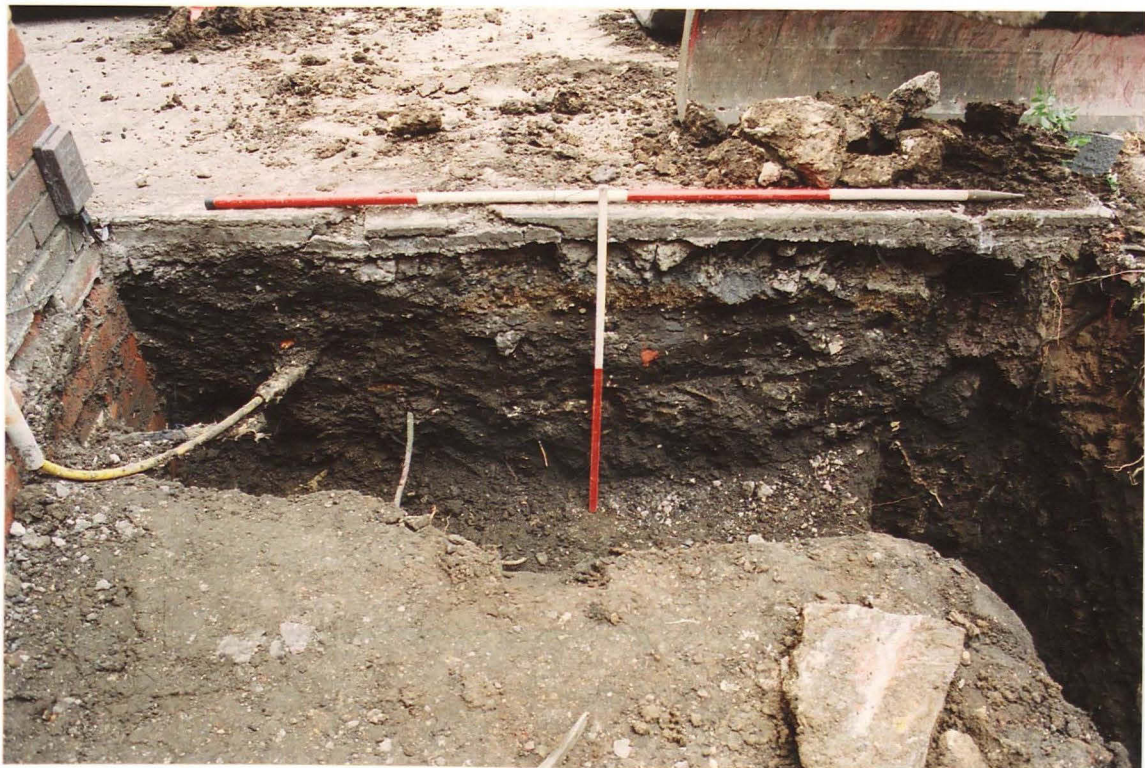
Pl. 4. Trench 4 showing modern deposits in the south-facing section, (scales 1m and 2m).

Pl. 4 Photograph of trench 4 showing modern deposits in the south-facing section.

Trenches 3 & 4 were excavated to a lesser depth (0.60m), due to the building regulation requirements, and exposed only previously disturbed modern deposits. This was mainly due to the underpinning work undertaken in recent years.
