**PLOT ADJOINING THE OLD VICARAGE,
CHURCH LANE, LAUGHTON,
LINCOLNSHIRE**

**ARCHAEOLOGICAL WATCHING
BRIEF REPORT**

Site code	OVL 02 7
NGR:	SK 9500 9847
LCCM Acc No:	2002.181

Report prepared for Mr & Mrs J Crowther
by S.A. Savage

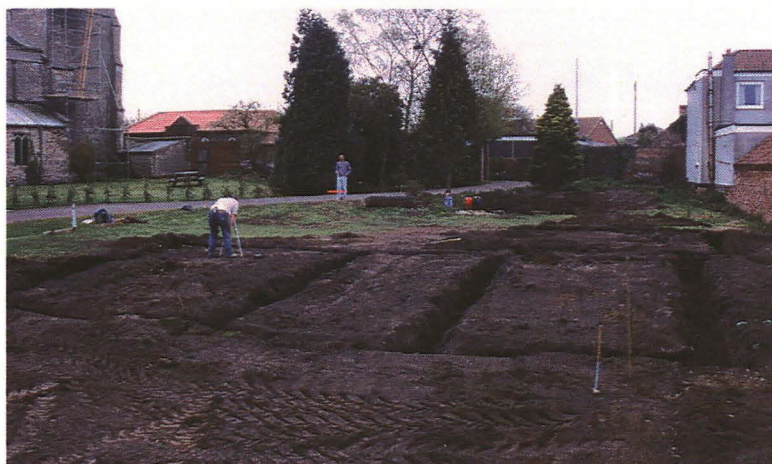
Plate 1: General view of the site during excavation, looking SW.

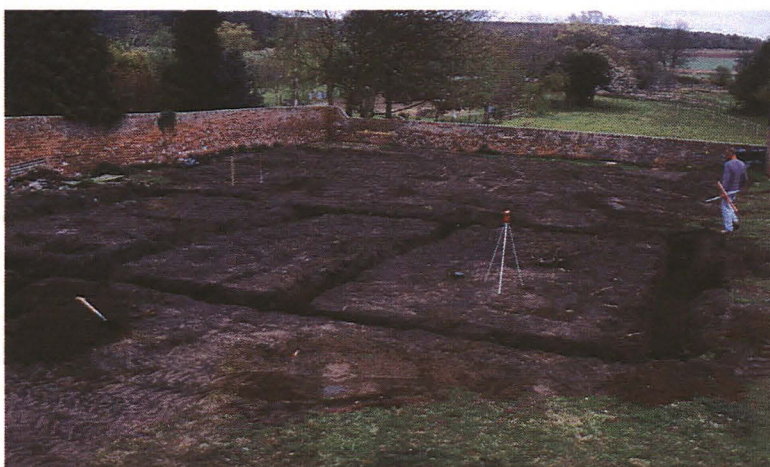
Plate 2: General view of the site, showing the foundation trenches of the house itself, looking NE.

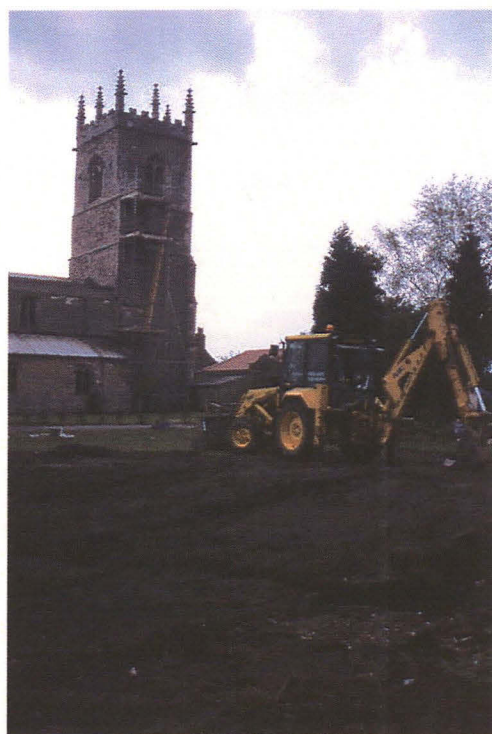
Plate 3: General view of the site during excavation of the foundation trenches, looking SW. The proximity of the church to the site is clear from this shot.

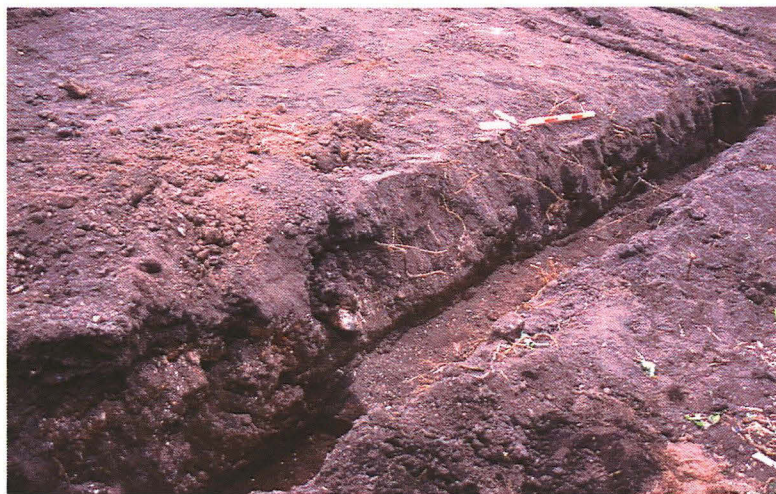
Plate 4: Brick wall foundation [012], seen in the foundation trench for the north wall of the house, looking SW

In the northern part of the house plot, a brick foundation was encountered (figs. 5&6). This foundation, [012], was constructed primarily of handmade brick (220mm x 110mm x 65mm in size) with occasional small and medium limestone fragments as infill. The bonding material was a friable lime mortar. Foundation [012] extended from the NW corner of the house plot to the NE corner, where it continued beyond the development footprint – a distance of some 8.3m. It was 0.98m wide and up to 0.22m thick. The iron and antler knife handle was recovered from the topsoil in the vicinity of this wall foundation.

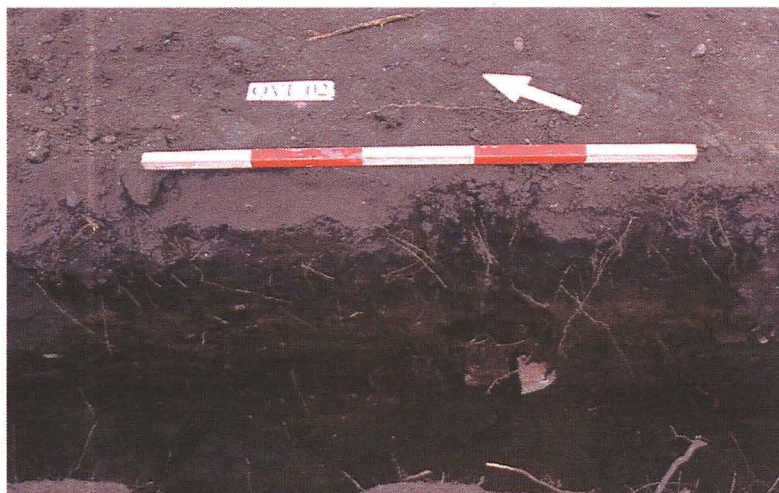
Plate 5: Limestone wall foundation [008], seen in the foundation trench for the west wall of the house, looking NE.

As machining of the trenches progressed, localised patches of limestone were encountered, which, upon close inspection of the trench sections proved to be the remains of wall foundations (figs. 7-9). These foundations were constructed of medium and large limestone fragments, generally c0.25m on a side and 0.07m thick (the largest being 0.4m square x 0.1m thick), set in a mid-greenish grey clay bonding. The foundations themselves (context numbers [004] – [011]) were generally 0.4m wide and varied between 0.18m and 0.32m thick.

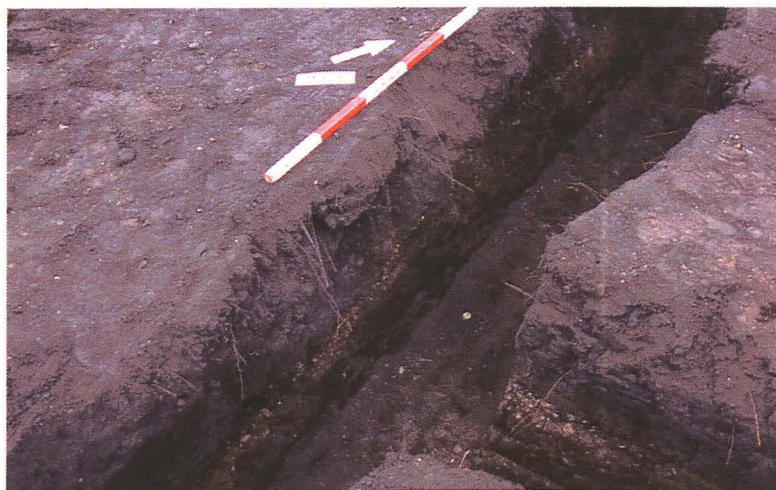
Plate 6: Gravel layer [014], seen in the foundation trench for the west wall of the house, looking NW. Limestone wall foundation [006] is located below the scale bar.

In the trenches on the SW side of the house, a gravel layer was exposed; abutting walls [006] – [009]. This layer, 014, consisted of mid-greenish grey poorly sorted medium gravel with occasional small angular limestone fragments (up to 0.05m in size) and occasional localised sandy patches. Layer 014 was seen in an area some 8m x 4m and was evenly deposited to a thickness of 0.14m.
