**St Mary's Preparatory School, Chancery Garden,
Pottergate, Lincoln**

Archaeological Watching Brief

LAS Report No. 604

July 2002

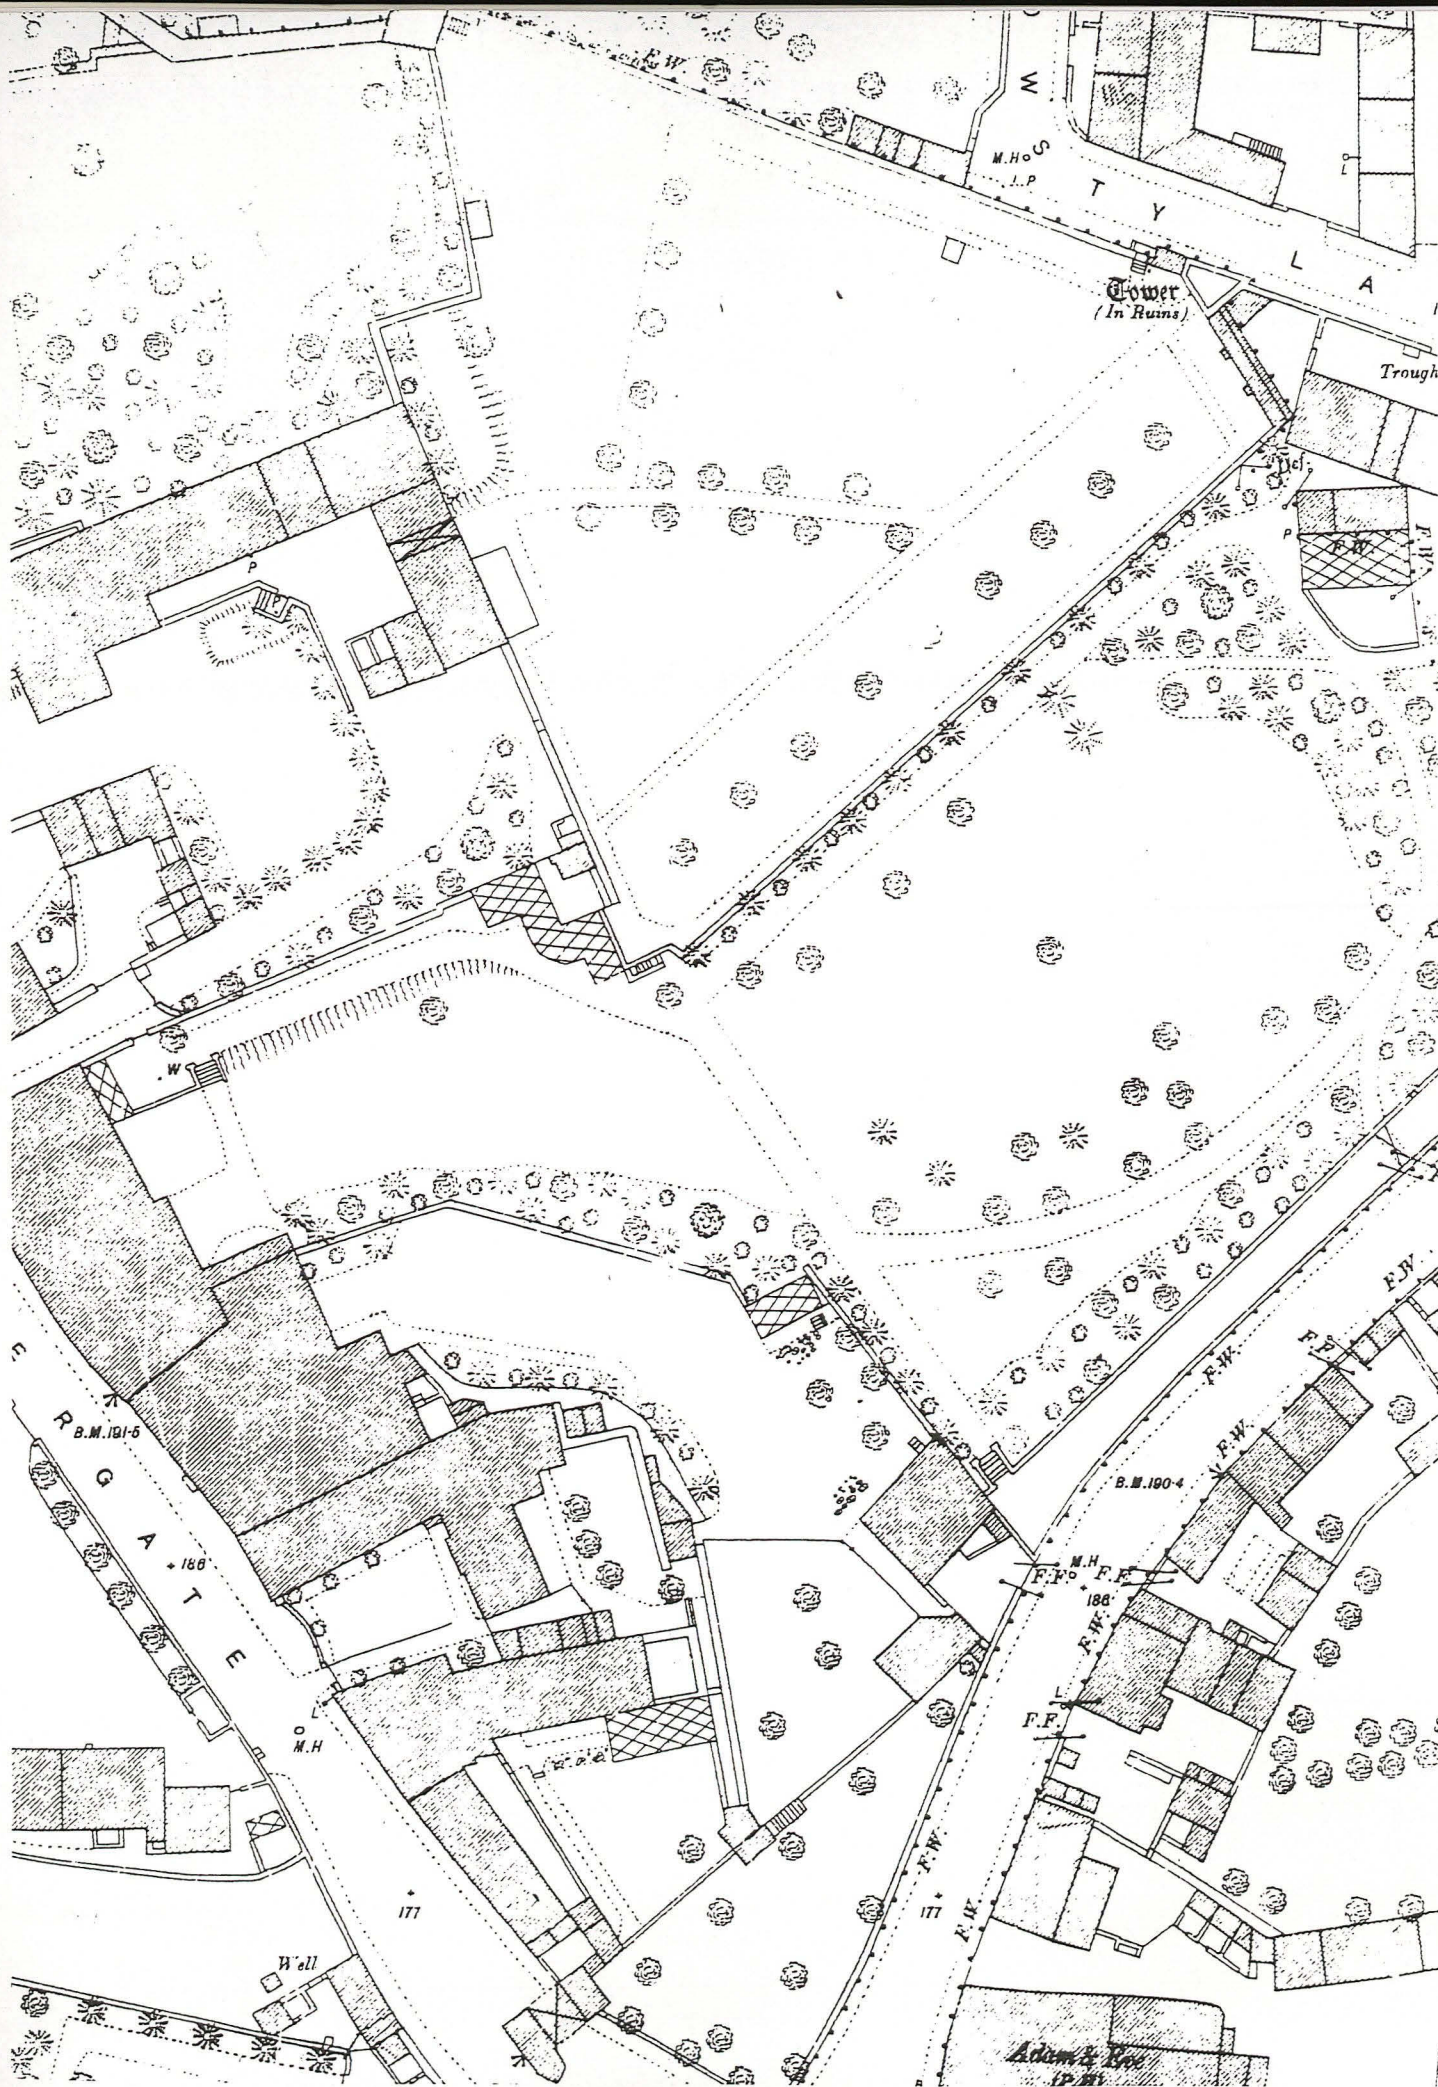
Fig. 6 Chancery Garden, as surveyed in 1885-6, showing the mound and a garden path in the approximate position of drain 4 (reproduced, at reduced scale, from the 1888 Ordnance Survey 1:500 map, Sheet Lincs. 70.7.8).

Although the wall robber trench was not excavated, the approximate earliest possible date of the robbing can be gauged from the structure of a tile-lined drain 4 which had been cut through the robber trench backfill at the limit of the surviving foundation (Pls. 5, 6 and 9). From the alignment of the drain, past the edge of the remaining foundation, it seems either that the survival of the wall foundation reflects either a removed land boundary (of which there was no other indication) or, more probably, a section of the wall to the north remained upstanding and in use when the robbing of below-ground material took place. The drain extended at least 0.7m NE of the wall, falling slightly towards the east, but this area was not threatened by the groundworks and its extent was not traced. Its alignment coincides with the course of a path leading from the rear of the Chancery into the former Chancery Garden, as shown on the Ordnance Survey 1:500 plan surveyed 1885-6 (Fig. 6; OS 1888).

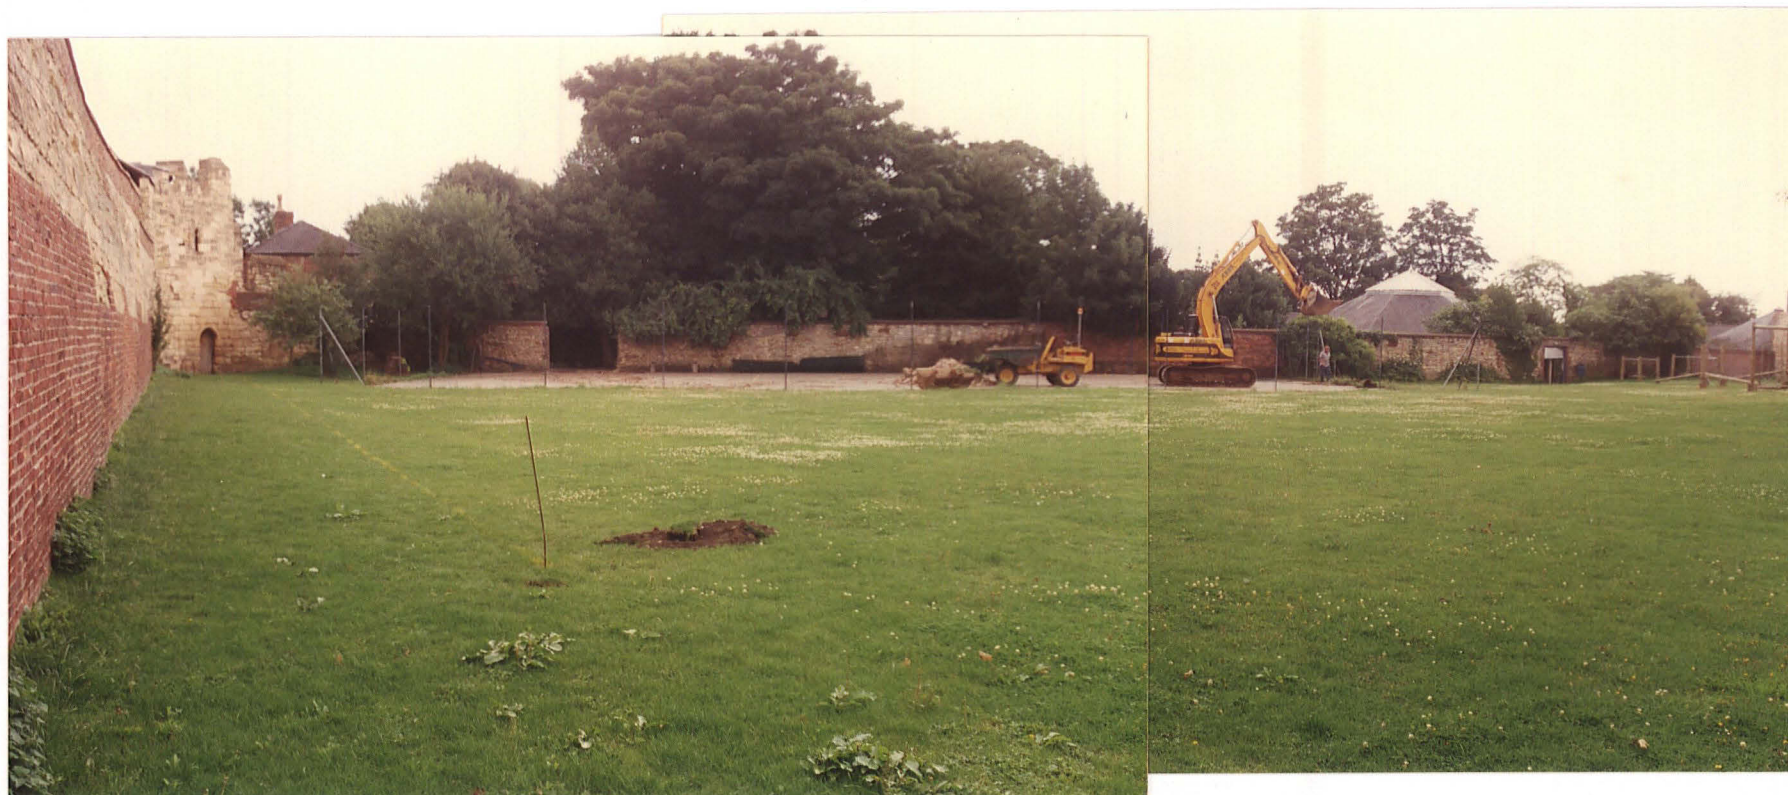
Pl. 1 Area of the new pitch, prior to topsoil stripping. The tarmac tennis courts are against the stone garden wall (background); to the left is the repaired Close Wall. School buildings can be seen (right background). Looking SE.

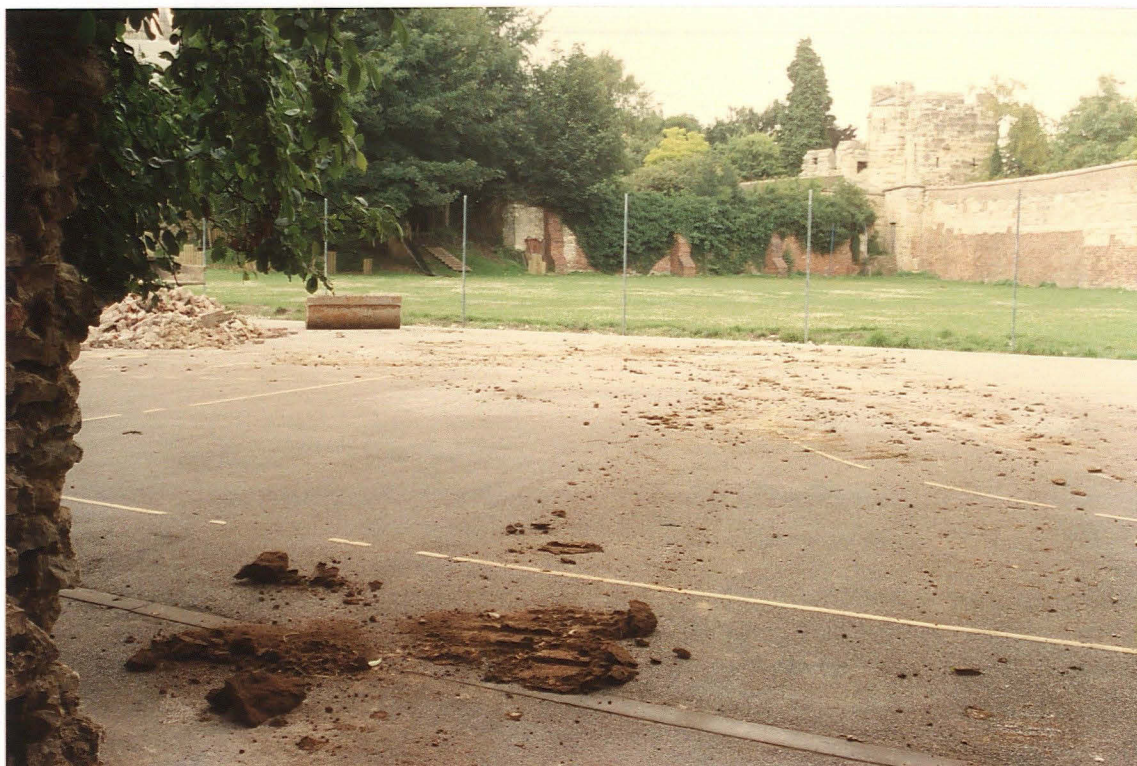
Pl. 2 Area of the new pitch, looking NW. The Close Wall is to the right, with a buttressed wall leading from the tower. Play equipment is in place on an earth mound (upper left).

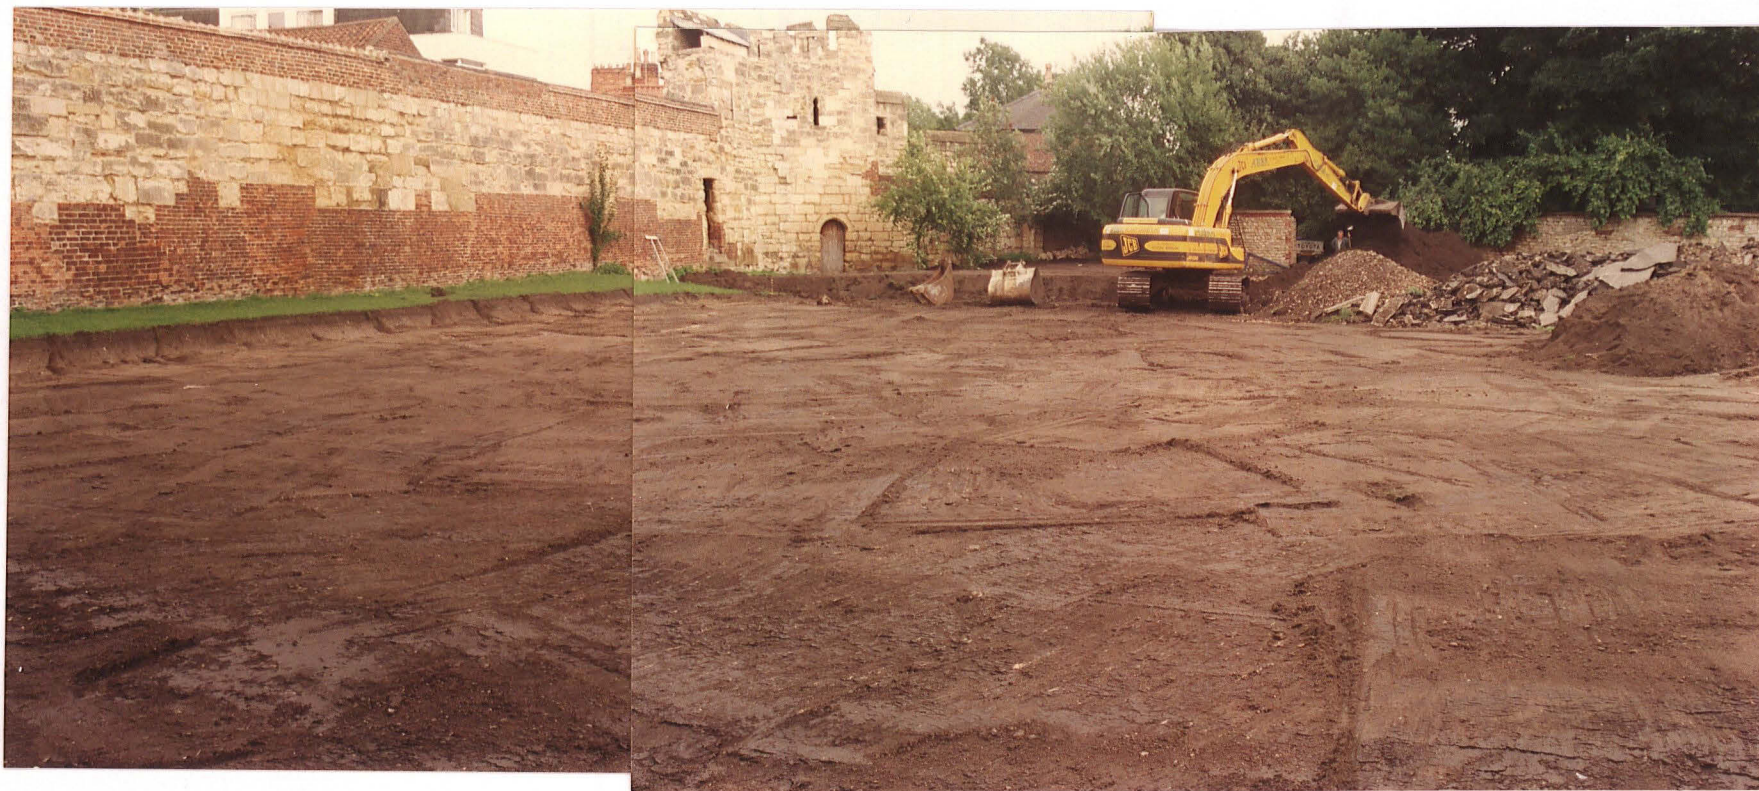
Pl. 3 Eastern side of the pitch area, after reduction to the required base level (looking east).

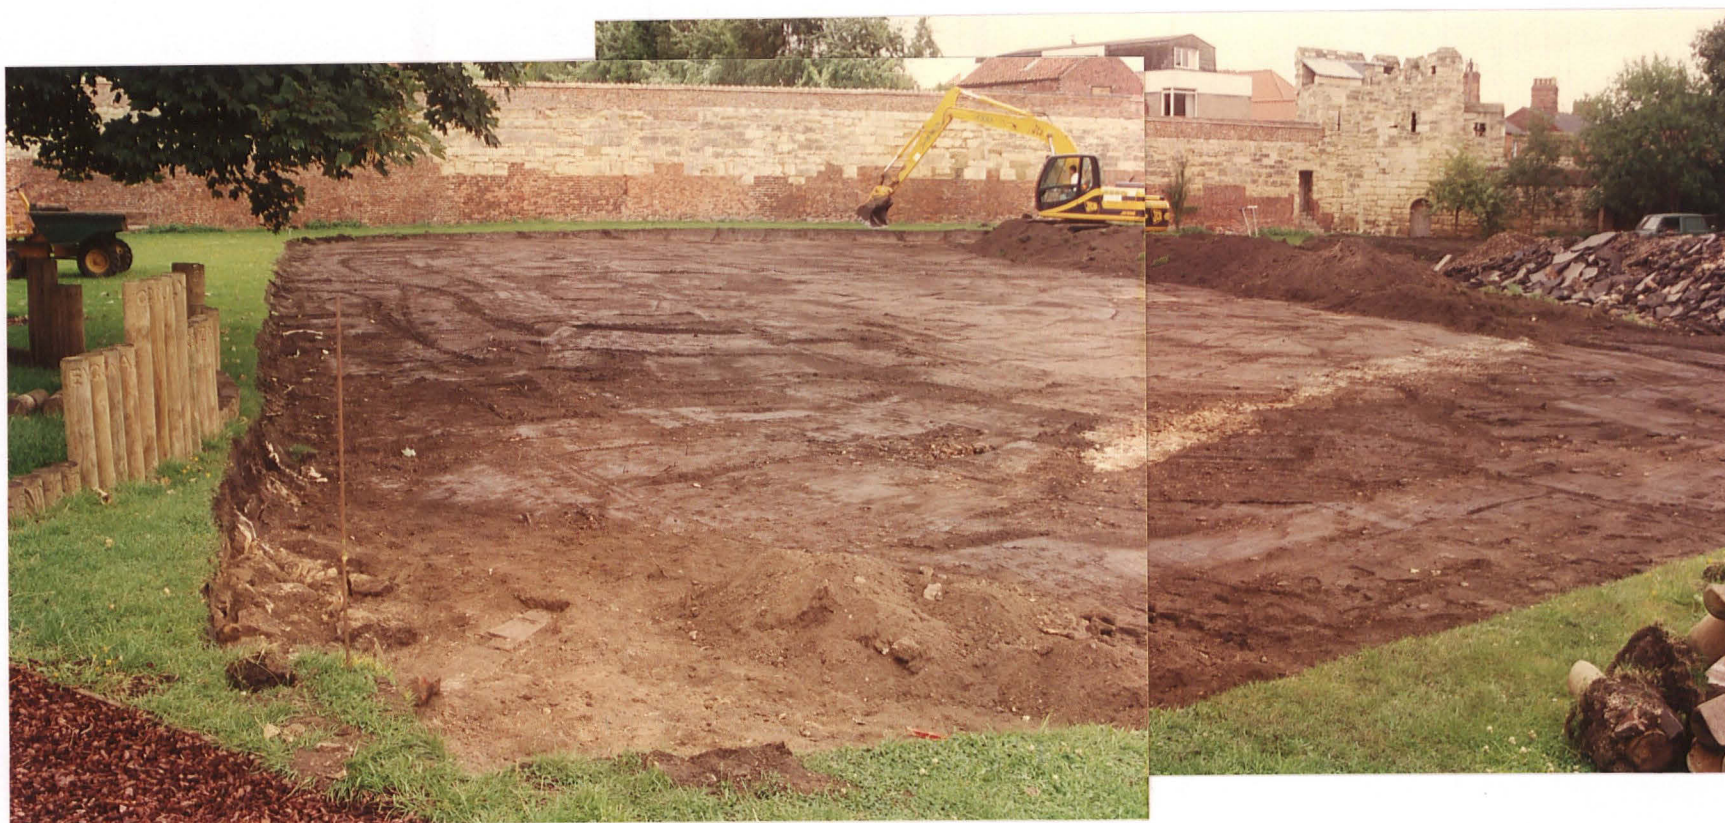
Pl. 4 Western side of the pitch area, after reduction. Stone rubble can be seen exposed (left foreground), as well as the mortar and rubble wall foundation 17 crossing the site. Looking east.

A mortared stone rubble foundation **17**, aligned west-east, was visible across the site between the tile-lined drain and the former tennis court (Pl. 4). This was not a regular width, and may have been a garden wall with adjacent structures or buttresses. It did not survive as far west as the robbed wall **9**, and it is not thought to have been contemporary with it. It could be contemporary with the upstanding wall to the SW of the new pitch.

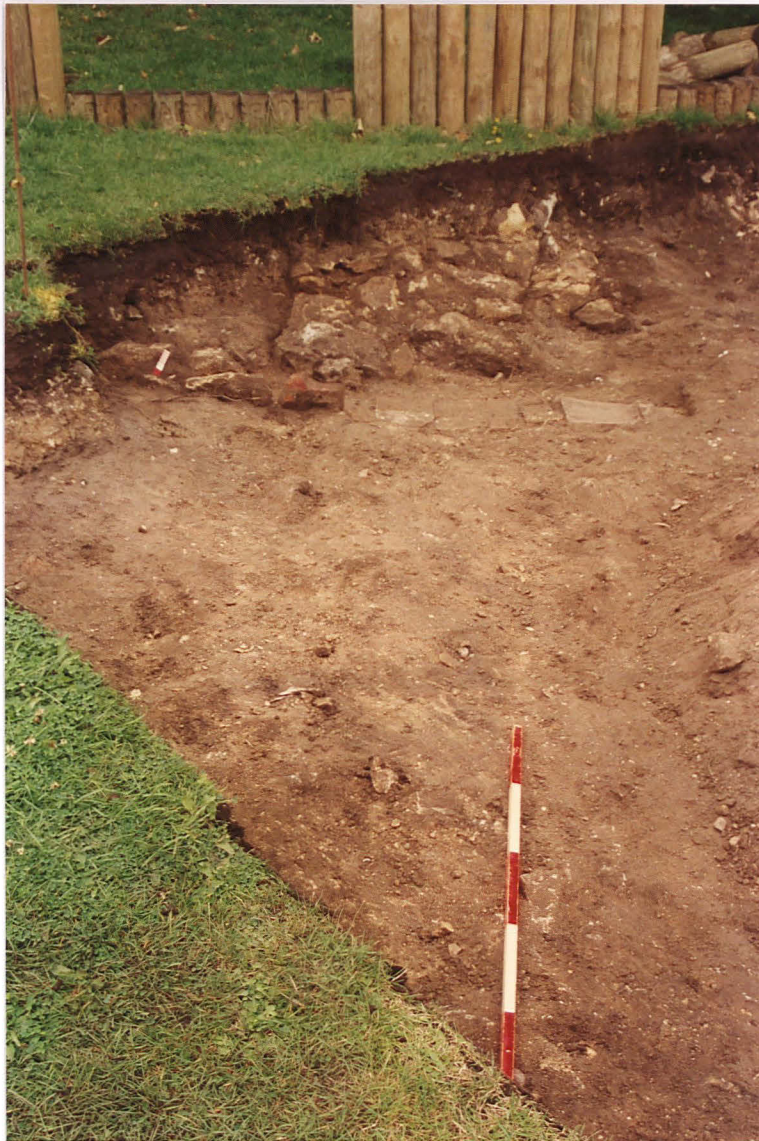
Pl. 5 Stone rubble of wall foundation 9, in the NW corner of the new pitch (looking NW). The 1m scale is aligned along the eastern edge of the robbed foundation, distinguishable by the cream mortar inclusions.

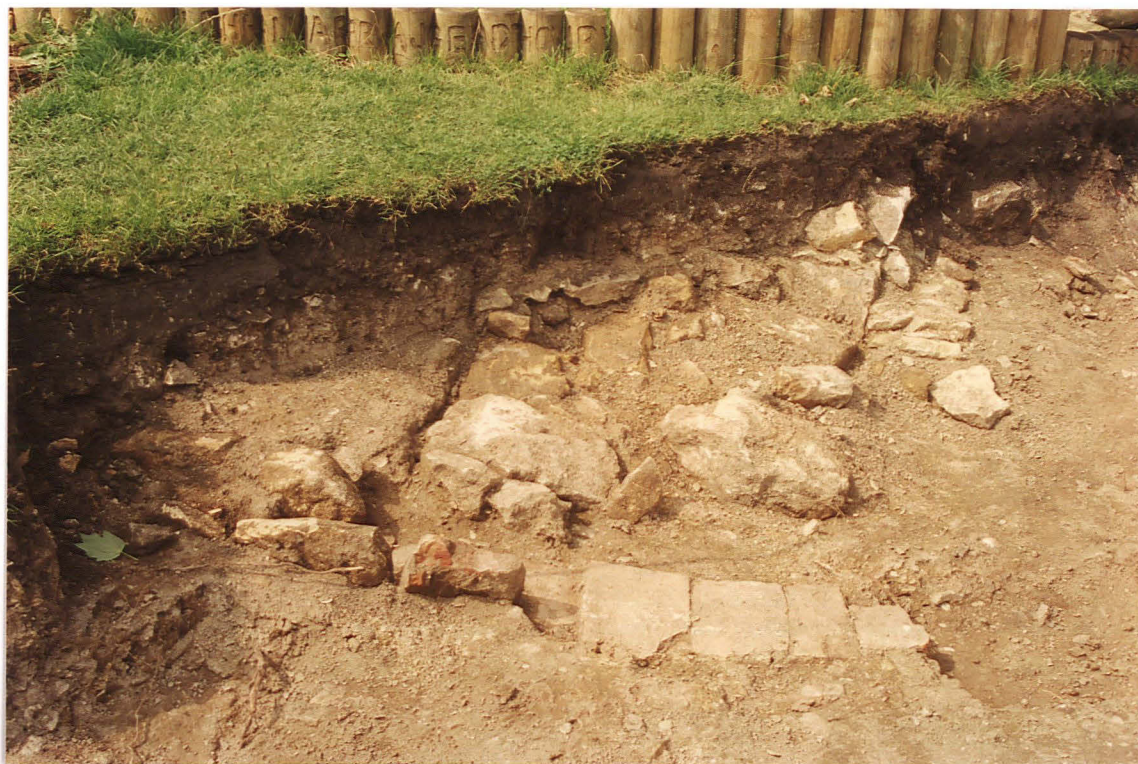
Pl. 6 Detail of the stone wall foundation 9, with the tile-lined drain 4 passing its southern edge. Looking NW.

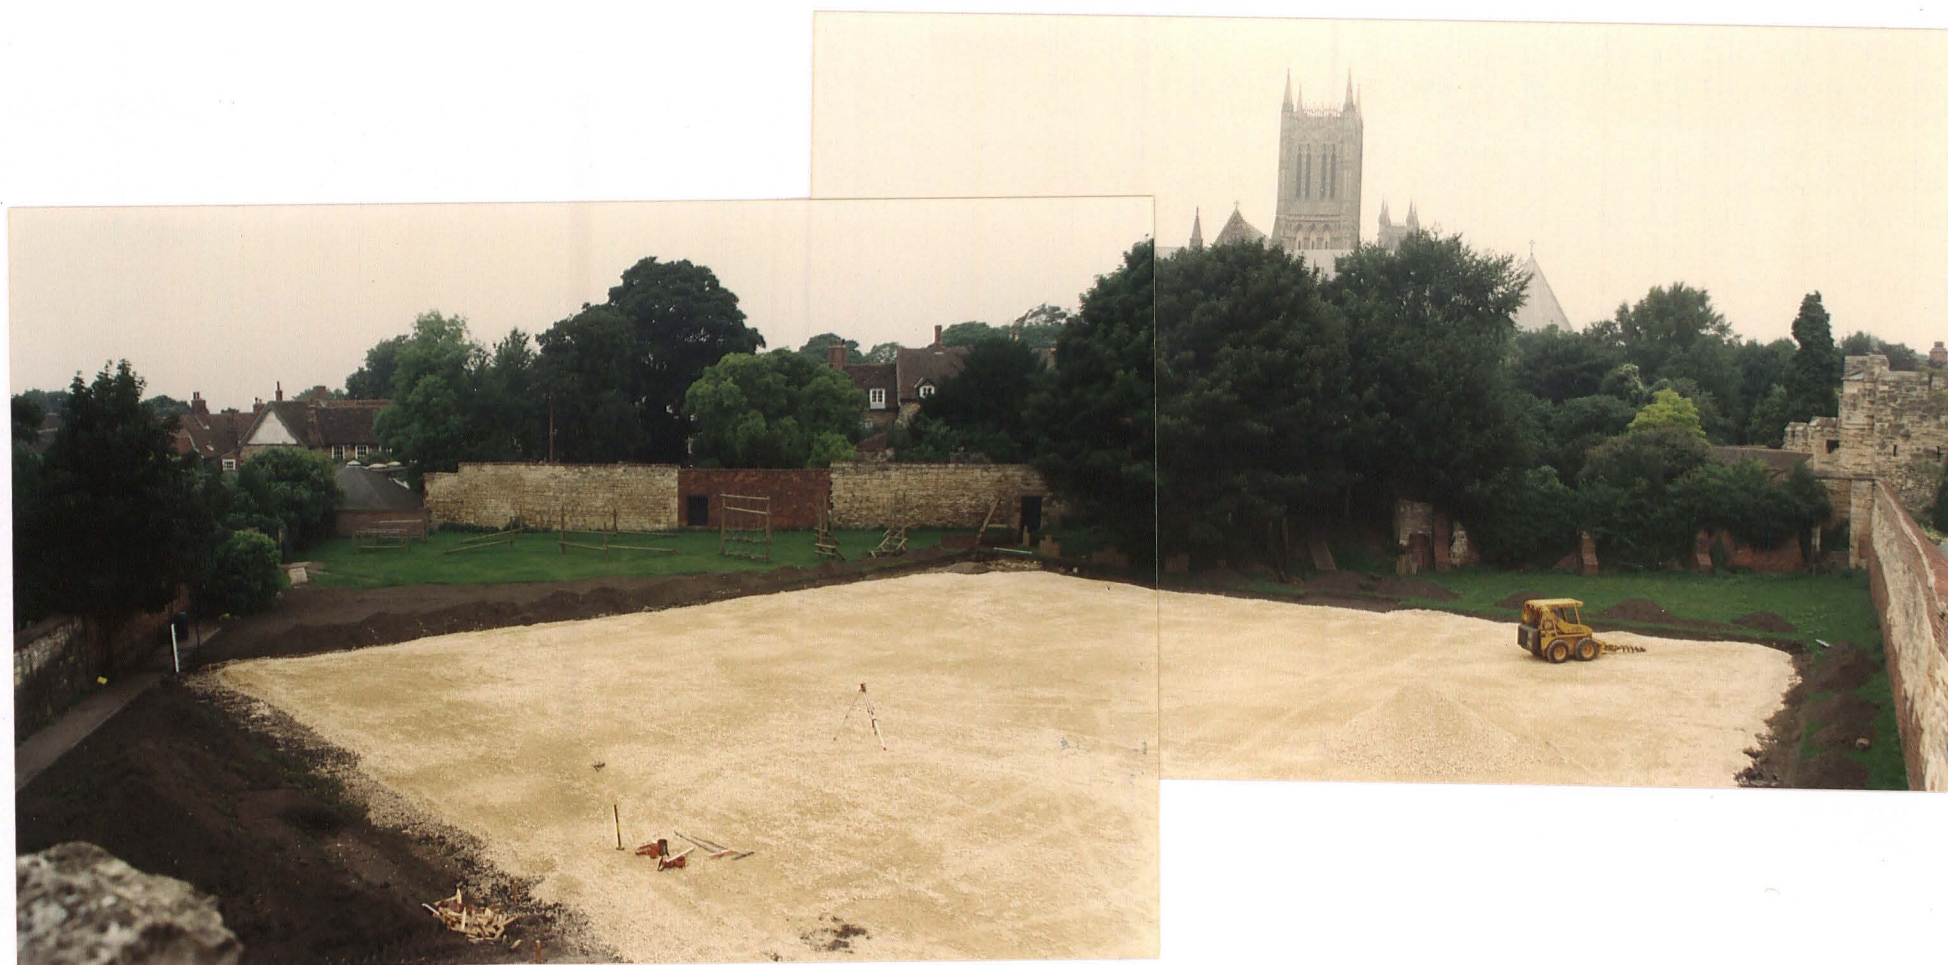
Pl. 7 Position of the wall foundation 9 (upper corner of pitch area) in relation to the upstanding boundary wall (upper left). Looking west from the Close Wall tower beside Winnowsty Lane.

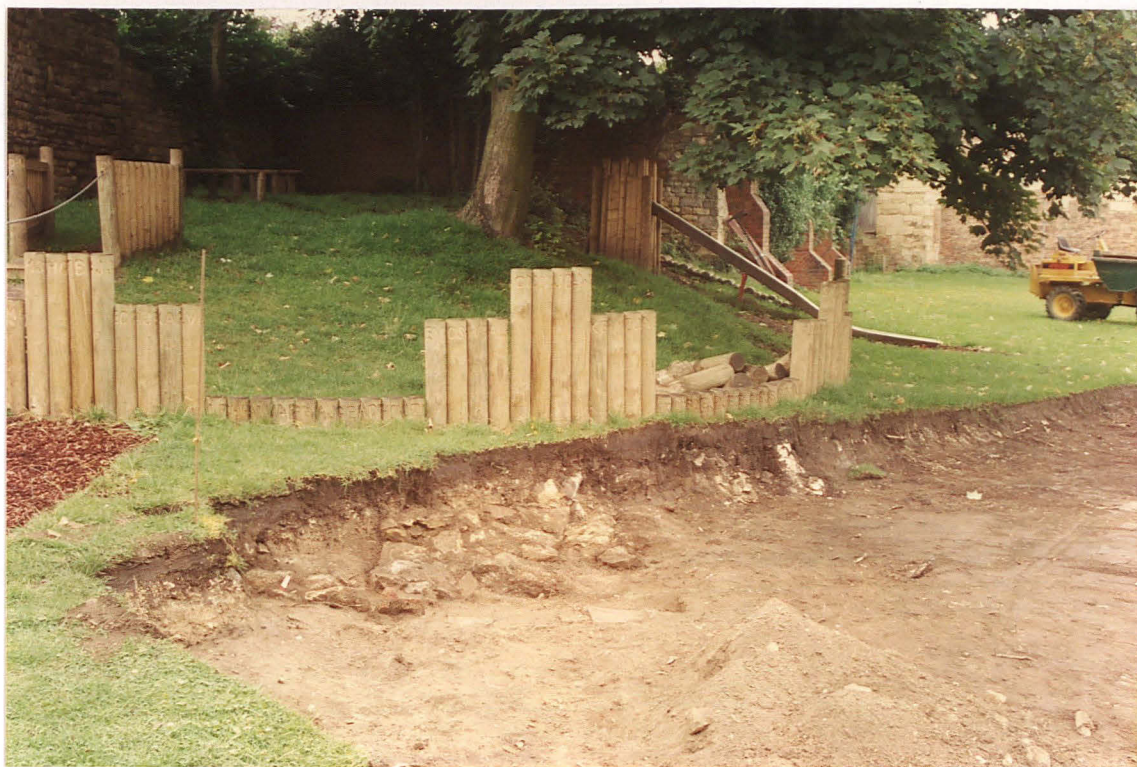
Pl. 8 Projection of the alignment of wall foundation 9 leads below the tree-planted earth mound, and coincides with a crack in the brickwork of the short brick wall beyond (looking NW).

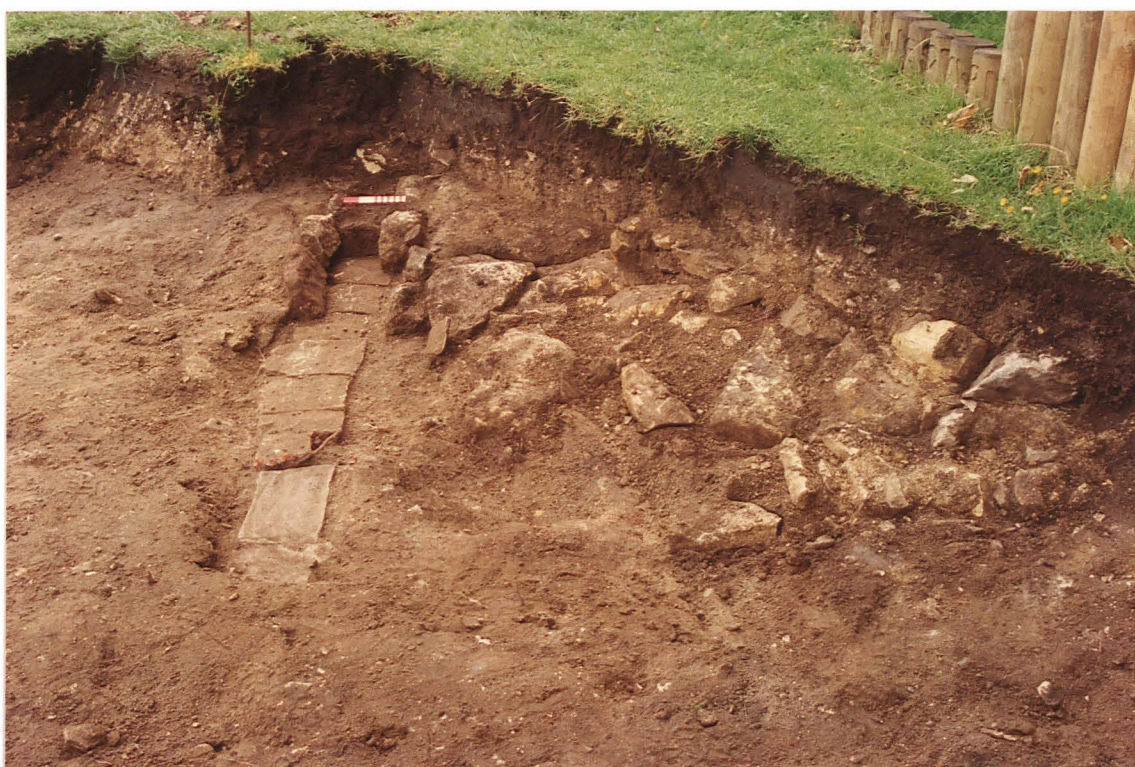
Pl. 9 Tile-lined drain 4 (after partial excavation of its silt fill), at the southern extent of the unrobbed wall foundation 9. Looking SW.

The drain was a roughly constructed feature, with re-used ceramic roof tiles placed as a lining along its base. The tiles had adhering mortar, but they had not been mortared in this position. One tile bore a 'nib', and has been dated on the basis of that feature to the fourteenth - seventeenth century. Other tiles were larger, with no surviving nibs, suspected to represent kiln damage. The drain sides were of limestone rubble placed on end, one stone high (0.15m - 0.2m), and 0.17m apart. A flat stone surviving in the excavation edge appeared to be evidence for a simple capping, but this may have been fortuitous arrangement of the more widespread rubble layer 3. The resultant 0.17m high channel was not entirely filled, but the 0.09m thick silt 3 contained fragments of bird bones and numerous land snails. The deposit was sampled for possible environmental analysis, but discarded after consultation with the environmental archaeologist.

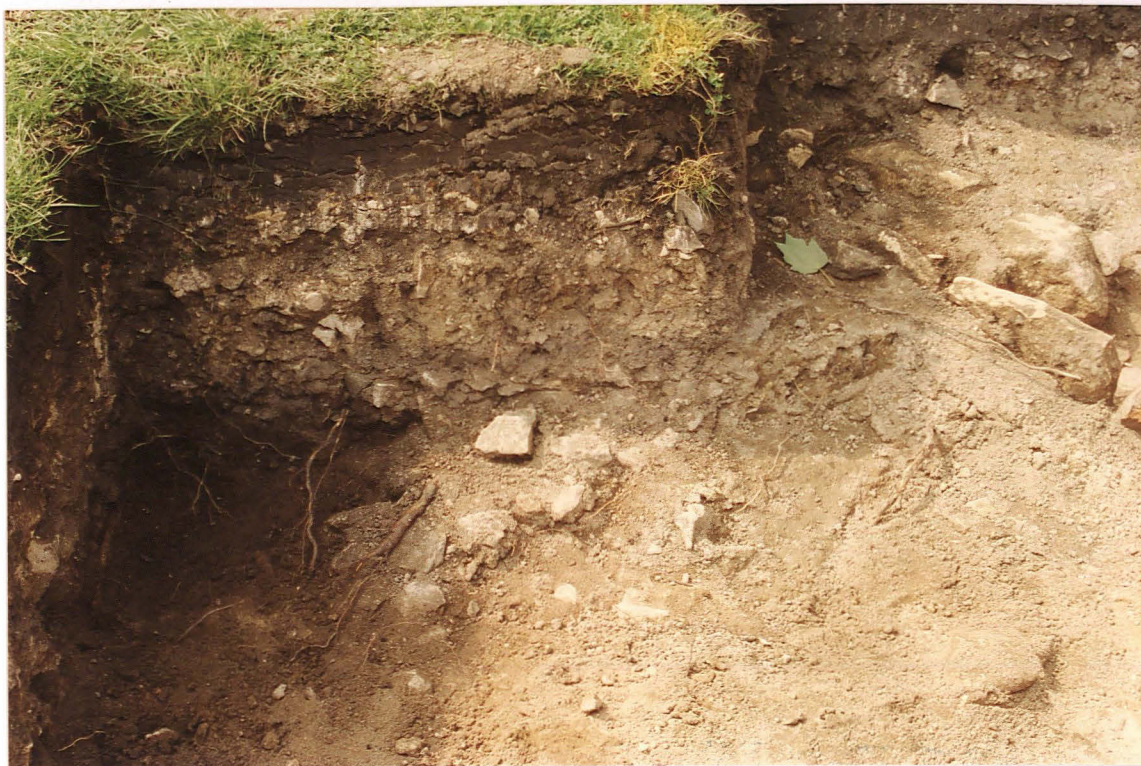
Pl. 10 Section at the trench edge, west of the robbed wall foundation. The turf and topsoil cover a layer of disturbed mortar and stone rubble, derived from the adjacent foundation. Below that deposit is a grey ashy layer, covering a thin band of small limestone chips. Looking SW.

To either side of the line of the stone wall foundation 9 were markedly different deposits. Disturbance around the visible foundation was too great to determine the stratigraphic sequence with certainty, but it is probable that a grey ashy layer 12 on the western side (and an underlying 0.05m thick layer of stone chips 14) were contemporary with the standing wall (Pl. 10). The very small area seen this side of the foundation makes it impossible to make any conclusions regarding the medieval ground surface here.

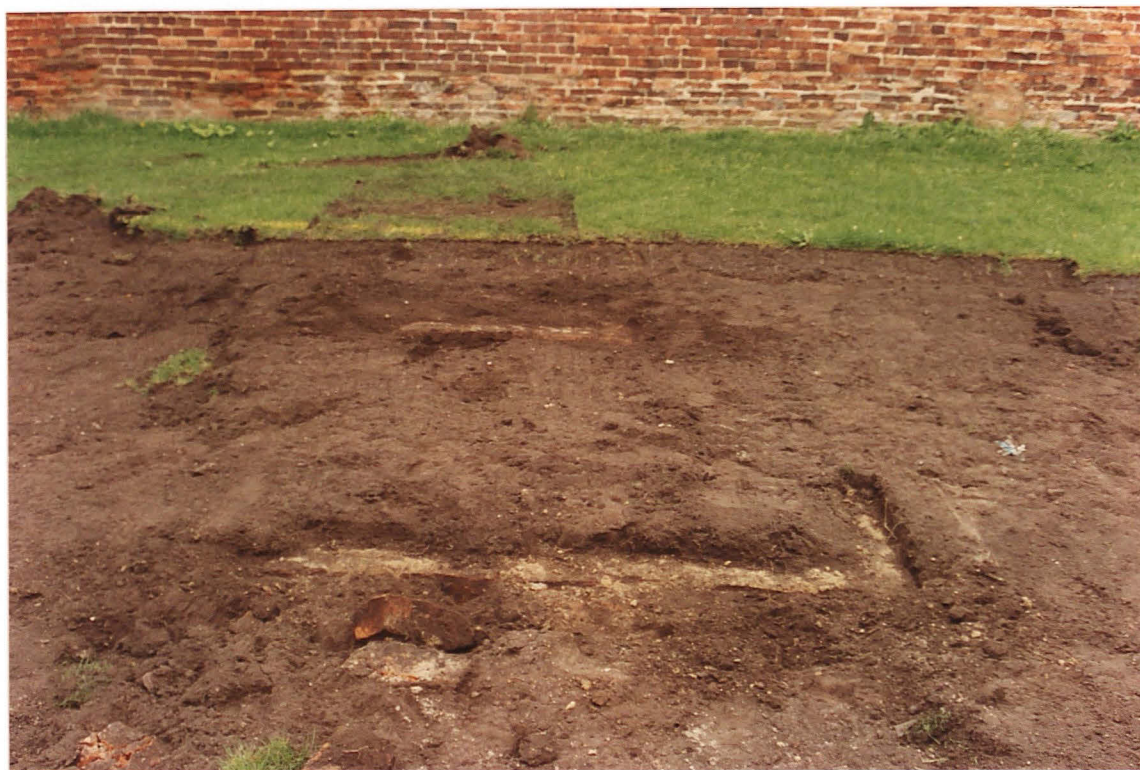
Pl. 11 Mortared brick foundations 15 (upper) and 16 (foreground), near the upstanding repaired Close Wall (looking NE). The foundations are interpreted as the base for a coldframe or other garden feature.

At the northern edge of the area stripped for the new pitch, the SE corner of two small brick foundations were exposed below the turf (Pl. 11). The northerly one **15** survived to at least two courses deep (brick dimensions 225mm x 110mm x 75mm), while the other **16**, about 1m to the south, was at least three courses deep (225mm x 110mm x 80mm). This structure seemed to be a support for a garden or school activity feature, such as a coldframe or barbecue. Isolated patches of ash and pea-grit, apparently from a removed, relatively modern, path, were not assigned context numbers.

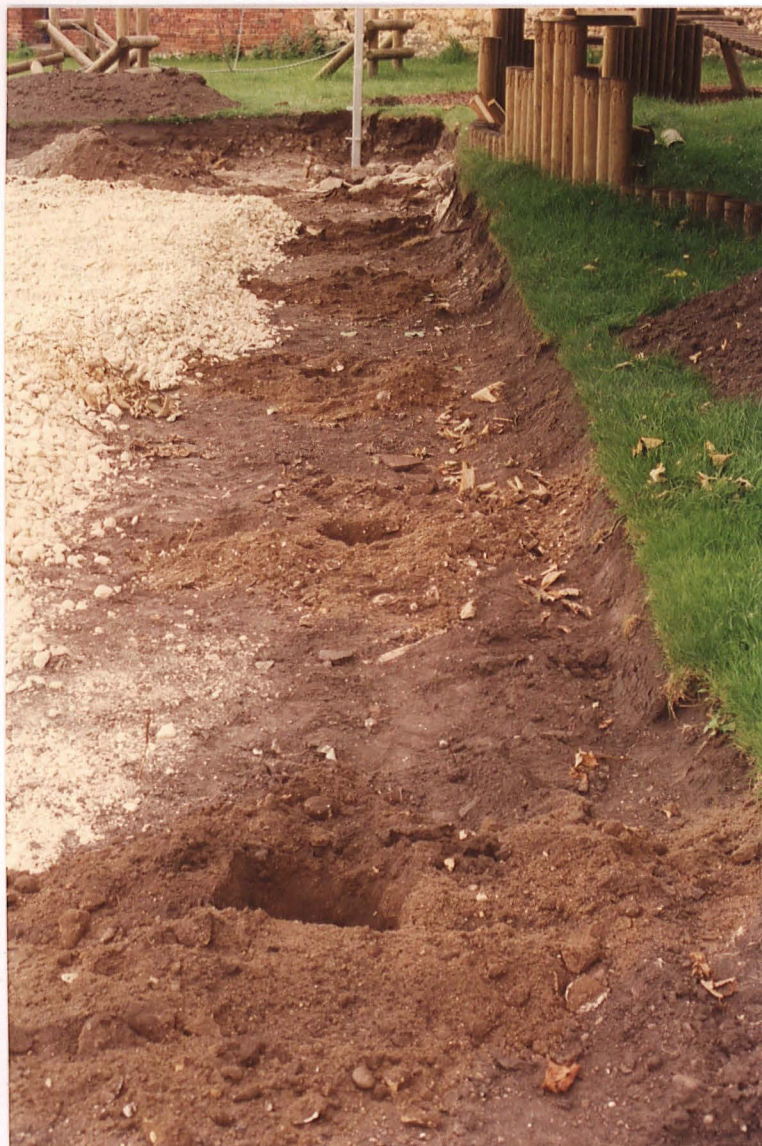
Pl. 12 Augered fence posts around the NW perimeter of the new pitch (looking SW).
Oyster shells can be seen in the upcast beside some holes.

A machine-mounted auger was used to excavate post-holes around the perimeter of the new pitch, 55 of which were inspected after excavation (Pl. 12). The holes were 0.25m diameter, with the edges of most holes at spacings of about 2.05m. The base of the holes was at about 0.6m below the stripped surface. Loose soil partly obscured the base of the holes, and the auger action pushed material into the sides of the holes, but some indication of the deposits present was obtained from the visible sides. Numbers were assigned to each hole by LAS for recording purposes, starting with **31** and continuing anti-clockwise to **82** in the NW corner of the new pitch, with **83-85** in the other corners.

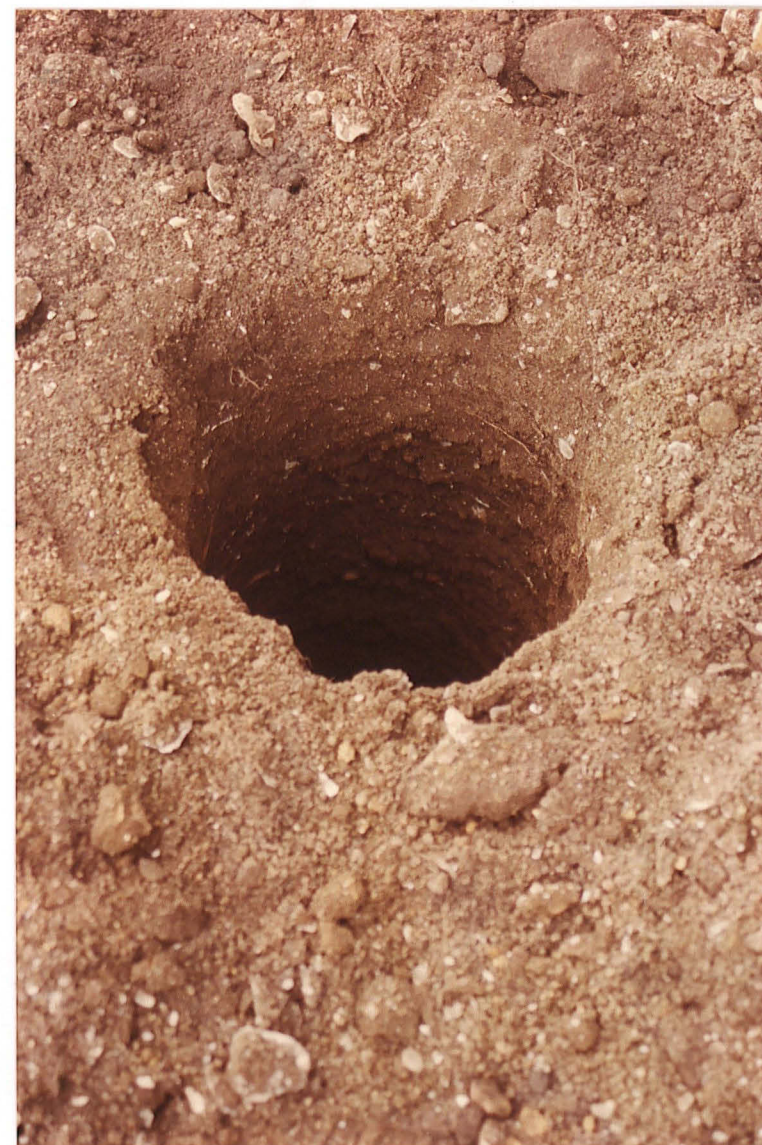
Pl. 13 Smeared side of auger hole 65, where numerous oyster shell fragments
suggested underlying Roman rubbish deposits.

Alongside the Close Wall, stone rubble and yellow clay was revealed in **62** and **68**, with a sherd of Roman pottery in **66** and oyster shell fragments in **65** indicating a rubbish deposit probably of Roman date. The NW side produced mixed results, with brick rubble, cream-coloured clay and stone rubble. In the western corner, either side of the exposed archaeological remains, oyster shells and Roman pottery indicated another Roman rubbish deposit (Pl. 13). **41**, near the southern corner, cut through a compact thin layer of brown ash (black at its base) which may have been a hearth or bonfire site of unknown date (Pl. 14).

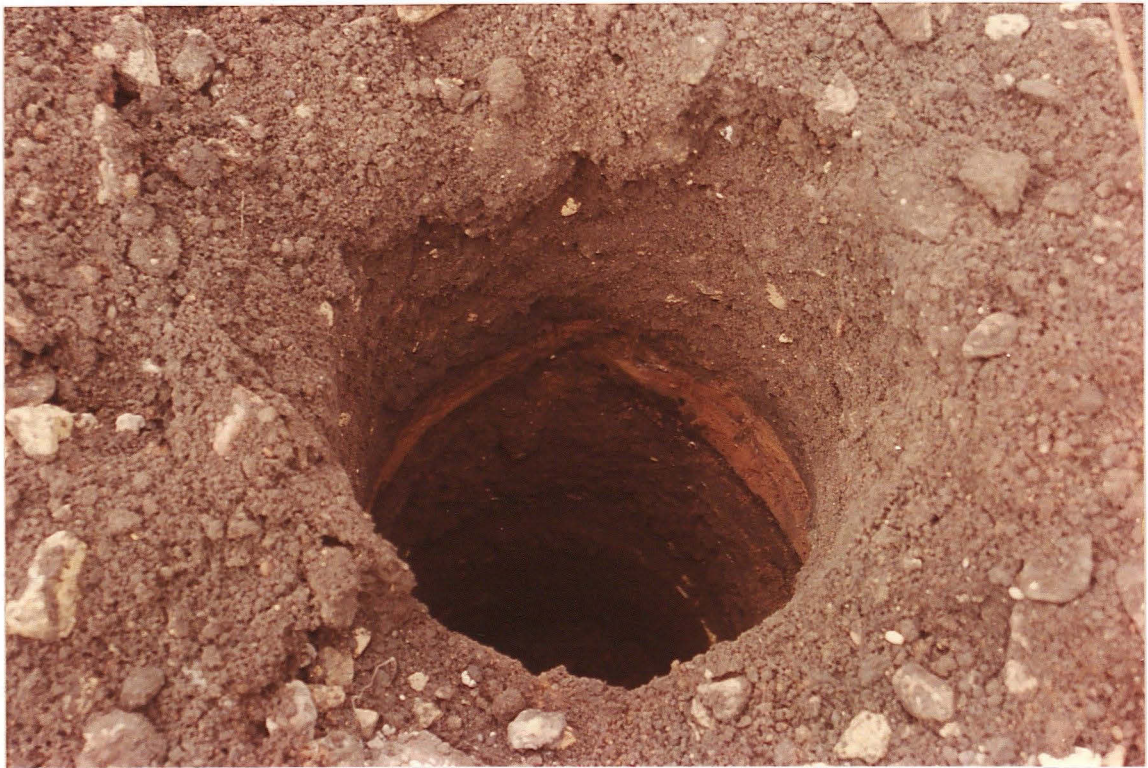
Pl. 14 Auger hole 41 cut through a feature with burnt material, possibly a hearth.

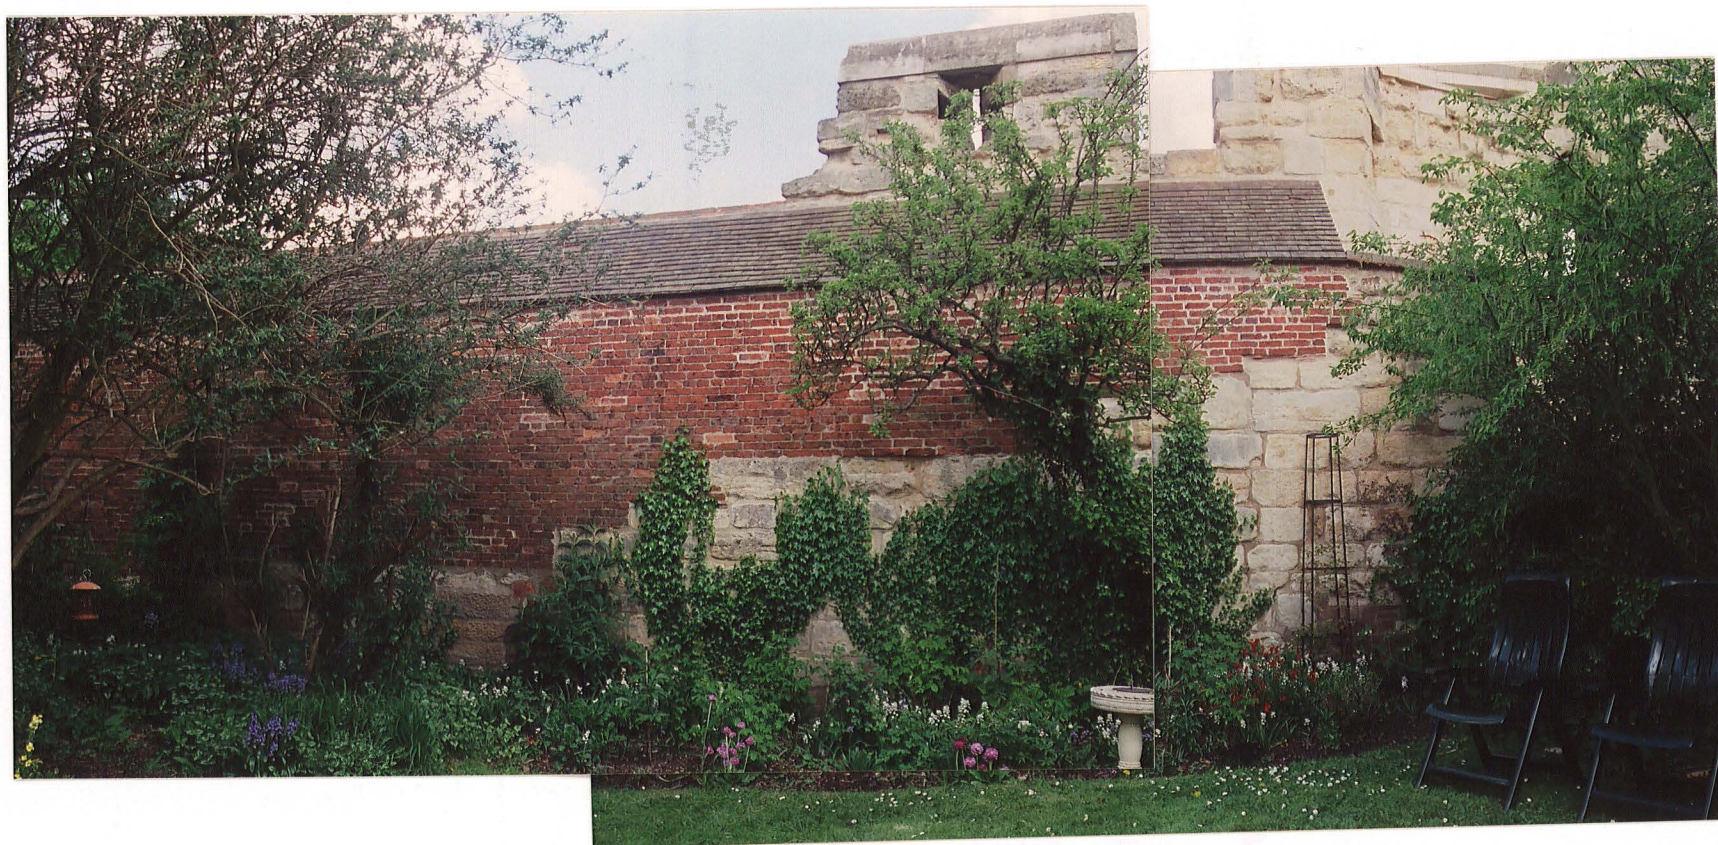
Pl. 15 The Close Wall forms part of the northern boundary wall of the garden of 10, Pottergate (looking north). On the projected line of the wall foundation 9, the Close Wall is of different construction, with pecked limestone blocks in the lower courses, and brickwork above. This may mark a blocked entrance on the line of the medieval lane.

A projection of the alignment of wall foundation 9 passes the western edge of the Church of St Peter in Eastgate, the conjectured position of the lost St Peter's Lane. Although no features are apparent within the lawn of the garden NW of the school premises, a 6m wide stone and brick blocking of the Close Wall (on the projected alignment) may mark a former entrance through the Close Wall (Pls. 15 and 16). The blocking bricks are 223mm x 105mm x 55mm (probably later than sixteenth century), above pecked dressed limestone blocks.

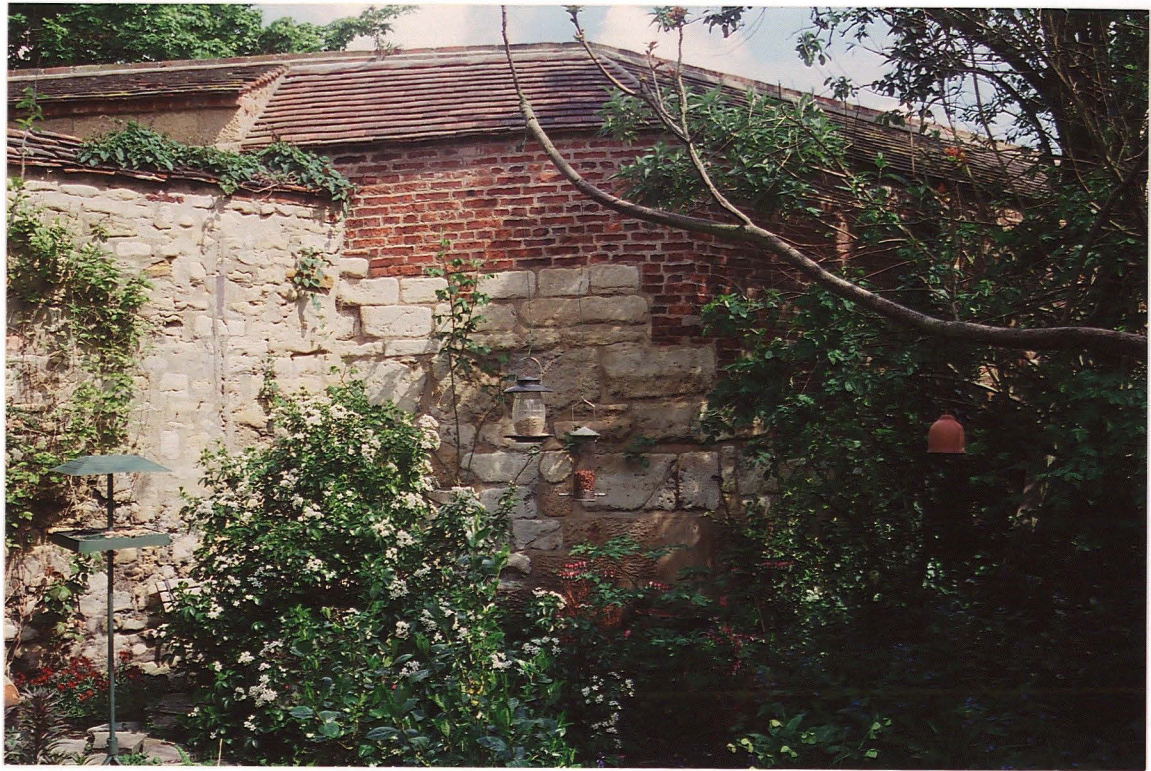
Pl. 16 The pecked limestone blocks in the Close Wall extend as far west as the corner of the wall (looking NE).
