Archaeological Watching Brief
of a Water Pipeline at Manor
Farm, Friskney, Lincolnshire.

**ARCHAEOLOGICAL WATCHING BRIEF
OF A WATER PIPELINE AT
MANOR FARM,
FRISKNEY,
LINCOLNSHIRE**

Work Undertaken For
Anglian Water Services Ltd.

April 1994

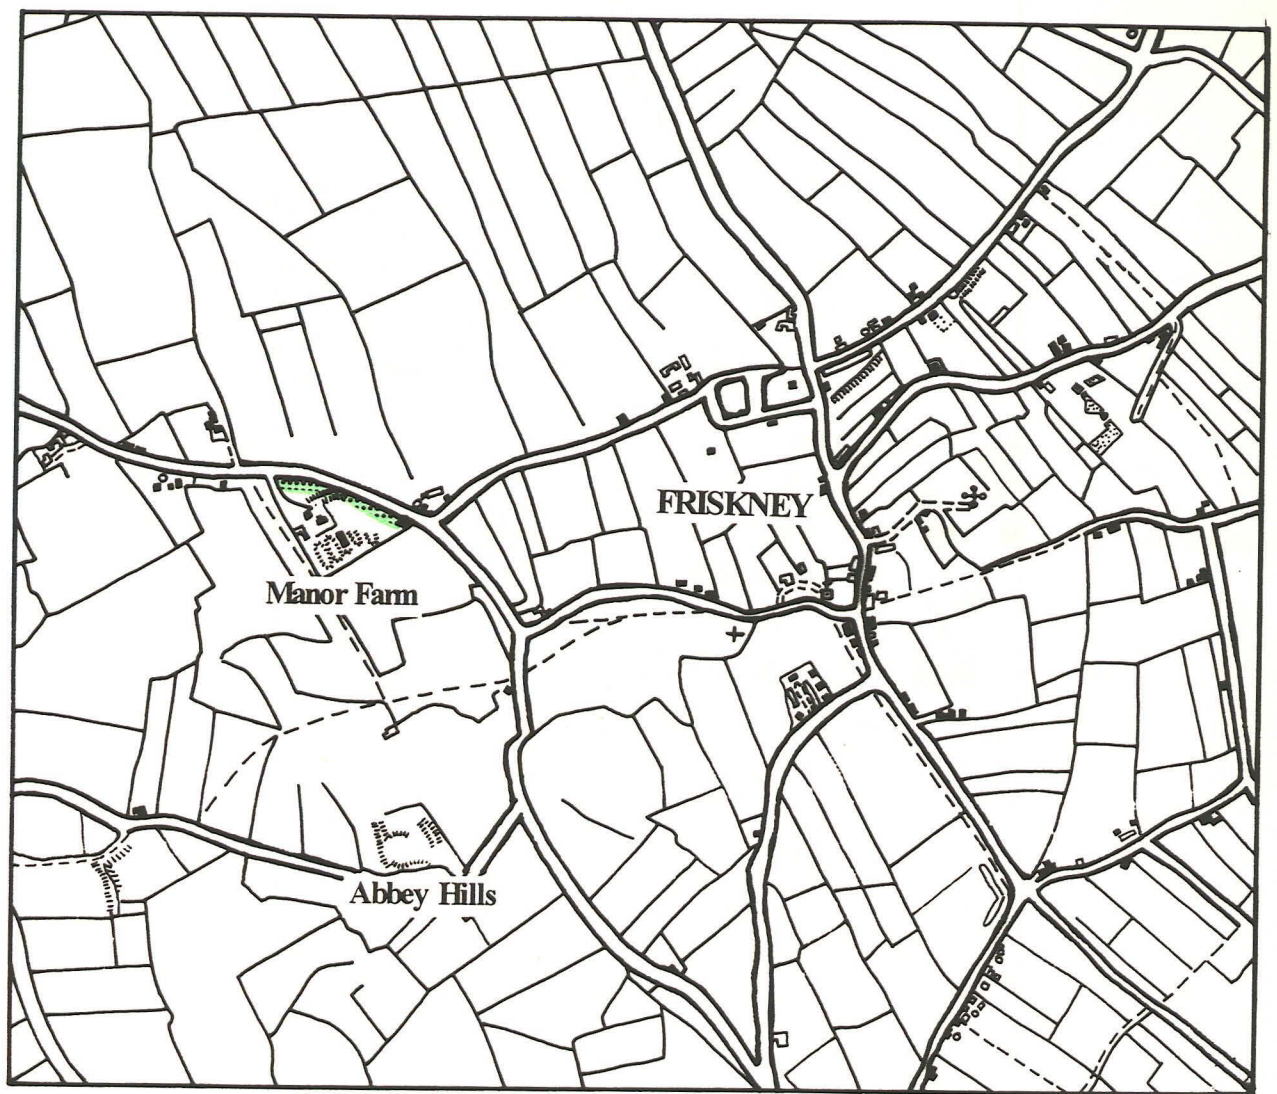
Fig. 3 SITE PLAN

A 10m wide easement along the northern boundary was stripped of topsoil. A mechanical excavator was used for the construction of the pipe trench, that measured *c.* 1m wide and varied between 1.3m to 2.5m deep. See Fig. 3 for a plan of the trench and the location of the recorded sections.
