**ARCHAEOLOGICAL WATCHING BRIEF  
OF DEVELOPMENT ON LAND AT  
10 EAST STREET,  
RIPPINGALE,  
LINCOLNSHIRE.  
(RES02)**

Work Undertaken For  
Mr. W A Gadsby

Report Compiled by  
Steve Thomson BSc (Hons)

A.P.S. Report No: 97/02

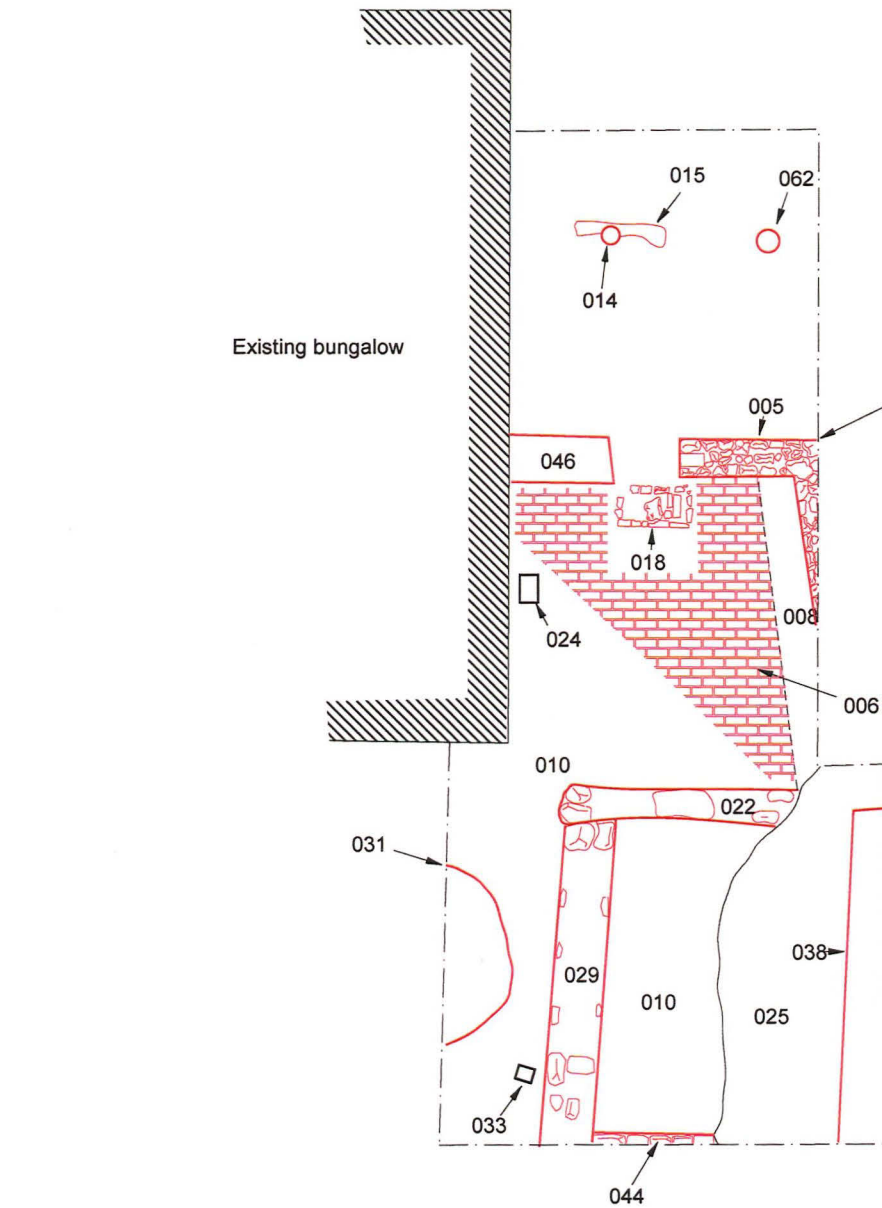
Fig.5a

Figure 5a - Plan of stone post/column pad

Located on the corner of foundation (005) was a probable post or column pad (009) (Fig.5a). The pad was constructed of ashlar limestones sawn to copy handmade brick shapes and measured 0.56m north-south and 0.5m east-west. A depression was visible in the centre of the pad possibly suggesting that it supported weight though this could equally be due to later disturbance.

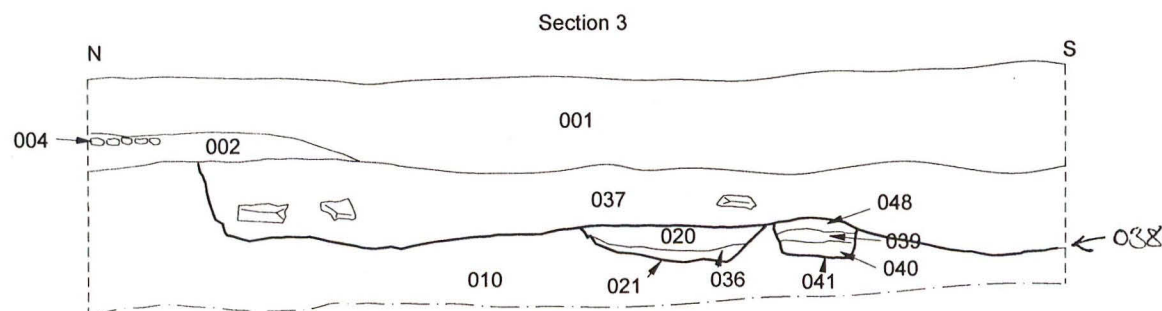
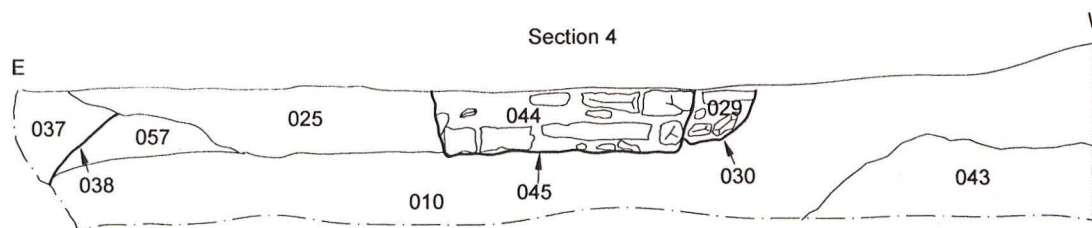
Figure 8 - Section drawings 1-4

A rectilinear cut (028) (Fig. 4a, Fig.8-Section 1), measuring 3.3m north-south, 1.5m east west, up to 0.6m wide and 0.18m deep was interpreted as a foundation trench. The cut was filled with a mid-grey sandy clay (027) containing frequent charcoal fragments, small limestones and sandstones. Pottery of the 12<sup>th</sup> - 13<sup>th</sup> centuries, fired clay, a flint flake and animal bone was recovered from (027).

A series of limestone wall foundations (005, 046, 022, 029, 037, 044) (Fig.4, Fig.8 - Sections 3 & 4) defined part of a structure. The foundations comprised a mix of roughly hewn, faced, ashlar, flagstones and moulded stones. A relief carving and

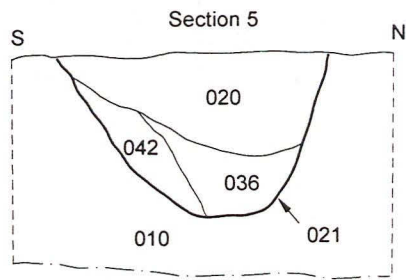
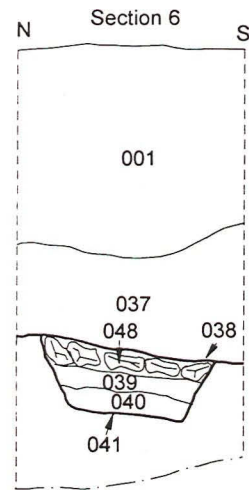
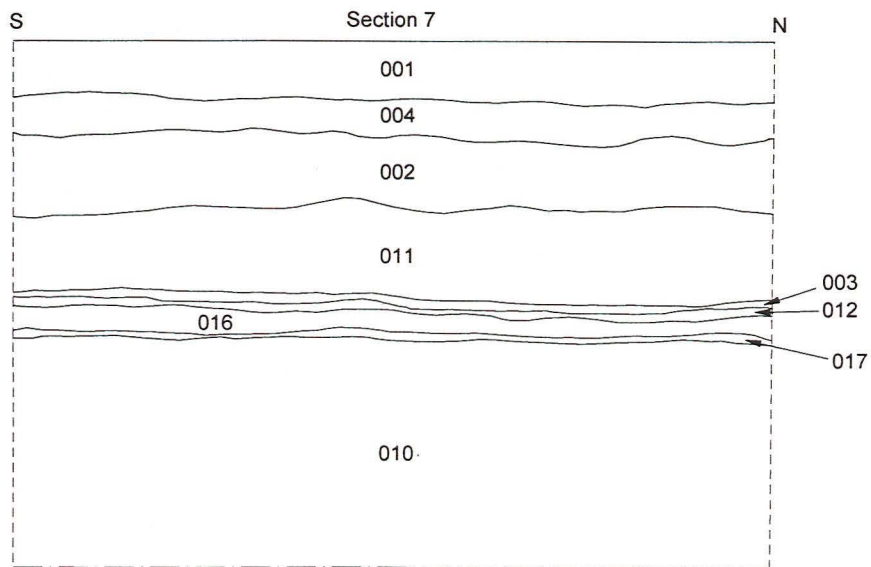
Figure 9 - Section drawings 5-7

To the north of wall foundations (005 & 046) was a 6-10mm thick white mortar (017) (Figs. 9 & 10 – Sections 7 & 8), extending 4.1m north-south and 4m east-west. The layer abutted the wall foundations and represented a floor surface.

Overlying (017) was a 50mm thick light brown sandy clay (016) which in turn was overlain by a mid-yellowish brown sand (012). Both deposits were interpreted as make up layers for a light whitish pink sandy mortar floor (003) (Figs. 9 & 10 – Sections 7 & 8). The mortar floor (003) also extended over approximately 4m north-south and east-west and abutted the wall foundations. However, (003) was truncated

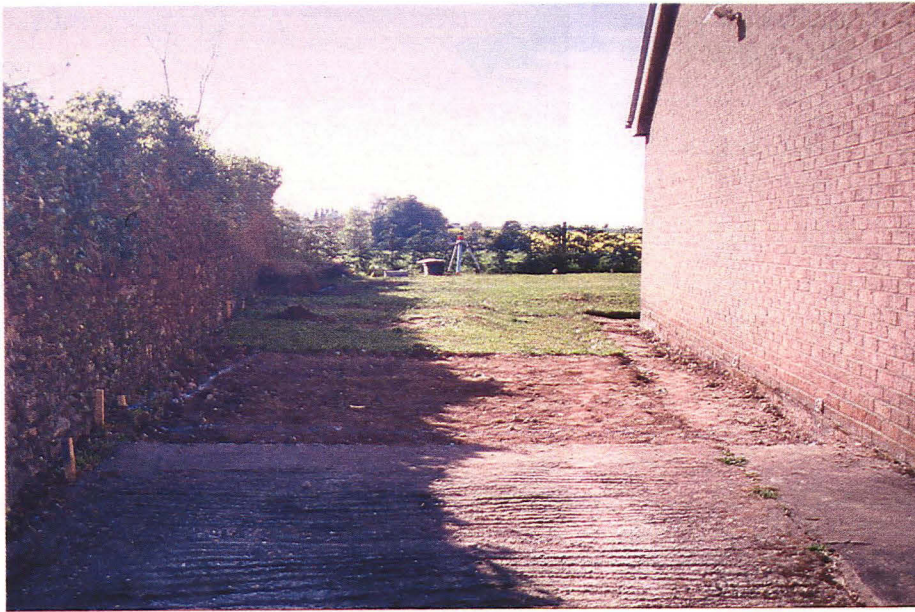
Plate 1 General view of site prior to groundworks looking south

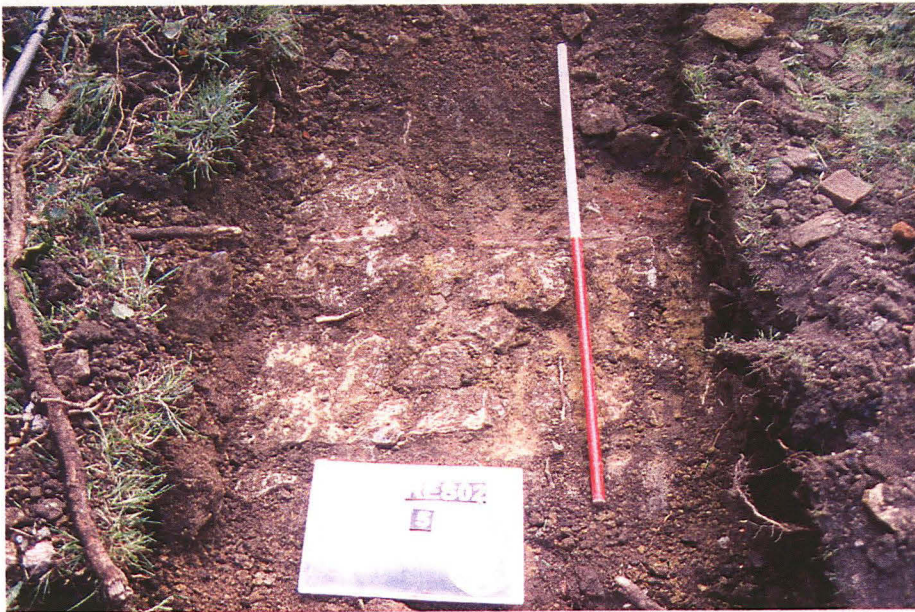
Plate 2 Wall foundation 005, looking south

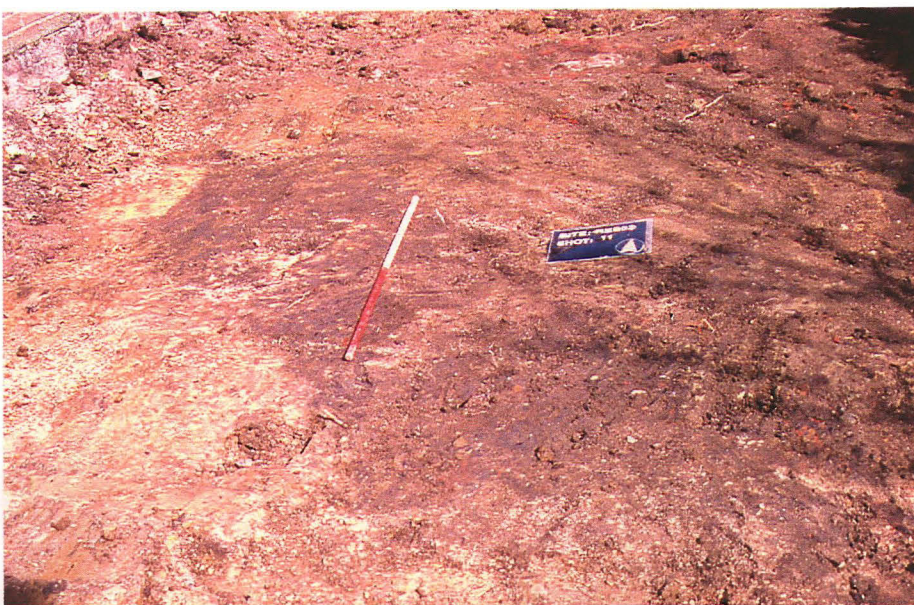
Plate 3 Ditch 021, looking south

A medieval ditch was observed aligned northwest – southeast, and interpreted as a boundary ditch. This makes its alignment of particular interest. If East Street represents a fossilisation of a medieval street, then the ditch may represent an early phase of the medieval village's development, suggesting an agricultural field boundary lying outside of the nucleus of a fledgling Rippingale. Alternatively the ditch may represent a property boundary, indicating a different route for the medieval street and possibly the layout for the village. The village exhibits a bi-focal layout with two main thoroughfares north and south with boundaries of many of the burgess plots surviving (Fig. 6 & 7). If an earlier focus on a northeast-southwest alignment can be postulated in the southern half of the village, it may be possible to suggest an element of replanning the layout for the village in the early medieval period.

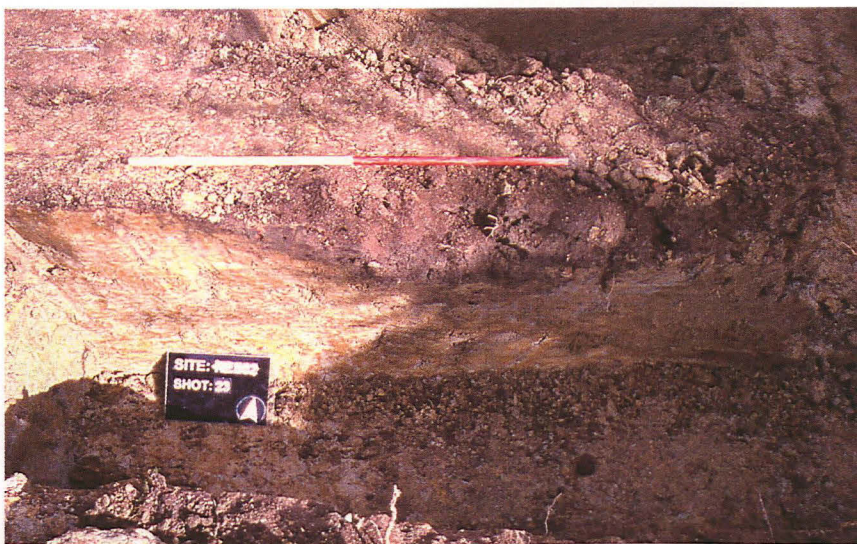
Plate 6 Ditch 021, section 2,  
looking north

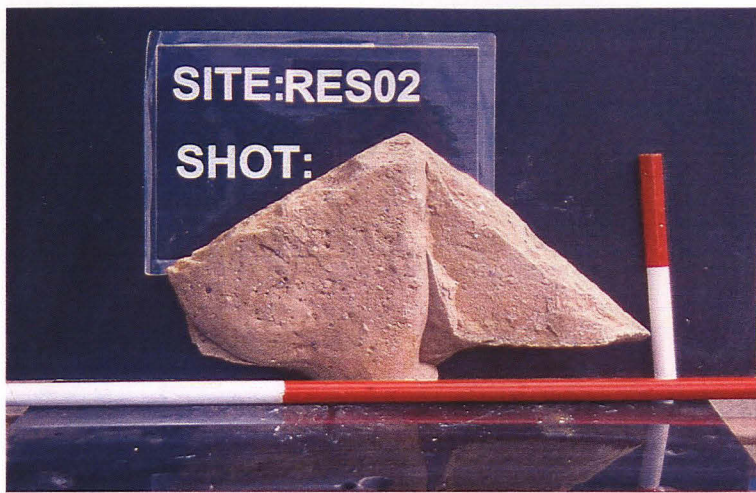
Plate 7 Carved stone  
animal torso

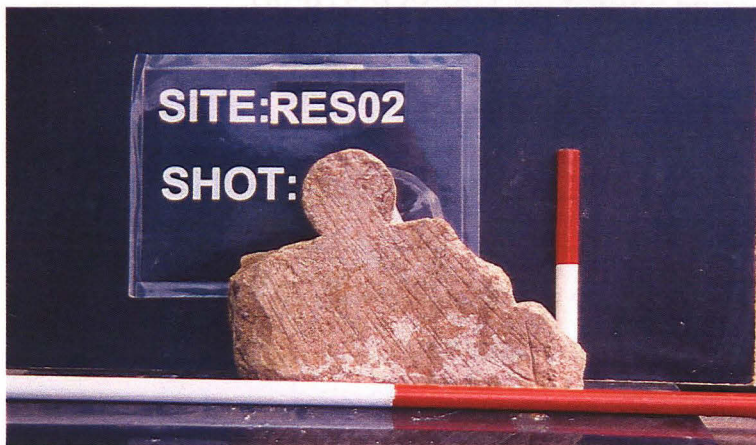
Of particular interest is the reused masonry recovered from the foundations. One moulded piece is almost certainly medieval in date (Plate 8). This piece may have derived from either an ecclesiastical or secular building. However, the location of chapel fields to the southeast of the development (Fig. 6) is likely to relate to the 14<sup>th</sup> century 'Holy Chapel of The Cross'

Plate 8 Carved stone  
angle roll, door or  
window surround

Four pieces of moulded masonry were collected. One is a probable door jamb with ovolo (quarter round) moulding at the corner. This is likely to be post-medieval in date and comparable moulding occurs on buildings dating from 1570-1698 (Alcock and Hall 1994, 54). Additionally, this form of jamb moulding often occurs in association with ovolo-moulded window mullions of the period 1567-1741 (*ibid.*, 38), but has also been noted in earlier windows dating to the later medieval period, including at Caythorpe church. The second piece has a torus or half-round moulding and may be part of an angle roll of a door or window surround (Curl 1999, 560; Pevsner and Wilson 1998, 748). This is likely to be medieval in date and would have derived from high status stone structure such as a church, chapel or manorial establishment. Too little survives of the remaining two pieces for their form to be accurately determined. One is a small shaft that may be from an angle roll or similar. Column drums of similar form and dimensions may also form the newel that a spiral staircase rotates around, such as the later 15<sup>th</sup> century example at Tattershall Castle. However, there is no clear evidence that any of the other masonry forms part of a stair slab associated with such a newel column. The other moulded piece is a concave or cavetto moulding and is likely to be from a door or window jamb but could be part of an angle roll or similar part of a door join.

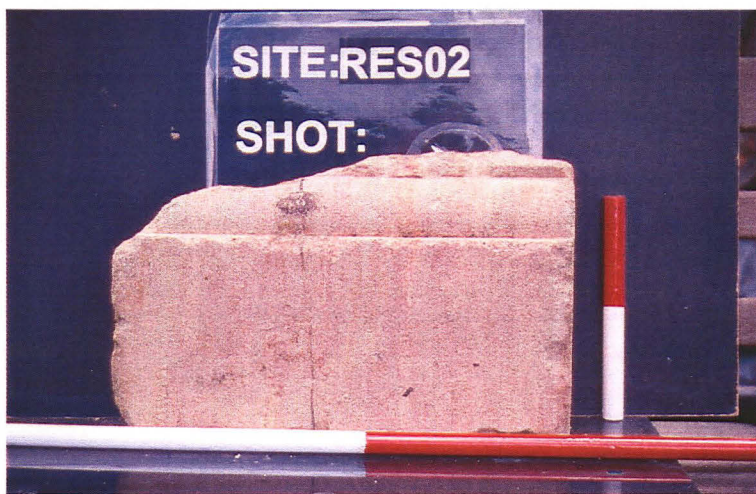
Further piece of dressed masonry appears to have had three separate uses (Plates 9 & 10). The primary use appears to have been as a door or window jamb. A secondary use as a flagstone is evidenced (Plate 10) by the characteristic wear concavity to one side. A final use is found in the foundations of the building identified on the development site.

Plate 9 Masonry with  
ovolo moulding

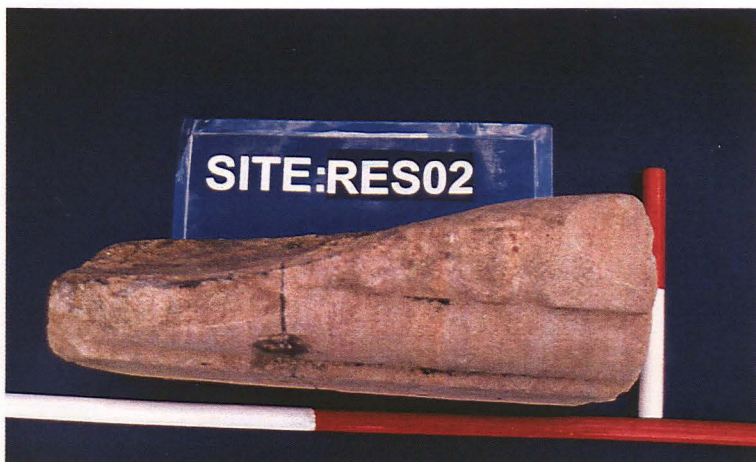
Plate 10 Side view of  
moulded masonry  
showing wear concavity

Pieces of several separate flagstones and one of ashlar were recovered and all display pronounced wear on one face. On most of these flagstones the wear forms a distinct cavity that is located to one side of the piece and in from the ends. This is characteristic of stones used as thresholds or steps. As there are several such pieces it is likely that they derive from a flight of steps.
