# ARCHAEOLOGICAL WATCHING BRIEF AT EMPINGHAM ROAD, STAMFORD, LINCOLNSHIRE

Work Undertaken For Anglian Water Services Ltd.,

Report Compiled By Paul Cope-Faulkner

May 1994

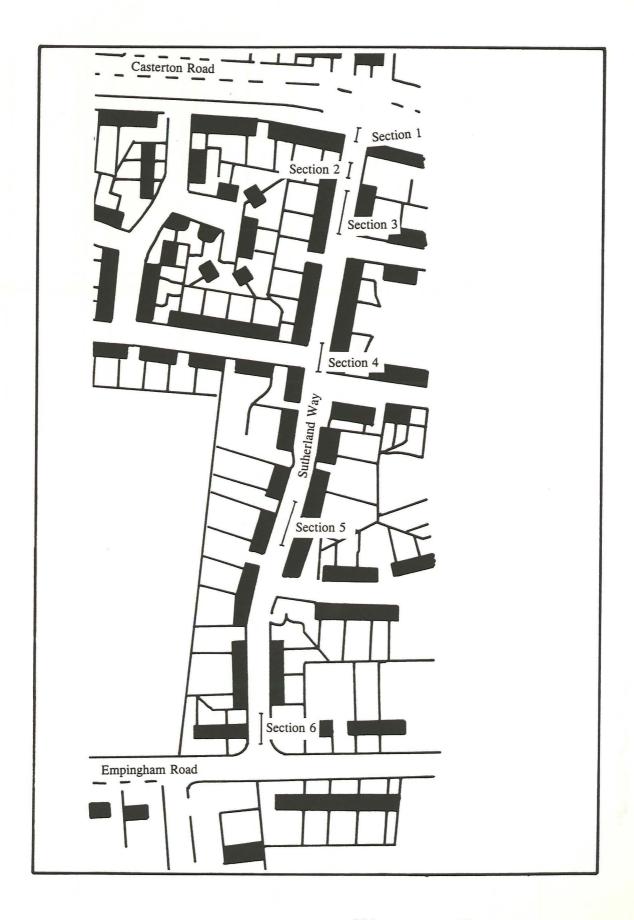
A mechanical excavator was used in the construction of the pipe trench, which measured 0.6m wide and averaged 1.3m in depth. See fig. 3 for a plan of the route of the trench and location of the recorded sections. The sides of the trench were cleaned by hand and inspected for archaeological remains prior to recording the sections. Each archaeological deposit revealed within the pipe trench was allocated a unique reference number with an individual written description. A photographic record was compiled and sections were drawn at scale 1:20. Additionally, the natural geology was recorded.

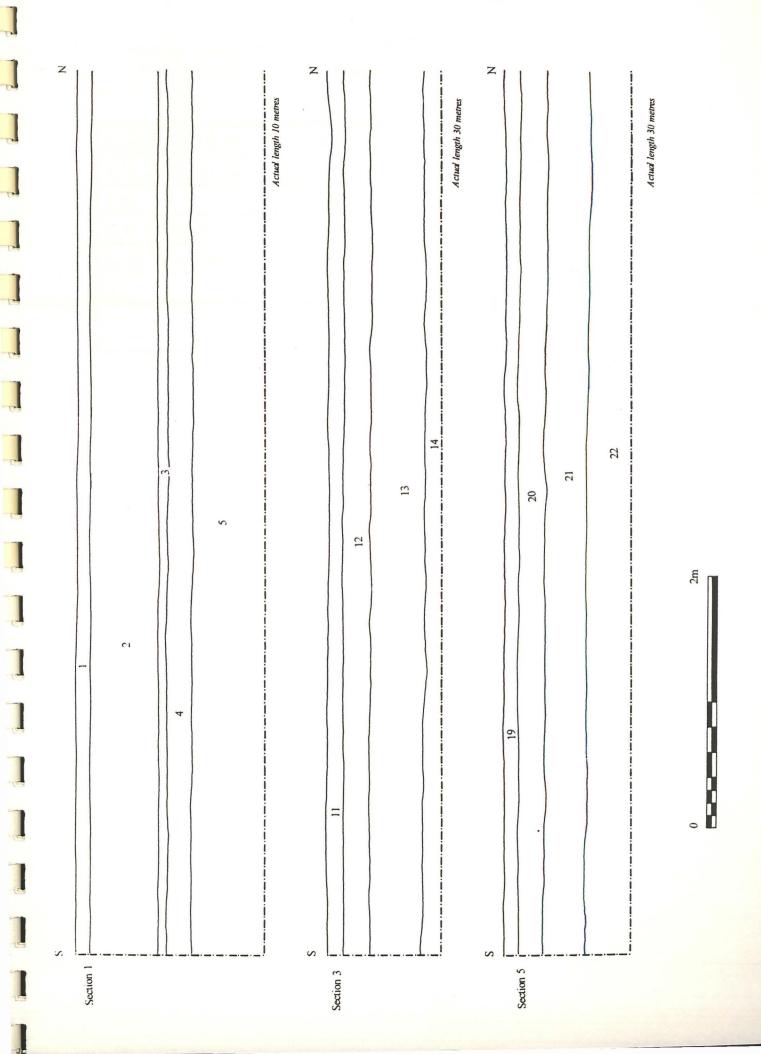
Sealing the oolitic limestone in sections 1, 2, 3, 4 and 6 was a brown-yellow silty clay frequently containing limestone fragments. This layer is interpreted as a disturbed subsoil. This subsoil was also encountered in section 5, except that here it was a brown-grey silty clay.

Sealing the subsoil at the northern end of Sutherland Way (section 1) was a layer of yellow brown clay containing 50% limestone fragments. This was sealed by a layer of road tarmac, that in turn was sealed by a layer of crushed limestone. This was overlaid by a layer of tarmac which constitutes the modern road surface.

The disturbed subsoil (phase 2) is considered to have formed through previous agricultural use of the land. Where the subsoil was recorded in section 5 it was noted that it was browngrey, as opposed to brown-yellow, in colour. This is the position at which the route of the pipe trench crosses the Roman road, Ermine Street. Although no evidence for the road survived, it is possible that the grey colouring is the result of the effects of leaching, which may represent the position of Ermine Street before it was destroyed by the construction of Sutherland Way.

Section 1 revealed two phases of road construction which were not observed elsewhere. Tarmac constitutes the present ground surface.
