**Caistor Grammar School,  
Caistor, Lincs  
Roman Wall Evaluation**

Site Code: CGSW 02  
LCNCC Museum Accession No: 2002.93  
NGR: TA 0137 1163

**Archaeological Evaluation**

**LAS Report: 573**

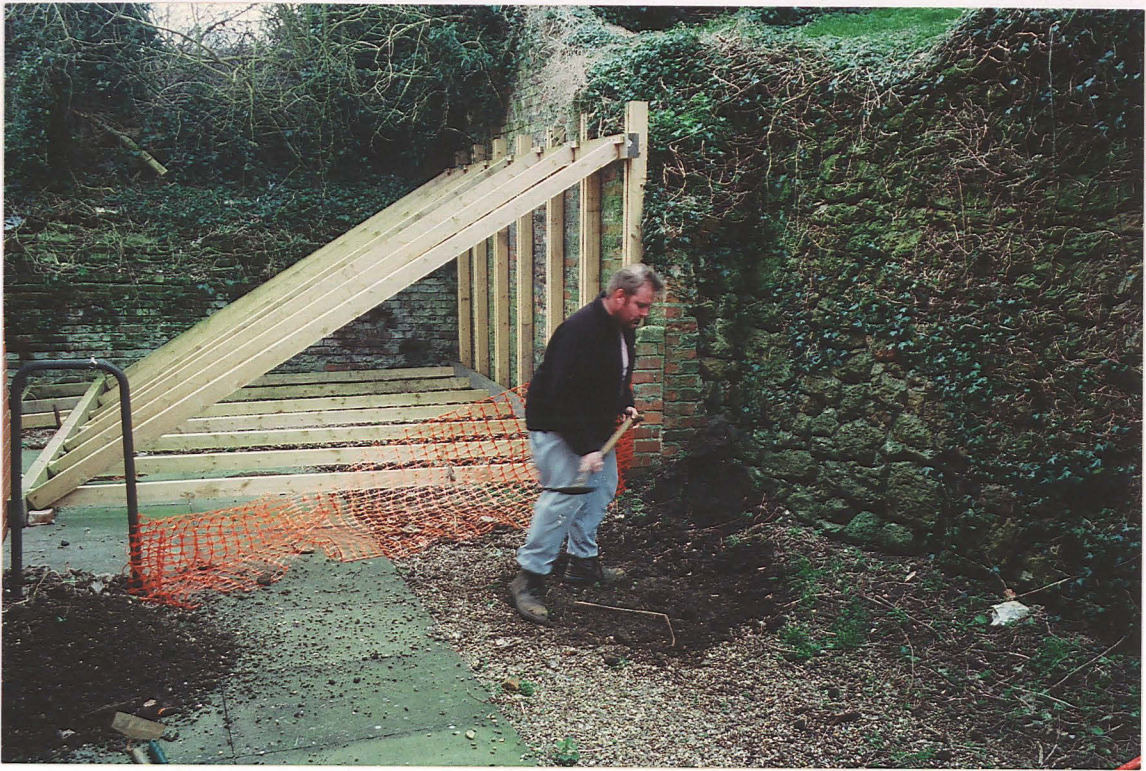
Pl. 1 Evaluation trench location during clearance.

A single trench, measuring 3m x 2m, was positioned to examine the ground next to the retaining wall which follows the presumed line of the Roman defences and defines the limit of the Scheduled Area. It was excavated by hand (PI. 1) and stratigraphic relationships were recorded. A temporary bench mark was established on the site (79.86m O.D.).

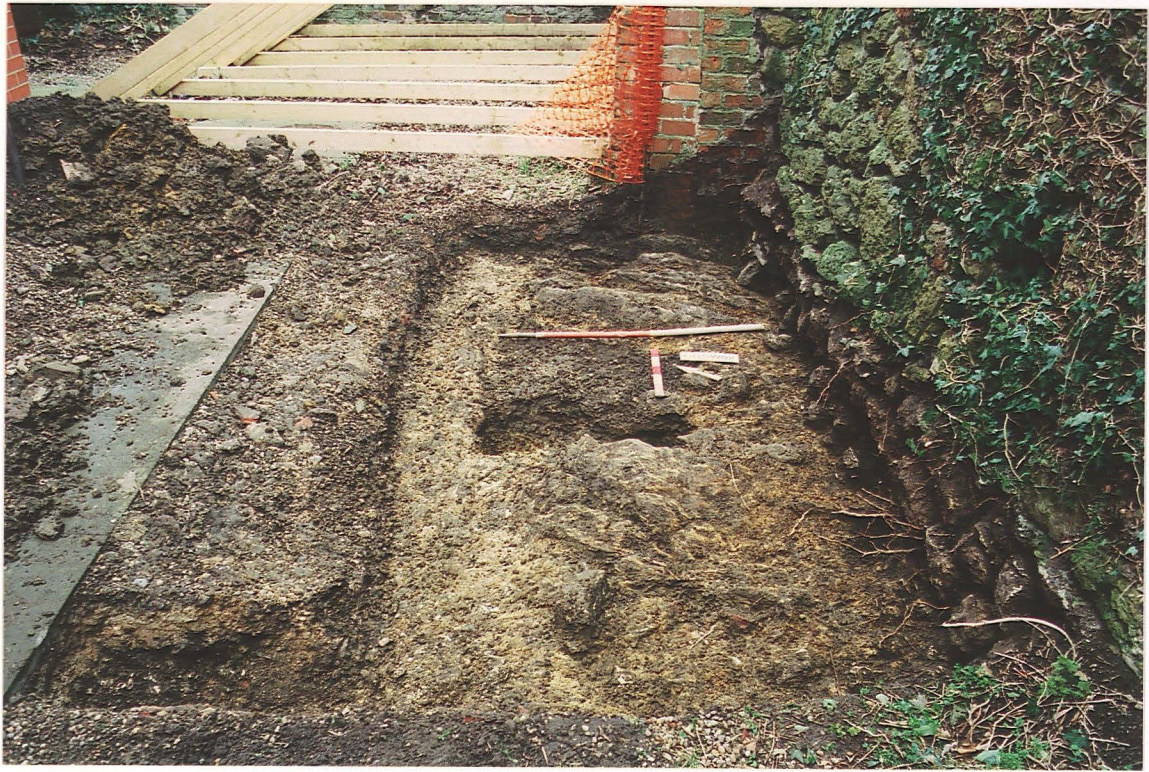
Pl. 3 The evaluation trench, post-excitation. Looking north east. Scales 1m and 0.50m.

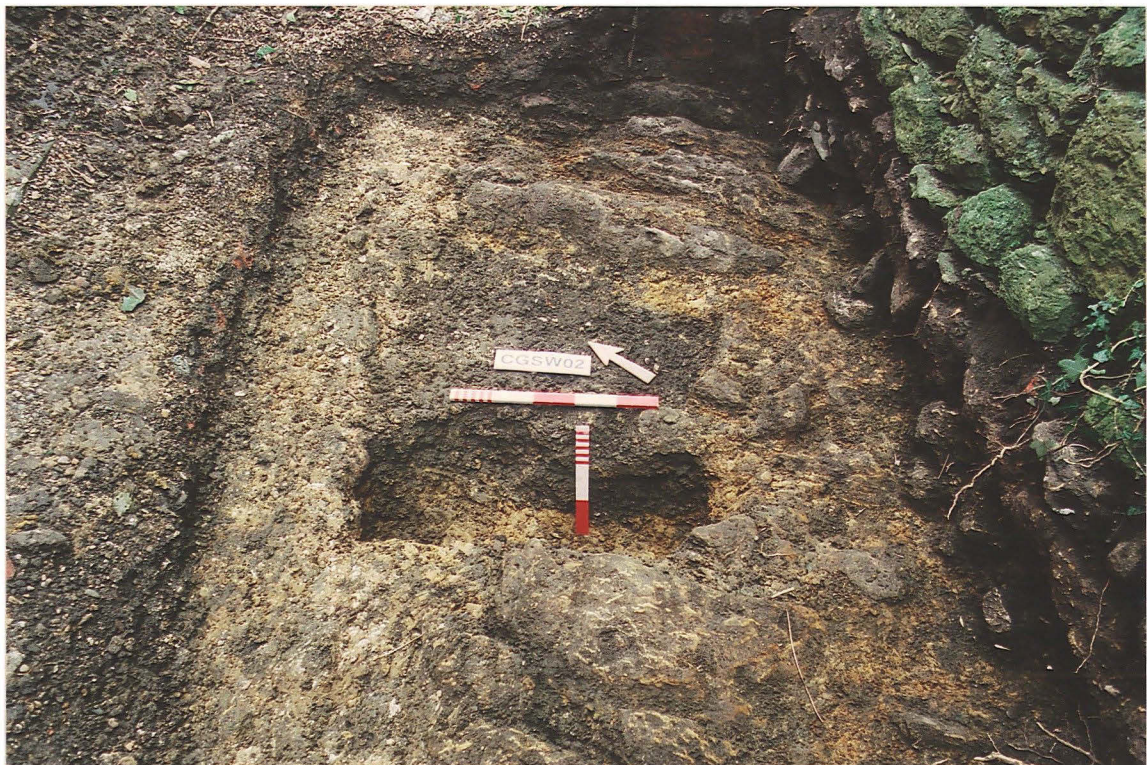
Pl. 4 Pit 112, half-sectioned, looking north east. Vertical scale 0.30m, horizontal scale 0.50m.

Beneath **102** was a rectangular pit **112** (Pl.4), 1.00 x 0.80 x 0.42m, filled with a black humic soil, **113**, containing modern brick and tile fragments. A layer of black soil containing modern brick and tile, **103**, lay below **102**, covering a 0.10m deep deposit of chalk fragments, **104**, possibly some sort of surface. All the above deposits projected approximately 1.20m into the trench and were within construction cut **116**.

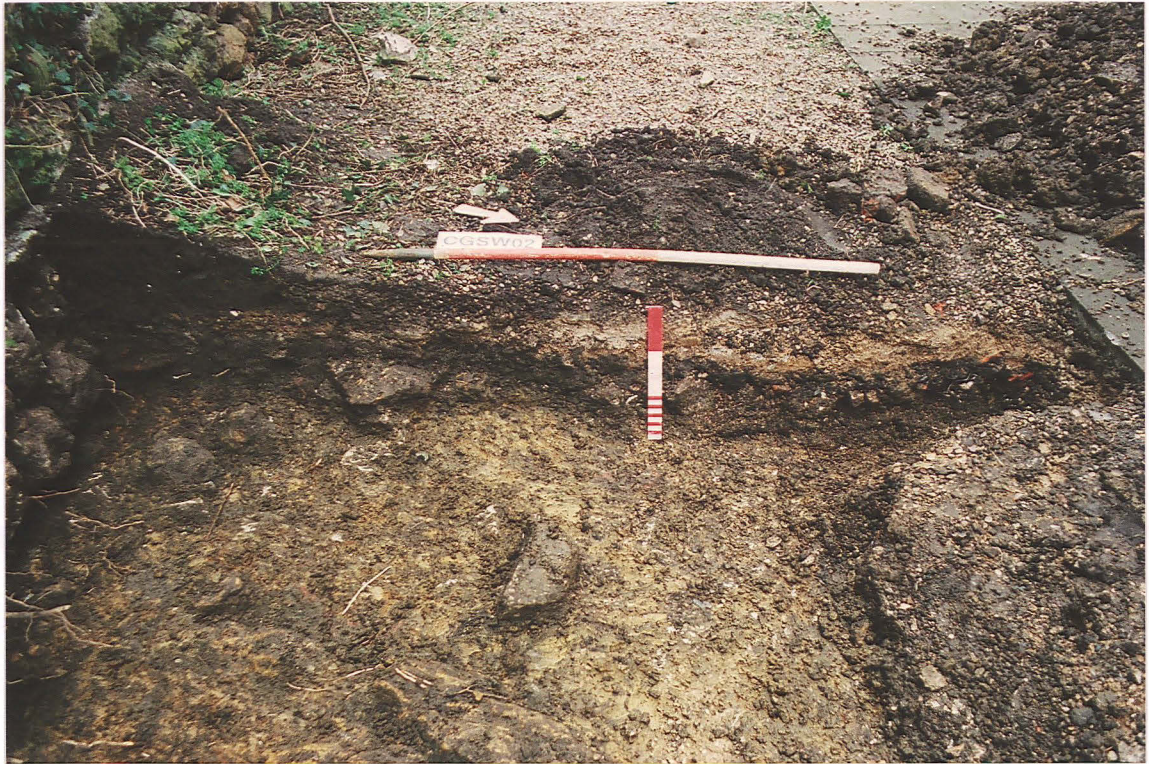
Pl. 5 Trench section, looking south-west. Vertical scale 0.30m, horizontal scale 1m.

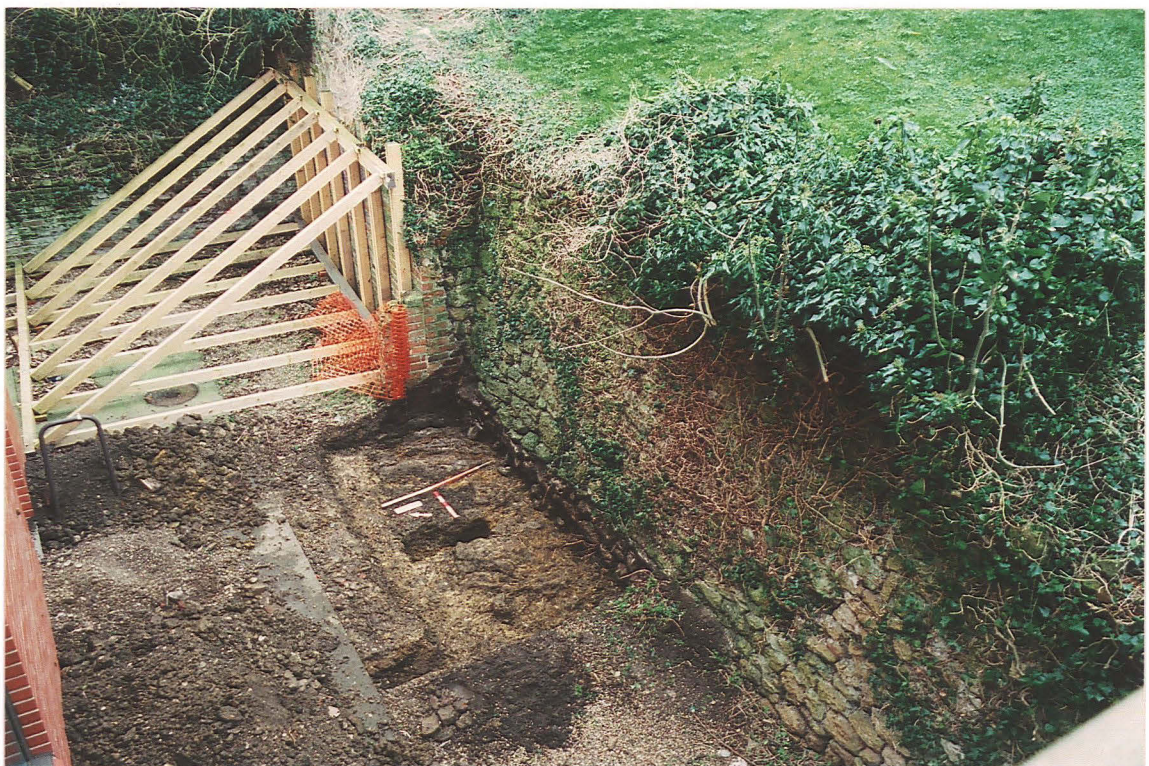
Pl. 6 Retaining wall 111 with all courses of stonework exposed. Looking east. Scales 0.50m and 1m.

The retaining wall, **111**, which is 2.91m in height, appears to cut into **105/106/110** (Pls.6 and 7). From the exposed two courses of stone at the base of the wall **111** it appears that no foundations appear to have been built for the wall, nor does it utilise the Roman foundations. No date could be given to layer **106/110**, due to contamination of the deposit, so it is not possible to determine the age of the retaining wall.

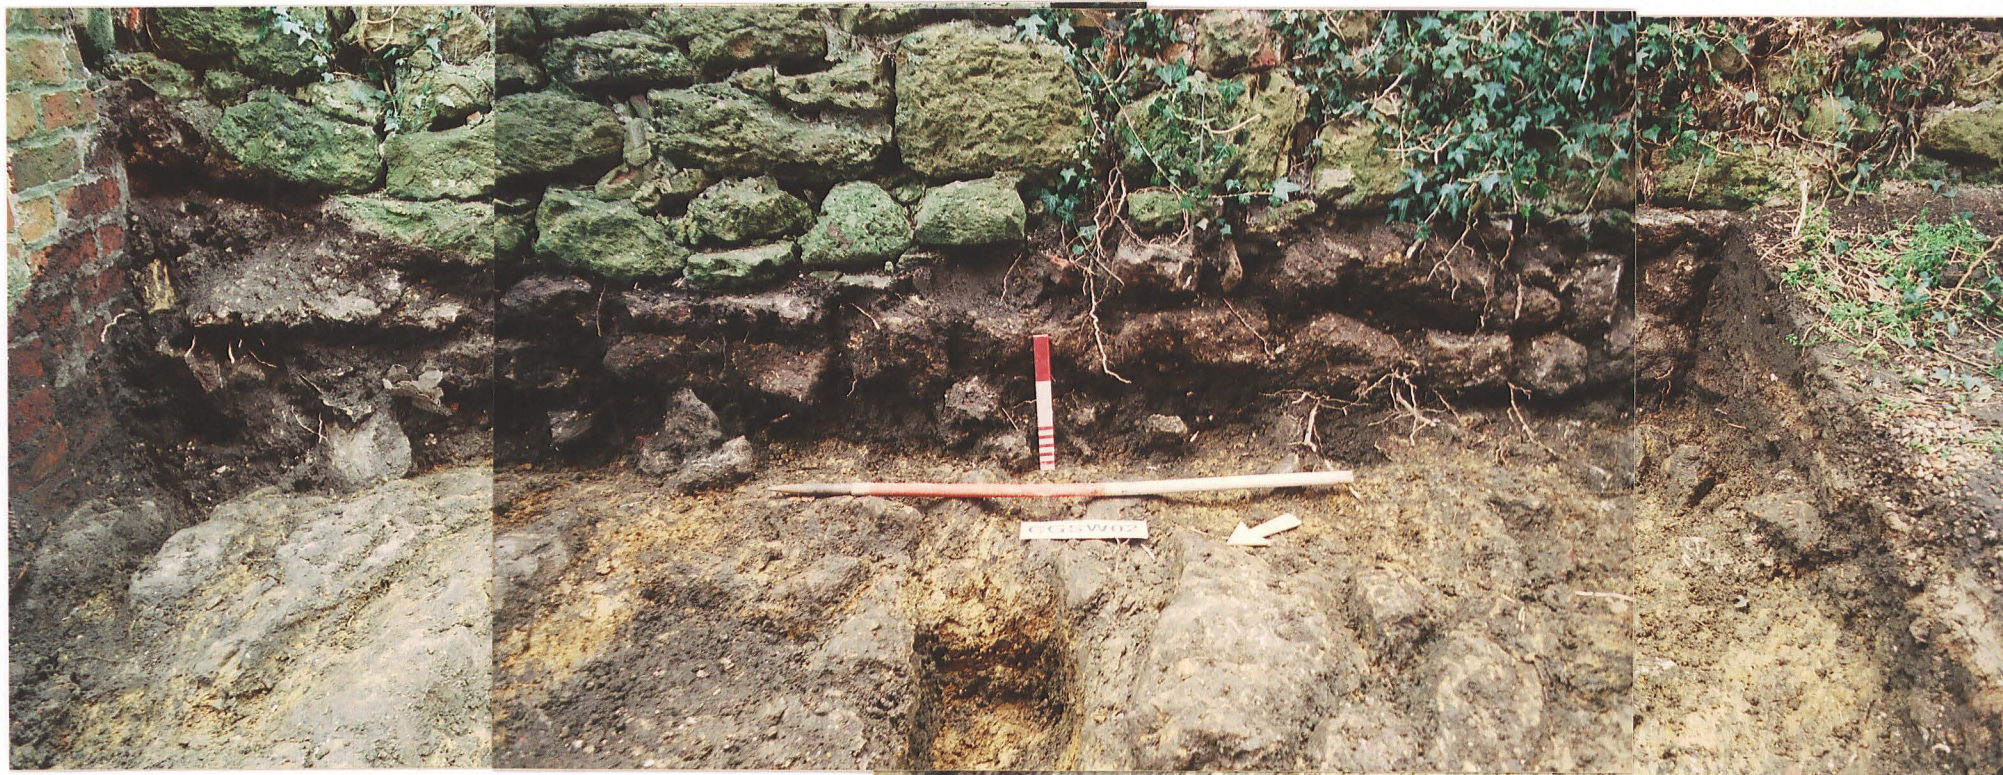
Pl. 7 Lower courses of stonework of wall 111 above layer 110. Looking south-east.  
Vertical scale 0.30m, horizontal scale 1m.

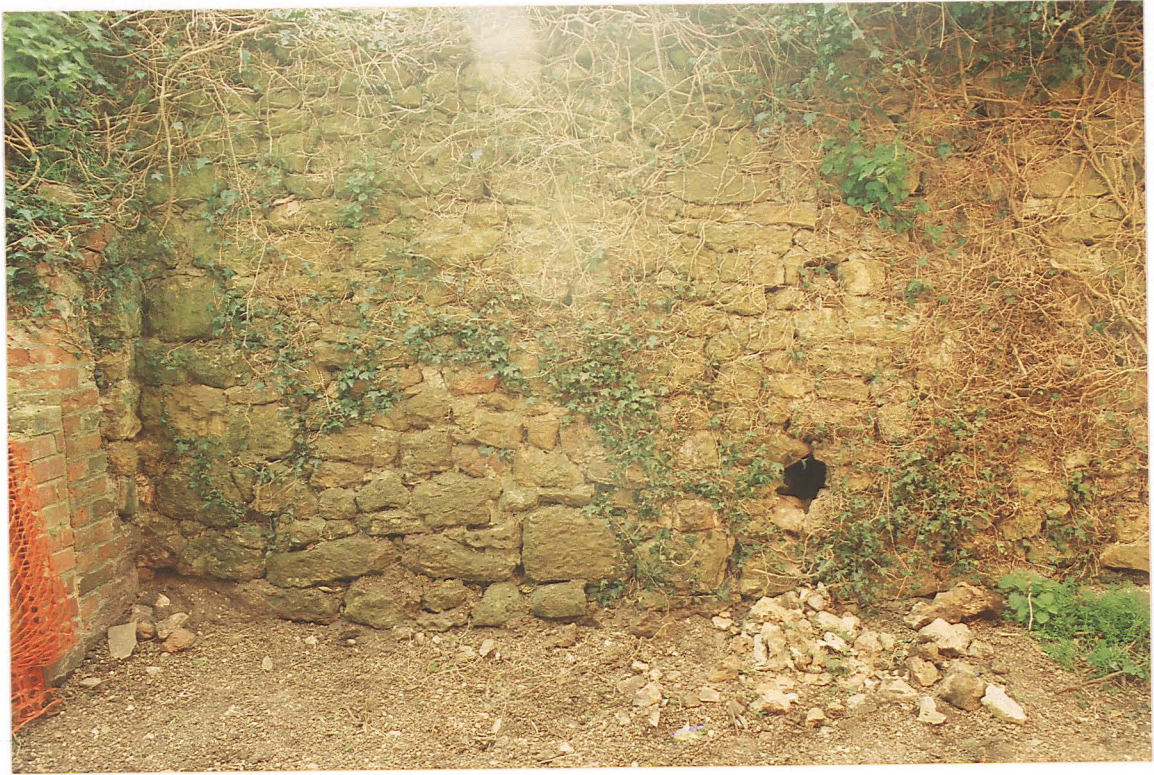
**Pl. 8** Borehole 1 at the east end of the retaining wall.

Core 1 was located 2.70m west of the return wall and 0.60m above existing ground level (Pl. 8) Core 2 was positioned 1m east of the brick retaining wall and 0.90m above existing ground level (Pl. 9). The two cores through the facing wall established that it was 300mm thick with a 300-400mm backing consisting of brick rubble, mortar.

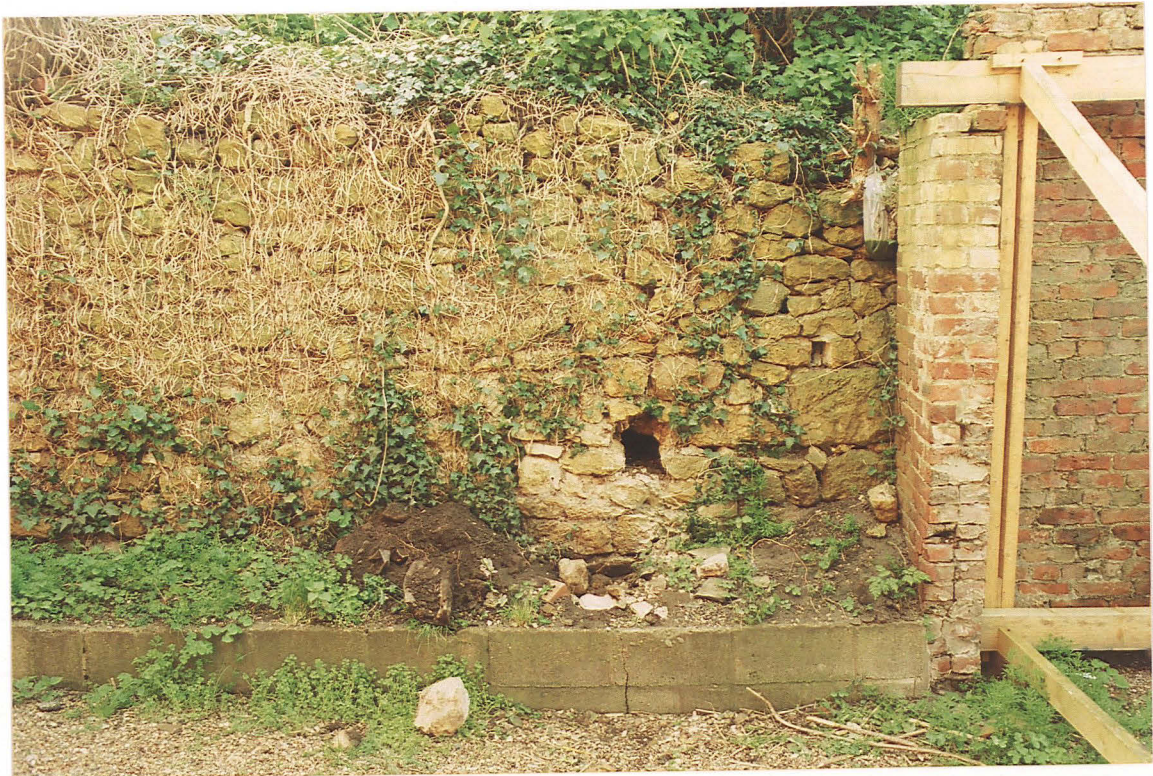
**Pl. 9** Borehole 2 at the west end of the retaining wall.

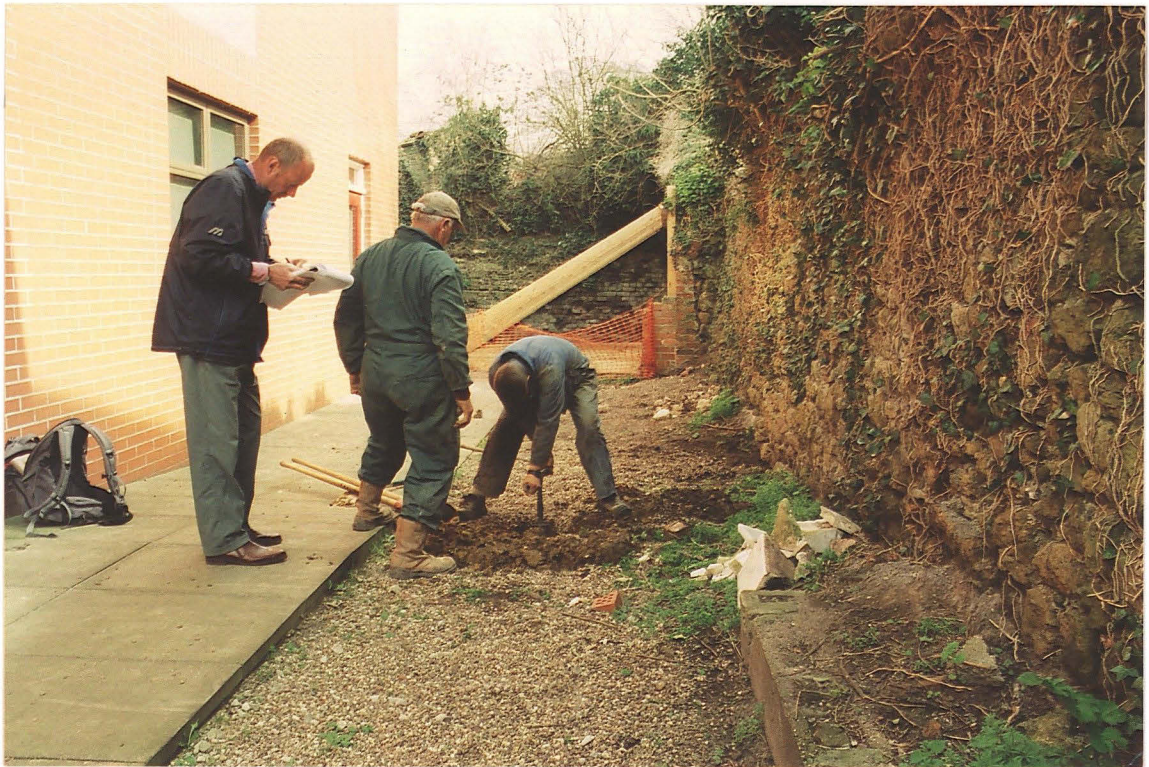
PI. 10 Test pit/auger hole on external side of the retaining wall.

The test pit was dug to a depth of 1.5m by hand and augered beyond to a depth of 3m. There was a silty orange clay to a depth of 1m below the existing ground surface which merged into a stiff clay at a depth of 1.20m. The water table was reached at a depth of 1.1m.

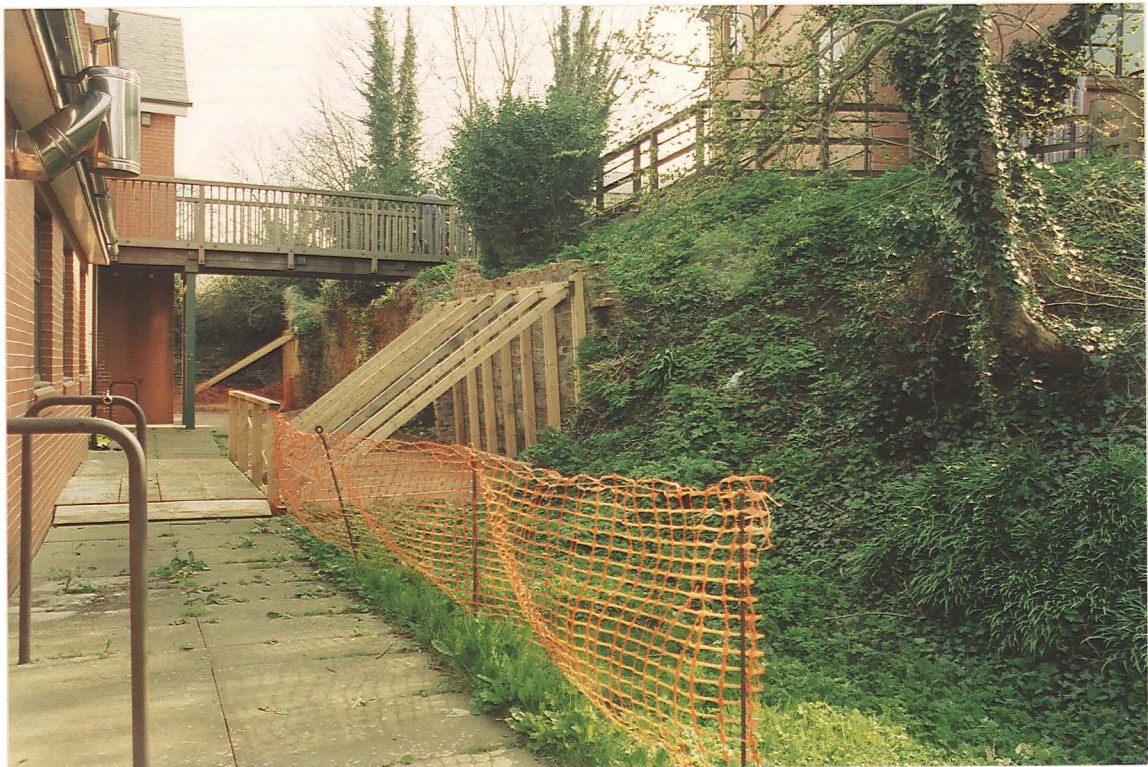
PI. 11 View of retaining wall and sloping ground beyond, looking north-east.

There was no evidence for stonework behind the existing retaining wall or any indication of Roman deposits. It is possible that before the present wall was constructed the ground sloped as it does to the west of the retaining wall (Pl. 11). After its construction the void behind it would have been filled with rubble and soil, which would explain the absence of any archaeological remains. Either the Roman wall has been completely robbed above ground level or its core remains intact some distance behind the present wall.
