**Bracebridge, Lincoln  
Water Mains Replacement Scheme**

**Archaeological Monitoring**

**Report prepared for  
PDM Associates (on behalf of Anglian Water Services Ltd)**

**LAS Report No. 616**

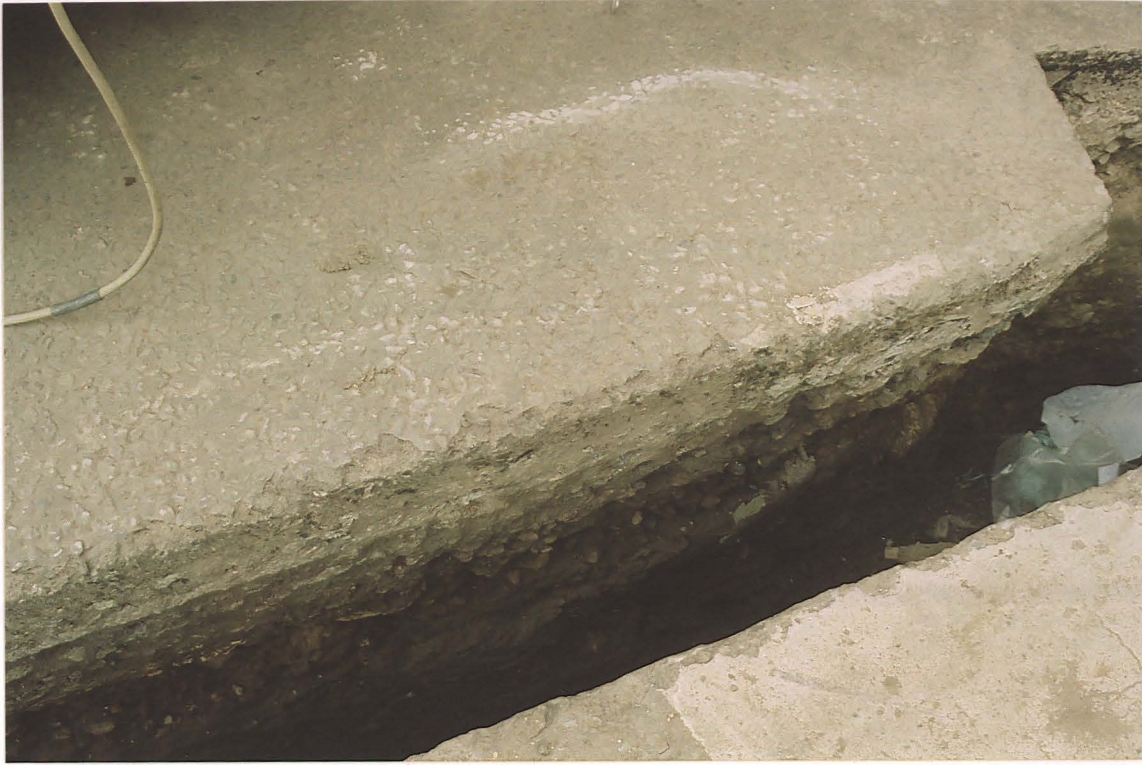
Pl. 1 The tarmac road surface overlies a gravel band near 210 Newark Road (2), probably a post-medieval road surface.

1. The most easterly point of the scheme monitored was by Bracebridge Hall. Here the trench exposed the backfill of earlier trenches.
2. Outside No. 210 Newark Road, the 0.22m thick tarmac road surface covered 0.38m of gravel, interpreted as a post-medieval road surface (Pl. 1). This overlay dark grey silt. To the west, in the centre of the Brant Road junction, the gravel layer was thinner and mixed with asphalt, which suggested a later date. The observed trenches were at the southern edge of the modern road, and this might explain why more substantial surfaces were absent. The silt is thought to represent marshland beside the river, or flood alluvium.

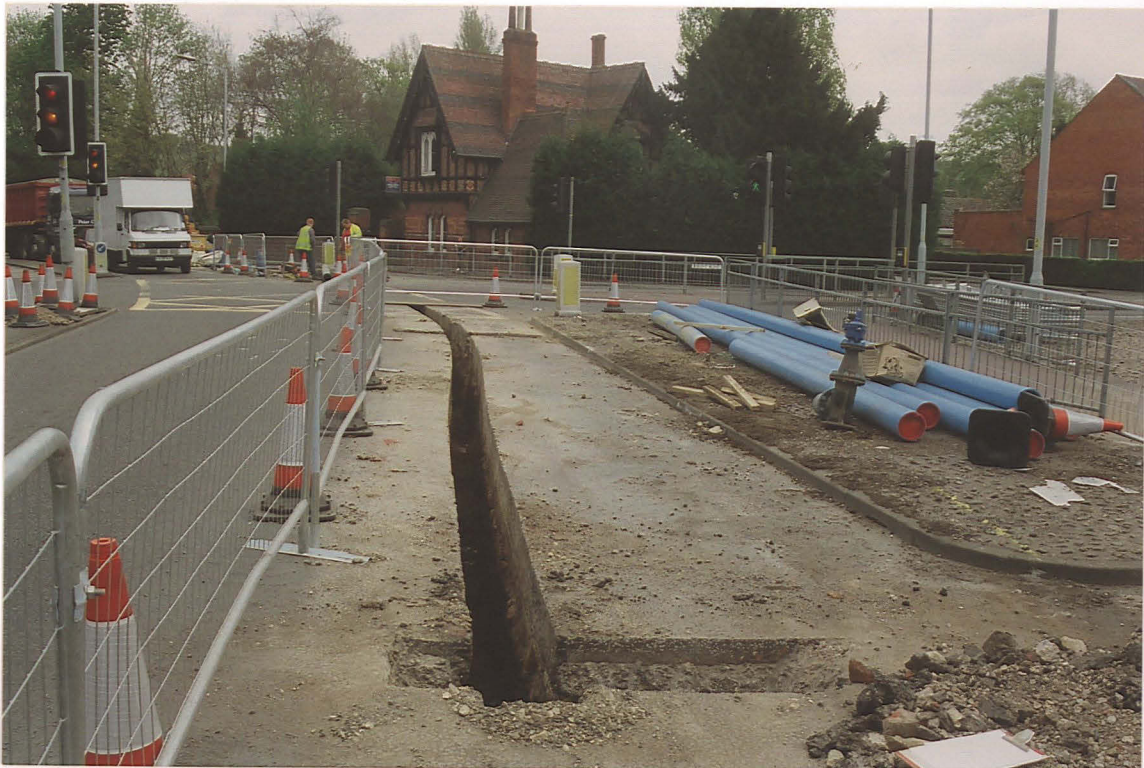
Pl. 2 At the approach to the eastern side of the river bridge (3), the foundation bedding for the modern road was thicker, with limestone rubble over clinker, ash and brick rubble (looking east).

3. Evidence of more substantial road construction at the approach to the bridge over the River Witham was recorded near the western slip road from Brant Road (Pl. 2). Here the modern road was on a 0.22m thick layer of limestone blocks and stone rubble. Beneath it was 0.18m of red ash and other signs of burnt material, and 0.3m of clinker (Pls. 3 and 4). The silt layer was found 1m below the modern surface. There was no visible dating material within the clinker layer; one interpretation is that it represents factory furnace waste from the late nineteenth or early-mid twentieth century. Although Roman pottery kilns are known from the west side of the river, the burnt material contained no trace of ceramic wasters.

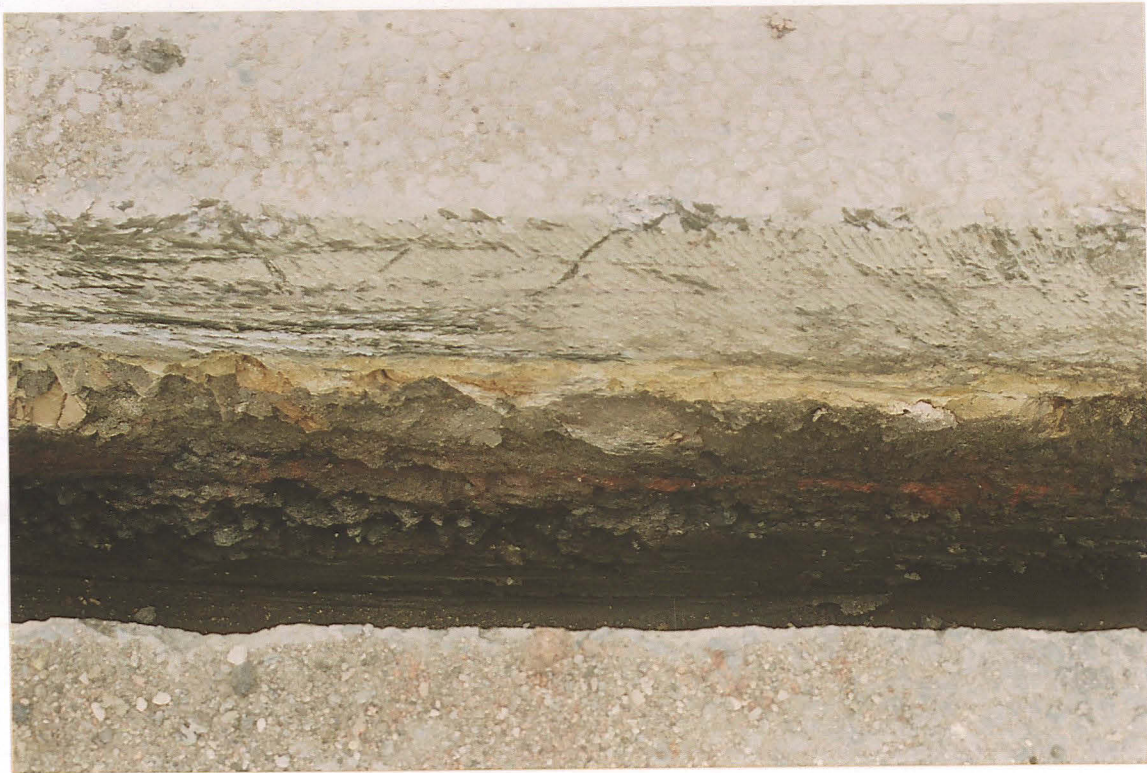
**Pl. 3** Ash, burnt material and clinker were visible in the trench face east of the river bridge (3).

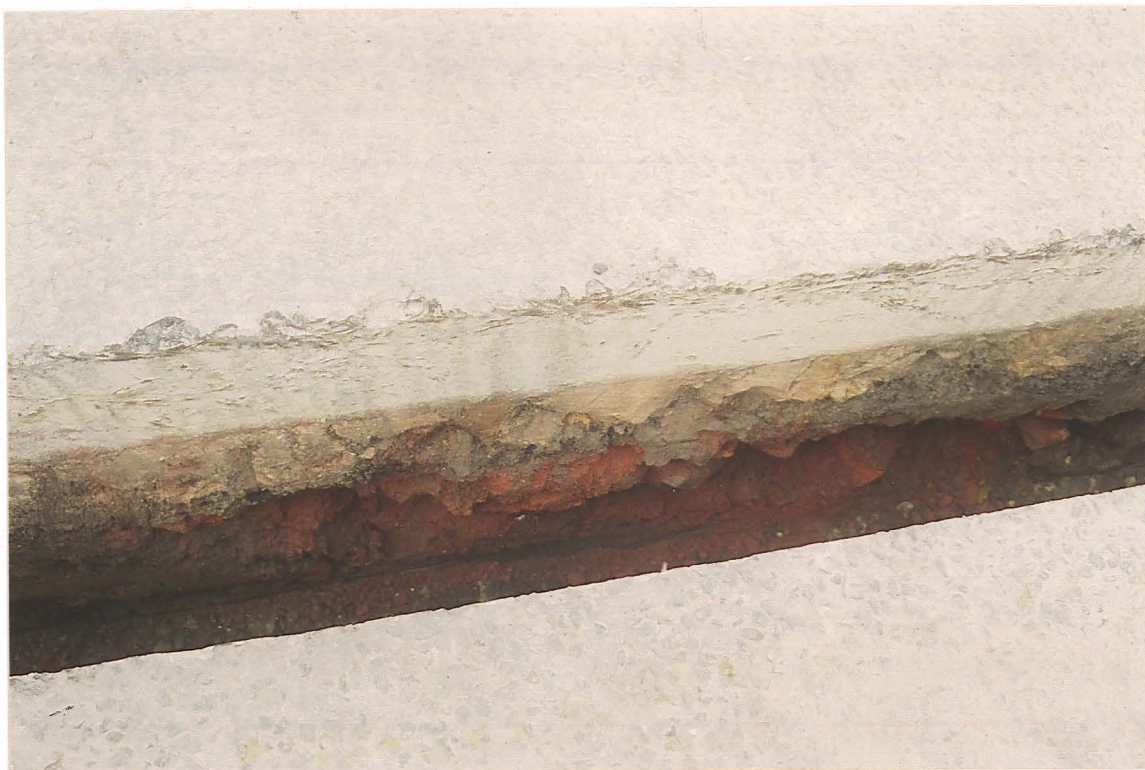
**Pl. 4** Burnt material at (3), between the clinker and the underlying dark silt.

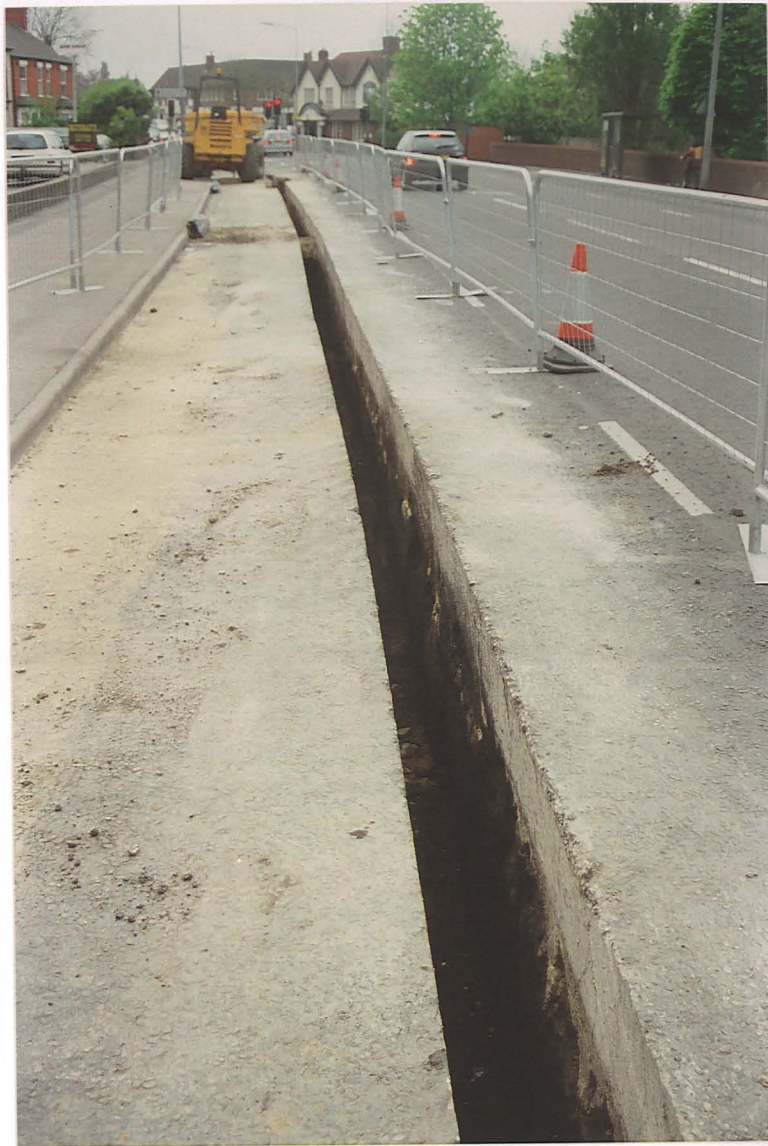
Pl. 5 Dark silts below the road bedding west of the river (4), looking NW.

4. To the west of the bridge, opposite the Plough public house, the road foundation was on dark brown and grey silts (Pl. 5).
5. East of the Waggon and Horses public house, the underlying silts were lighter and sandier than closer to the bridge (Pl. 6). The colour indicates that these probably incorporated less waterlogged organic material, and so may have been drier soils away from the river.

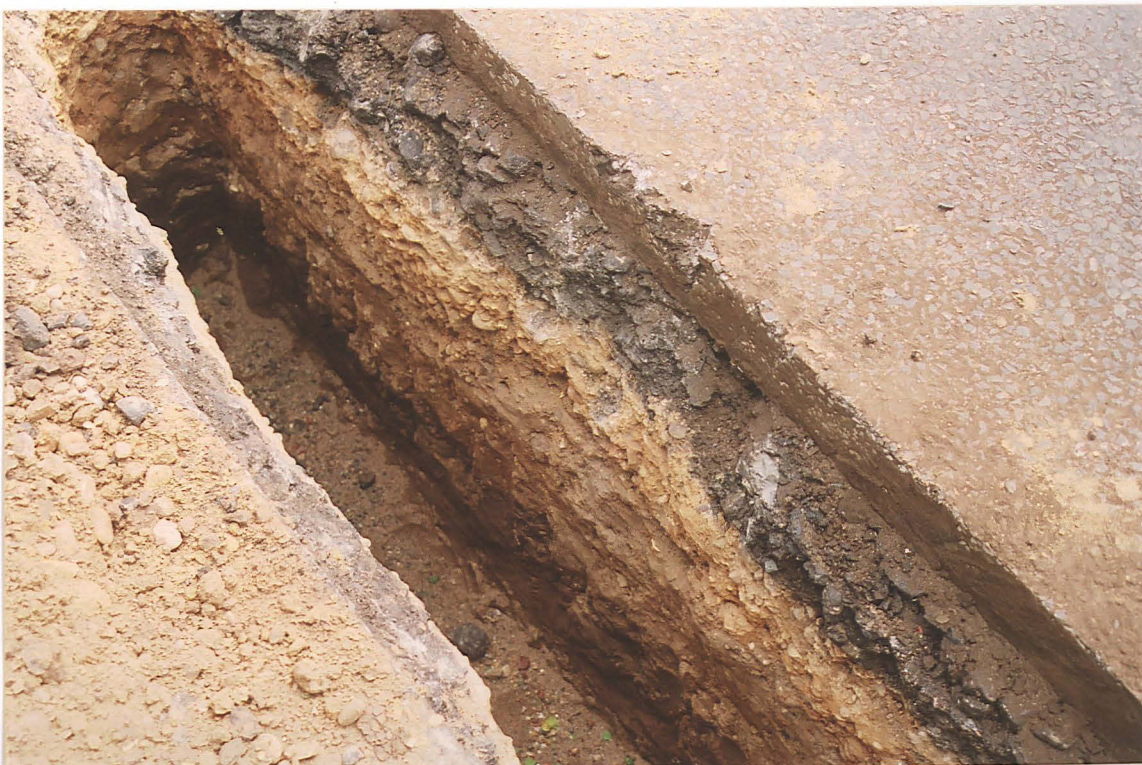
Pl. 6 Near the Waggon and Horses (5), the modern road lies on a thin layer of gravel, with brown loam below.

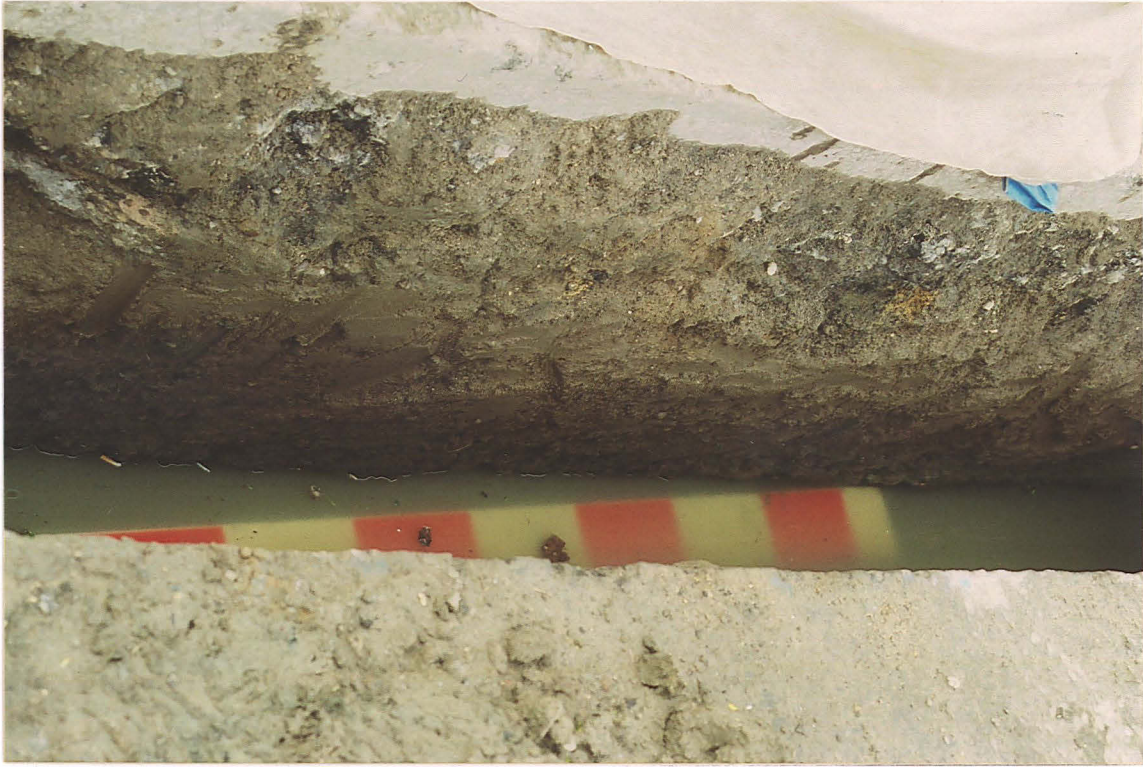
PI. 7 At the junction with Rookery Lane, the trench at the southern edge of the road revealed silt loam, with no trace of Roman road metalling.

6. Close to the Rookery Lane junction, at the southern side of the modern road, the 0.3m thick road surface covered 0.25m of limestone rubble. Beneath this the deposits were a brown/dark brown loam, which may have been a drier version of the silts recorded closer to the river (Pl. 7). This material, at least 0.5m thick, may have been the ground surface with soil sequence prior to construction of the road.

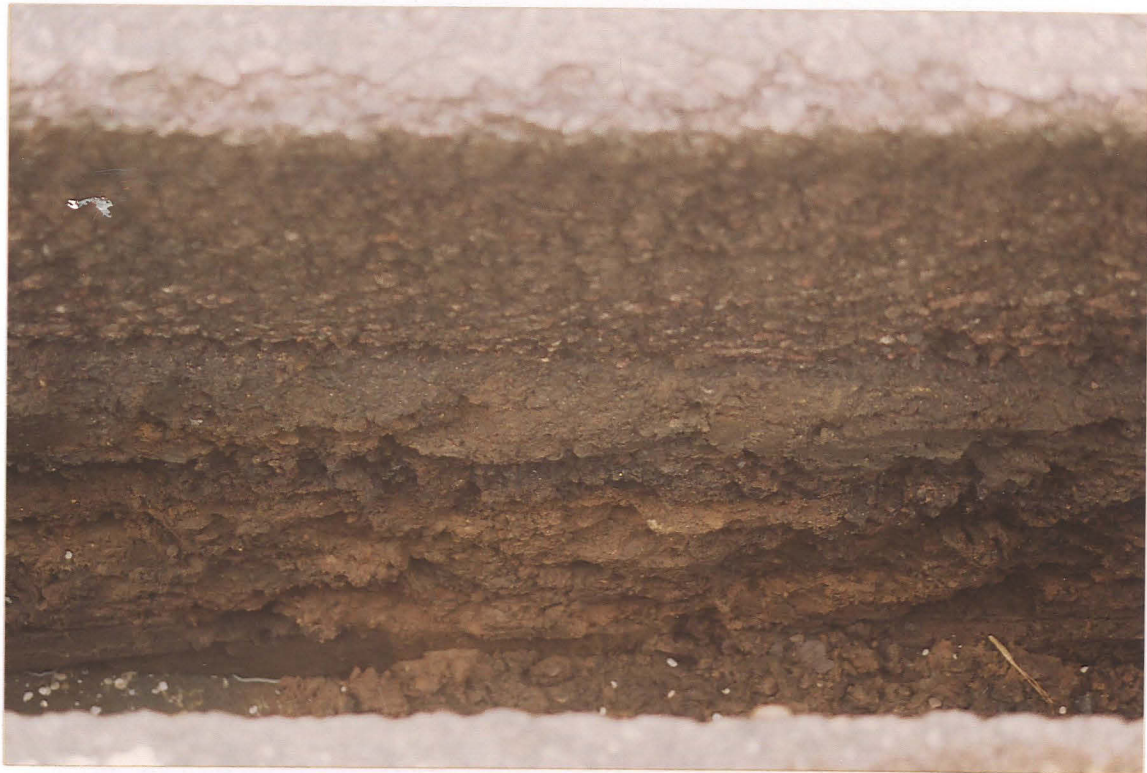
PI. 8 Near 447 Newark Road (10) a thick brown sandy clay deposit was seen.

10. Opposite 447 Newark Road, the clinker layer had been spread on a light brown sandy clay deposit, at least 0.45m thick (Pl. 8). This may have been natural river alluvium.

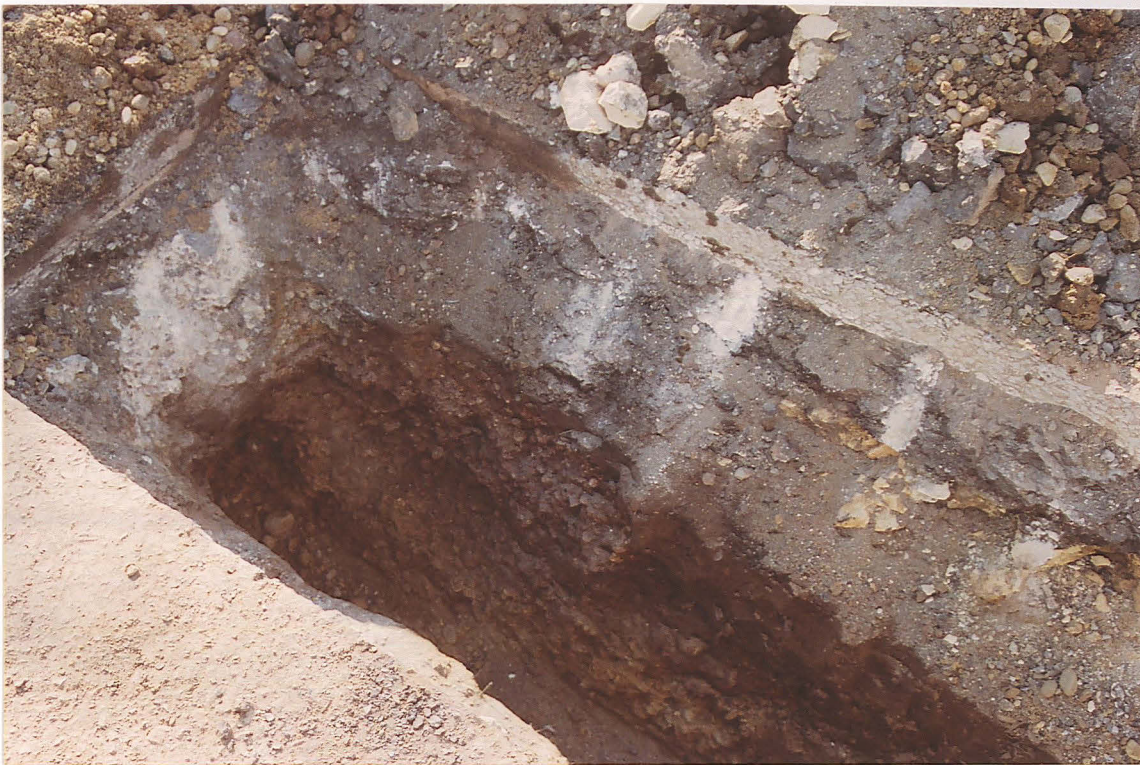
PI. 9 Dense gravel was seen in the trench west of 471 Newark Road (13).

13. South of 471 Newark Road, dense gravel and sand was present 0.5m below the modern surface, extending below the base of the trench (Pl. 9).

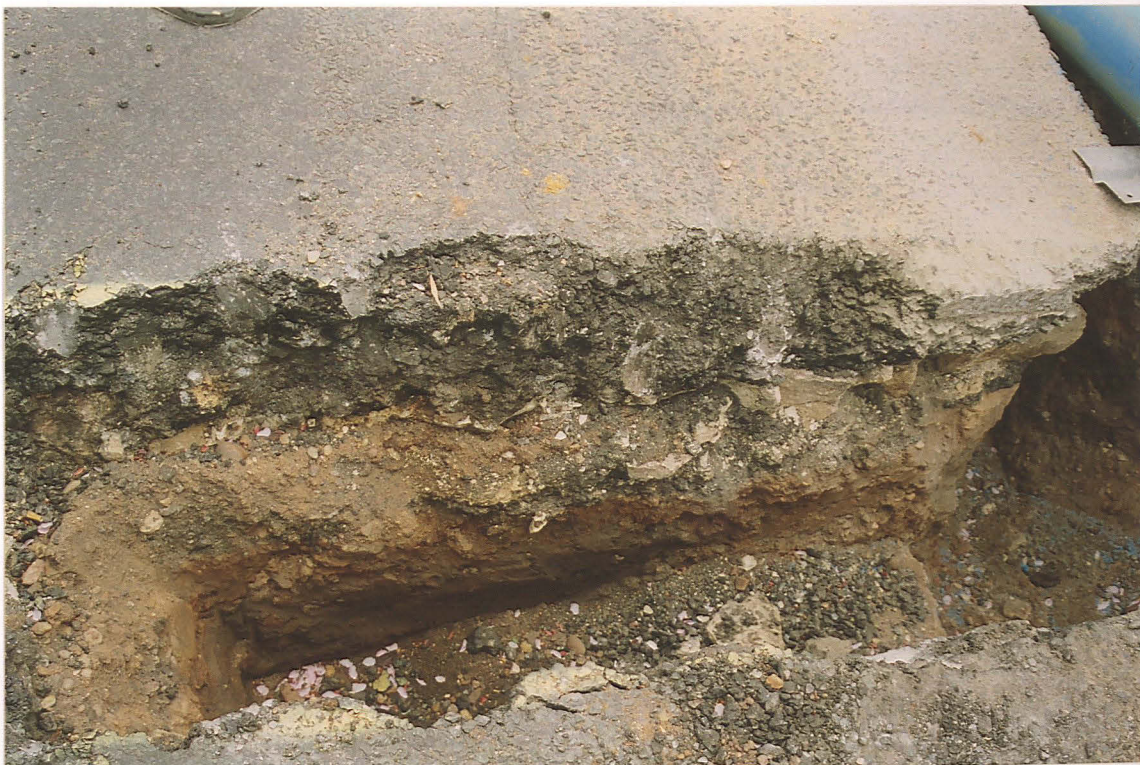
PI. 10 Mixed gravel was recorded in the trench face near 406 Newark Road (14).

14. At 406 Newark Road the 0.27m thick tarmac covered a 0.18m thick bedding layer of limestone rubble. Below this was gravel; the upper 0.2m was clean but lower deposits were discoloured and mixed (Pl. 10).

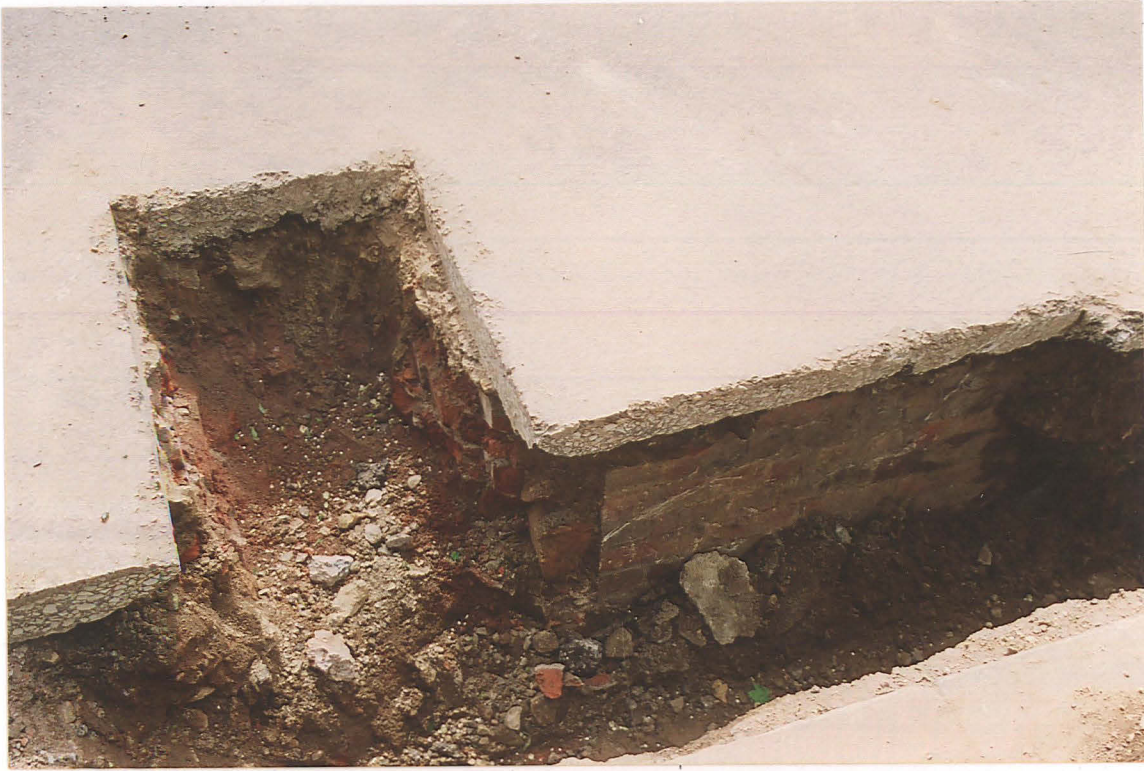
Pl. 11 Close to the junction of Doddington Road with Newark Road (15), a brick structure was seen. This is probably a bridge across the Pike Drain.

15. Outside The Gables, at the junction of Newark Road with Doddington Road, the remains of a brick structure was seen below the modern road to the east of the existing central island (Pl. 11). A single piece of stone rubble was seen incorporated into the brickwork. The structure was interpreted as a minor bridge or culvert carrying Pike Drain below Doddington Road.

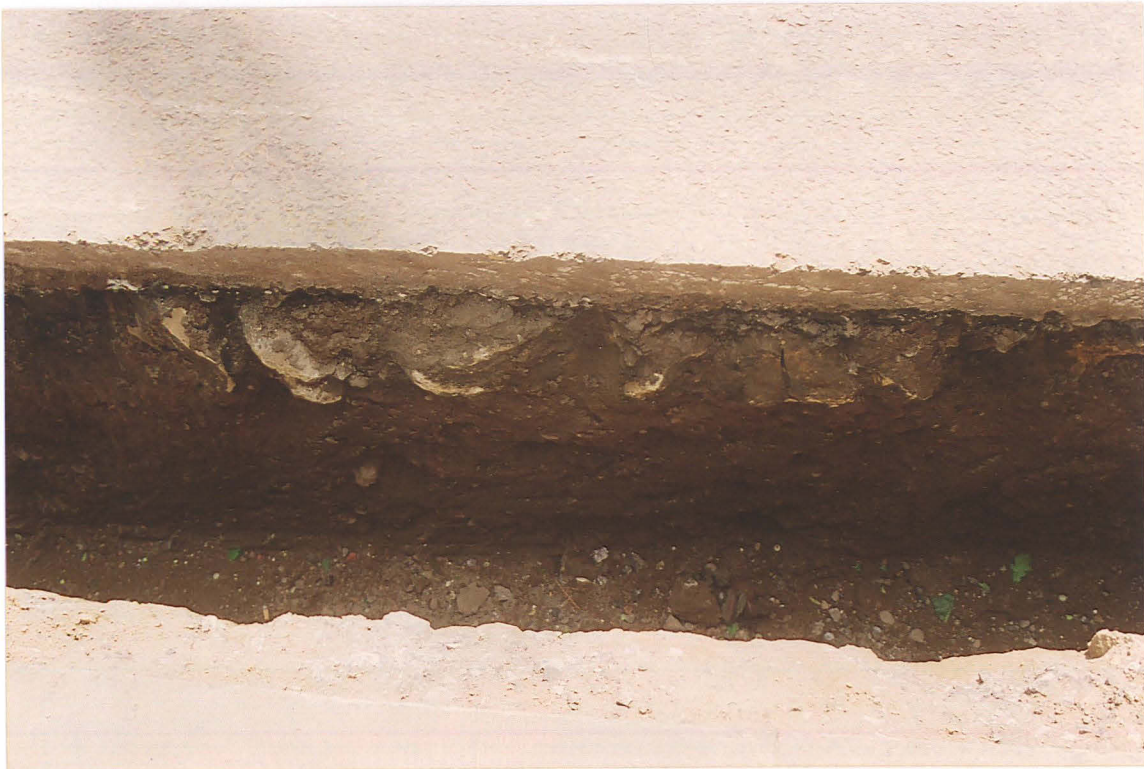
Pl. 12 South of 6 Doddington Road (16), the rubble bedding for the road lay on loamy sand.

16. In front of 2 Doddington Road, the 0.1m thick tarmac surface covered a 0.26m thick layer of limestone rubble, laid on its edge for greater wear (Pl. 12). Beneath this was 0.25m of ash and clinker. The rubble and clinker layers seem to have been restricted to the vicinity of the Pike Drain bridge; rubble was only seen south of 6 Doddington Road. Below the clinker was 0.08m of discoloured loamy sand, merging to pale yellow sand.

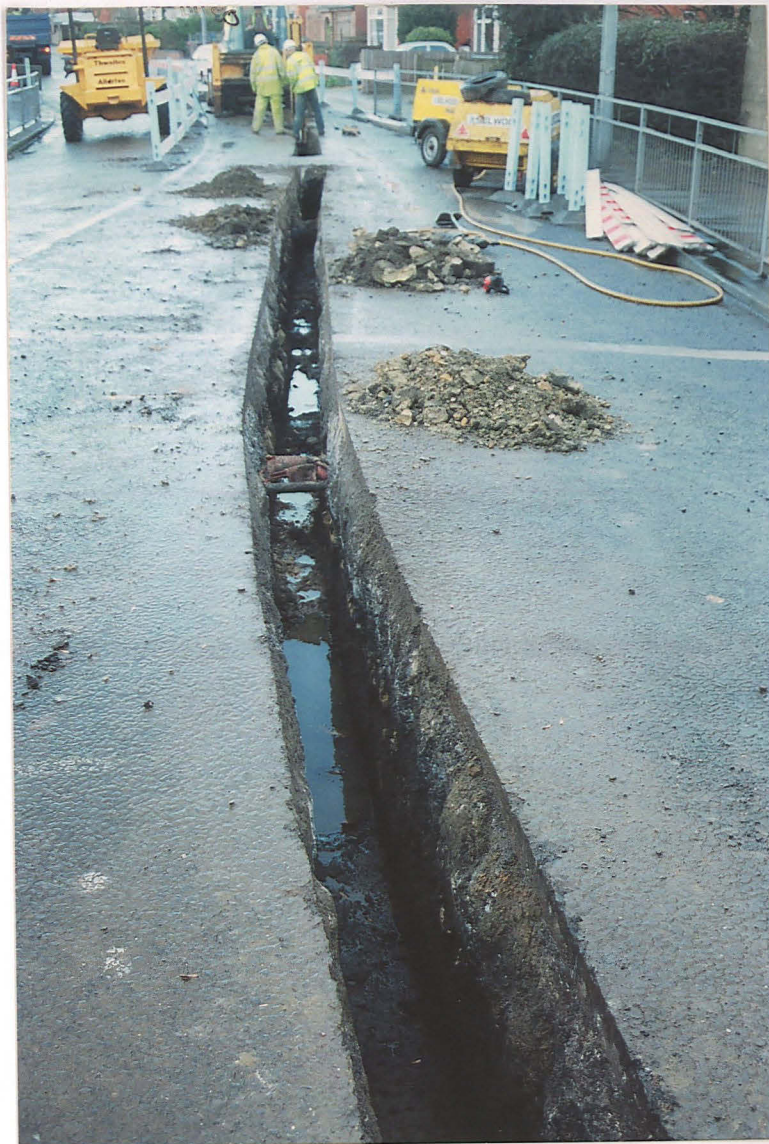
Pl. 13 Open-cut trenching in Rookery Lane (looking north). Deposits close to the junction with Newark Road (21) were dark silts, with overlying brown loam.

21. To the north of this sand, the ash layer rose slightly over a ridge of brown sand, 17m wide, with black silt below it (Pl. 13).

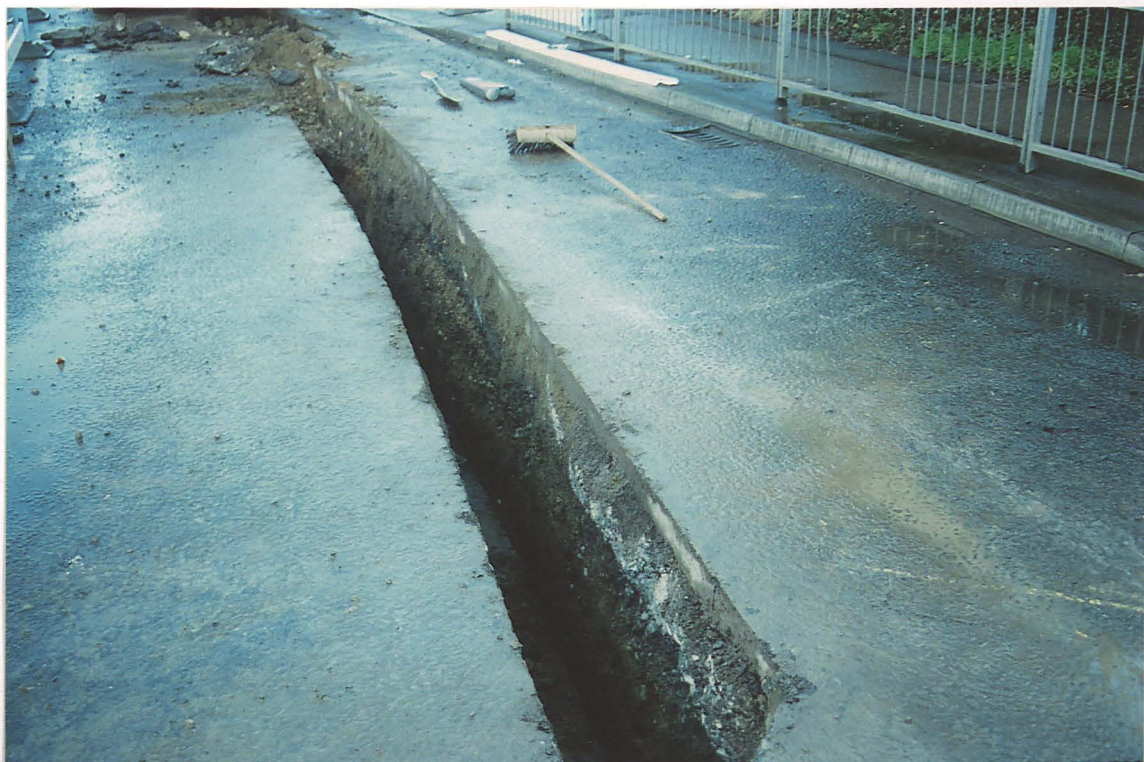
Pl. 14 To the north of (21), the dark silts dipped below layers of gravel (22). The gravel was initially thought to be Roman road metalling, but has been reinterpreted as naturally deposited material within an ancient stream channel. (Looking north).

22. The northern slope of the brown sand ridge was overlain by gravel lenses, which extended from the base of the ash layer to the black silt at the trench base (Pl. 14).

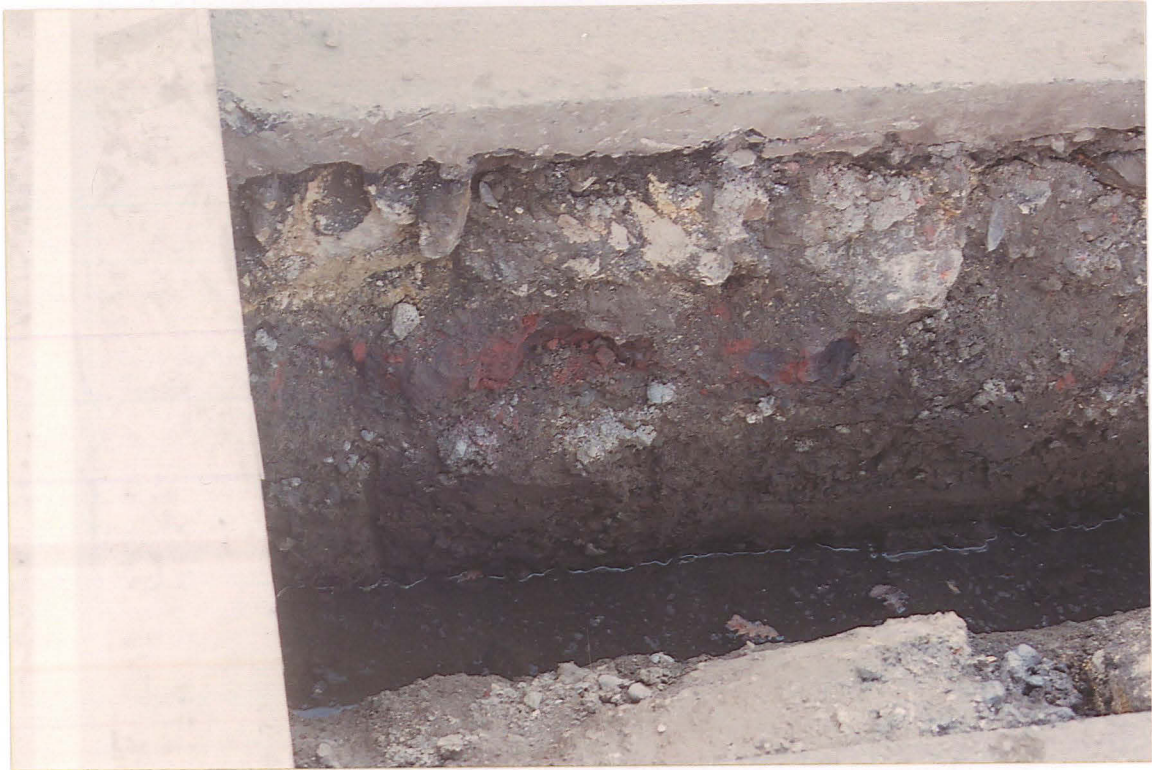
Pl. 15 Brick rubble over a thin band of gravel at (24), 50m north of the junction with Newark Road.

24. 50m north of the junction with Newark Road, the upper surface of the gravel dipped for about 2m. Here the limestone rubble overlay brick rubble; this may have been sewer trench backfill but this was unclear (Pl. 15).

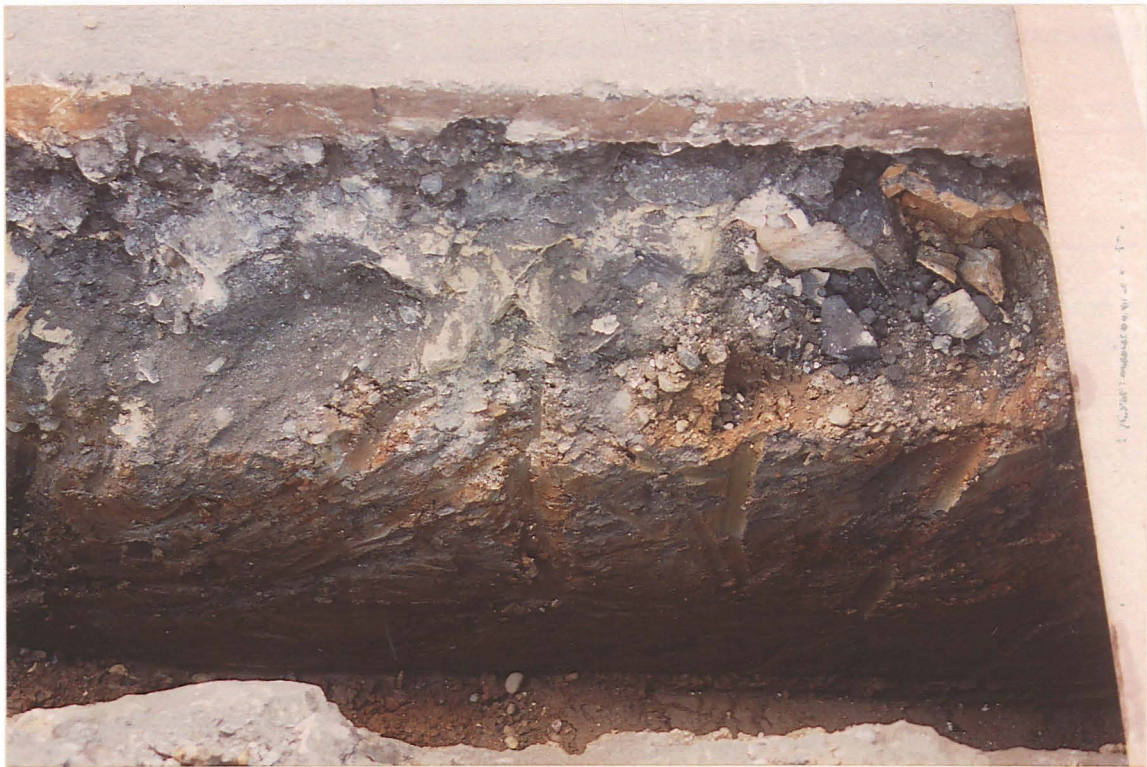
Pl. 16 The thin gravel band was traced northwards to 16 Rookery Lane (26), where it overlay clay. This suggests that the uppermost gravel may have been a post-medieval road surface.

26. At 14-16 Rookery Lane, about 67m from Newark Road, the silt band thinned and ended about 0.6m from the modern road surface. The overlying gravelly loam also thinned and ceased about 3m to the north. The gravel band continued, directly covering the orange sandy clay which extended below the trench base (Pl. 16). It appeared that the gravel band had been spread as an earlier lane surface, prior to construction of the modern road. The orange sandy clay was interpreted as a natural deposit at the northern edge of a broad feature extending southwards beyond Newark Road.
