**Woolsthorpe Manor, Lincolnshire
Archaeological Excavation**

**NGR: SK 9243 2436
Site code: WMS02
LCNCC Accession No. : 2002.444**

**Report for
The National Trust**

**LAS Report No. 621
November 2002**

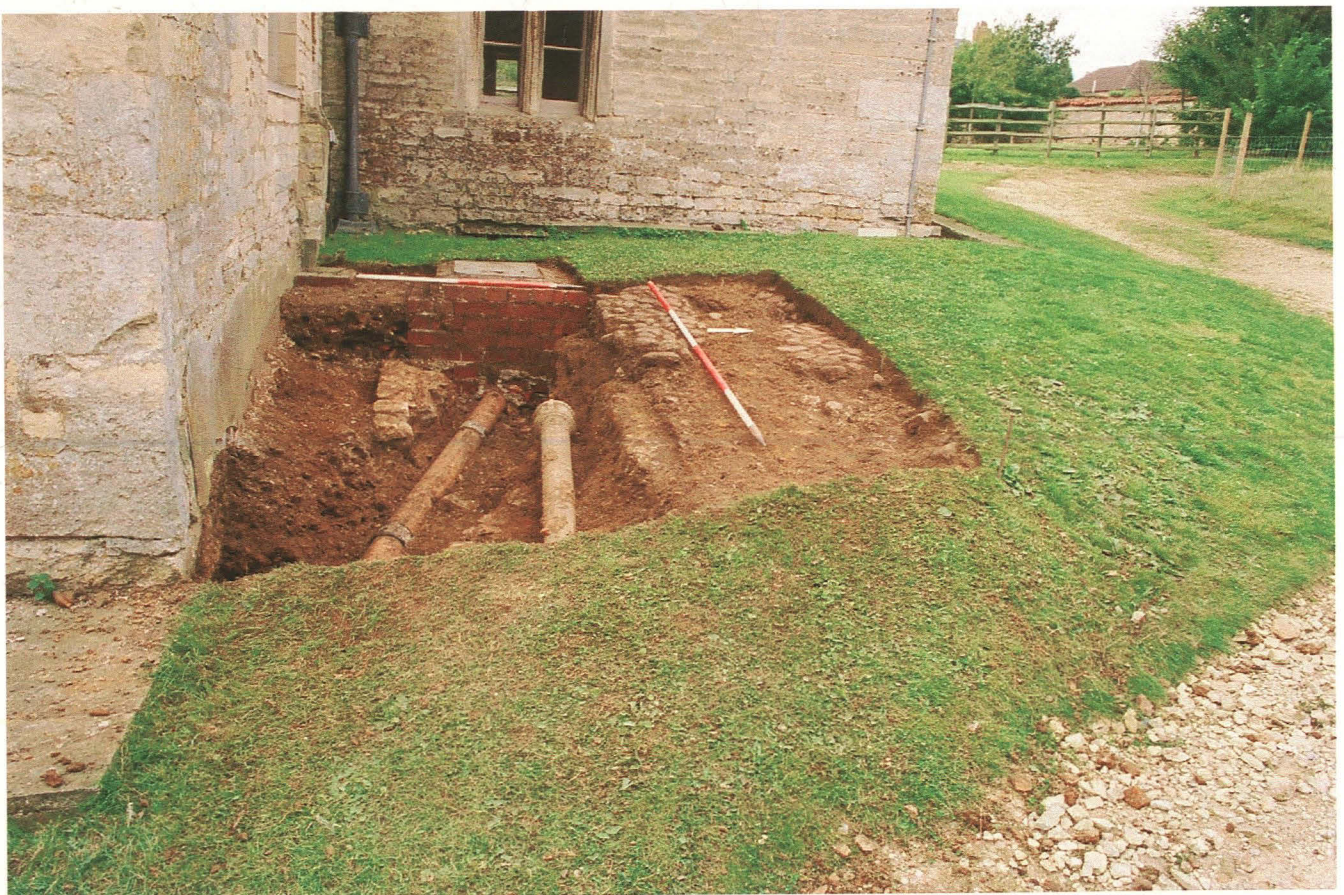
Pl. 2 General view showing excavation trench, looking west.

Stripping of the turf and topsoil (100) in the original trench revealed several service trenches (Fig. 3, Pl. 2), mostly very modern.

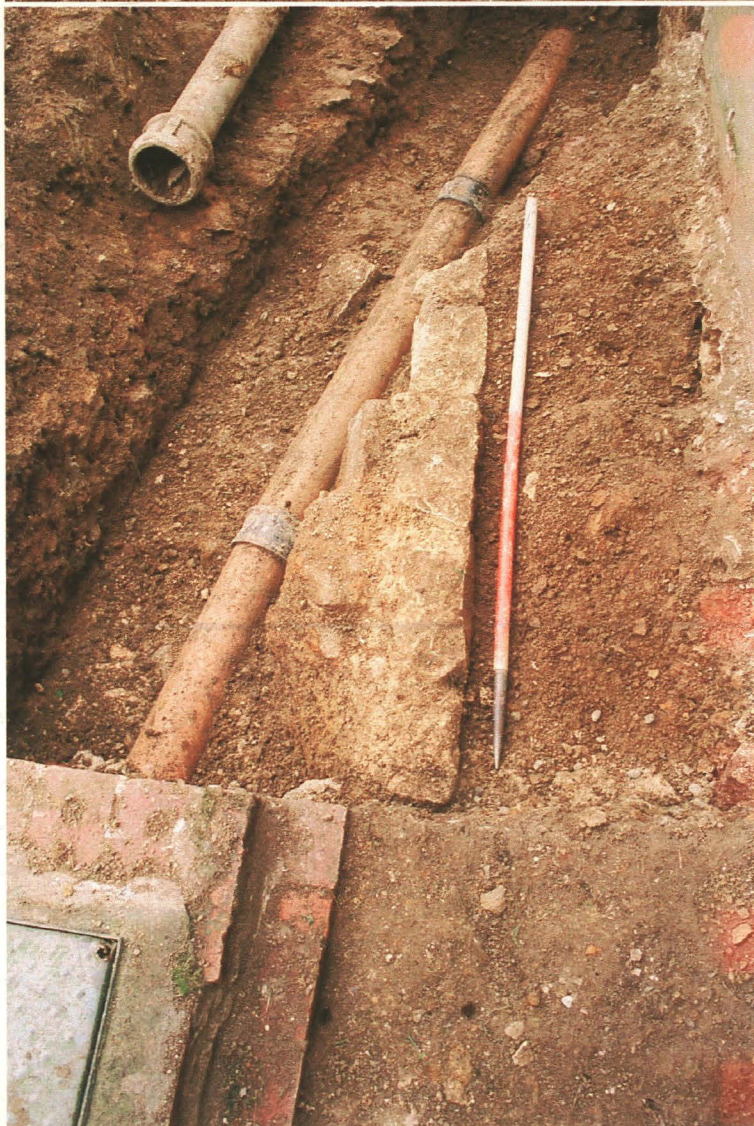
Pl. 4 (left) View looking east showing the limestone wall (103), cut through by the partially excavated service trench 111 (left) and 108 (right). Scale 1m.

Removal of the fills of the drainage trenches, (104) and (107), uncovered the remnants of an E-W aligned limestone wall, (103), with a cream-coloured mortar bonding (Pl. 4). The wall was built upon a natural ironstone deposit and lies 0.45m from the building. Only one course of the south face of the wall survived, 1.2m in length, its full width is unknown. This may be a remnant of the footings for the dismantled staircase.

Unfortunately, the demolition of the staircase in the early 1940's was exceptionally thorough, and the later criss-crossing of the area with drains completed the obliteration process. The small stub of mortared limestone 103 appears to be all that remains of the foundations for this staircase but so little survived that this interpretation can only be conjectural.

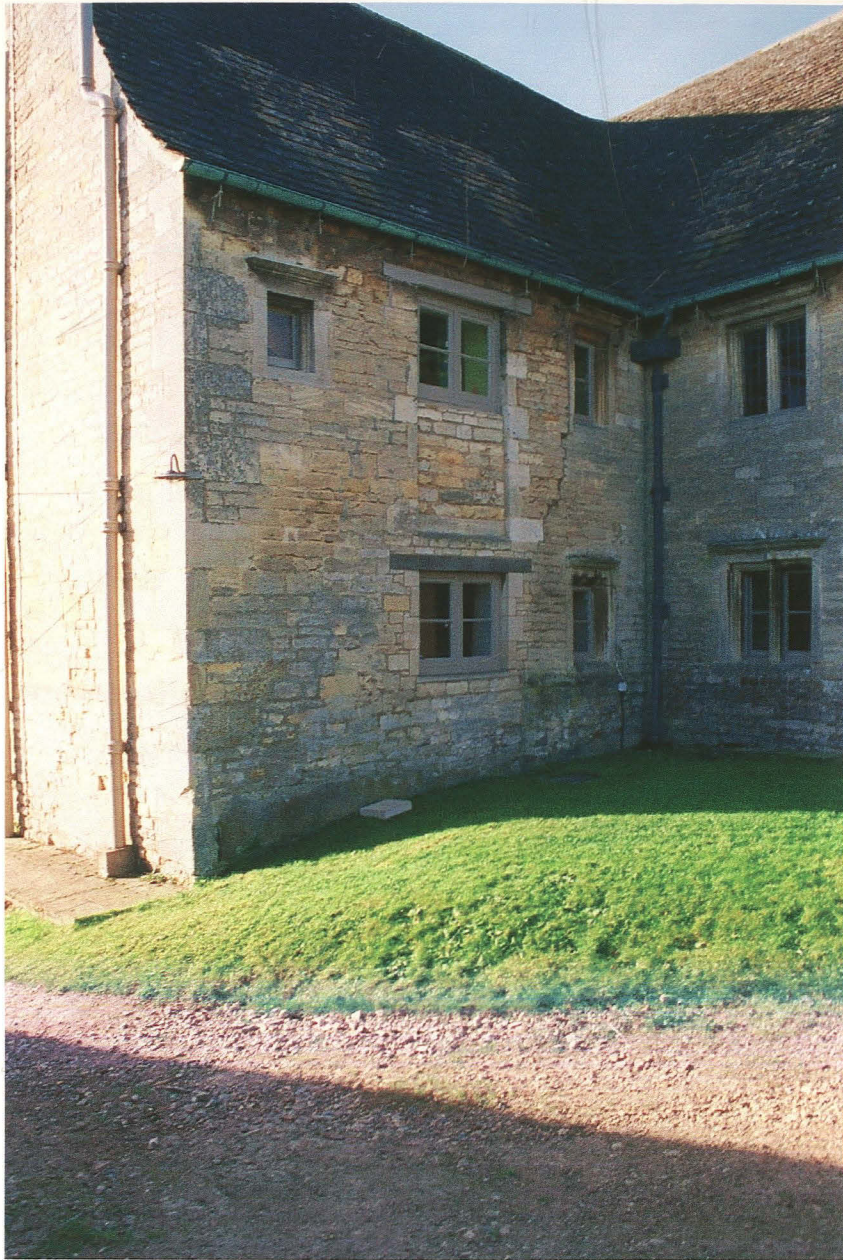
Pl. 5 North wall of east wing showing shadow of removed stair to left of central floor window and blocked door above.

This part of the east wing was originally a thatched lean-to known as the 'dirty kitchen' which was altered between 1798 and 1805 to its present appearance (National Trust 2001, 8). A photograph held by the National Trust at Woolsthorpe Manor shows the position of the stair parallel to the north wall of the East Wing. The zig-zag scar of its position is still visible on the wall, as is the blocked first-floor doorway which led into the store above the ground floor kitchen (Pl. 5). The door jambs appear to be quite different from the jambs surrounding the other openings on this side of the building and appears to be inserted. The staircase is not marked on J. C. Barrow's plan of 1797, although there appears to be one on the south side of this wing. The door, and the stair access, were probably both part of the scheme of alterations known to have taken place at the turn of the 18th/19th century.
