CENTRAL LINCOLNSHIRE TRUNK MAIN. PHASE III ARCHAEOLOGICAL WATCHING BRIEF REPORT

Site Code: CLTM02
NGR: SK 9915 to 5176 - sk 992
TF 9755 4146

Report prepared for Anglian Water services Ltd.
by
Alex Brett

December 2002

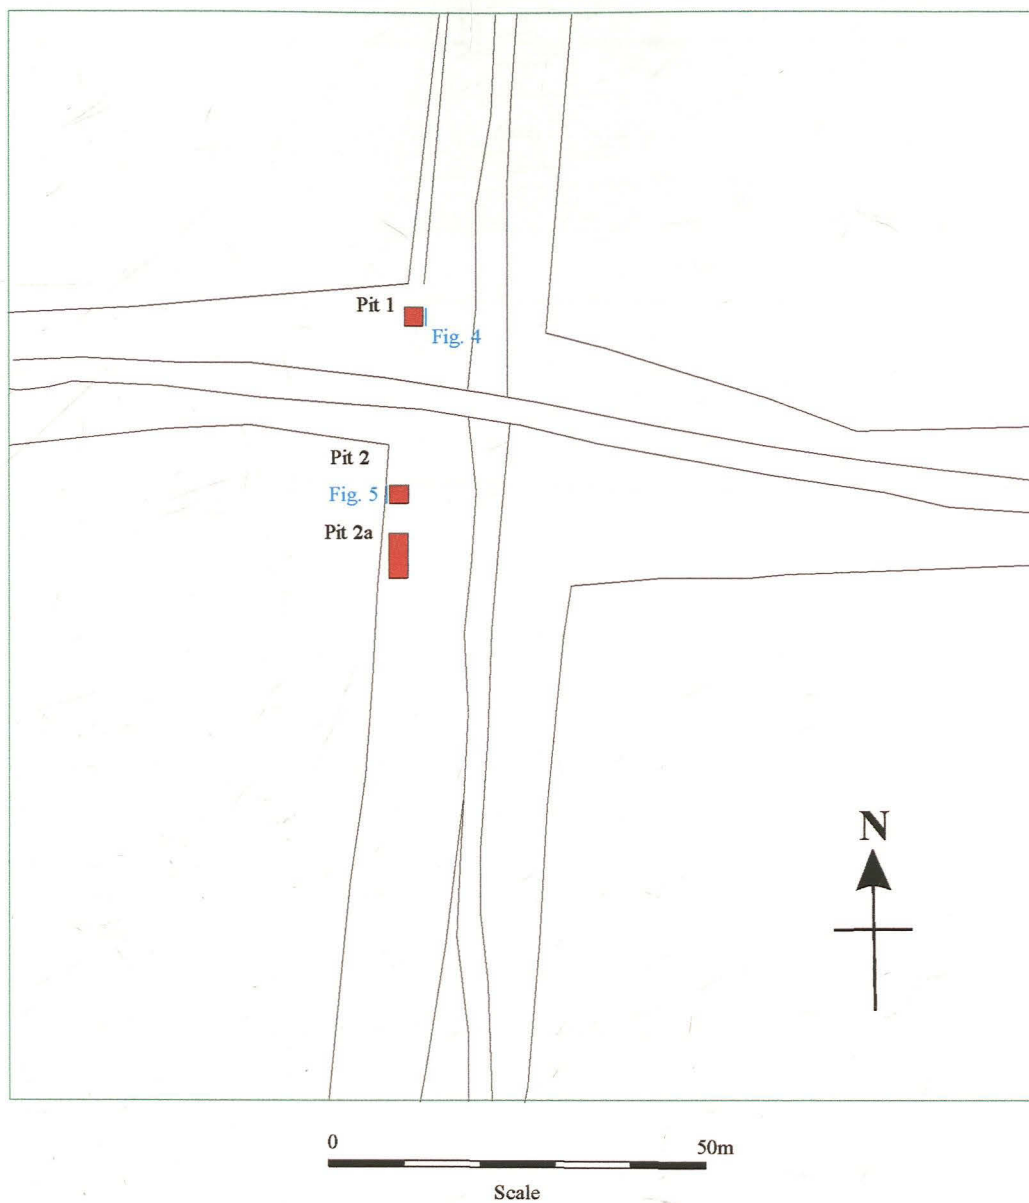
Fig. 3: Close-up of northern portion of route showing precise location of pits 1, 2 and 2a. Also shown are locations of fig.s 4 and 5 which show archaeological remains. 1:1,000.

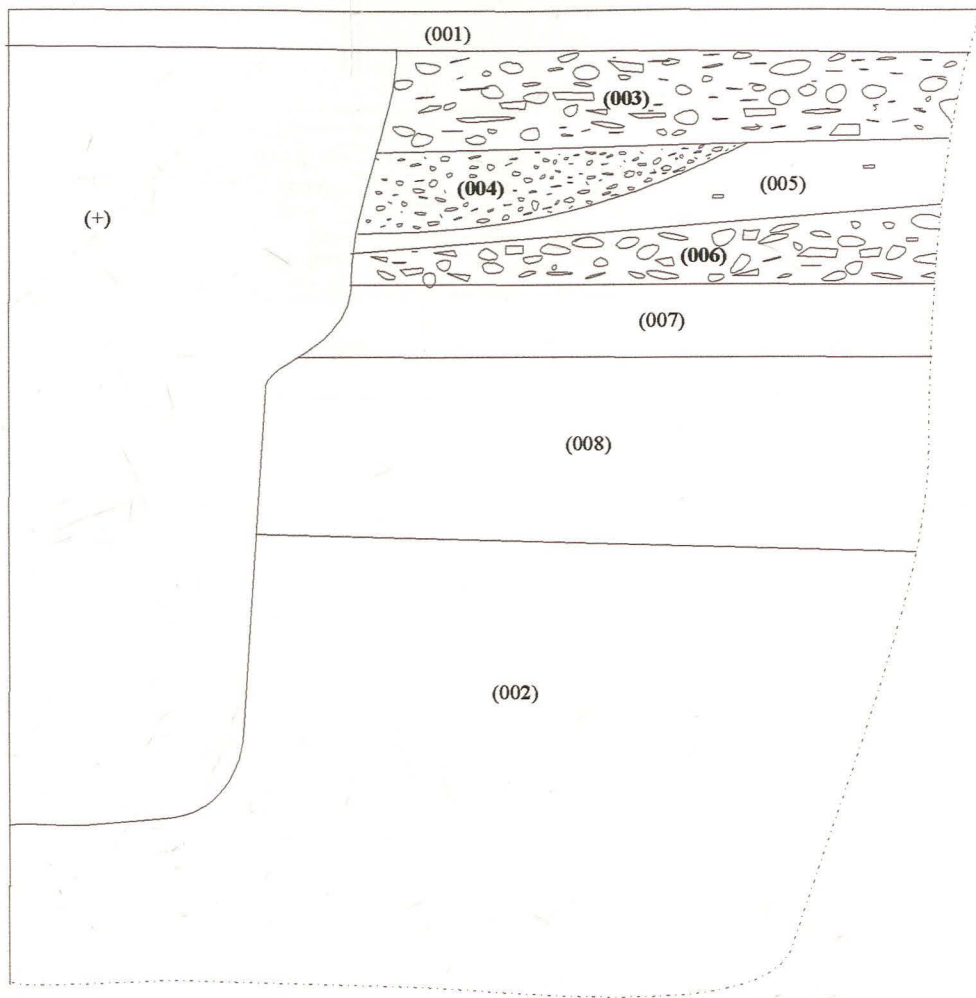
Immediately beneath the topsoil was (003), a deposit of small rounded limestone pieces bonded with light brown silty sand; both materials being derived from the local bedrock. This material formed an even layer and was interpreted on-site as a road surface. Beneath this was (004), a similar deposit with slightly smaller stones which terminated towards the south of the pit. (005) was a mid to dark brown re-deposited soil containing occasional charcoal flecks. This was interpreted as possible up-cast from a roadside ditch that was not observed. A single fragment of medieval tile was recovered from this deposit.

Beneath (005) was (006), a 0.20m thick layer of re-deposited and degraded bedrock containing further medieval tile fragments. This deposit was interpreted as embankment material used to build up the road surface. It sealed (007), a further layer of limestone chippings bonded with limestone sand. It was unclear whether this was a natural or cultural deposit.

Beneath (007), (008) was a deposit of compact slightly silty sand of natural origin, and this was over the undivided limestone bedrock, context (002).

Fig. 4: West facing section from pit 1.

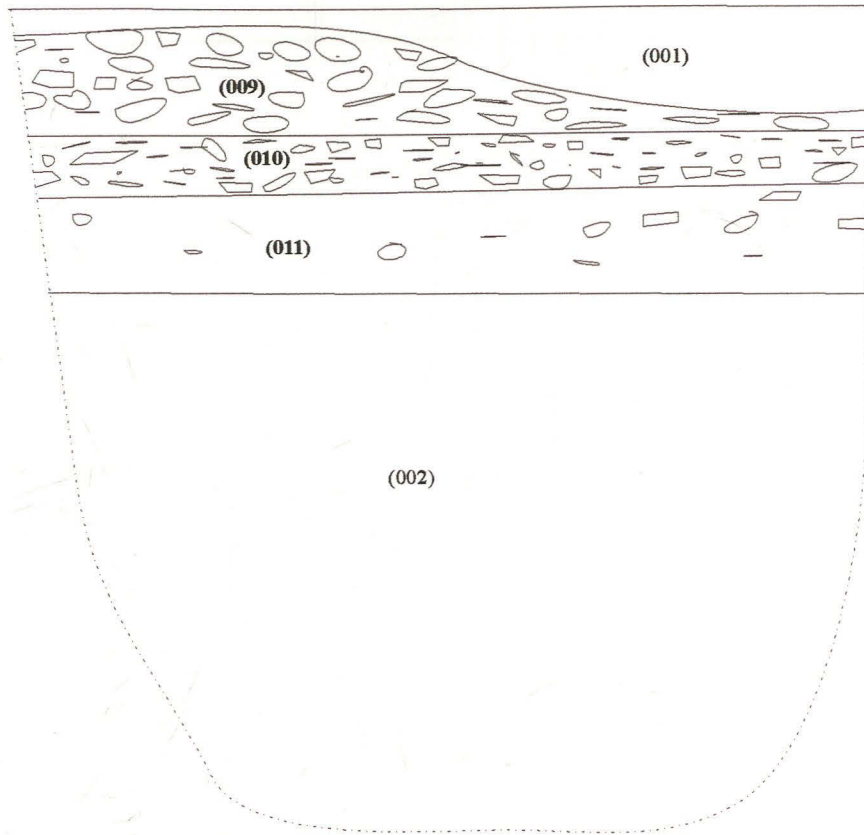
Beneath the topsoil, the upper deposit was (009), made up of small and medium sized rounded limestone in a matrix of compact silty sand. This lensed out towards the north, and was interpreted as a road surface, possibly a repair or re-surfacing to the underlying layer. Given that there is a well defined edge to (009) visible in the east facing section it may be that this surface runs east to west not north to south. The underlying deposit, (010), was similar to (009), but was made up of smaller stones. This too was interpreted as a road construction deposit.

Layer (011) was composed of slightly silty sand derived from the local bedrock, and containing occasional small limestone fragments. This was originally believed to be a further level of road construction, but its proximity to the underlying bedrock (002), coupled with the fact that sand is unstable for road construction, leads to the re-interpretation that it was a natural subsoil deposit.

Fig. 5: East facing section from pit 2.

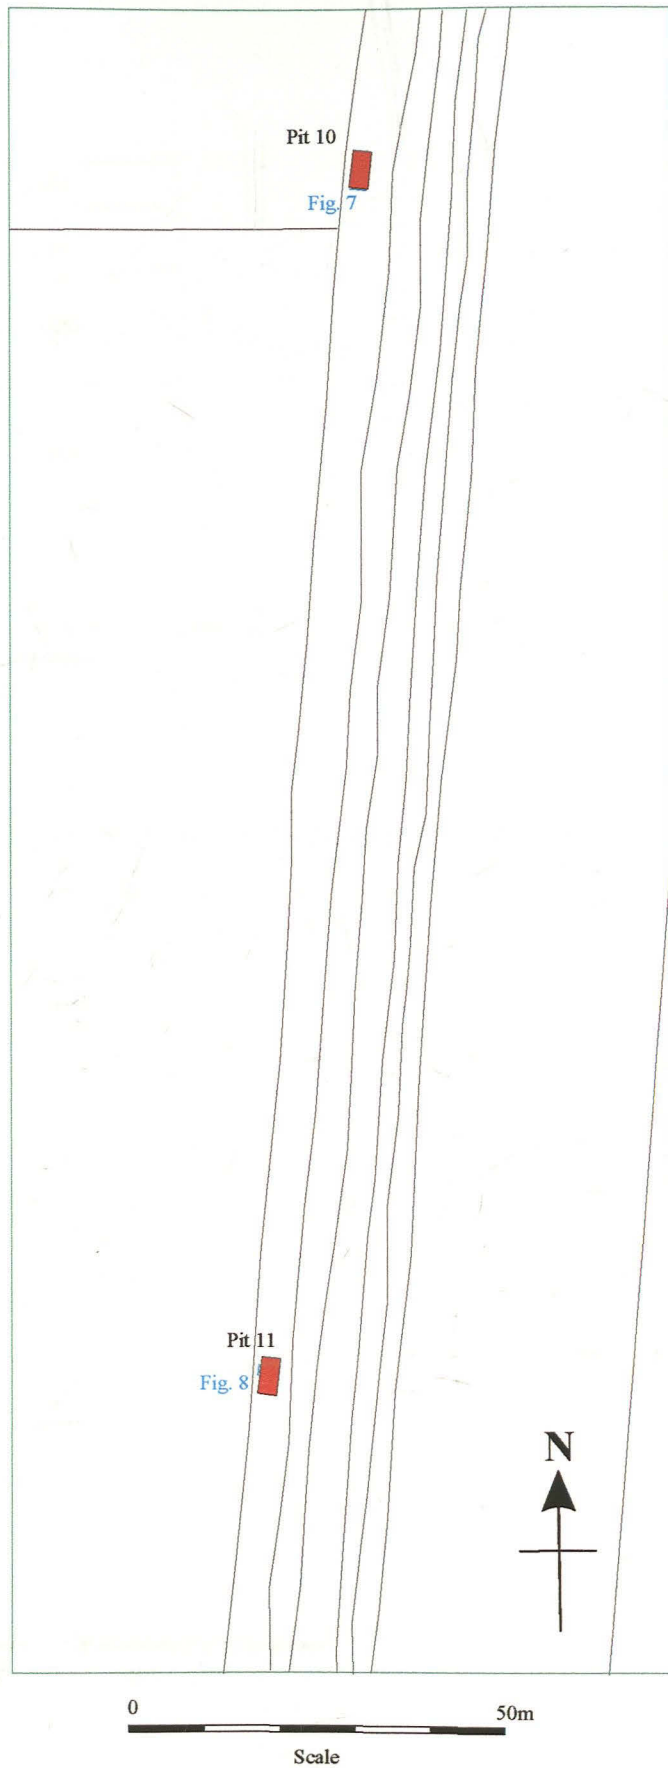
Fig. 6: Close-up of portion of route showing precise location of pits 10 and 11. Also shown are locations of fig.s 7 and 8 which show archaeological remains.
1:1,000

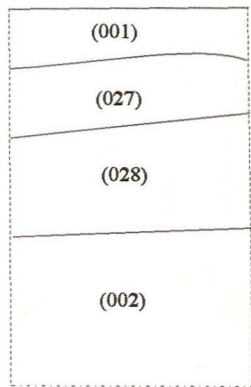
Two archaeological deposits were recorded in this pit. Beneath the topsoil, (027) was a layer of rough limestone pieces bonded with crushed limestone and limestone gravel. Below it (028) was similar, but it incorporated pieces of stone that were approximately twice the size. These deposits are interpreted as a road surfaces that were built onto a bedding layer of larger, natural, stones.

Fig. 7: North facing section from pit 10.

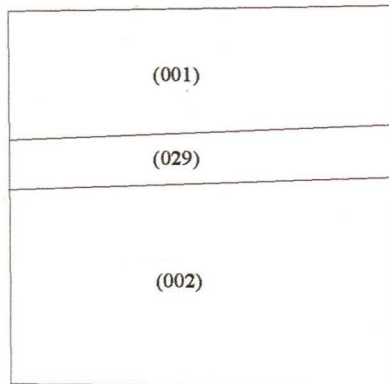
A single possibly archaeological horizon was exposed beneath the topsoil; layer (029) was made up of small pieces of limestone, bonded with coarse sandy silt. There were also inclusions of pea gravel. This was originally interpreted as a road surface, but the infrequency and small size of the stones renders a natural interpretation more likely.

Fig. 8: East facing section from pit 11.

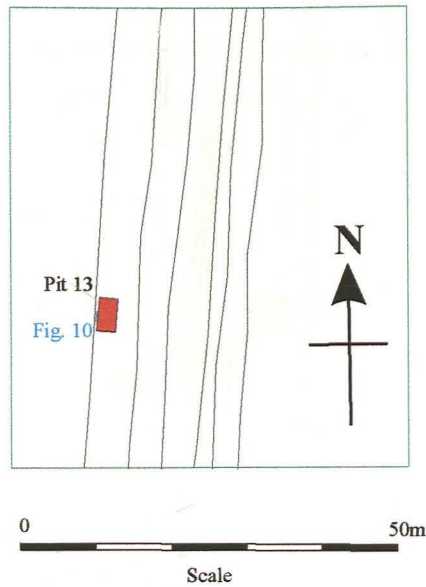
Fig. 9: Close-up of portion of route showing pit 13. Also shown is location of fig. 10 showing archaeological remains. 1:1,000

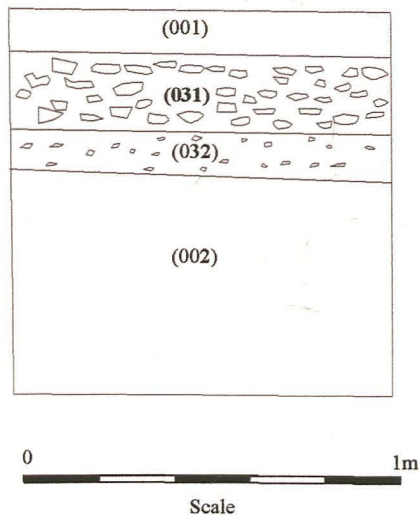
Directly below the topsoil was layer (031), made up from platey limestone pieces bonded with fine sandy silt; probably the same material crushed. This was over (032), dark grey sand containing charcoal flecks and occasional limestone. This was interpreted as a buried soil, the charcoal indicative of burning in the vicinity.

Fig. 10: East facing section from pit 13. 1:20.

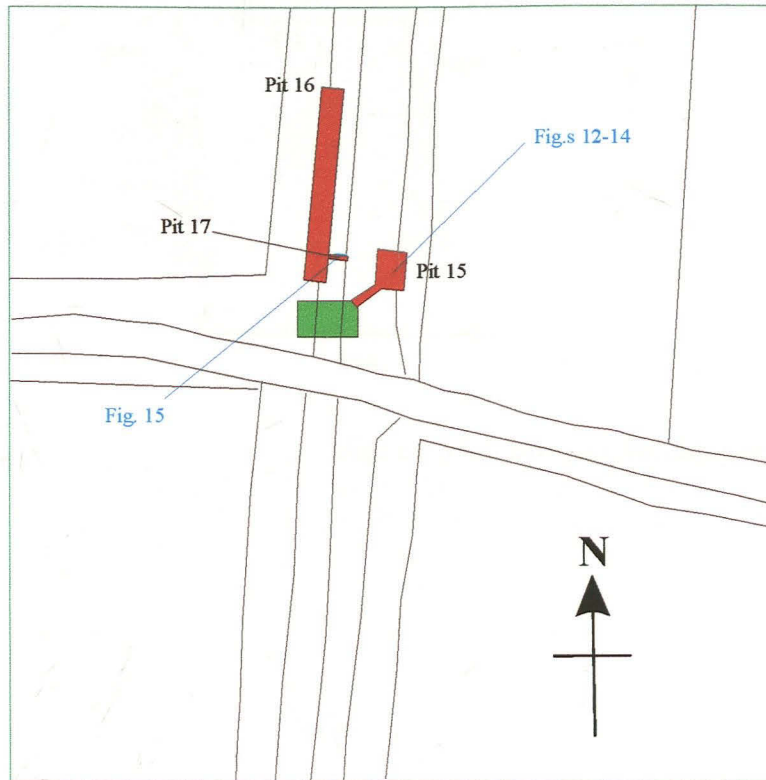
Fig. 11: Close-up of southern portion of route showing precise locations of pits 15-17. Also shows location of fig.s 12-15.
1:1,000

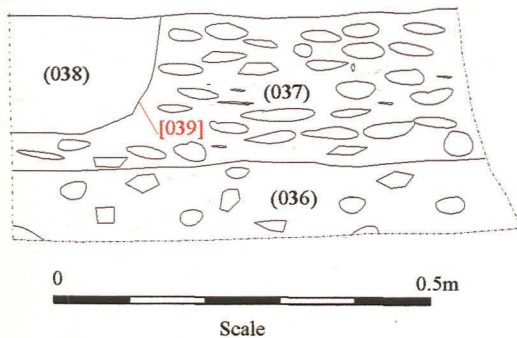
To the east of the pipe trench was a further limestone layer, (037); similar to (035), in that it did not present a smooth upper surface, but resembled a roughly constructed make-up deposit. This was also over the buried topsoil (036).

Cutting into the eastern side of this material was a cut feature, [039]. A single steep side of this was observed. It had a flat base and was filled with (038), comprising small spheroidal limestone gravel and sand. The 'feature' was interpreted as reflecting wear to the road material (037), that was later repaired with rammed gravel, (038).

Fig. 13: North facing section from pit 15 showing surface (037) cut by later linear feature (039). The lower material (036) is a buried soil. 1:10.

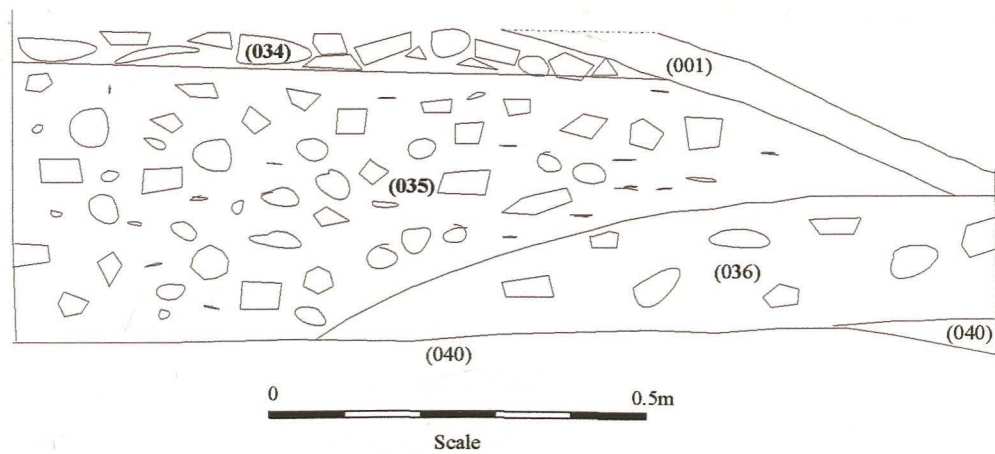
The above deposits sealed (036), friable greyish brown sandy silt with frequent limestone inclusions. This material appeared to be a buried topsoil, sealed when the stone layers above were deposited. It rested over (040), a natural deposit of reddish limestone sand, weathered from the local bedrock.

Fig. 14: Northwest facing section showing road surface (034) over make-up layer (035). Below this is the buried soil (036) and below that weathered bedrock (040). 1:10

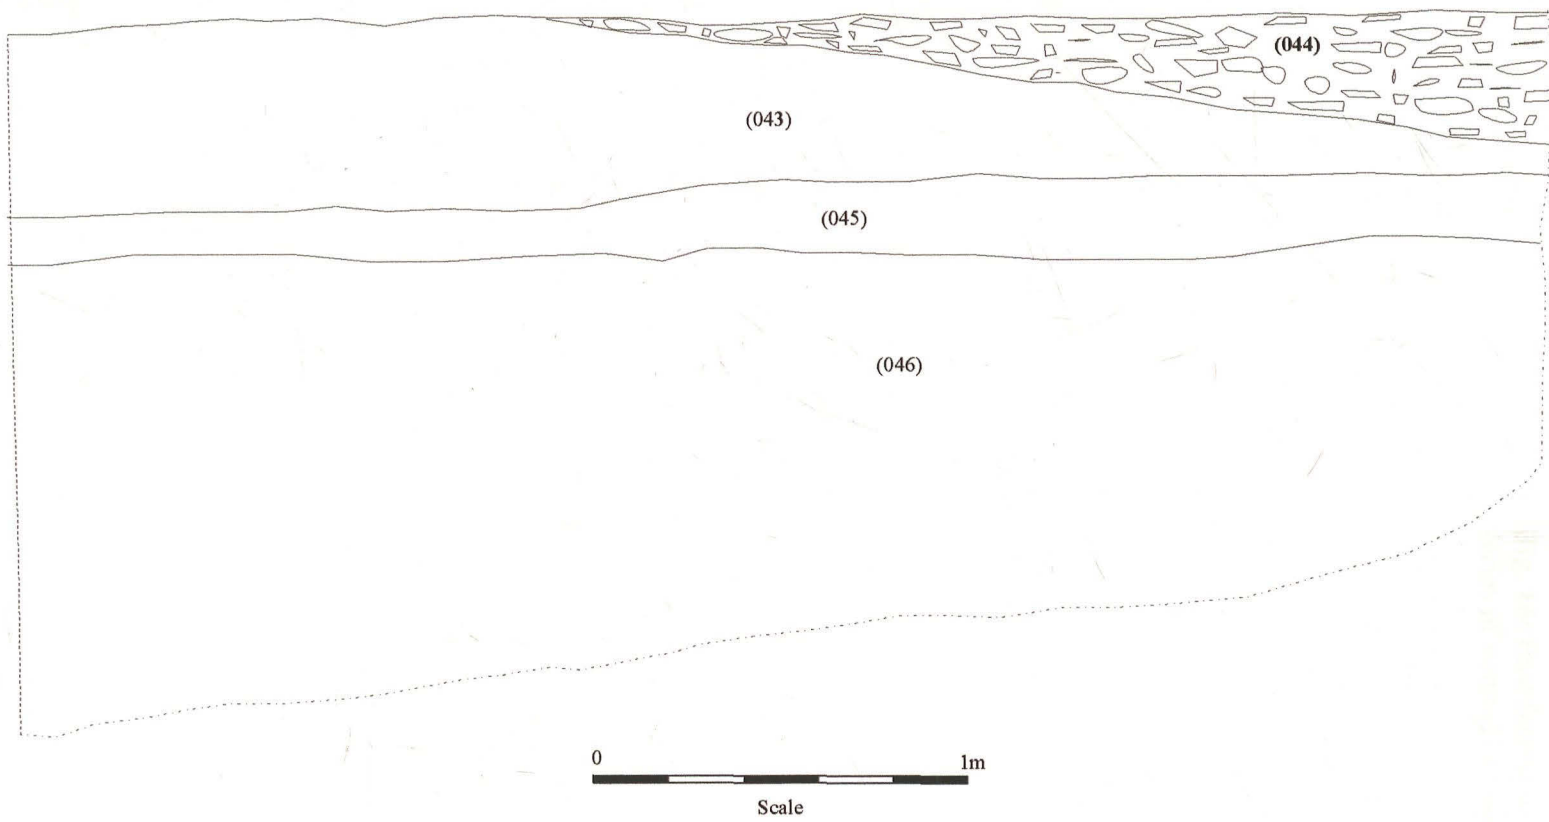
Fig. 15: South facing section from pit 17. Shows re-deposited road make-up (044) over modern topsoil (045). 1:20.

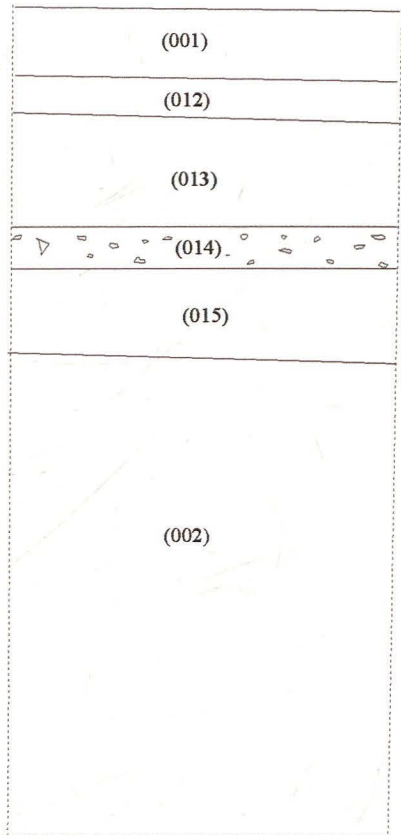
Fig. 16: East facing section from pit 3. Shows a series of natural limestone layers. 1:20

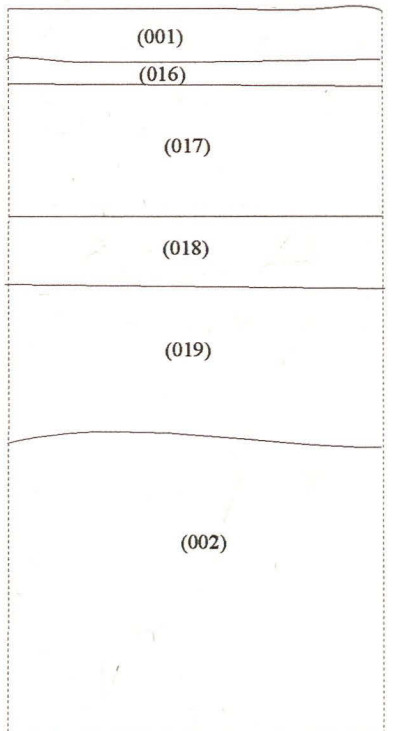
Fig. 17: West facing section from pit 4. Shows a series of naturally formed degraded natural layers. 1:20.

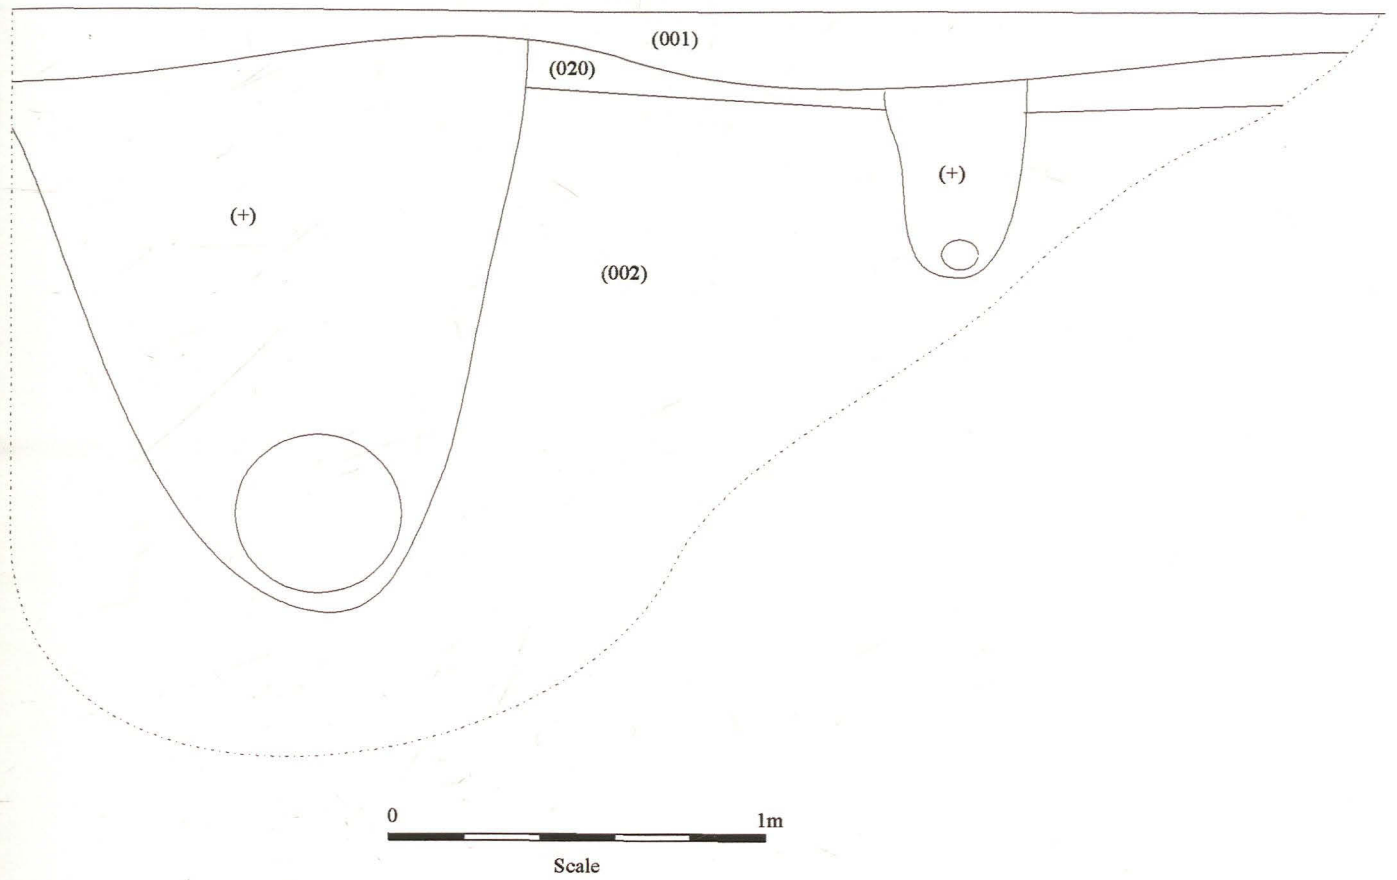
Fig. 18: South facing section, pit 5. Shows modern pipe trenches cutting natural deposits. 1:20.

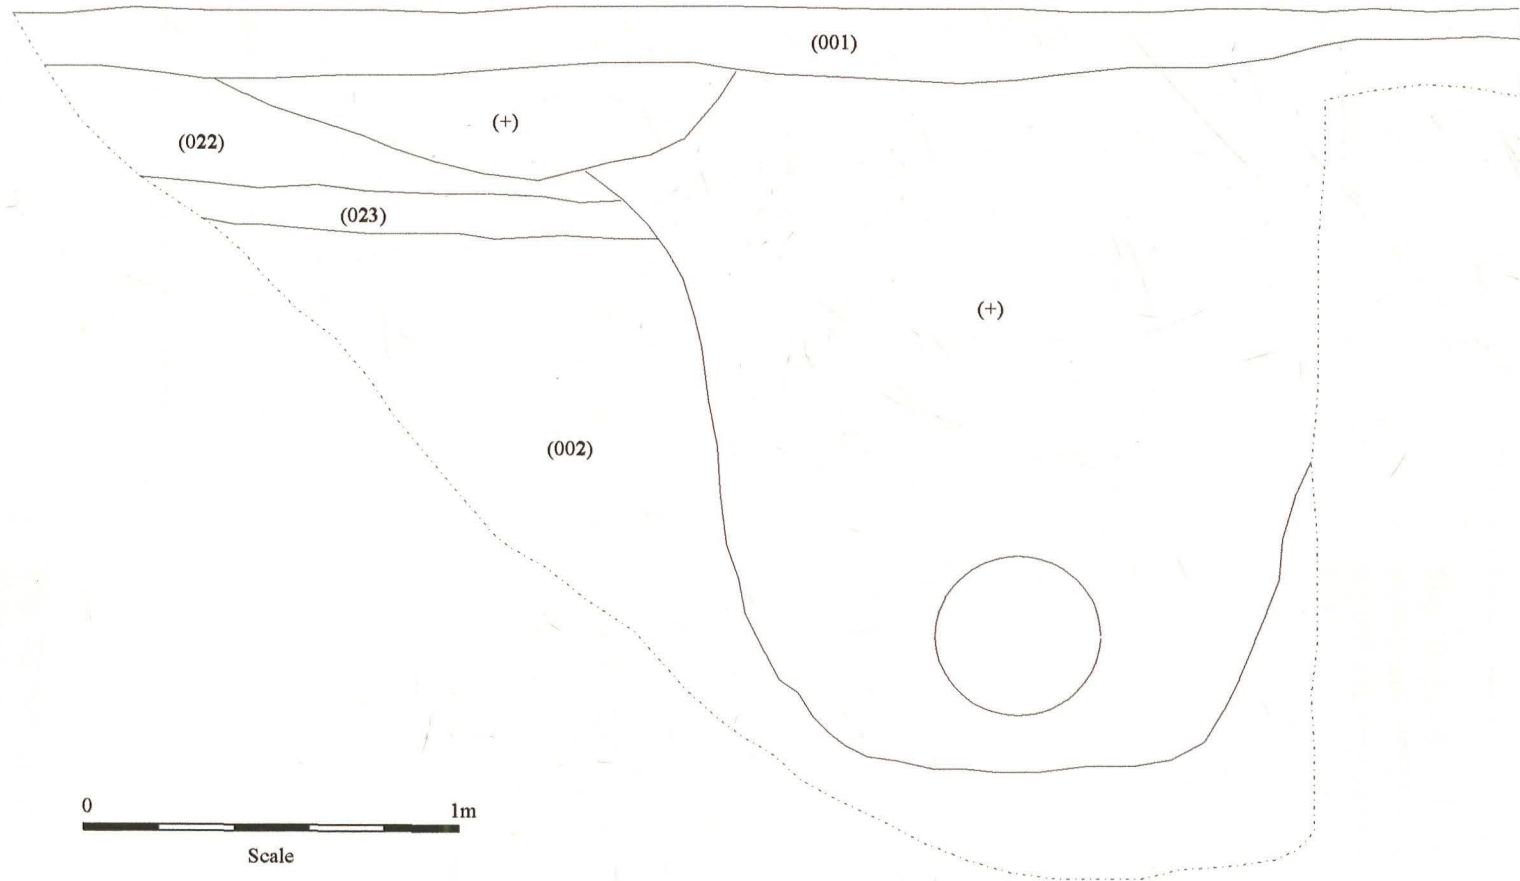
Fig. 19: South facing section from pit 6, showing pipe trenches cutting through a series of natural deposits. 1:20

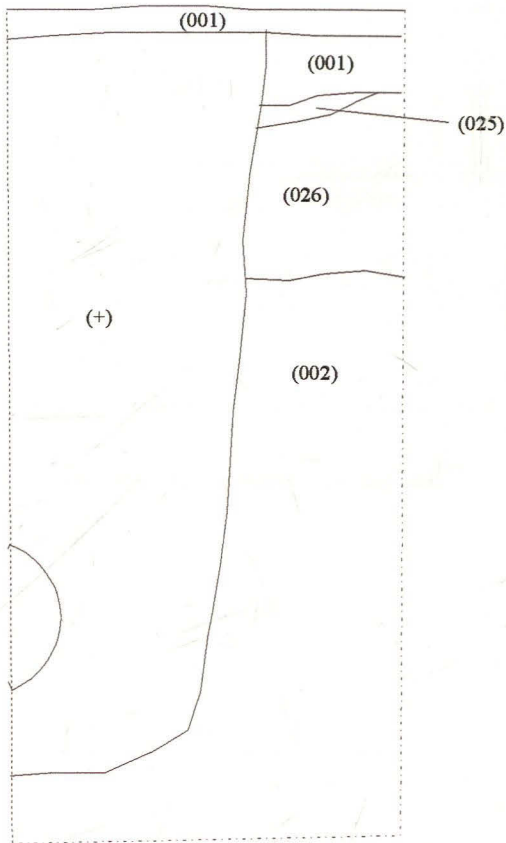
Fig. 20: South facing section from pit 7, shows pipe trench cutting through topsoil and degraded natural layers. 1:20

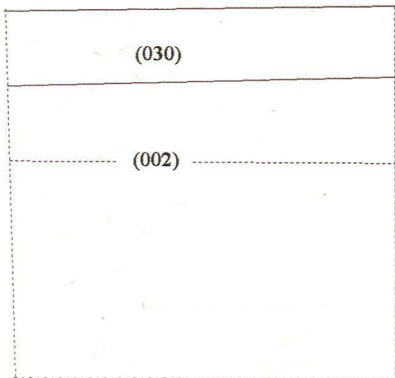
Fig. 21: North facing section from pit 8, shows topsoil over bedrock, the upper portion of which is degraded. 1:20.

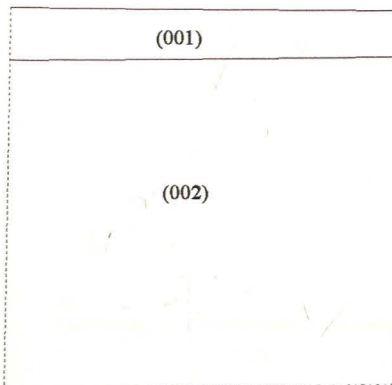
Fig. 22: West facing section from pit 9, shows topsoil over bedrock. 1:20.

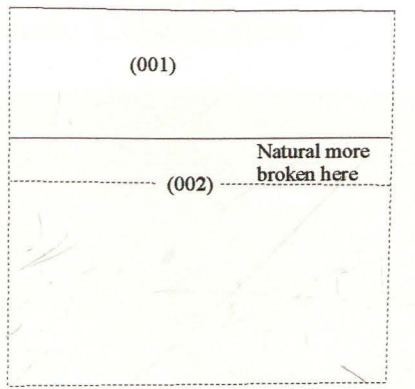
Fig. 23 : East facing section from pit 12. Shows topsoil and bedrock. 1:20

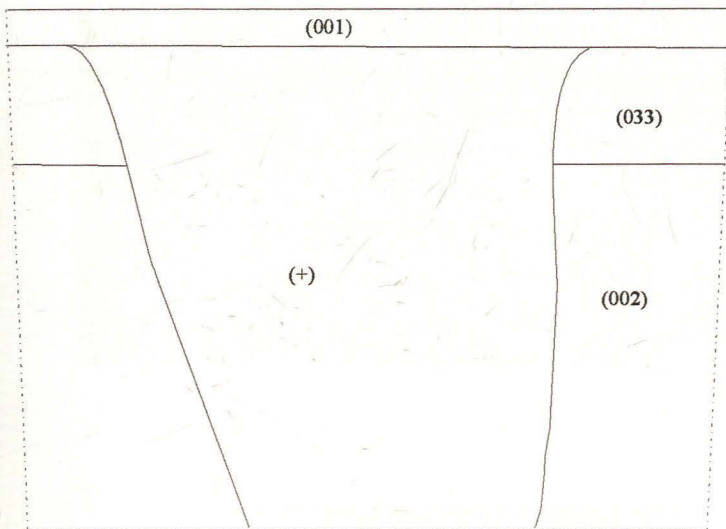
Fig. 24 : North facing section from pit 14. Shows modern pipe trench cutting through natural subsoil and bedrock. 1:20

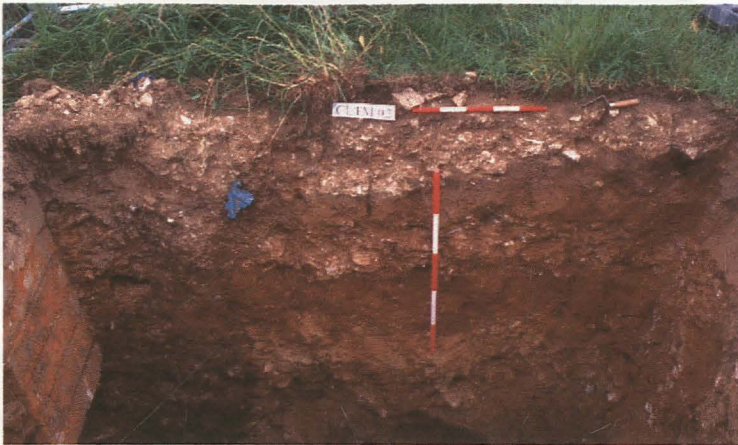
Pl. 1: West facing section from pit 1. Material at top of section is modern dumping but the deposit in the centre of the scale is a medieval road surface.

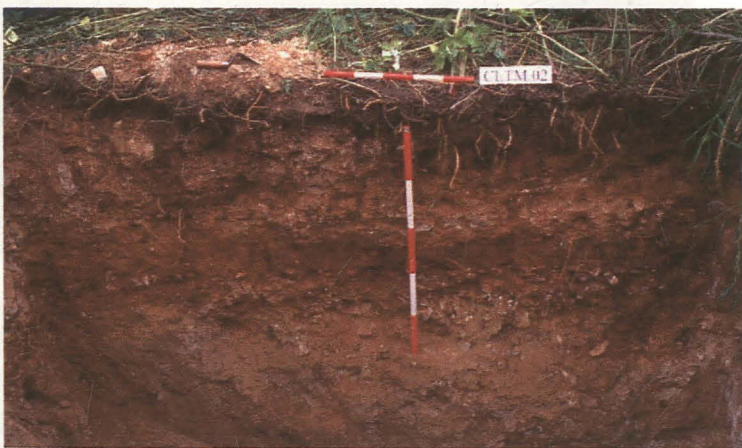
Pl. 2: East facing section from pit 2. Top rubble layers are road deposits sealing a natural material, possibly a buried soil.

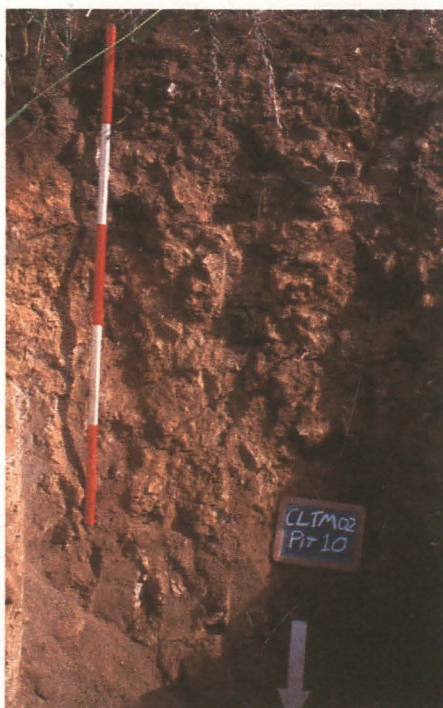
Pl. 3: South facing section from pit 10. Topsoil is visible at the top of the frame, bedrock starts approximately 40cm up the scale. Between are 2 road layers.

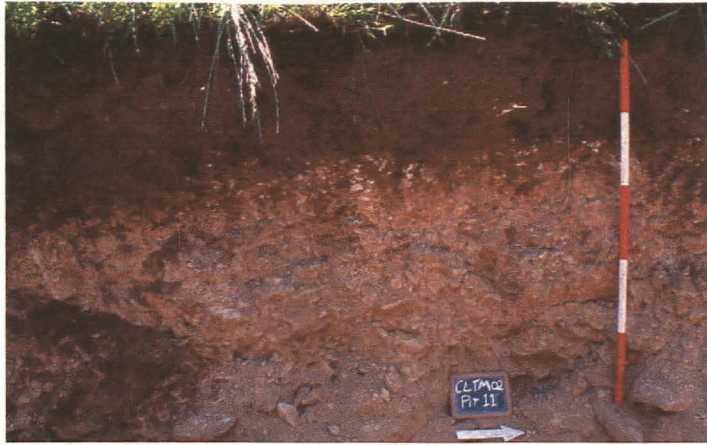
Pl. 4: West facing section from pit 11. Band of material between bedrock and topsoil has been interpreted as a road surface.

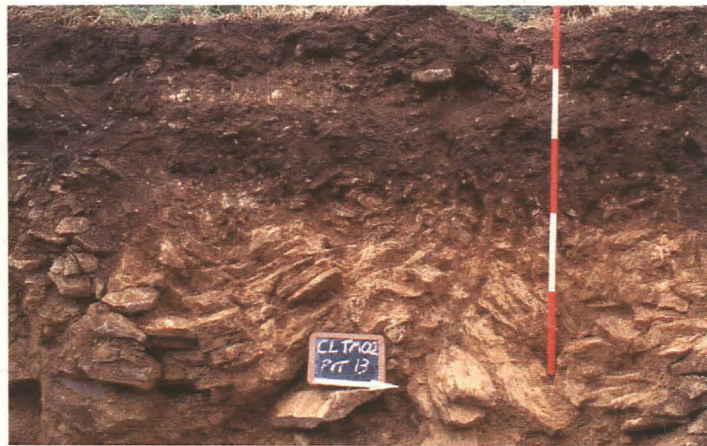
Pl. 5: West facing section from pit 13. Two layers between topsoil and bedrock were interpreted as road deposits

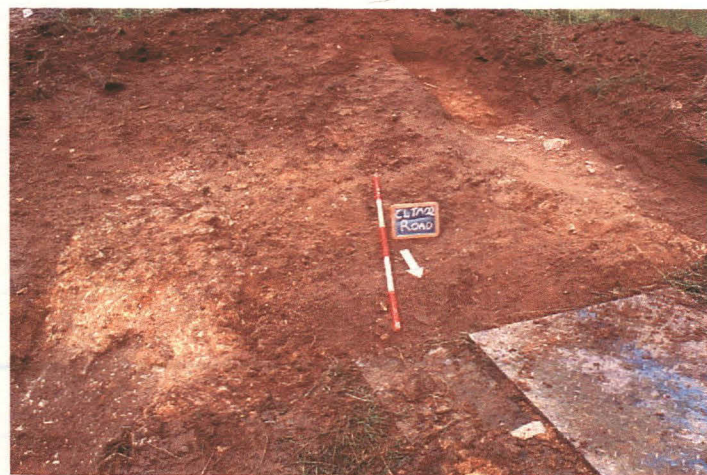
Pl. 6: Road surface exposed in pit 15. Note surface deposit and lighter make-up layer in bottom left corner. Centre of frame is modern truncation.

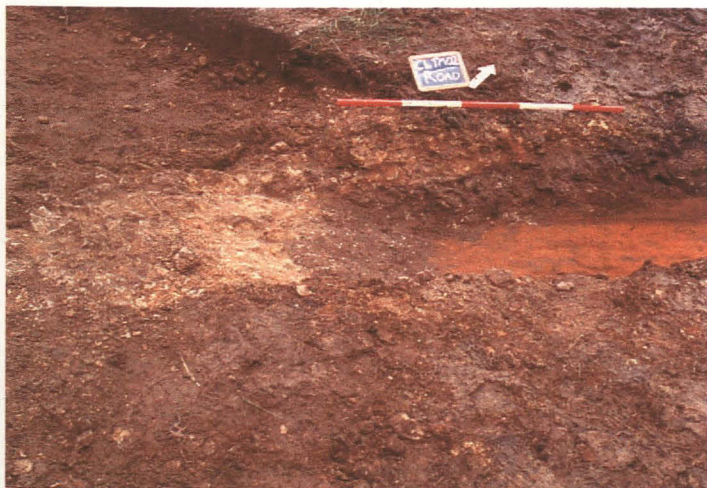
Pl. 7: North west facing section from pit 15. Shows road layers over buried topsoil, red sand to left of image is a natural deposit
