**ST. NICHOLAS' CHURCH,  
NEWPORT, LINCOLN.  
ARCHAEOLOGICAL  
WATCHING BRIEF REPORT**

Site Code: SNCL02  
 NGR: SK 9768 7244.  
 Planning Ref. N/A  
 Accession No. 2002.435.  
 480

Report prepared for M.B. Architecture.  
by  
Alex Brett

December 2002

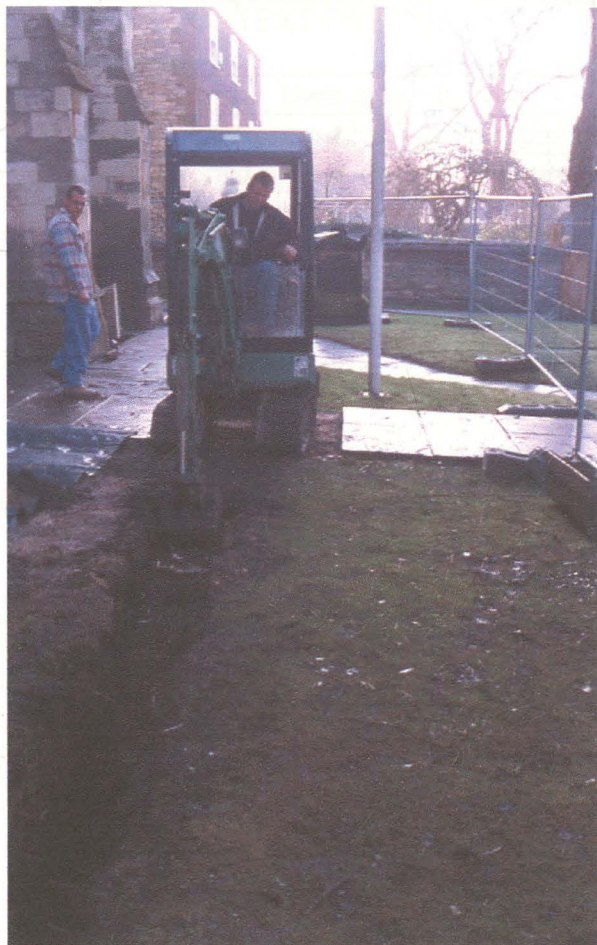
Only two deposits of any note were exposed during the course of this watching brief: beneath the modern topsoil was a layer of crushed limestone sand and chippings which probably dates to 1839-40, when St Nicholas' Church was built. An examination of this structure appeared to indicate that the tower and spire on the southeast corner were additions, and so the main archaeological horizon could conceivably be more specific to this phase of work. Pottery recovered from the underlying buried topsoil dates to the 18<sup>th</sup> or 19<sup>th</sup> century. Beneath this material was what appeared to be a buried topsoil, which would have pre-dated the construction of the present church. The overlying material protects this deposit.

**Pl. s 1&2 :** Showing machine excavation of drainage trench, and west facing section with a rubble horizon that was interpreted as construction debris from the building of the church.
