**BUILDING RECORDING AT
BOLINGBROKE CASTLE,
OLD BOLINGBROKE,
LINCOLNSHIRE
(OBC00)**

**Work Undertaken For
English Heritage**

July 2002

APS Report No. 136/02

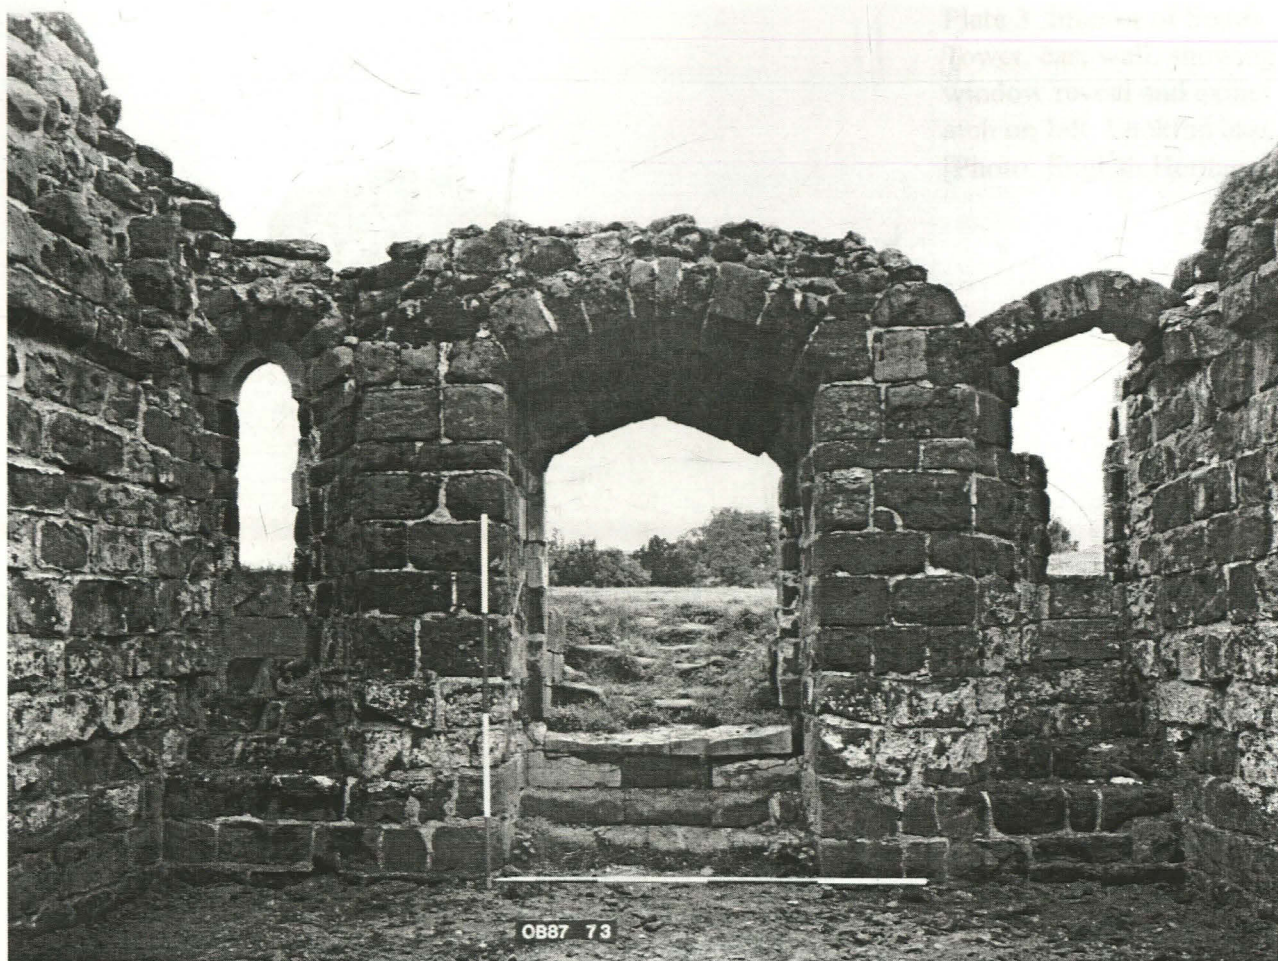
Plate 1 Interior of South Tower, showing extant window arch on right. Looking north. [Photo: English Heritage]

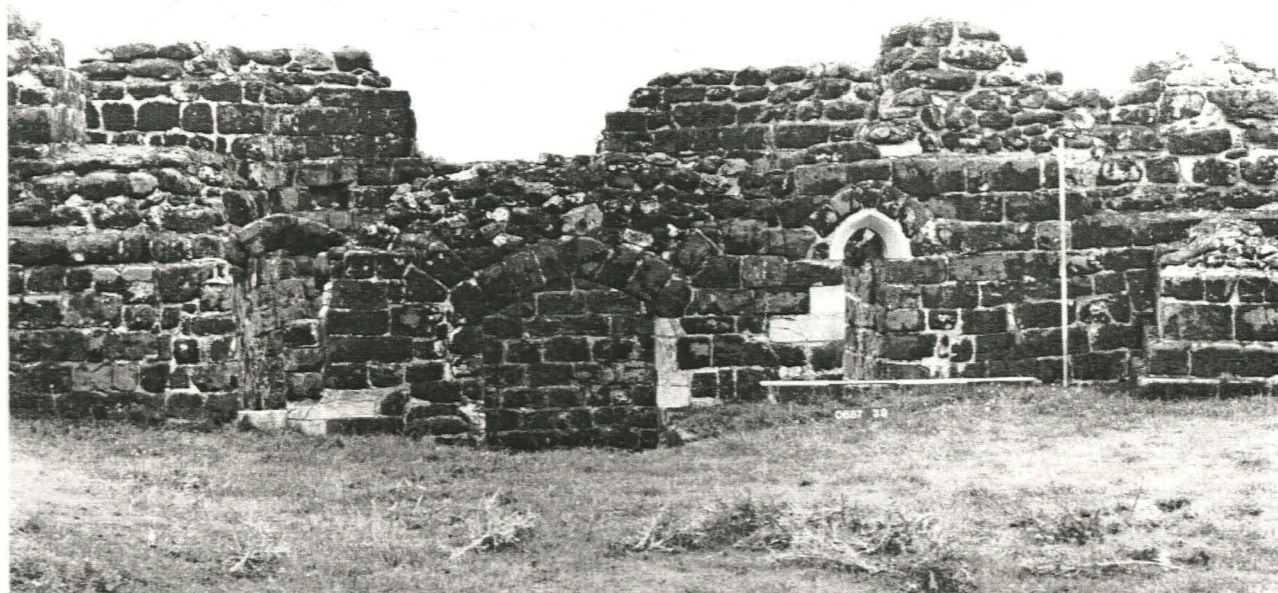
Plate 2 Curtain wall of castle, looking toward South Tower, showing extant window arch on left. Looking south. [Photo: English Heritage]

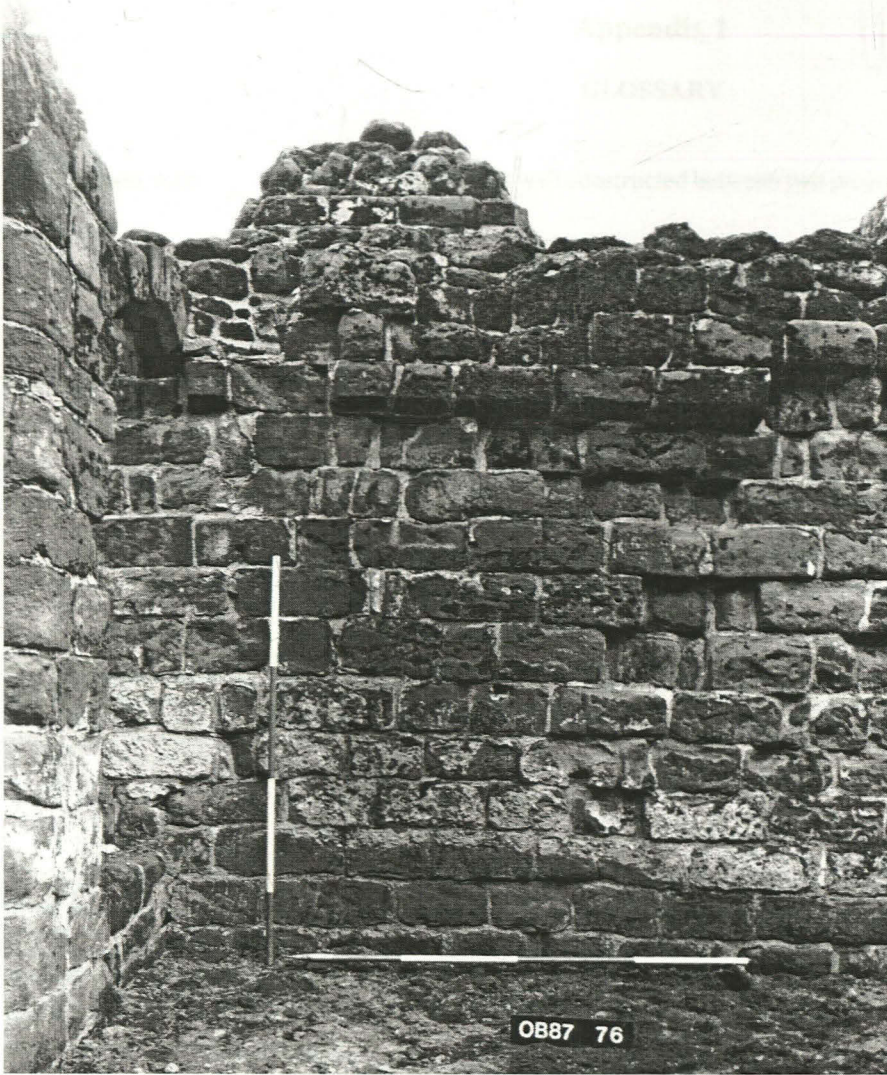
Plate 3 Interior of South Tower, east wall, showing window reveal and extant arch on left. Looking east. [Photo: English Heritage]
