ROBERT MANNING SCHOOL, BOURNE. ARCHAEOLOGICAL WATCHING BRIEF REPORT

Site Code: RMB02
NGR: TF 1011 2072. TF1012
Planning Ref. DC/612/0003
Accession No. 2002.535

Report prepared for Hyder Business Services Ltd.
by
Alex Brett

January 2003

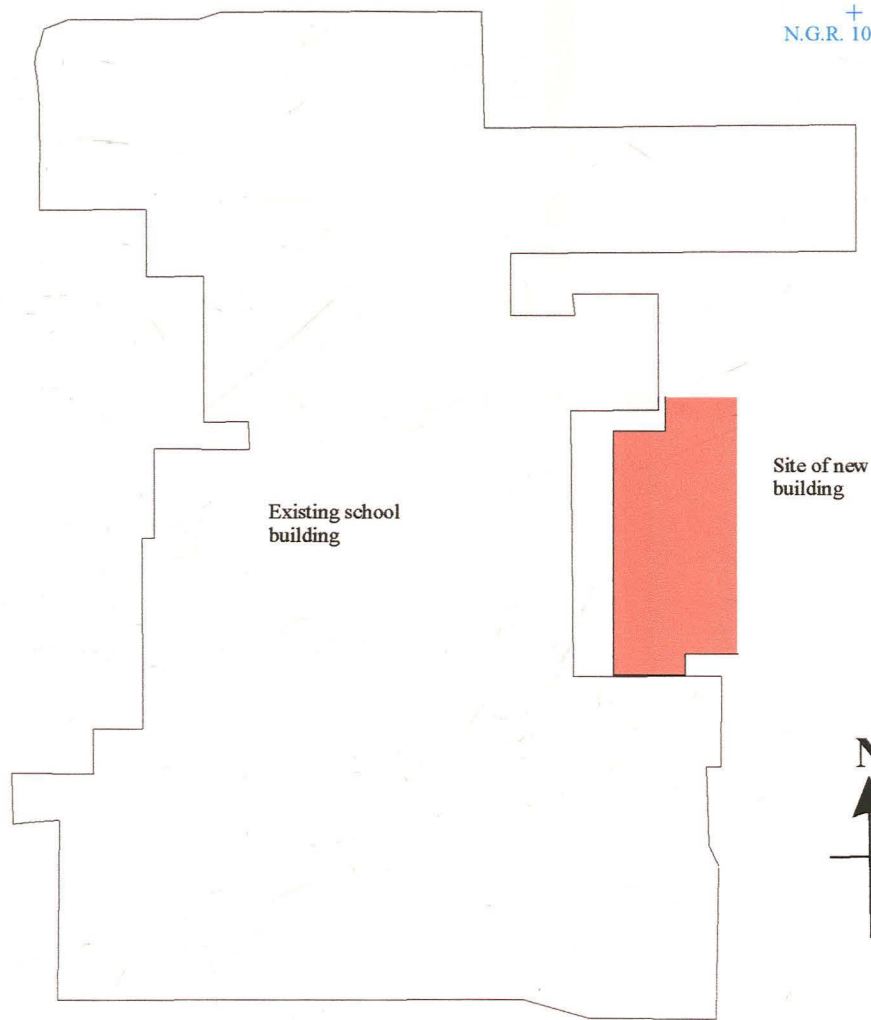
Fig. 2 : Plan showing outline of existing school buildings and location of proposed new buildings. 1:1,000

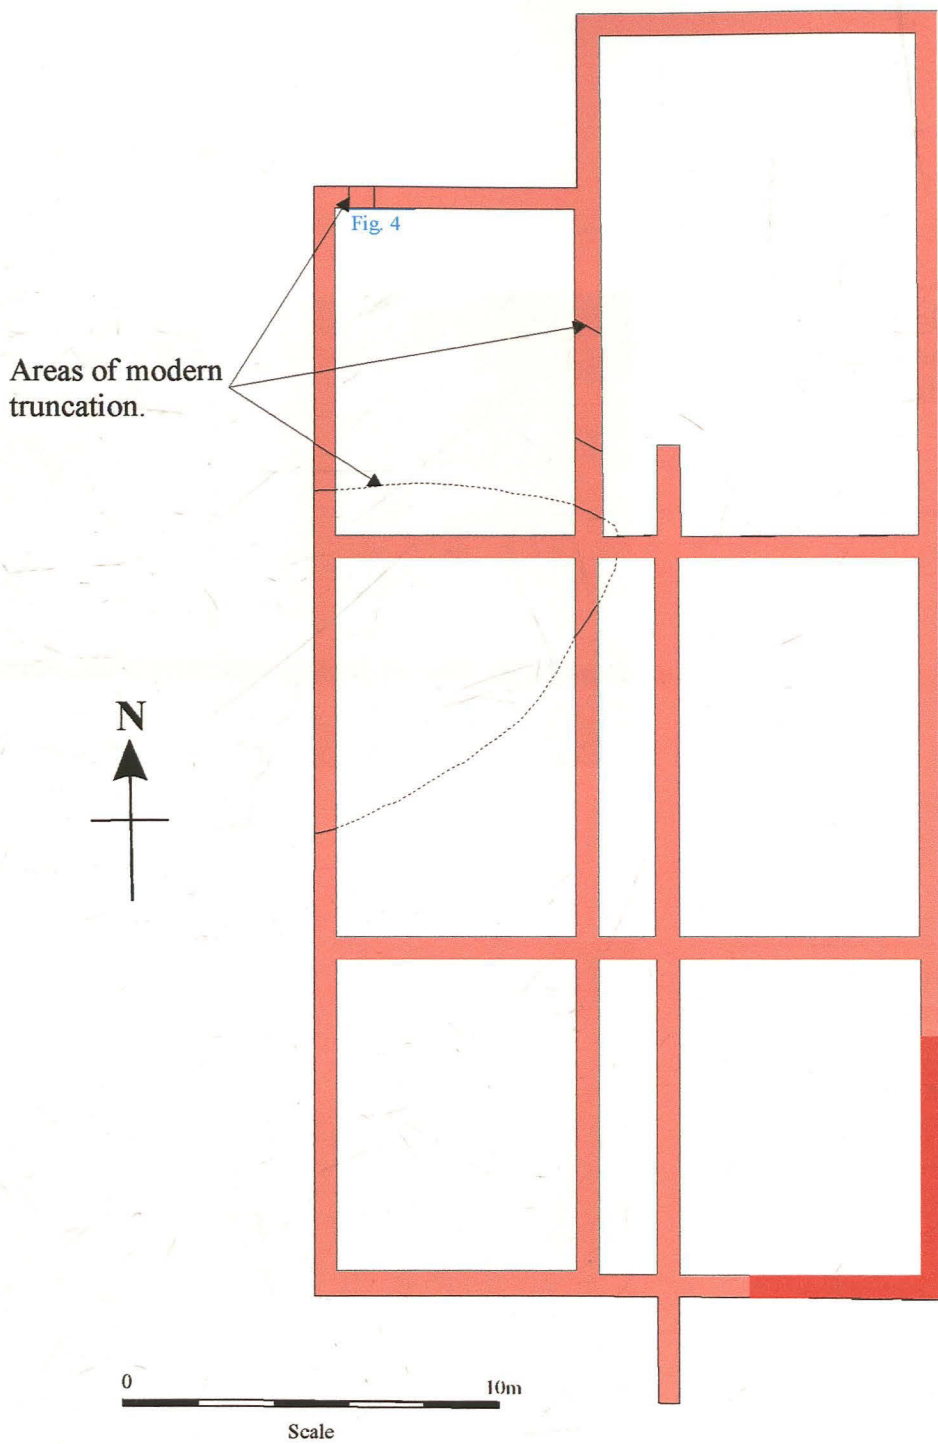
Fig. 3 : Layout of foundation trenches, showing area to the southeast that was not monitored. Also shown are 3 areas truncated by modern activity. 1:200

Three areas of modern truncation were observed in the western part of the site, one of which to the north was a machine-excavated trench, [004]; the other two were irregular depressions. These features contained significant quantities of tarmac in their fills.

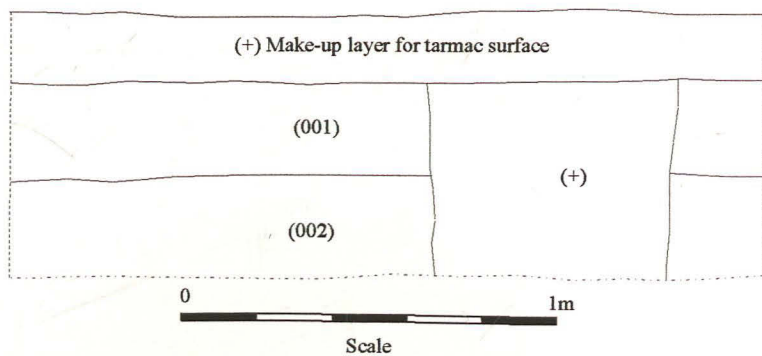
Fig. 4 : North facing section showing modern truncation and the 2 natural layers that were observed on the site. 1:20.

The uppermost material removed from the site was the tarmac surface of a former car park. Beneath this was a layer of limestone chippings, between 0.15 and 0.25m thick, which formed the bedding for this surface and levelled the site.

Below this limestone layer was a deposit of yellowish brown sandy clay, (001), that was interpreted as a natural alluvial deposit. As no topsoil was observed over this material, it seems likely that the base of the limestone layer was over a truncation horizon.

Beneath the above was a deposit of very mixed sand and gravel, (002), interpreted as a natural glacial deposit.

The interface between (001) and (002) appeared to undulate slightly. This could represent evidence of ridge and furrow; similar to that recorded during earlier work at the site, (Hardwick, 2000). Unfortunately, foundation trenches were filled in small sections, and it was not possible to examine a complete section to verify this.

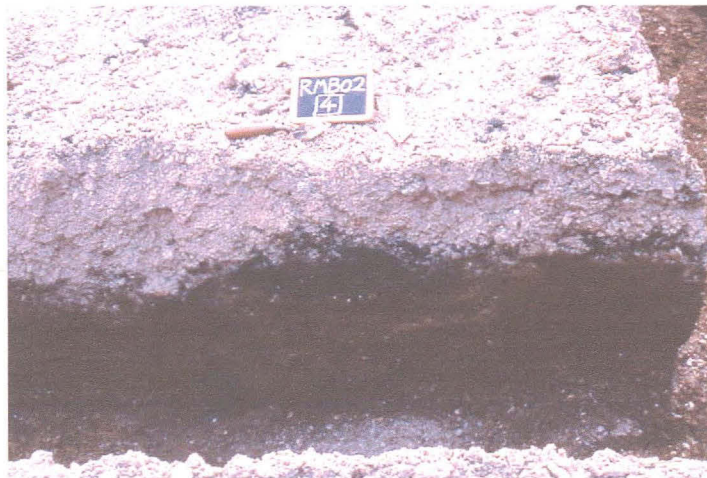
Pl. 2 : North facing section showing modern feature [004].

CONTEXT NUMBER	DESCRIPTION
001	Alluvial sandy clay, natural material.
002	Alluvial mixed sand and gravel, natural material.
003	Fill of [004], re-deposited (001) and (002).
[004]	Vertical sided ditch/trench. Probable pipe trench.

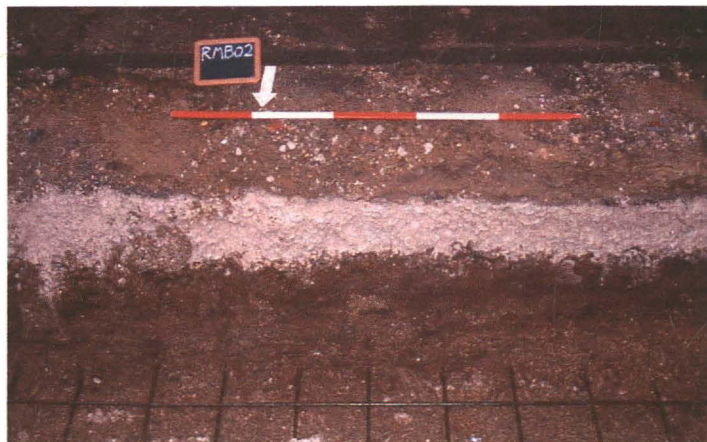
Pl. 3 : North facing section showing make-up layer for existing car park..
