Archaeological Watching Brief at Scotter C.P. School
(NGR: SE 8870 0057)

Lincolnshire County Council's Land and Buildings Consultancy commissioned Lindsey Archaeological Services (LAS) to conduct a watching brief on the groundworks for new buildings at Scotter Primary School, Scotton Road, Scotter (Fig. 1). Work had started before LAS were contacted on April 27th 1994, but an immediate visit confirmed that no archaeological features had been encountered. Two further visits were made when machining took place in other locations (29th April and May 11th); during the final visit some unrelated landscaping disturbances in the school grounds close to the new buildings were also investigated.

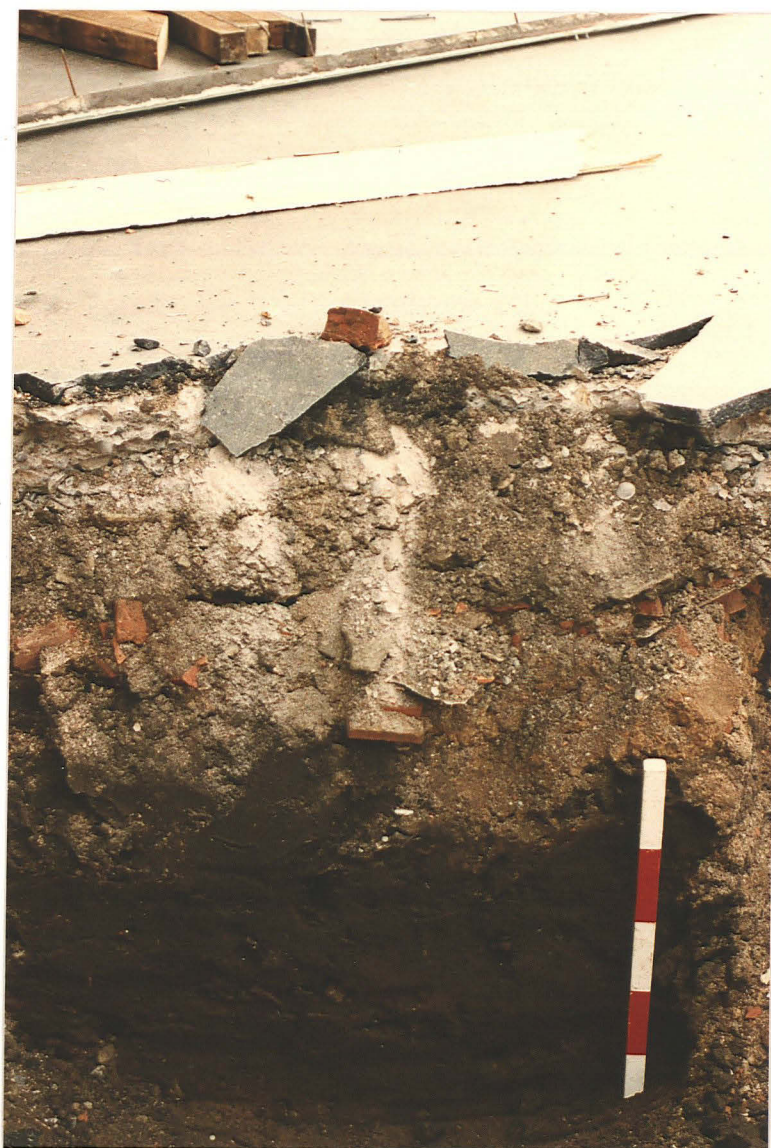
Pl. 2 Area A, section A1 (scale 0.5m)

A1 was at the SW corner, beside a retained covered external corridor. The stratigraphic sequence here was very simple: the asphalt surface overlay about 0.4m of loose rubble incorporating fine stone above a layer of brick rubble. Below this, a single 0.5m thick layer of dark brown soil was recorded, which seemed to be a former topsoil (Pl. 2).

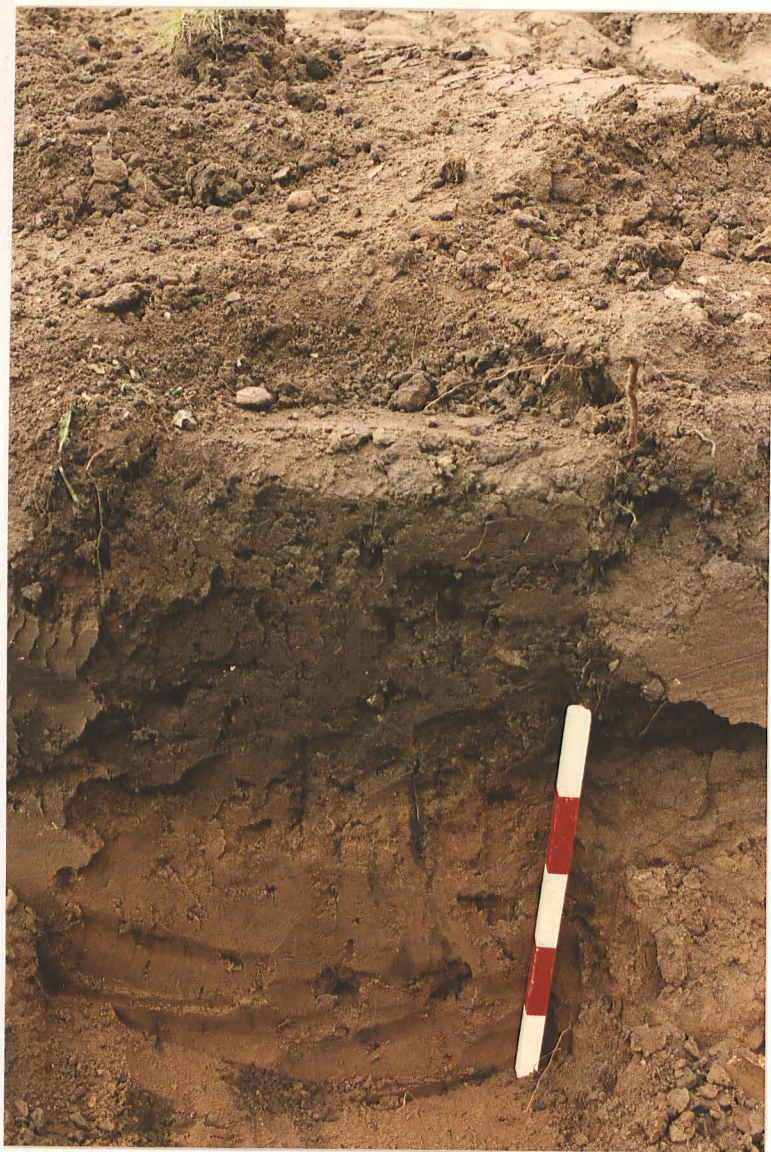
Pl. 3 Area A, section A2

A2 was cut directly through the garden on the west side of the classroom site, through a thick dark brown topsoil layer and 0.4m of the thick underlying light brown sand deposit (Pl. 3). None of the machined footings located any lower stratigraphy. The thickness of the topsoil layer may be the result of topsoil mounding in this area when the adjacent asphalted playground was laid; that lies at a noticeably lower level.

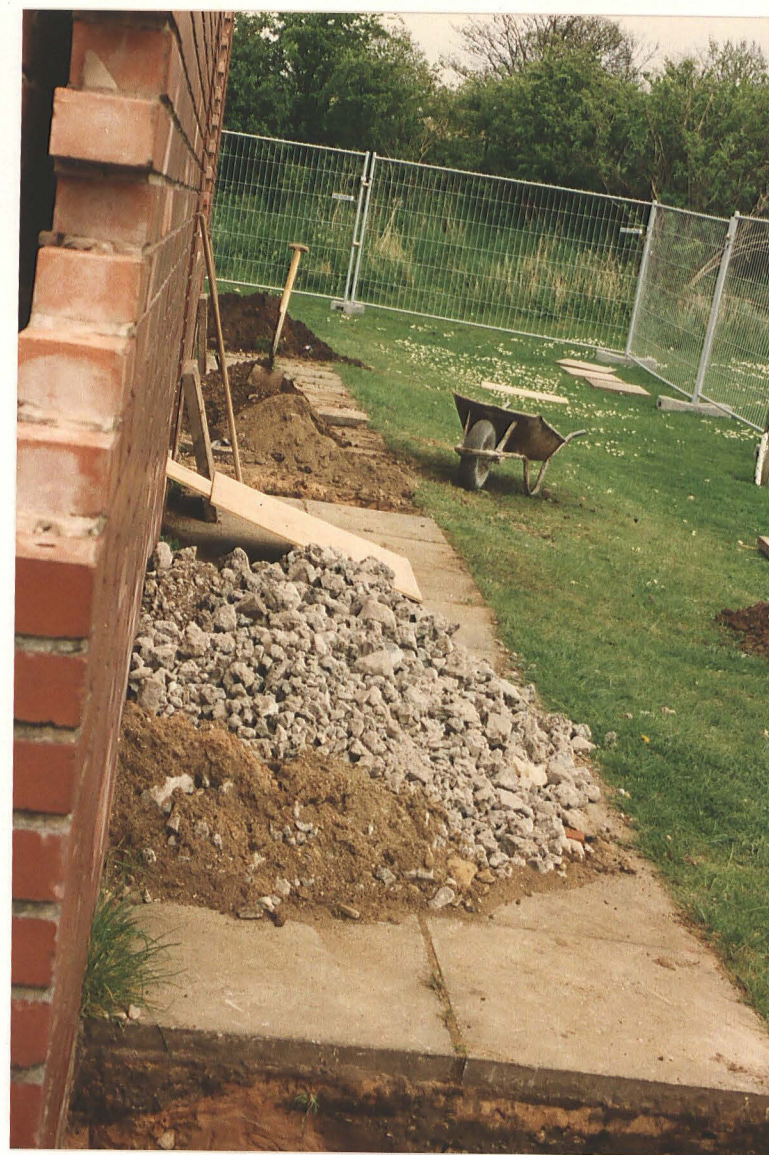
Pl. 4 Area B, external trenches, looking north

Area B consisted of a number of 1m square holes hand-dug both within and outside the wall of an existing building (Pl. 4). All these holes showed a similar sequence of the foundation trench for the present wall cutting down through some disturbed, probably redeposited, soil above a buried topsoil layer (Pls 5-8). The ground sloped upwards towards the southern end of the building, and a thin orange brown (?subsoil) layer was exposed below the buried topsoil (Pl. 6). This 0.04m band was a weathered version of the thick layer below, which continued below any excavated trenches. It was a dense fine scree deposit of limestone flakes, containing no trace of archaeological material.

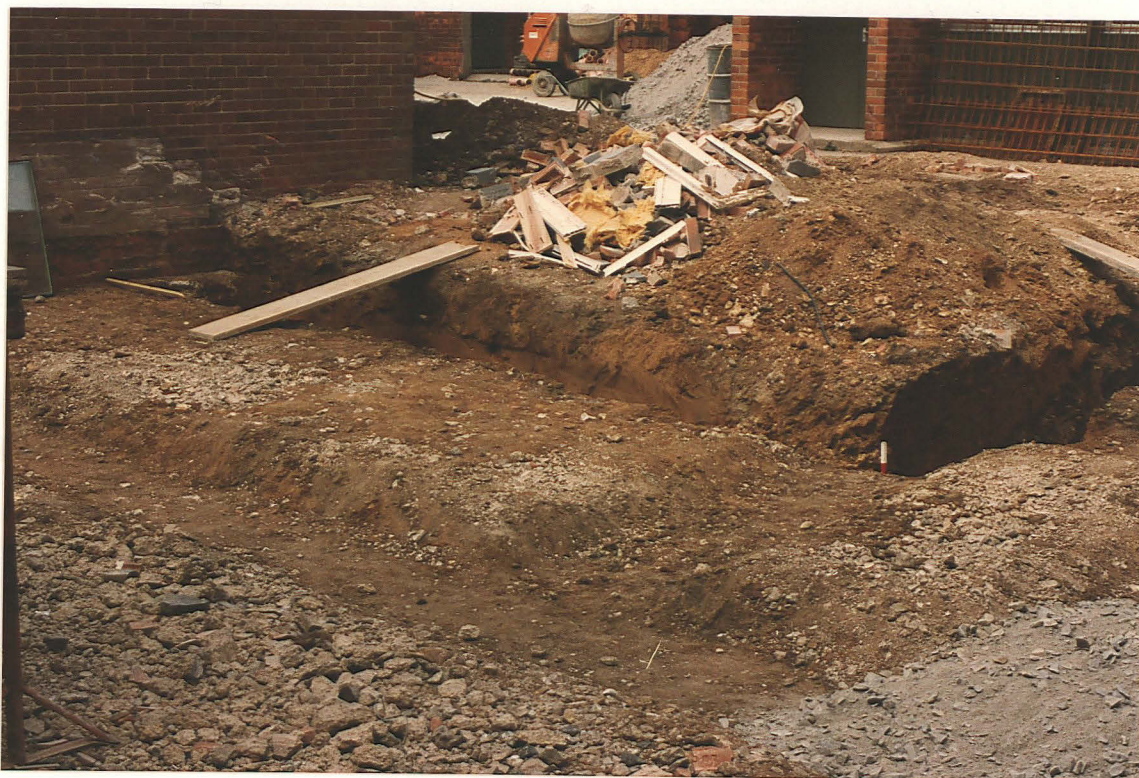
Pl. 9 Area C footings, showing loam-filled channel in section; looking NW

Area C was situated between Areas A and B, close to a former short flight of steps (Pl. 9). The footings here were in the form of three machined trenches, which the builders had cut deeply into the fine limestone layer suspecting it to be disturbed ground; they had not found the base of this layer.

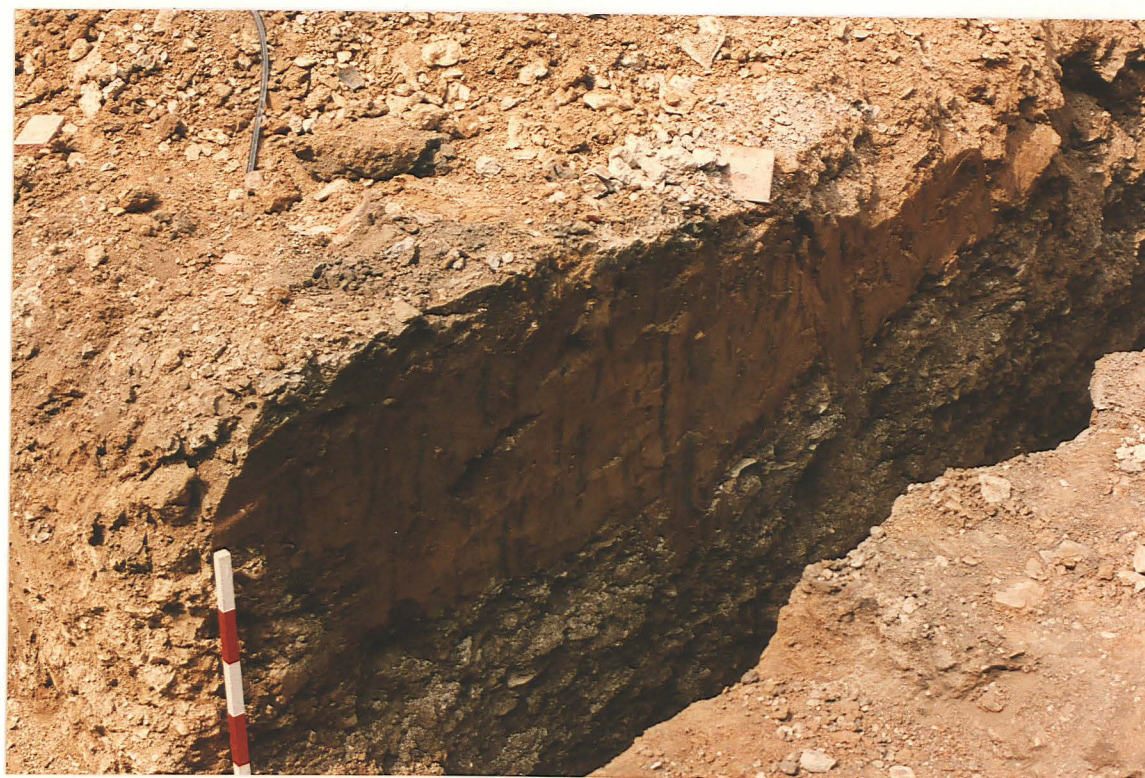
Pl. 10 Area C, loam-filled channel in section with fine sediments below

A feature, thought to be natural, crossed the trenches SW-NE. It had a sloping northern face and a steeper southern side, with a rounded base cut into the loose limestone layer (no later deposits survived) (Pls 10-13). The fill was a mid-brown compacted sand with frequent root runs and no large inclusions. This channel was interpreted as a relict stream course, although a remote possibility exists that it may have been artificial.

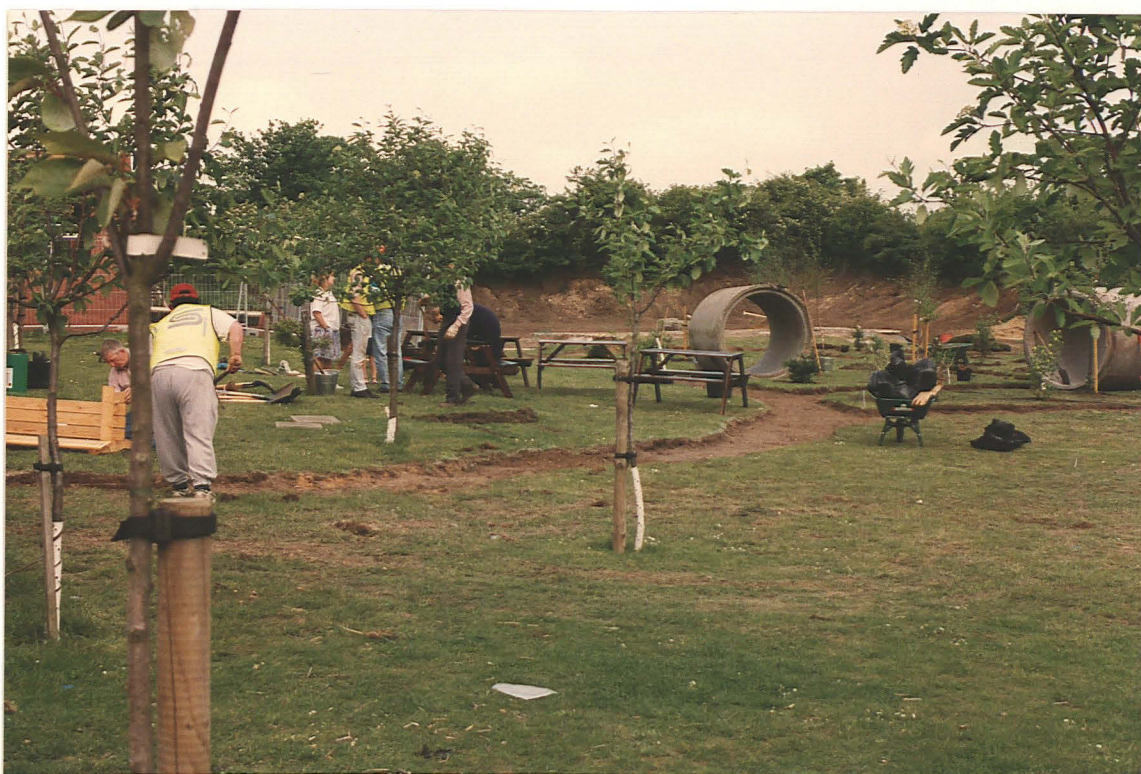
Pl. 14 Recreation Area, with scraped bank to north and east

While the building operations were continuing, an unrelated project on a recreation area to the east removed turf and scraped some soil from a boundary bank (Pl. 14). Access to this area was arranged with the Project Organiser and a rapid inspection was made of the exposed soil. The only helpful observation here was against the northern boundary of the site, at the base of the hedge. The 0.3m thick topsoil probably included bank material although this could not be distinguished; a small ditch may also be visible beside the photographic scale, meeting the hedge boundary (Pls 15 and 16). This sealed limestone bedrock, weathered to small thin lumps in a white lime matrix.

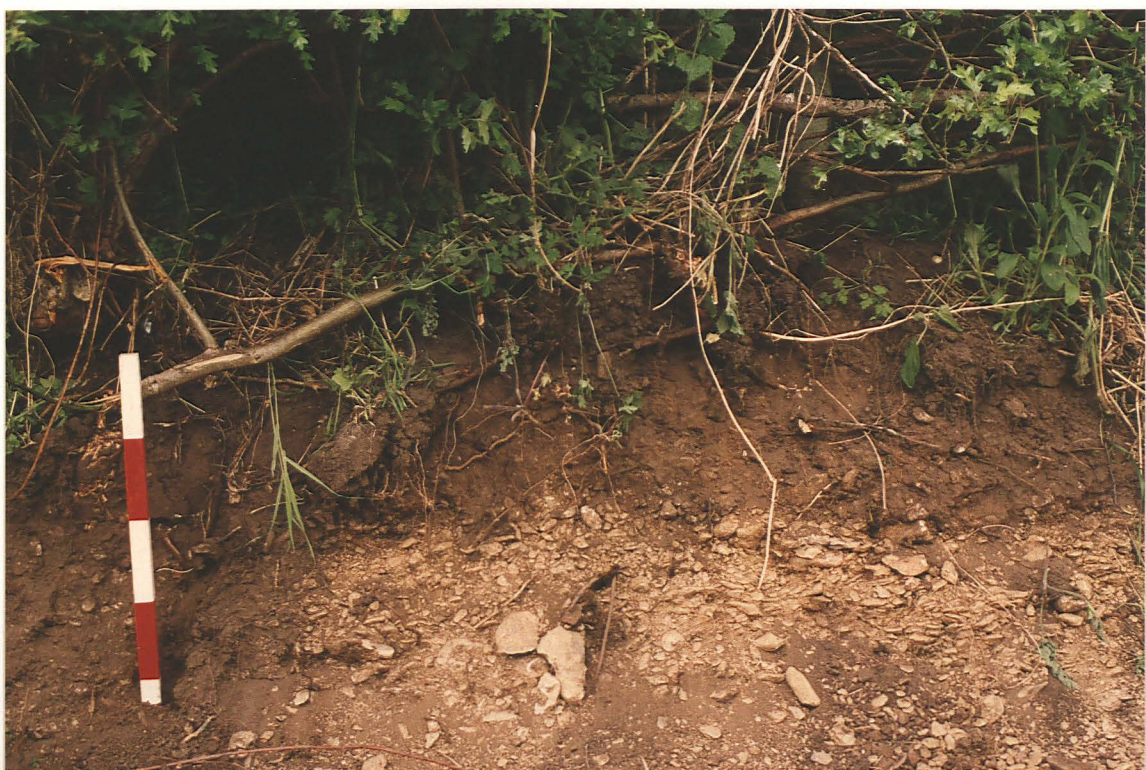
Pl. 16 Recreation Area, detail of undisturbed limestone beside hedge

The sequence beside the hedge had been protected from recent landscaping and mechanical earth movement, offering a glimpse of the original geological conditions of the school site. The absence of subsoil below the topsoil was interpreted as the result of ploughing or natural erosion before enclosure occurred in the post-medieval period.
