**RESULTS OF AN ARCHAEOLOGICAL TRIAL TRENCH EVALUATION:  
ON LAND OFF WOLSEY WAY, LINCOLN, LINCOLNSHIRE  
PLANNING APPLICATION: W/65/0566/95**

**SITE CODE: WWL02**

*Results of an Archaeological Trial Trench Evaluation:  
on Land off Wolsey Way, Lincoln, Lincolnshire*

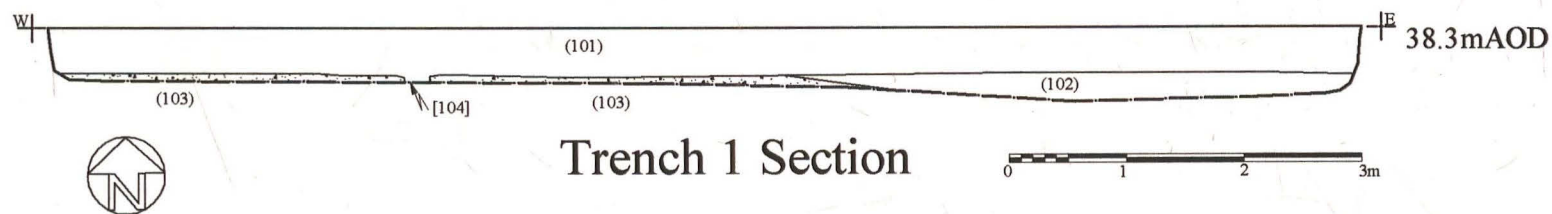
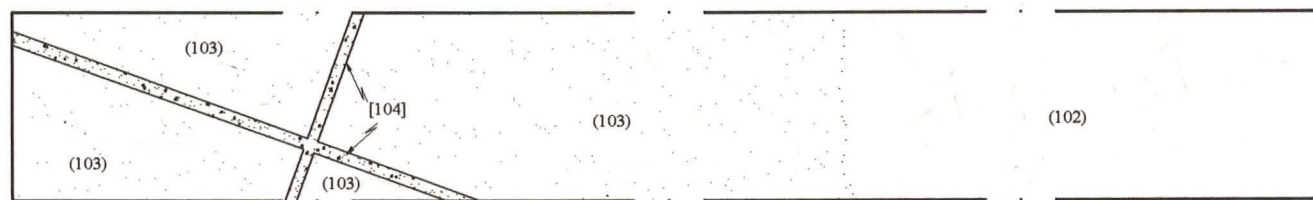
**Fig. 4 Trench 1 Plan**

- 6.3.1 The earliest recorded material comprised a yellow brown natural degraded limestone (103) which had been cut by a red ceramic field drain [104]. Poor jointing had washed in a sandy deposit around the junction causing the anomaly recorded. At the eastern end of the trench, a natural depression 0.3m deep and filled with an orange sand was present (102). The topsoil (101) sealed these features and was a dark grey brown silty loam measuring 0.5m in depth. No archaeological features were recorded.

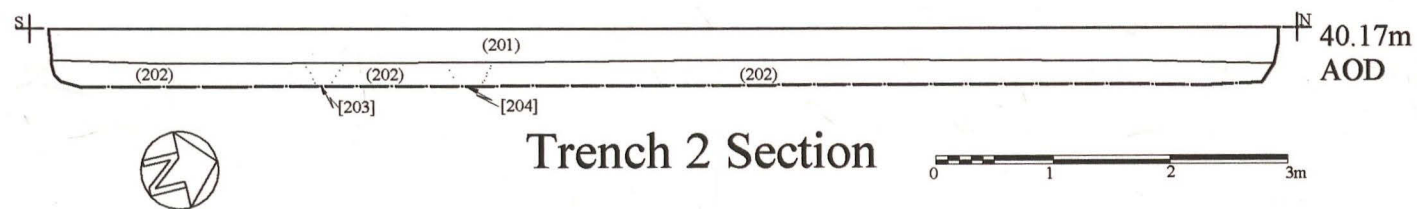
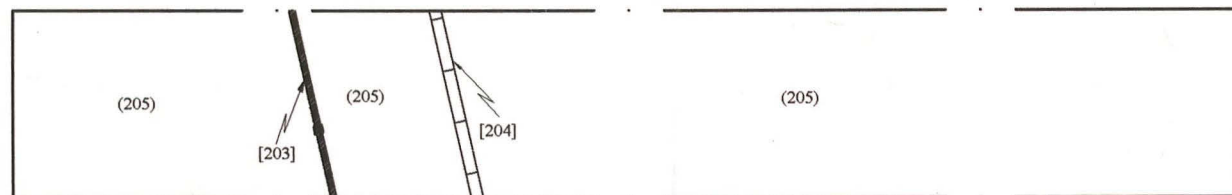
**Fig. 5 Trench 2 Plan**

- 6.4.1 Trench 2 was located over a large east-west aligned geophysical anomaly. On excavation, it was revealed that this response was caused by the presence of an iron water pipe [203] and a parallel ceramic field drain [204] at a depth of 0.6m below the present ground surface. The trenches for these pipes had been cut through a 0.2m thick layer of orange sand subsoil (202). This sand sealed the natural geology of a grey white degraded limestone (205). Topsoil (201) comprised a dark grey brown silty loam 0.4m in depth.

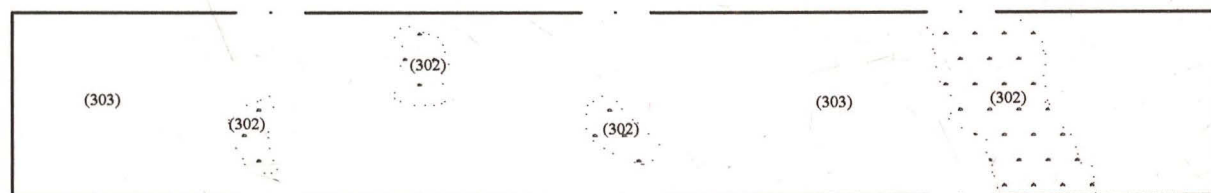
Fig. 6 Trench 3 Plan

6.5.1 Trench 3 was excavated to a depth of 0.8m. The natural geology was a grey white degraded limestone (303) with occasional orange sand deposits present in natural undulations. An orange red sandy silt subsoil (302) measuring 0.4m deep sealed the natural. Above this layer was a 0.4m thick topsoil (301), consisting of a dark grey brown silty loam and showed evidence of deep ploughing.

6.5.2 The water table was reached at a depth of 0.8m below the present ground surface and partial flooding occurred. No archaeological features were present.

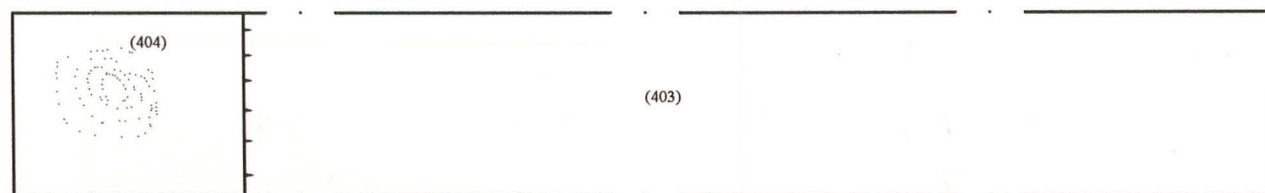
Fig. 7 Trench 4 Plan

6.6.1 Trench 4 contained a modern fire pit which had obviously occurred in the topsoil in the southern end of the trench. This interpretation was made due to the fact that it was clearly visible during topsoil removal and contained modern refuse material. As a result, the southern side of the trench was not machined as deep as the rest of the trench. It is recorded as (404) comprising a deep purple red sand. This was the reason for the geophysical anomaly recorded.

6.6.2 The natural geology was reached at a depth of 0.5m and is represented by a grey white limestone (403). This layer was sealed by orange brown sandy silt subsoil (402) measuring 0.2m deep. The dark grey brown silty loam topsoil (401) was 0.3m in depth.

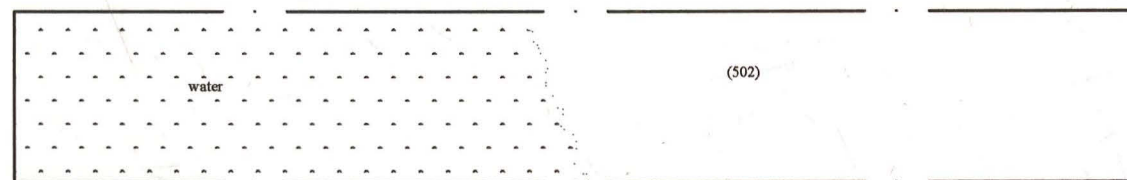
Fig. 8 Trench 5 Plan

6.7.1 Trench 5 was excavated to a depth of 0.8m down onto the natural limestone (503). It was at this depth that the water table was reached in the south east end of the trench. A natural orange sandy silt subsoil (502) measuring 0.35m deep sealed the limestone. A 0.45m layer of dark grey brown silty loam made up the topsoil (501). No archaeological features were recorded.

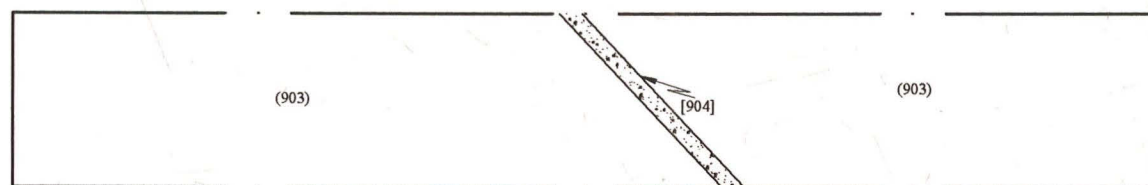
Fig. 12 Trench 9 Plan

- 6.11.1 Trench 9 was excavated to 0.7m below the present ground surface and onto the natural geology, a grey white degraded limestone (903). A field drain constructed of broken limestone [904], aligned northwest–southeast was cut into (903). This was sealed by a 0.25m layer of orangey sandy silt subsoil (902) which was sealed by a 0.45m layer of dark grey brown silty loam ploughsoil (901). The field drain contained no dateable evidence but is likely to be post-medieval in date as the cut for it is seen in section below the topsoil.

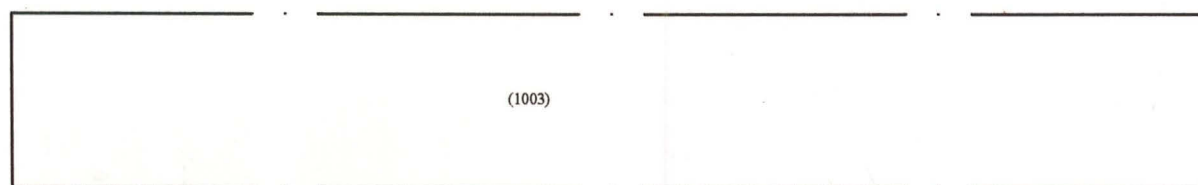
Fig. 13 Trench 10 Plan

- 6.12.1 Trench 10 contained no archaeological features. The natural limestone (1003) was reached at a depth of 0.7m. It was sealed by a 0.4m layer of orangey sandy silt subsoil (1002) which lay beneath a 0.3m layer of dark grey brown silty loam topsoil (1001).

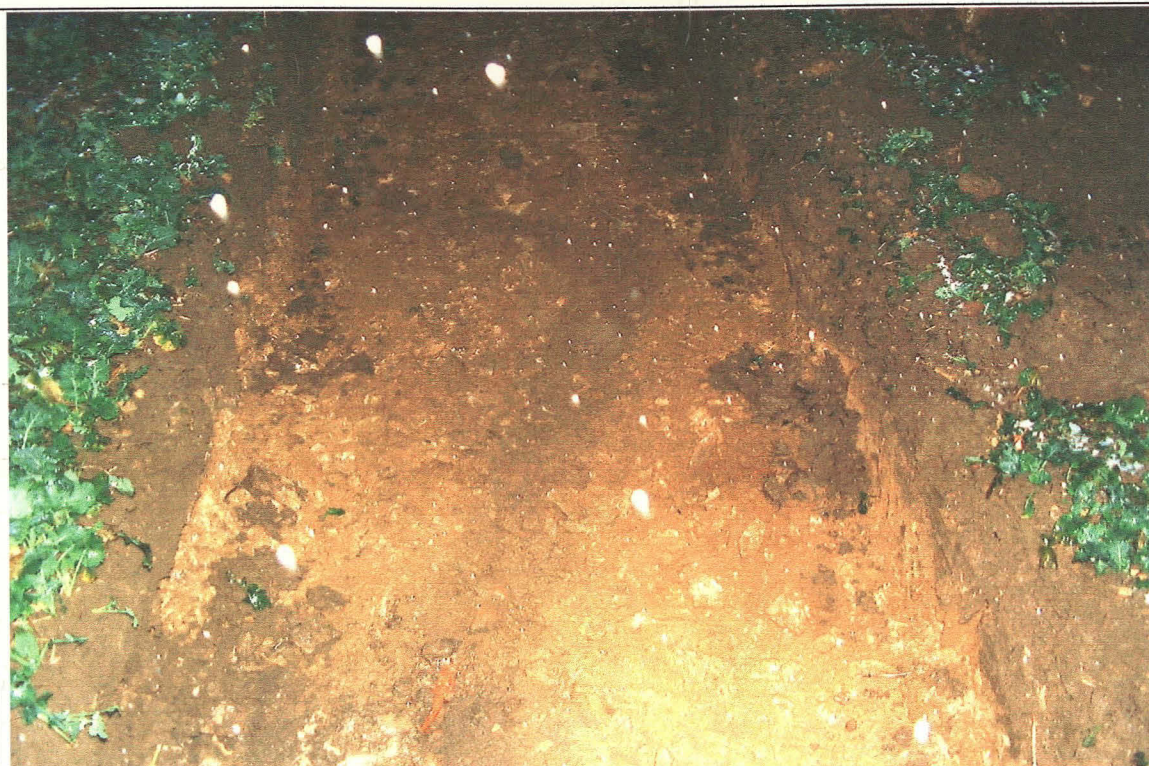
Plate 1. Field drain disturbance in Trench 1.

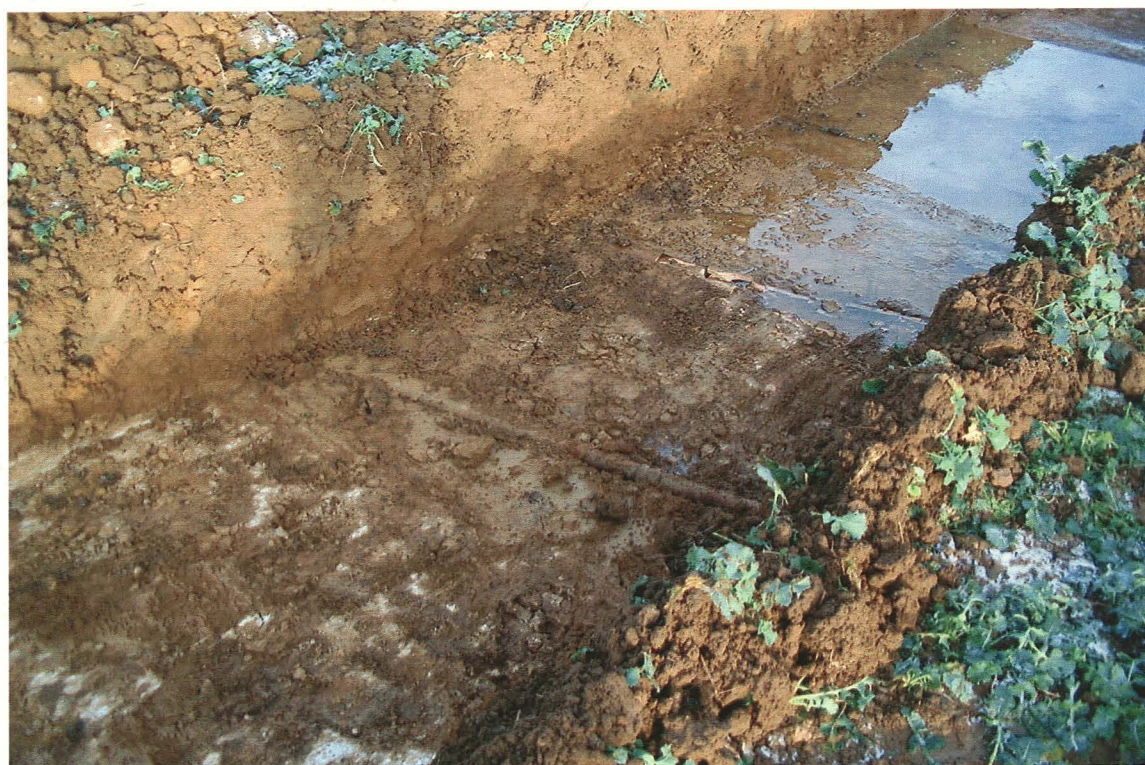
Plate 2. Metal water main and field drains in Trench 2.

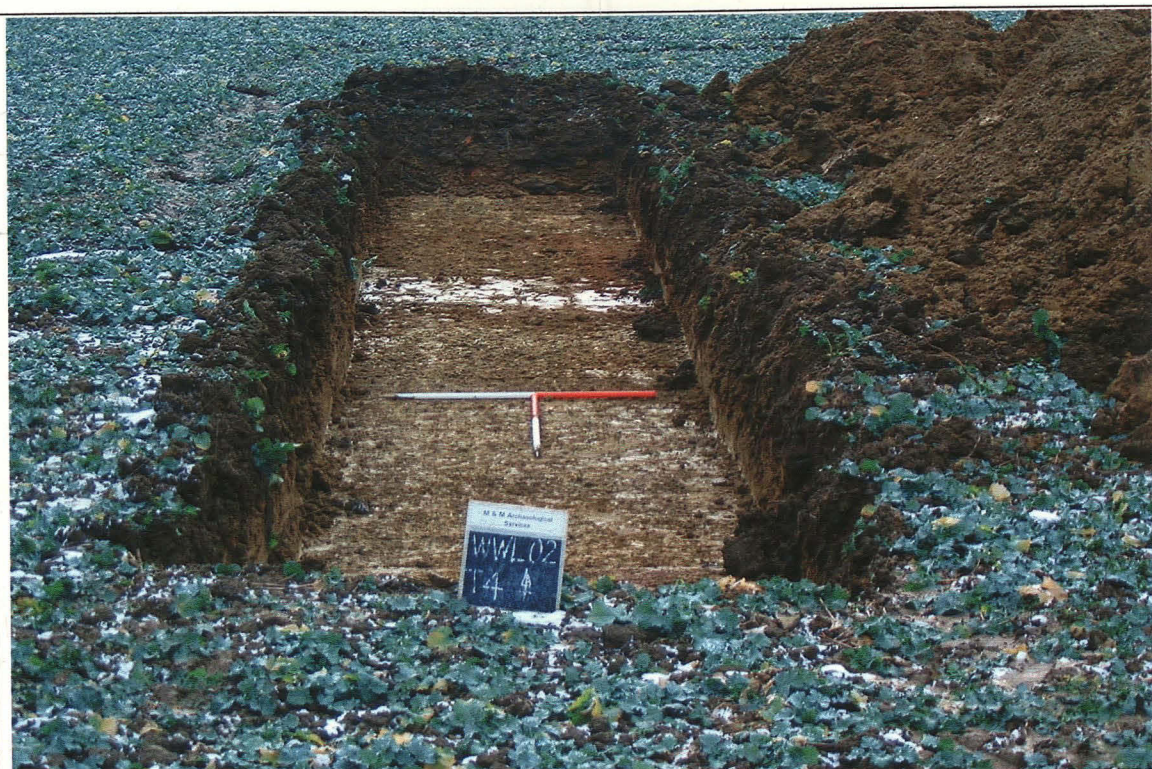
Plate 3. Trench 4 looking north.

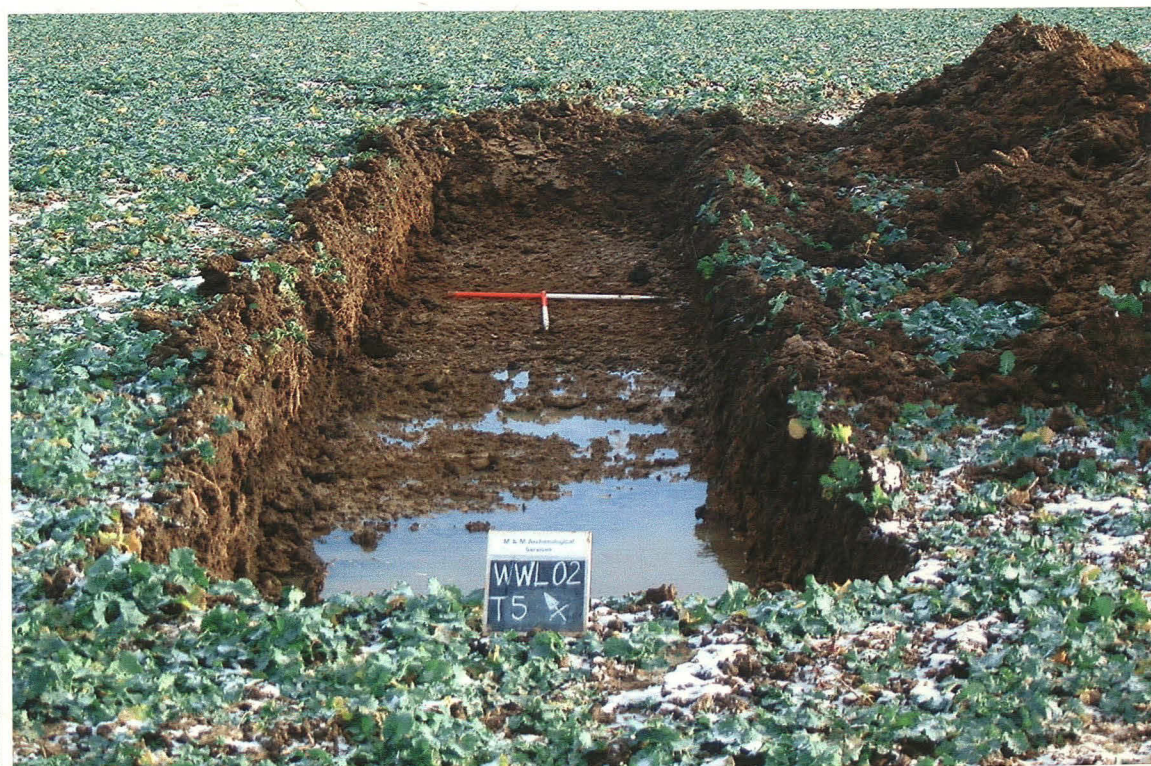
Plate 4. Trench 5 looking north east.

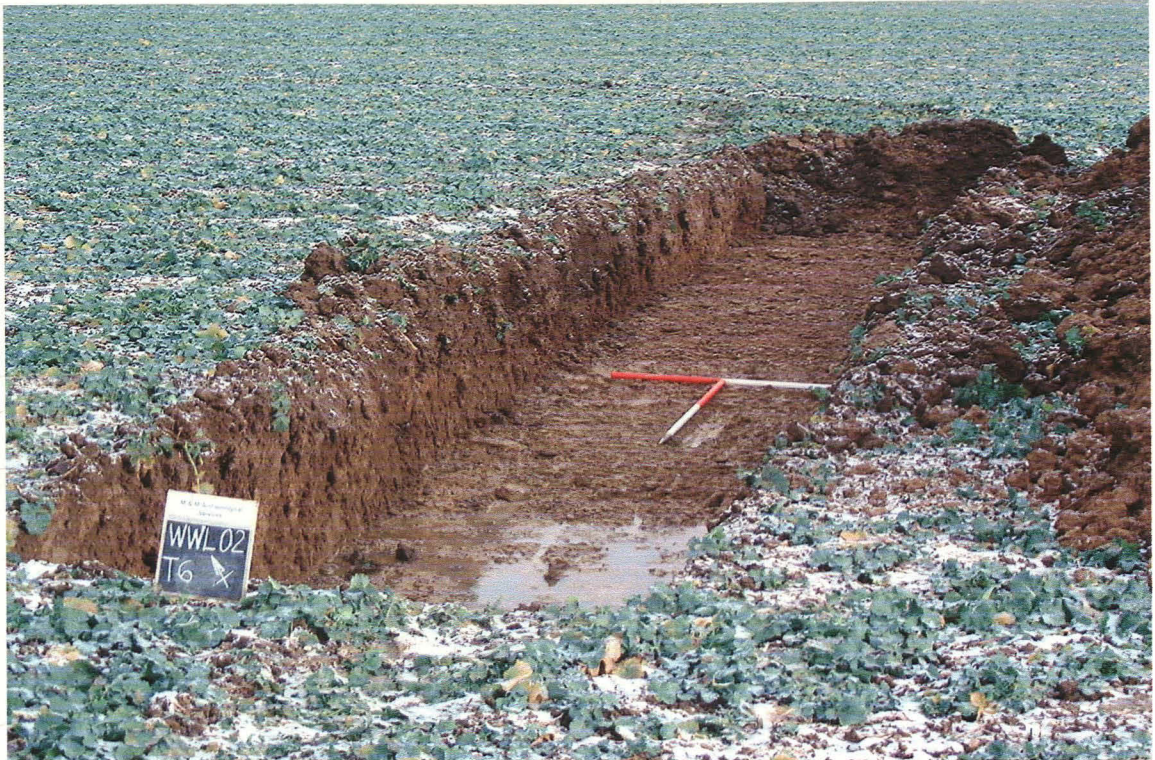
6.8.1 Trench 6 contained no archaeological features and was excavated to the top of the natural geology, comprising the grey white limestone (603) at a depth of 0.95m. This was sealed by an orange sandy silt (602) measuring 0.6m deep and was covered by a 0.35m thick layer of topsoil (601).

Plate 5. Trench 6 looking north.

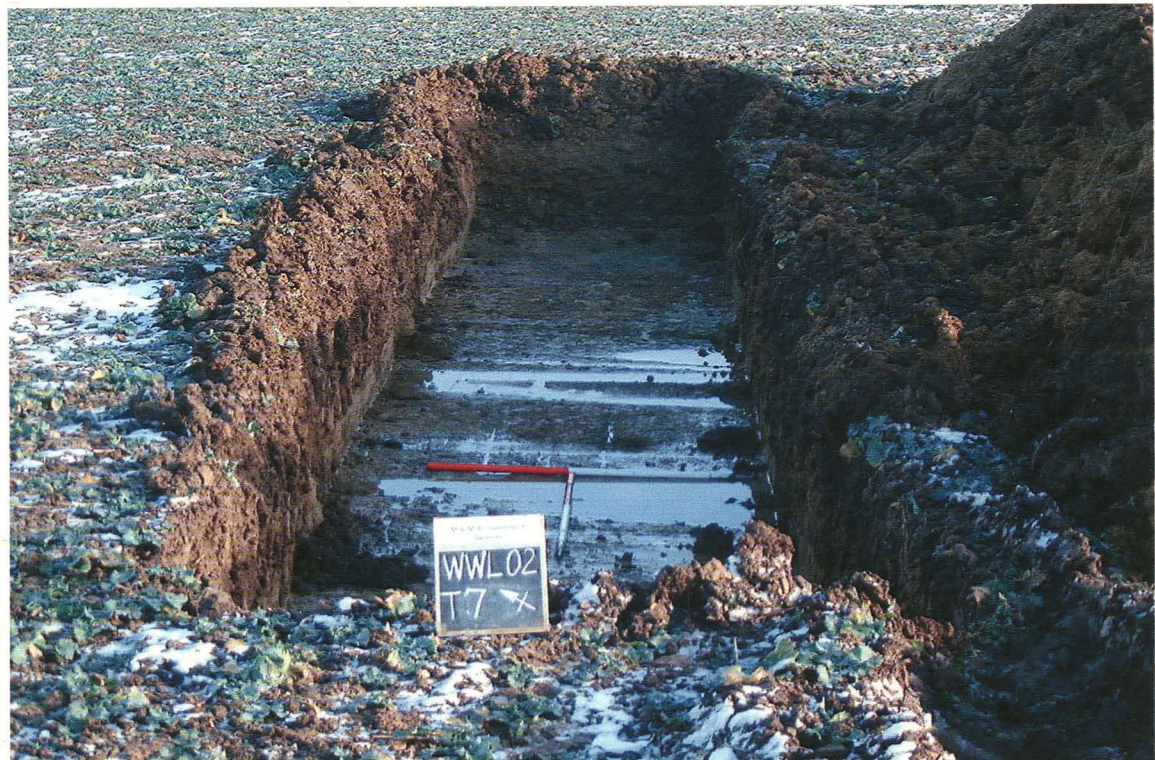
6.9.1 Trench 7 contained no archaeological features. The natural geology (703) was reached at a depth of 0.7m. At the western end of the trench, an area of natural sand (702) filled a natural depression in the limestone. The sand (702) was sealed by dark grey brown topsoil (701) which was 0.3m deep and showed evidence of deep ploughing.

Plate 6. Trench 7 looking north east.

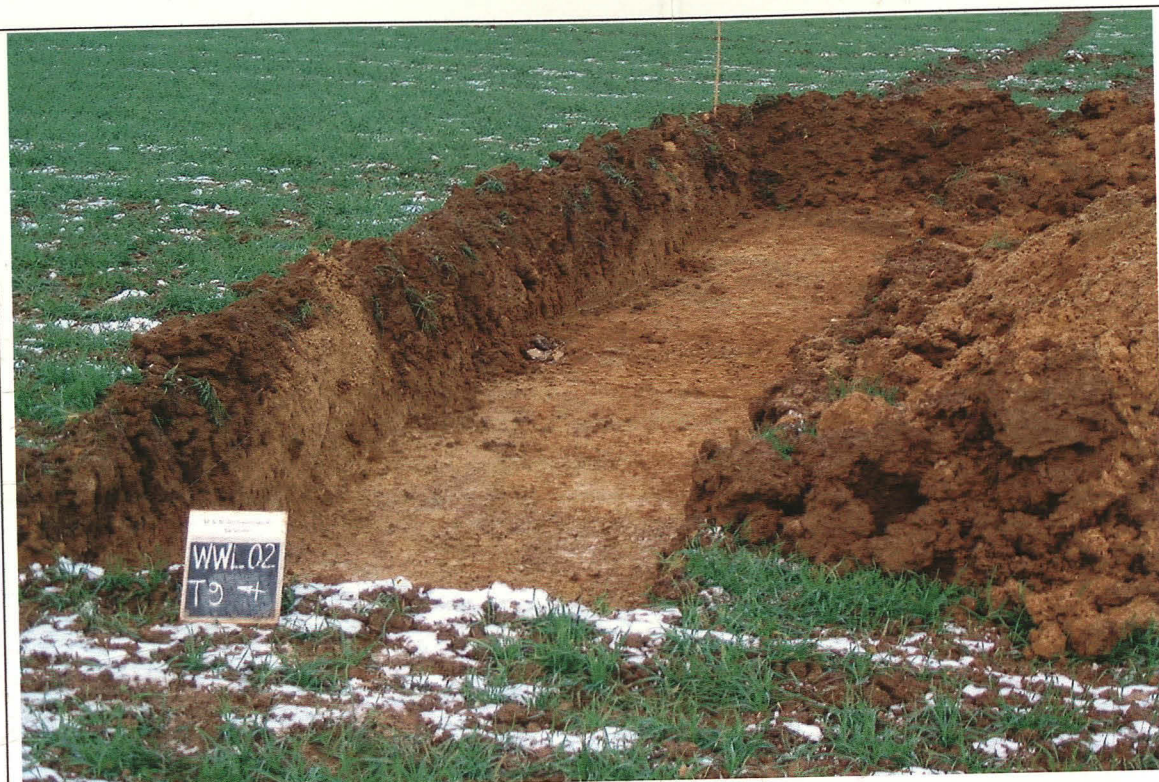
Plate 7. Trench 9 looking north east.

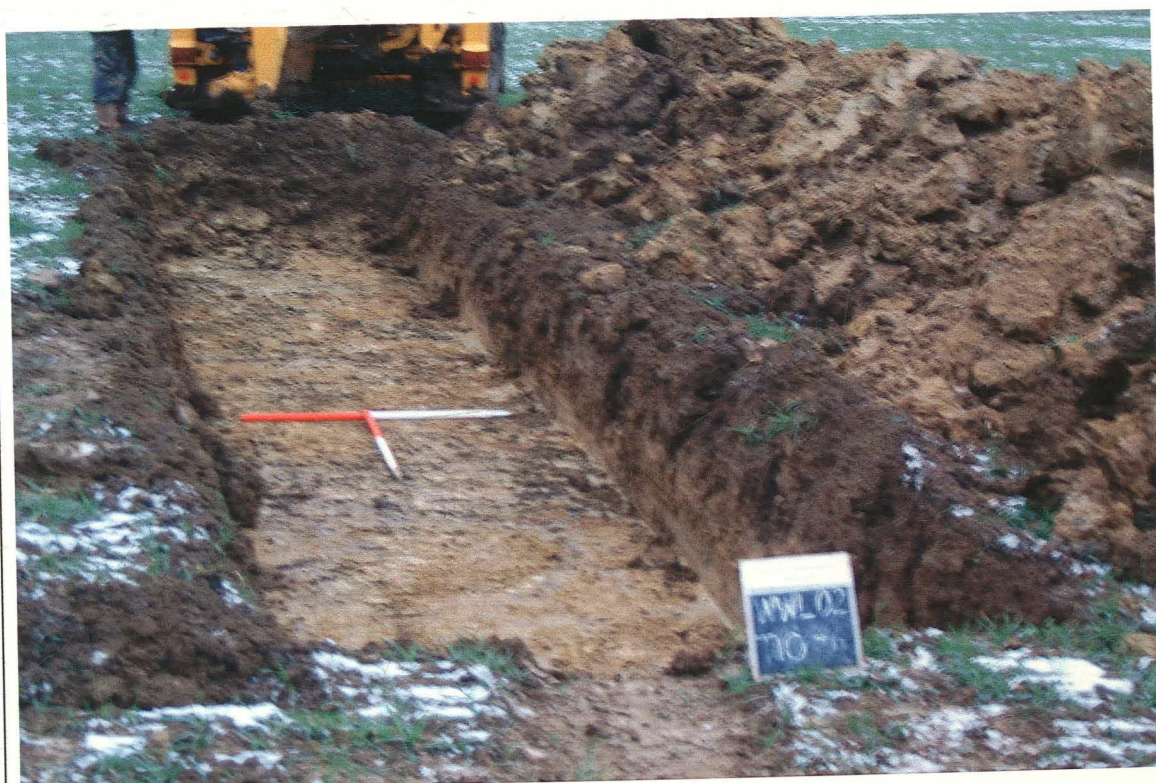
Plate 8. Trench 10 looking north east showing field drains.
