**Land North of the Old Rectory
South Willingham, Lincs.
Archaeological Watching Brief**

**NGR: TF 1940 8340
Site Code: SWOR 01
LCNCC Museum Accn No.: 2001.291
ELDC Planning Application: W/64/0689/98**

**LAS Report No. 595
July 2002**

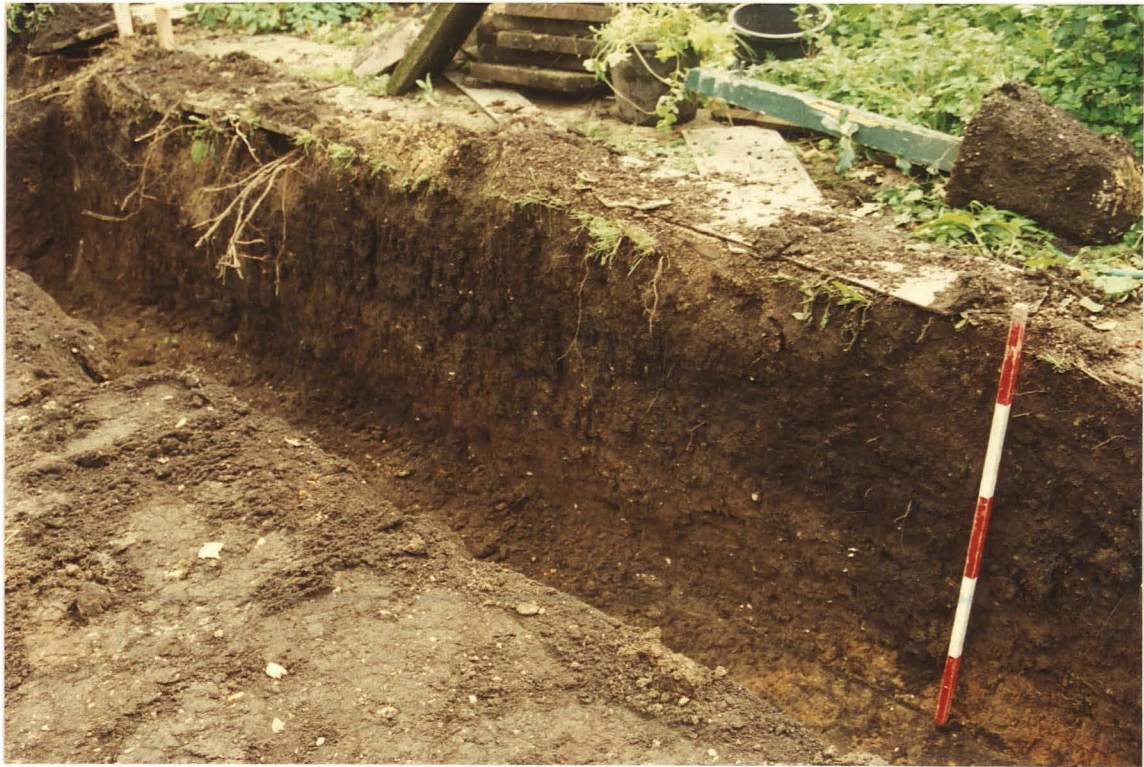
Pl. 2 The orange clay 15 (lower right) has been cut by a modern post-hole (behind the 1m scale), and by a broad feature 21 with a light brown fill (extending beyond the SE corner of the garage foundation trench). Looking SE.

In the eastern corner of the garage trenches, a large feature **21** was identified (Fig. 4b; Pl. 2). This was at least 4m wide, but there was insufficient exposed to discover its shape or alignment. It is assumed that it was at the NW corner of a pit, but it could equally have been near the NW terminal of a large ditch. Its dark brown fill **22** contained a sherd of thirteenth/fourteenth century pottery.

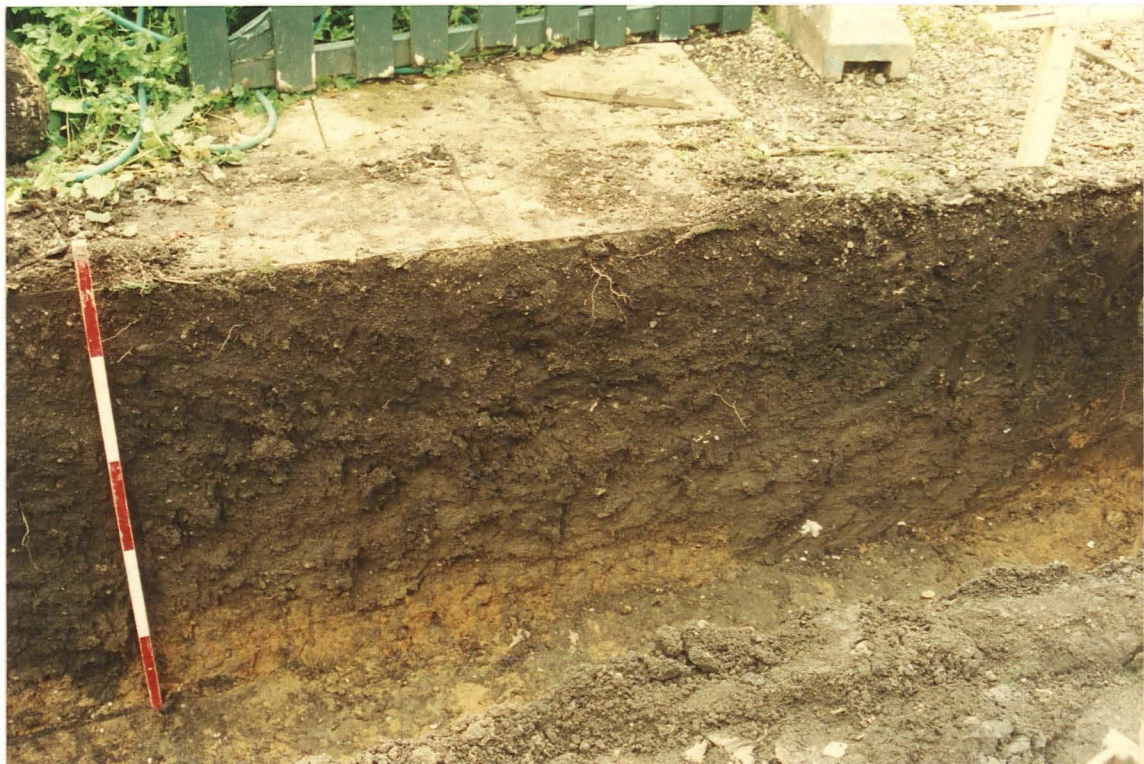
Pl. 3 Ditch 13, cutting orange clay 15 (right), near the SW corner of the garage (looking SE).

A 0.55m wide feature **13**, 1.5m west of **21**, was interpreted as a ditch on a SE-NW alignment, but no further sign was seen in trenches 3.5m away (Fig. 4c; Pl. 3). This would suggest that it was a large

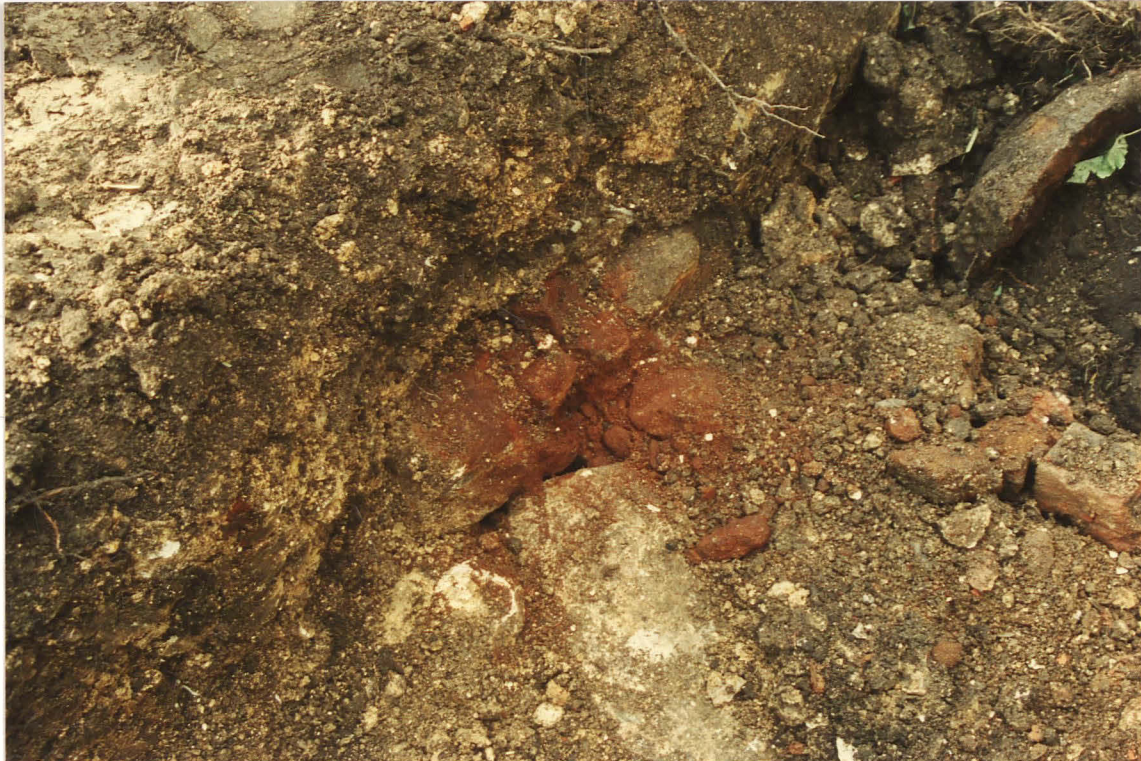
PI. 4 Stone rubble at the top of well 30 (looking NE).

A stone-lined well **30**, over 3.2m deep, was found at the northern corner of the new building, within a backfilled construction pit **50** about 2.4m wide (Pls. 4 and 5). The internal diameter of the shaft was about 0.6m, centred in the new trench. The well had been roughly capped, and buried below loose brick, flint lumps and stone rubble **51**; the rubble contained a discarded limestone architectural fragment, suspected to have been part of a medieval window (Pl. 6). The nearest known medieval building is St Martin's Church (100m to the SE). The contractors reported that there were supposed to be several wells within the grounds of the Old Rectory. The location of this one suggests that it could have served dwellings fronting onto the lane opposite Woodbine Cottage.

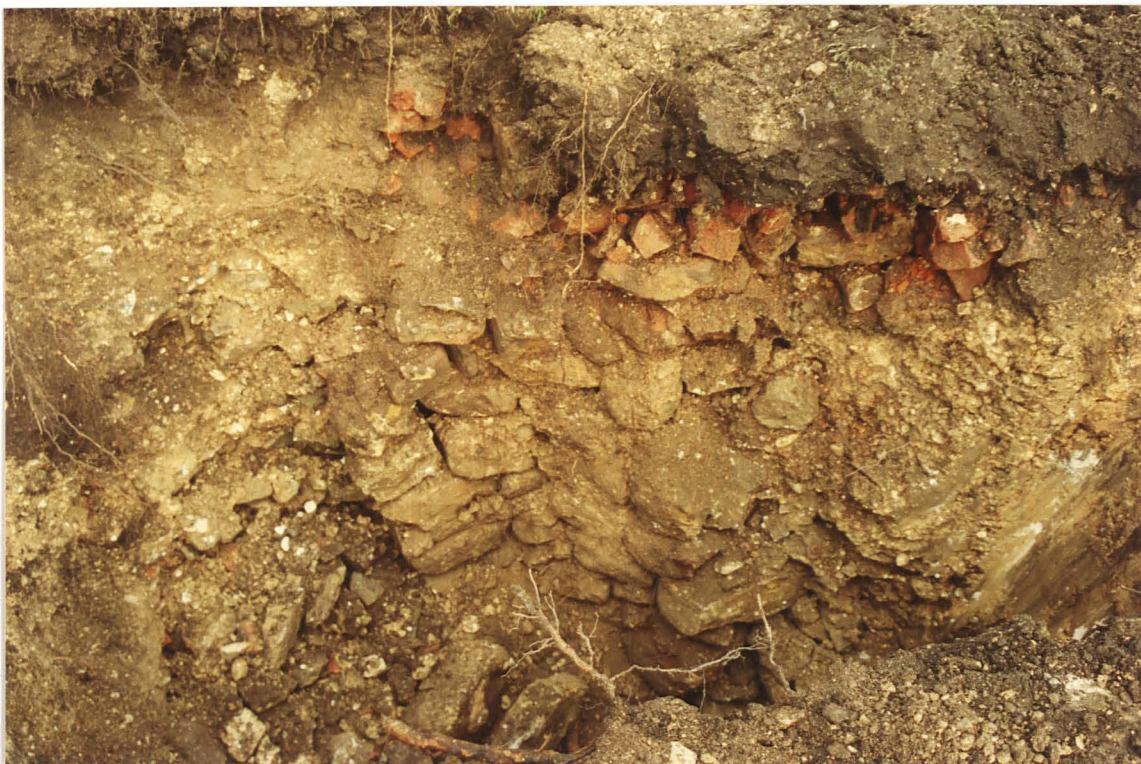
PI. 5 Stone rubble side of well 30, with brick rubble above (looking north).

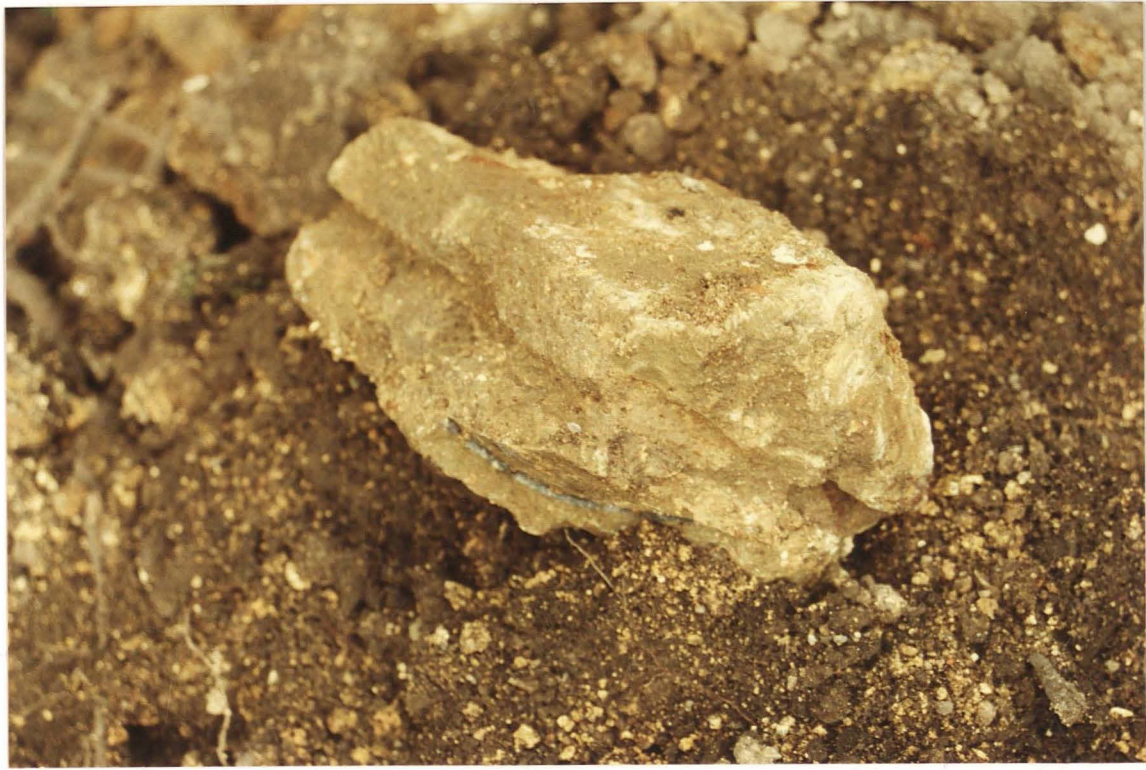
Pl. 6 Limestone architectural fragment (a piece of medieval window) reused in the stone rubble at the top of well 30. The stone may derive from the nearby church.

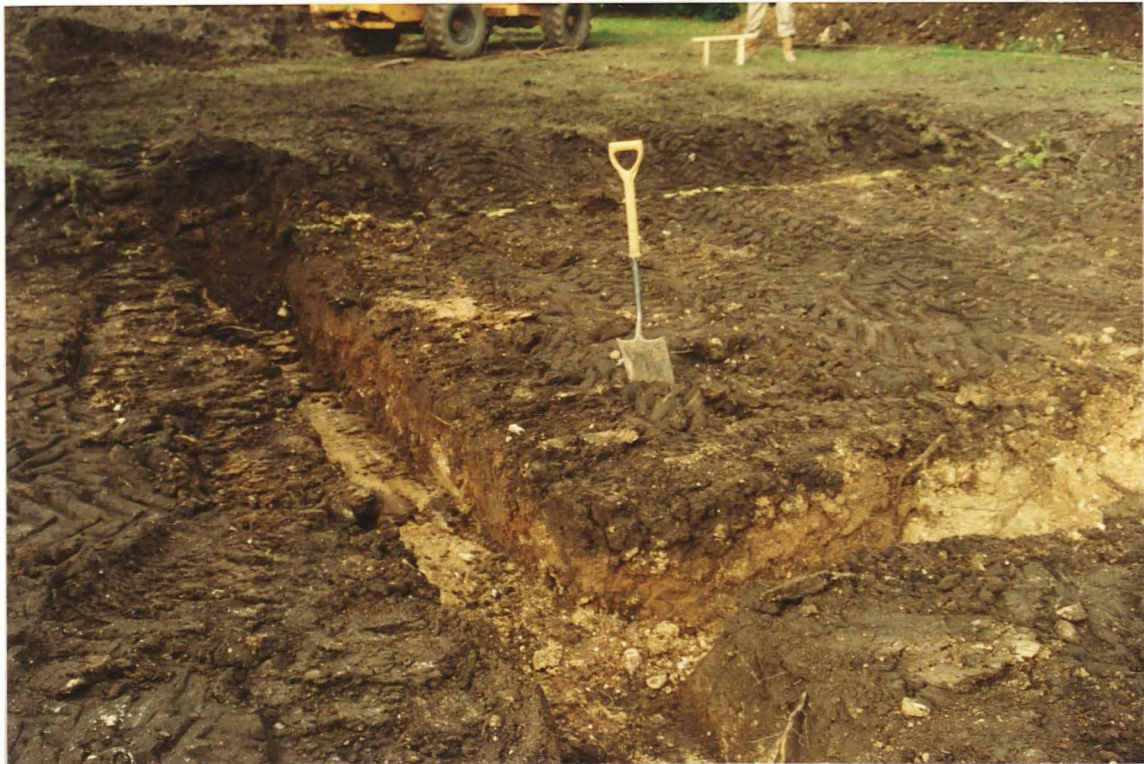
Pl. 7 Foundations for the bedroom, showing the orange clay fill of pit or ditch 29 (looking NE, with well 30 in the top left corner).

The well was not apparently associated with other features, but a 2m wide pit or ditch **29** was found 3m to its west (Fig. 5a; Pl. 7). The feature seemed to be NW-SE aligned, terminating in the south wall foundation trench for the new bedroom. Its fill **28** contained much of a twelfth-century jar, together with post-medieval sherds.

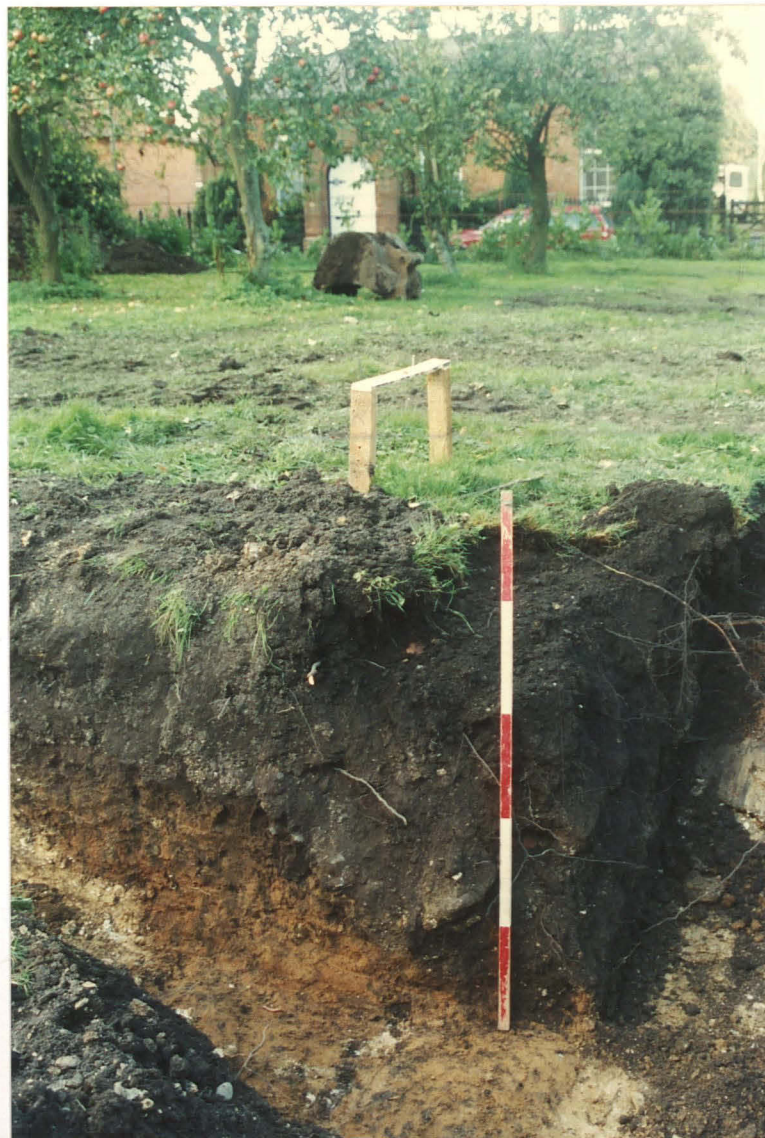
Pl. 9 Dark loam and rubble backfilling pit or ditch 36, with an earlier orange clay filled feature 25 below (looking NW).

Towards the western side of the new building, a cluster of features with dark fills (**3**, **10**, **36**, and **54**) were recorded (Pls. 8 and 9). These were all 1m wide, with their bases over 0.35m below the base of the modern topsoil **1**; they may have formed a linked series of drainage ditches, although their alignments varied. The arrangement of the foundation trenches resulted in the features only being exposed in places, and no firm conclusions could be made regarding their shape or function.
