## Land West of Middlefield Farm, Aisby, Lincs.

## Archaeological Watching Brief

LAS Report No. 646  
February 2003

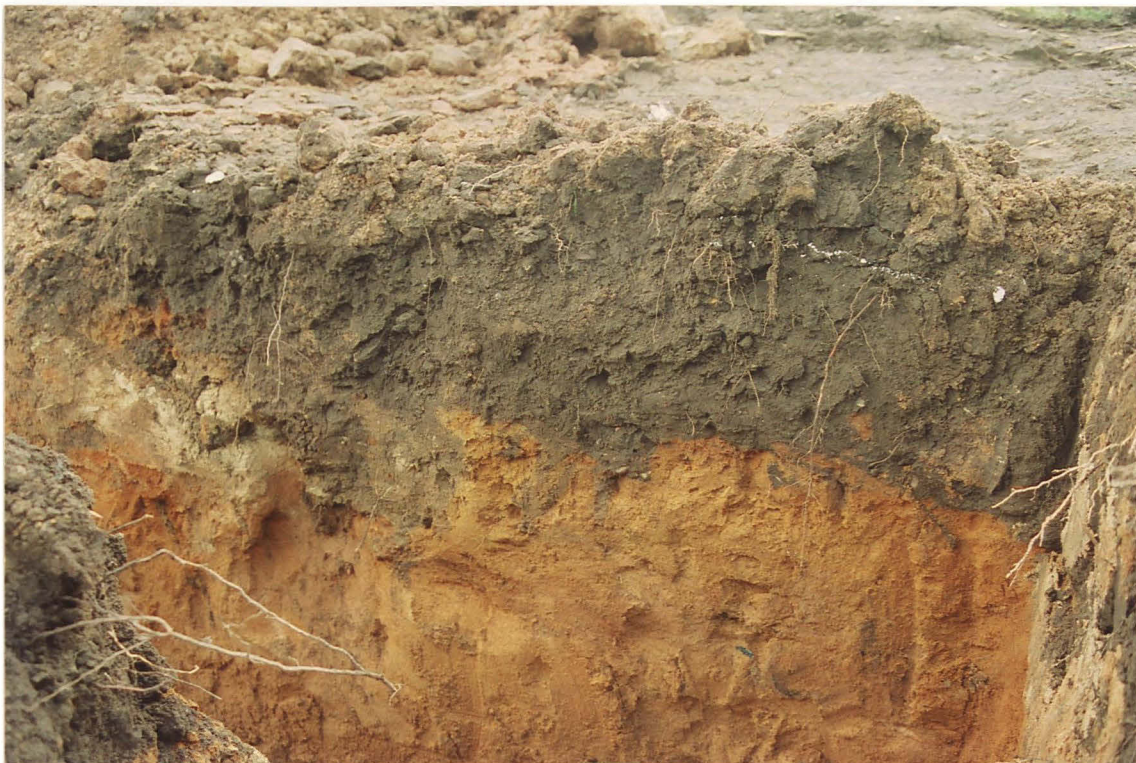
Pl. 4 Thick topsoil covered orange sand on the eastern side of the house plot.

Turf was stripped from the area of the new house but most of the topsoil layer **1** remained (Pl. 3). This layer was about 0.25m thick, but thicker at the lane frontage where it probably incorporated spread from the hedgebank. At the eastern side of the plot, the topsoil overlay an orange sand **7**, which extended below the trench base (Pl. 4). This deposit was interpreted as naturally formed, and may have been the same material as **20** at the western side of the plot. **20** was lighter in colour, but patches of leached sand were present to the east and NE.

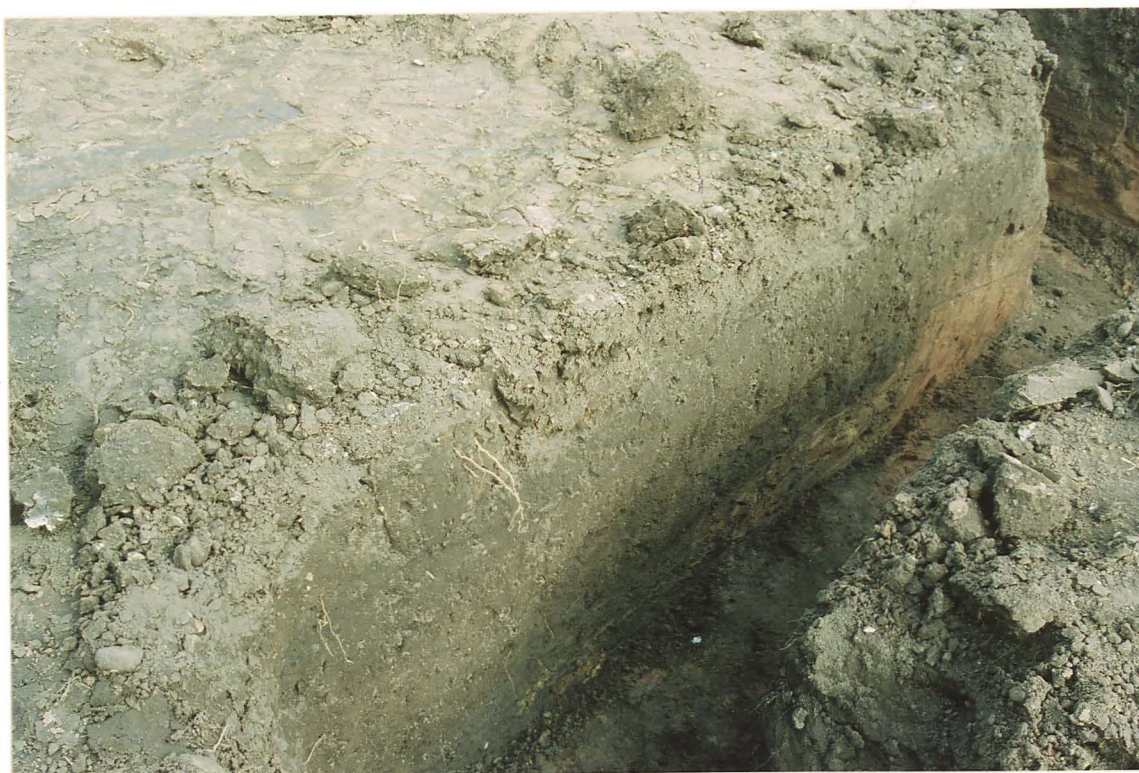
Pl. 5 Dark fill of pit 2, with the sand defining its eastern edge (looking NE). The pit extended lower than the base of the new foundation trench.

A 5m wide SW-NE aligned zone of natural clay **15** was identified in the centre of the house plot. This may have been an ancient stream channel; there was no suggestion that this was not a natural feature. Within this clay area were four pits, varying in depth and extent. The largest feature **2** was about 7m east-west, and between 2.5m and 4.5m wide. The foundation arrangement in the centre of the house was complex, and although this feature was seen in six foundation trenches, it was difficult to establish its profile. Its southern and eastern edge was a 0.3m - 0.6m deep shelf, broadest and deepest where underlying deposits were sand (Pl. 5). Two layers of backfill were present between the topsoil and the shelf. The upper layer **8** was 0.2m thick, slightly siltier and darker than the topsoil, and produced a sherd of late seventeenth/early eighteenth century pottery (Appendix 2). The underlying layer **3** was a lighter brown/grey sand, between 0.2m and 0.3m thick. Both layers were interpreted as levelling fills, although the uppermost, **8**, may have been remains of a subsoil preserved where settling of the feature had occurred.

Beneath **3**, at the level of the sand shelf, was a dark grey loamy sand **25**, 0.1m thick at the eastern edge, but becoming at least 0.3m thick towards the centre of the feature. To the east of this fill were various sandy deposits which may have been slumps down the face of the pit while it remained open. The largest, and earliest, of these was mixed yellow sand **6**, with its successors **5** and **4**, both of which were much darker. **5** contained lenses of dark green sand, the colouration of which may indicate human or animal waste. The deepest part of the pit was over 1.35m below the modern ground level.

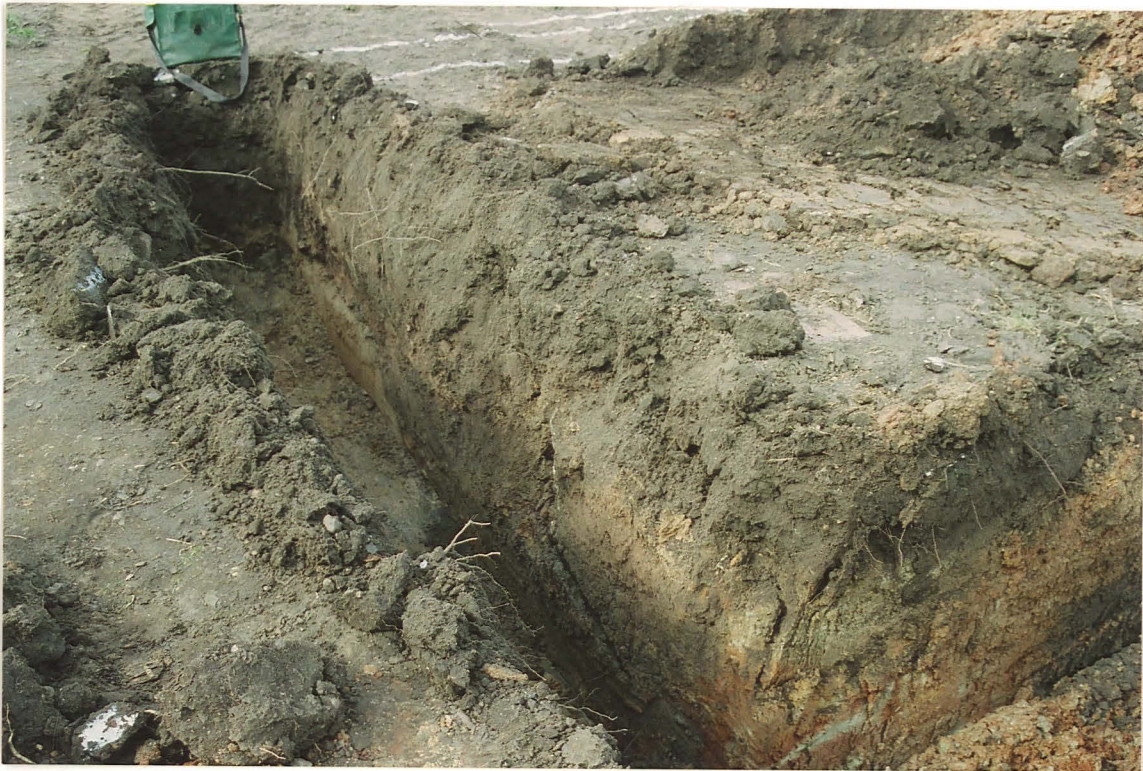
Pl. 6 Mixed fill of pit 19 at the front of the house plot, cutting through undisturbed sand (looking NW).

Pit 19 was 6m to the east of pit 9, and about 3m south of the large pit 2. 19 was 6m wide, with its base over 1.3m below modern ground level (Pl. 6). On the eastern side of the pit, the red clay fill 24 incorporated thin limestone rubble which could possibly have been a drain or a wall foundation. The main pit fill was a discoloured sand 18, with a thin clay dump 23 overlying it to the west. A shallow shelf, 0.5m below ground level, was seen to the east, west and south of this pit. The layer of dark brown sandy loam 17 above this shelf had settled into the pit below, and this was probably a deliberate levelling layer extending at least 5m west-east. As there remained a chance that this shallower deposit was fill of a separate feature post-dating the backfilled pit, the higher feature was assigned the context 16.
