Extension to 74D Winn Street, Lincoln

Archaeological Watching Brief

CLAU Report No. 506: Extension to 74D Winn Street, Lincoln Archaeological Watching Brief

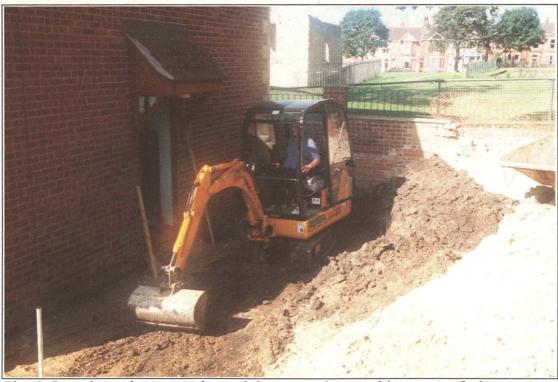
Plate I: General view showing initial ground clearance in the area of the extension (looking west).

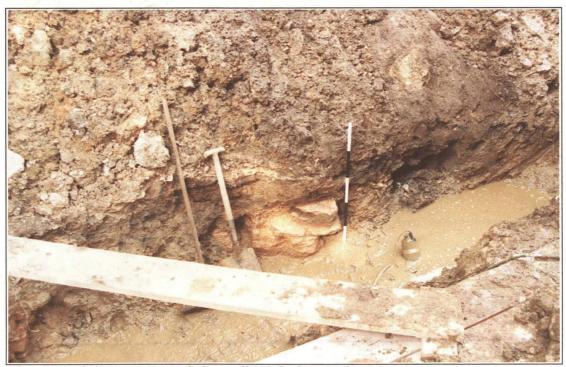
A stone-built wall or wall foundation (009) was found in the north wall foundation trench. It lay on a north-south orientation, was c. 600mm wide, and comprised three courses of roughly squared limestone blocks bonded by a coarse, light-brown mortar. Several fragments of architectural stone, recovered from the vicinity of the wall, were almost certainly built into the wall fabric (see Appendix 2).

The wall was abutted to the east by a soft mid grey-brown clay (010) and then sealed by a moderately compact, light grey-brown sandy silt (007) of possible alluvial origin, which may correlate with another deposit (003 – see above). The latter deposit, and a loose to moderately compact reddish-brown sandy silt (006) at the eastern end of the trench, were post-dated by a loose, dark grey sandy silt (005) containing frequent irregular limestone fragments. The deposit may have been contained within a cut. However, owing to unfavourable ground conditions (see Plate II below), the evidence for this was inconclusive. A very mixed deposit (004) of moderately compact material (probably modern) including very dark grey/black silt and mortar occupied the uppermost 200mm of the trench.

Plate II: South facing section including wall 009 (looking north-east).

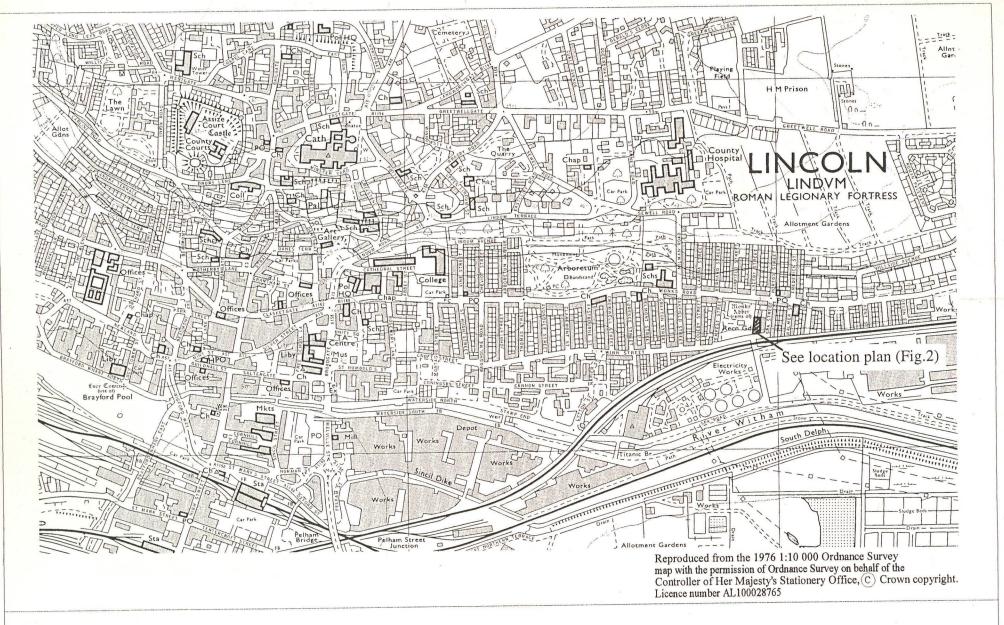
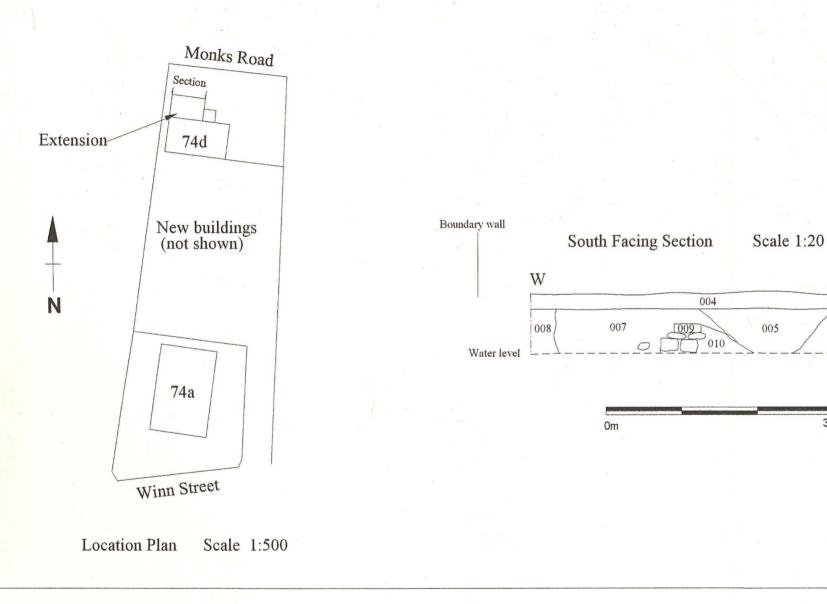
Fig.2

Bright orange sand with no inclusions (002), which extended throughout the lower levels of the foundation trench for the west wall of the extension, probably represented an undisturbed geological deposit. It mainly was sealed by a c. 300mm depth of silty/clayey soil (001) containing a moderate

quantity of modern building material. However, a deposit of black/dark grey silty organic clay (003) including some stone, was located at the north-west corner of the trench. This material could have represented the fill of a pond.

A deposit of irregular limestone fragments (c. 100mm average size) adjacent to deposit 007 (relationship uncertain) could have represented a more concentrated area of the stone distributed throughout deposit 003 (see above).

Location plan & Section
