## ARCHAEOLOGICAL EXCAVATION REPORT: ERMINE STREET / A1500 JUNCTION, LINCOLNSHIRE

Site Code:	ESTL01
NGR:	within SK93787778, 97247811 &
Planning Ref.	N/A
Accession No.	2001.296

Report prepared for Balfour Beatty Construction Ltd.  
by Alex Brett and Chris Clay  
(edited by Colin Palmer-Brown)

March 2002

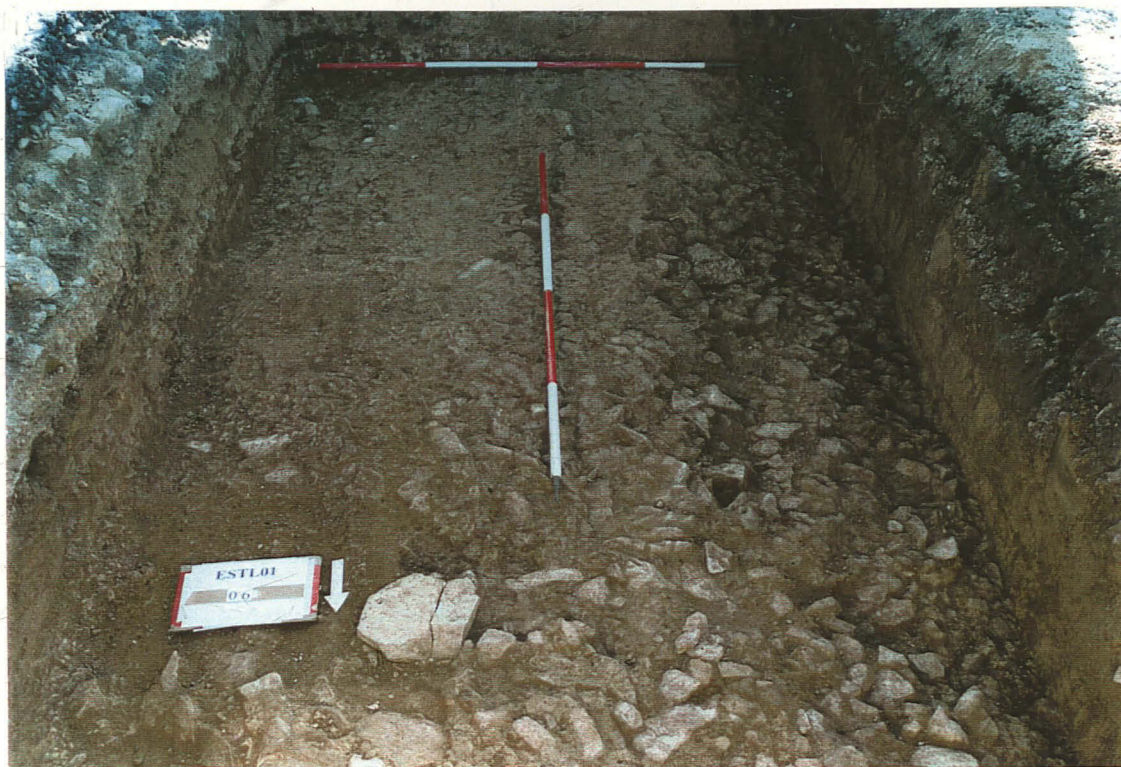
Pl. 1 Road surface (006) after top, finer component removed. A wheel rut can be seen to the right of the ranging rod.

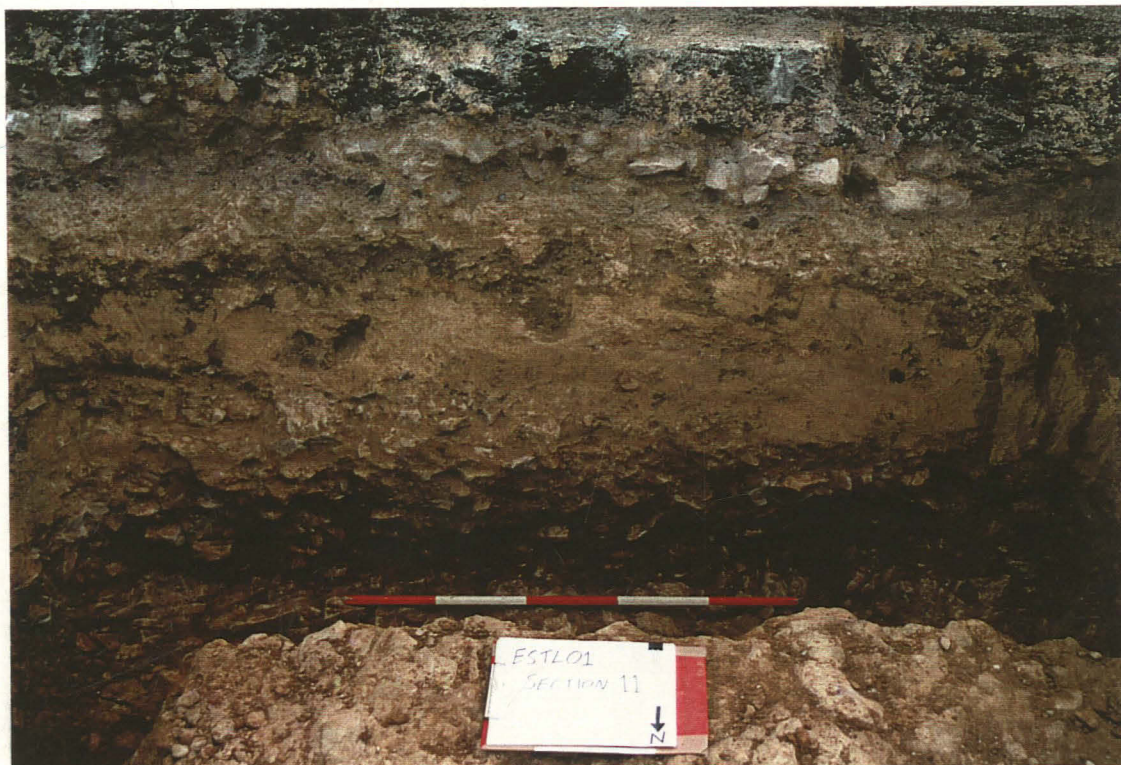
Pl. 2 Section through road layers from phase 1.

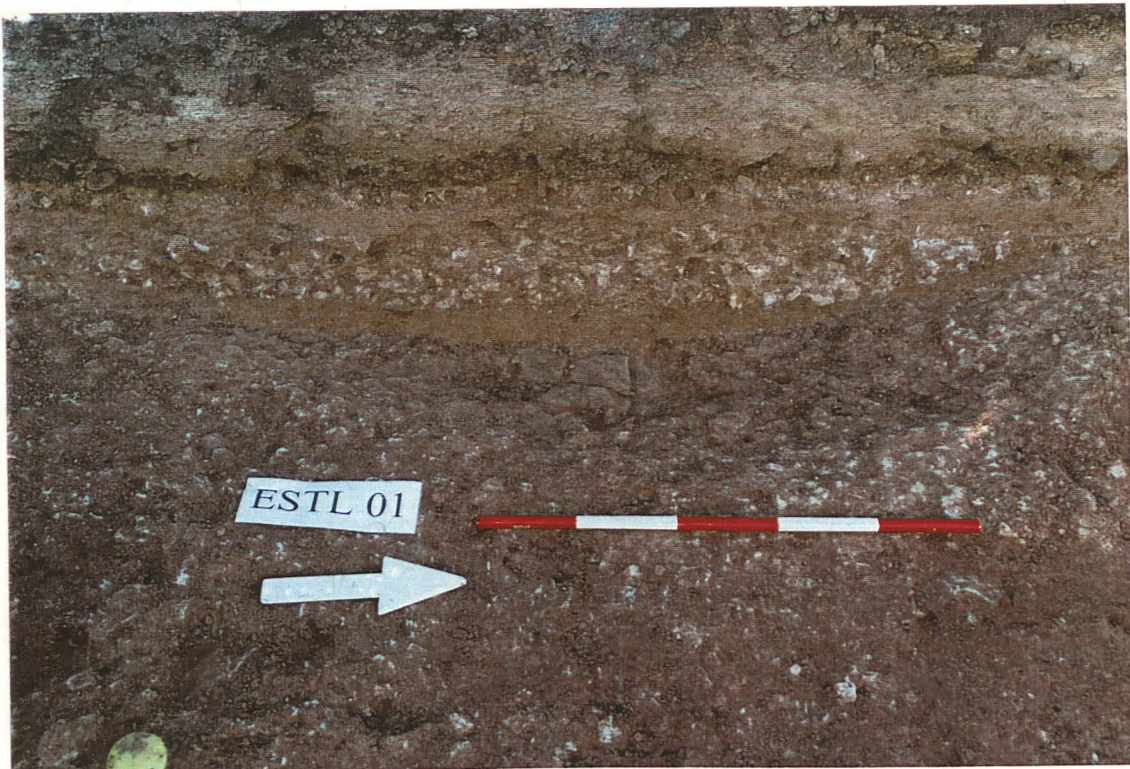
**Pl. 4** Pot-hole [112]. It has partially filled with sand before being repaired with gravel.

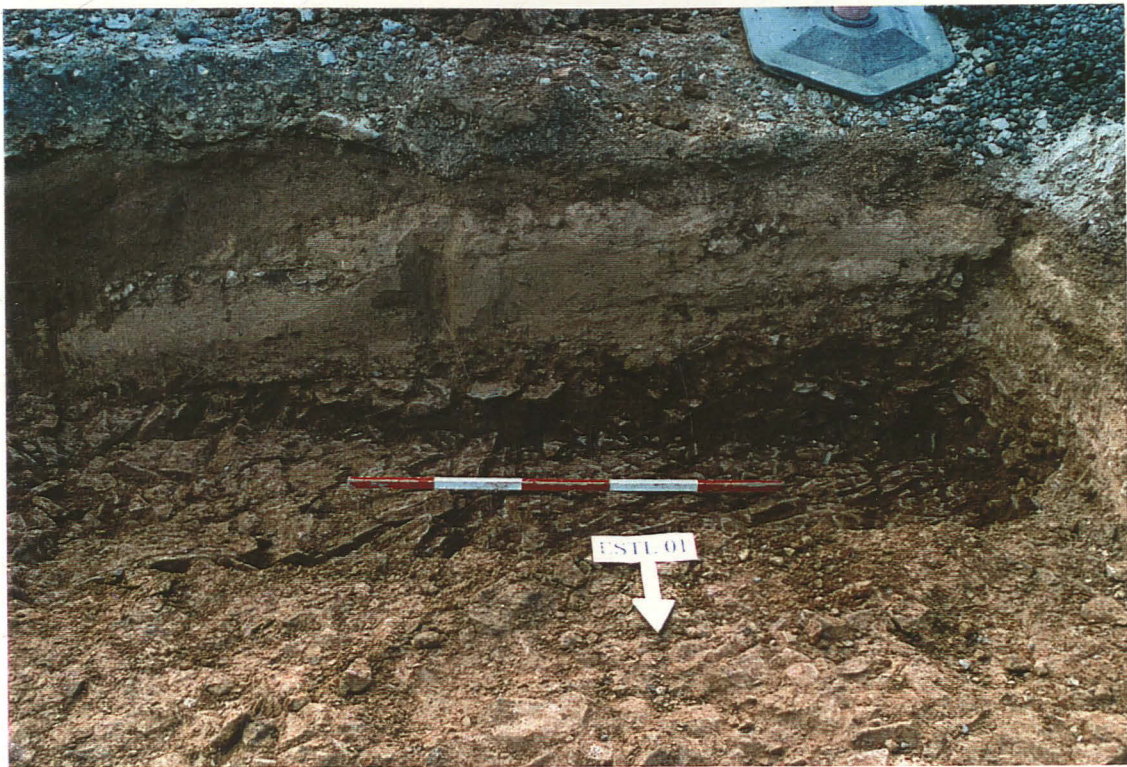
**Pl. 5** Close-up of north facing section. Shows agger, overlying road surfaces, make-up layers and other deposits.

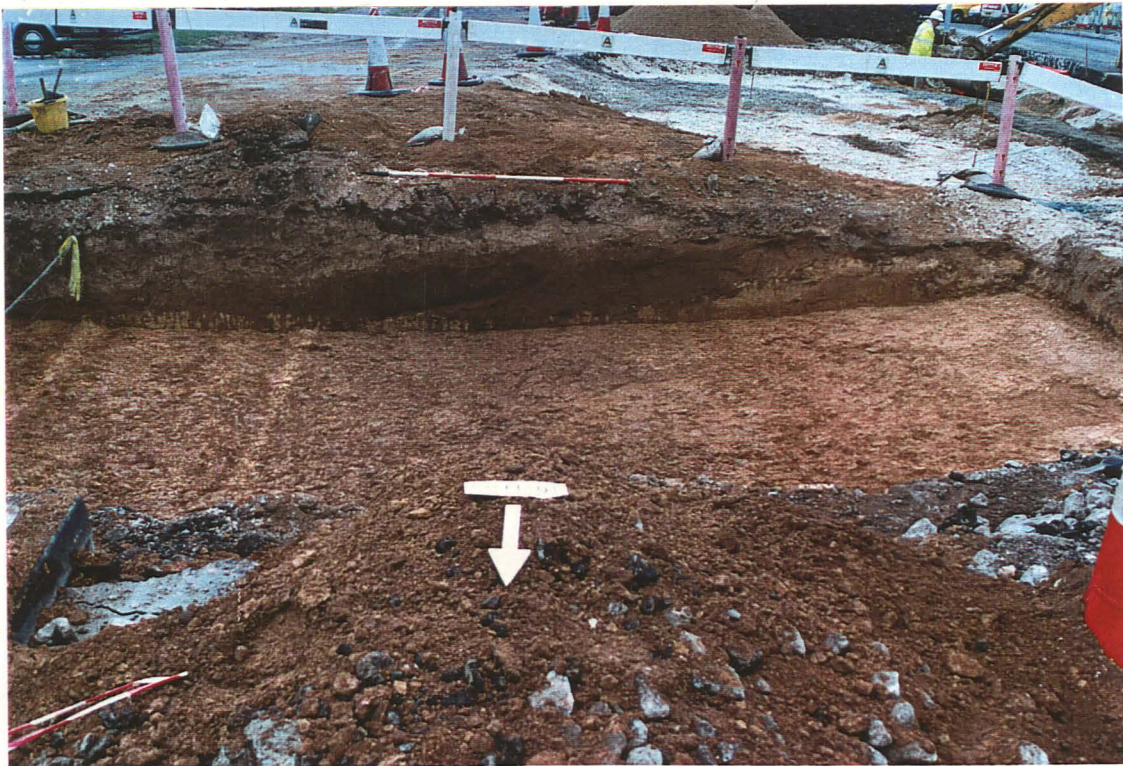
**Pl. 6** North facing section from phase 2.

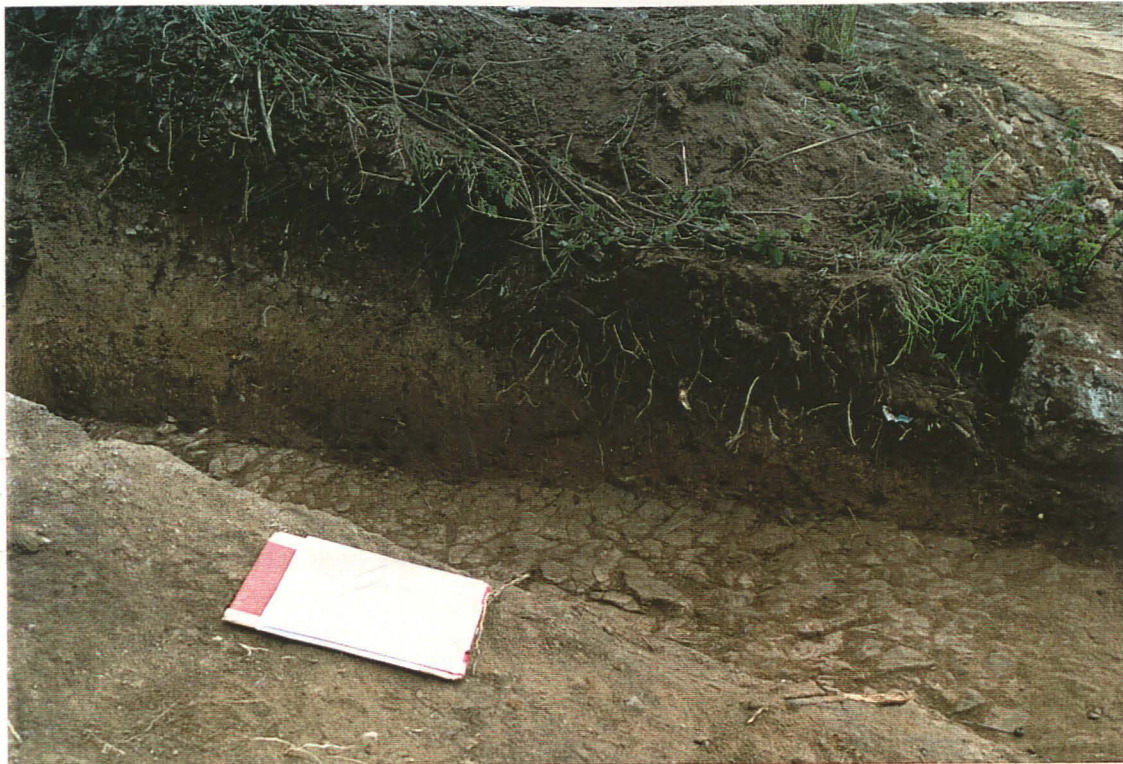
**Pl. 7** North facing section through deposits to the east of the road. Note ditch above number board.
