ARCHAEOLOGICAL EVALUATION
AT
NORTHFIELD LANE,
WILLOUGHTON,
LINCOLNSHIRE

Work Undertaken For
Severn Trent Water Ltd

September 1994

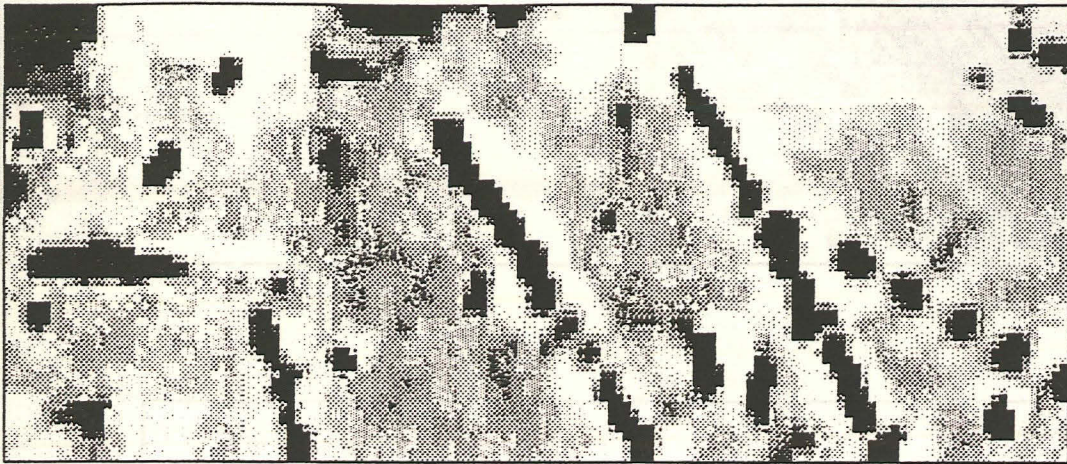
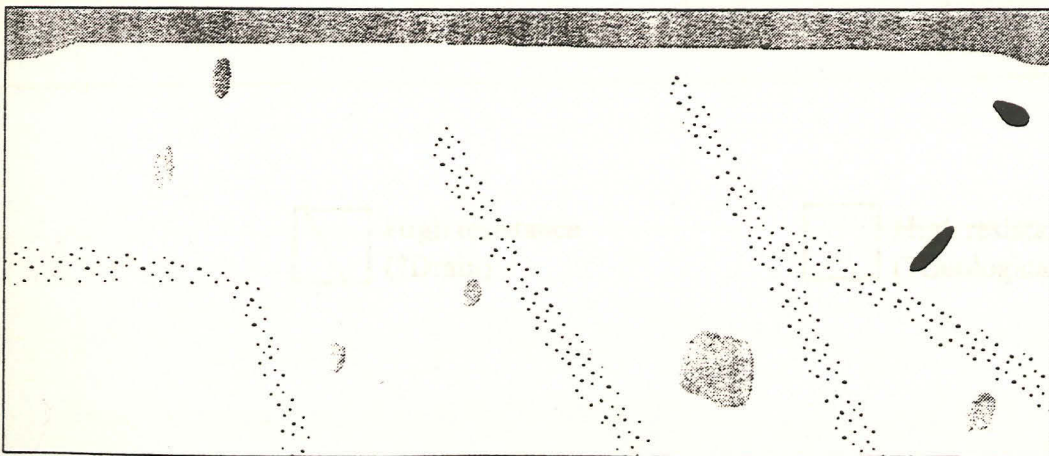
Fig. 4 Geophysical Examination, Results of Resistivity Survey

Results from the resistance survey show low background readings over most of the site, except for a small area to the east where there was a marked increase. This coincides with a slight break in slope and is likely to be a geological phenomenon (Fig. 4).

suggests that the cause of the magnetic deviation lay buried beneath the modern hillwash that provided the limit of excavation in this trench. Excavation established that a further signal, interpreted as a possible pit, was generated by a land drain. On the east side of the area, a change in the local topography coincides with, and is responsible for, a zone of high electrical resistance readings.

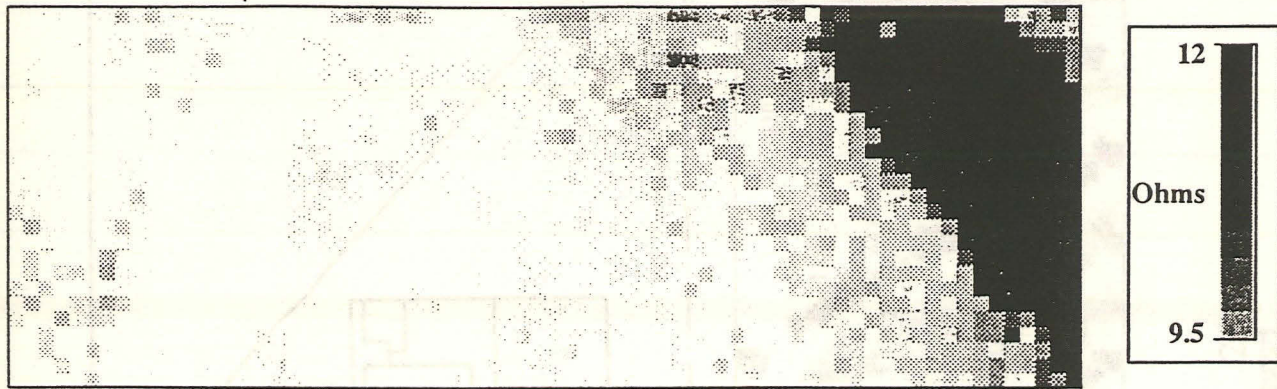
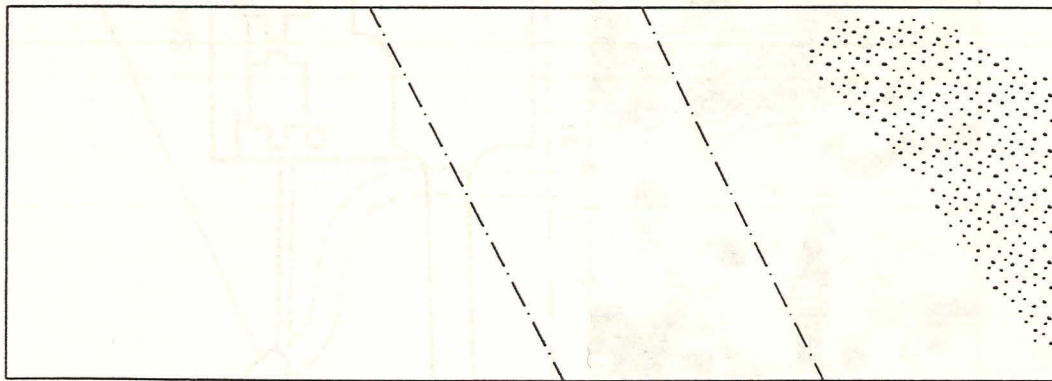
Fig. 5 Fieldwalking Results, superimposed on results of magnetometer survey

Finds recovered from the fieldwalking show an apparent random distribution of a wide range of material from the entire site. Most common elements were pieces of modern drain pipes and slag. Fragments of ceramic pipe support the known use of drainage in this field. The slag, concentrated along the west and north boundaries of the area, derives from the construction of the sewage works.

A few sherds of Romano-British pottery were also recovered and probably represent the spread of material from the known settlement area to the northwest (Fig. 5).

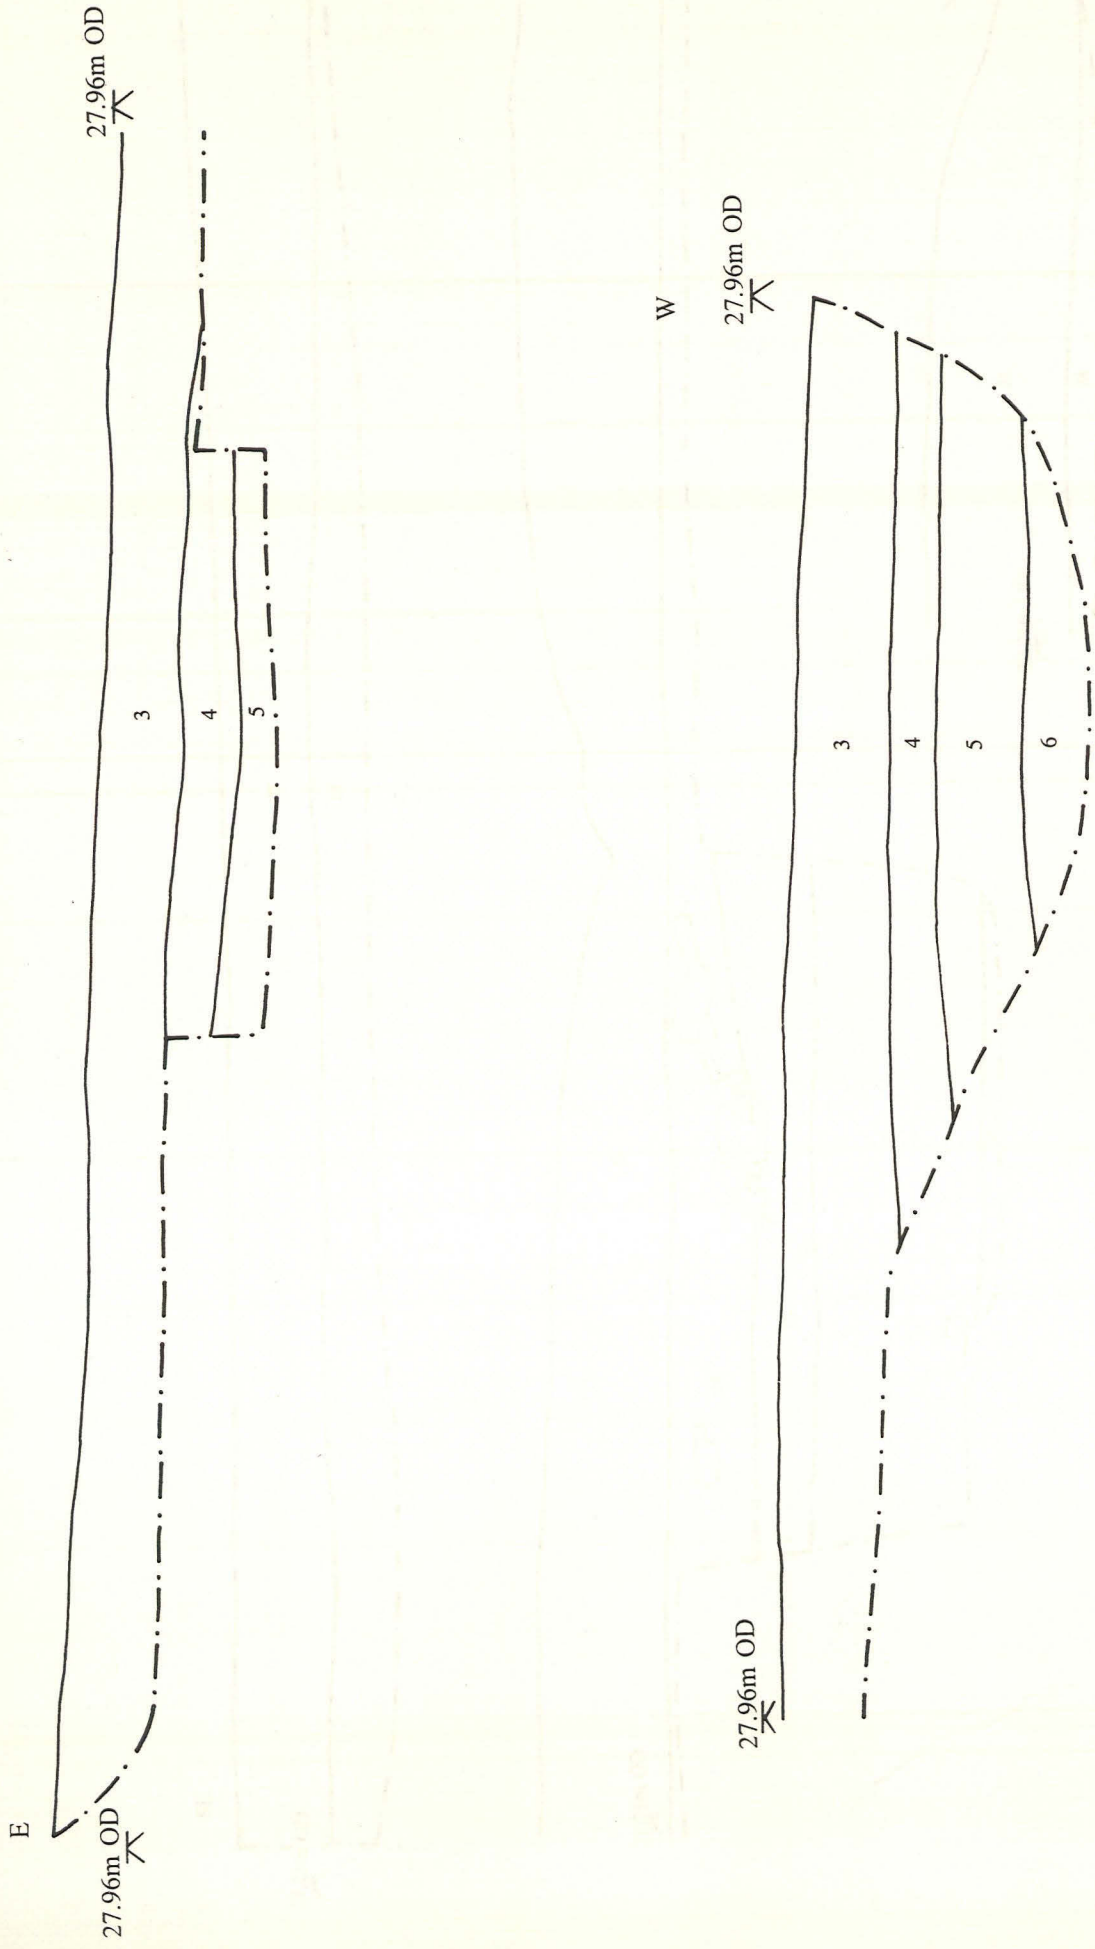
Fig. 8 Section of Trench D

Towards the eastern end of the investigation area, and above the basal clay in Trench D, was a moderately pebbly dark sandy clay (17). Containing fine organic matter and charcoal fragments, this is also considered to be alluvium (Fig. 8). However, the quantity and variety of inclusions suggests that this material was deposited in a higher energy environment than the underlying layers. A moderate quantity of Romano-British pottery of 4th century date, including a large piece of a Dales Ware jar (Fig. 10), was recovered from this deposit.

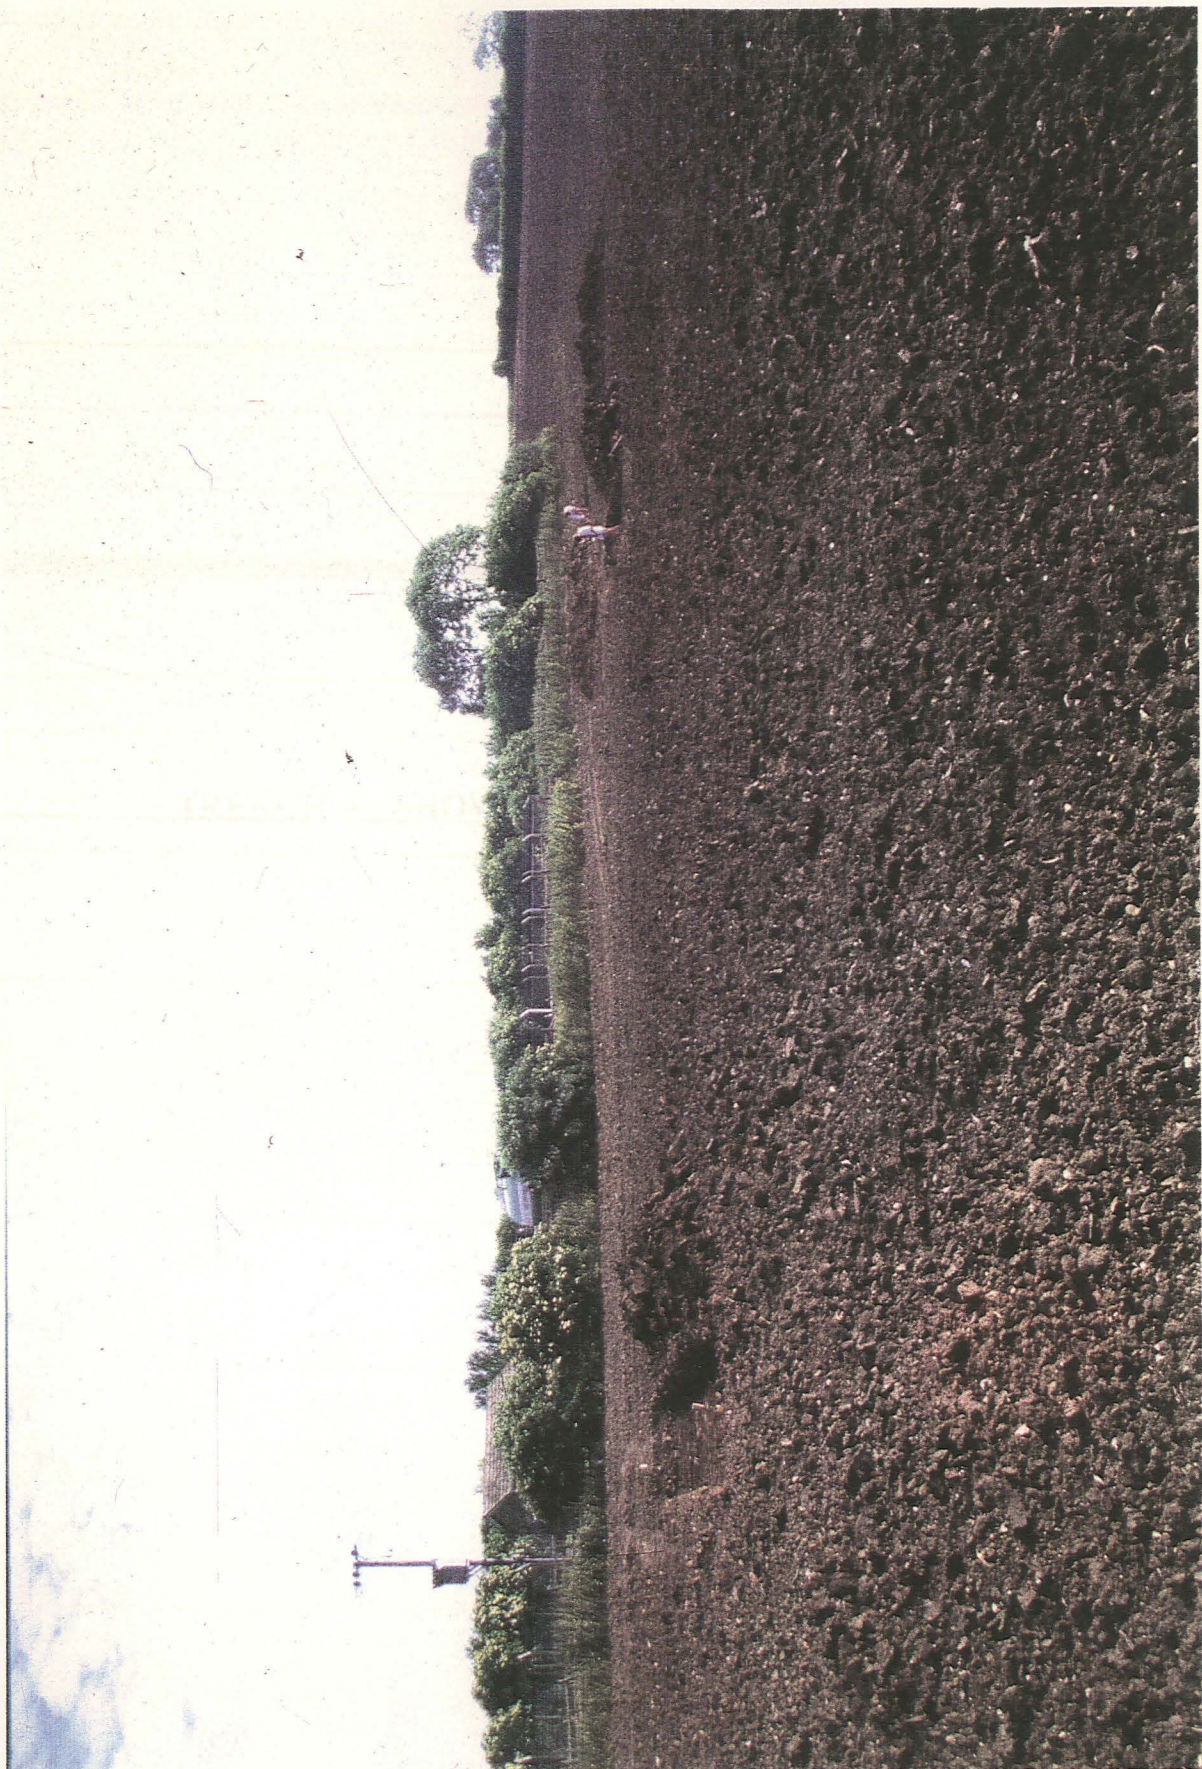
PLATE 2

Coarser clays and silts (phase 2), interpreted as hillwash, sealed these marsh deposits (Plate 2). Fragments of land drain included in these layers reveals their relative recent origination or transformation. Modern agricultural use of the land was represented by land drains and the ploughsoil that constituted the current ground surface (Plate 1).

TRENCH A, SHOWING TYPICAL SOIL LAYERING

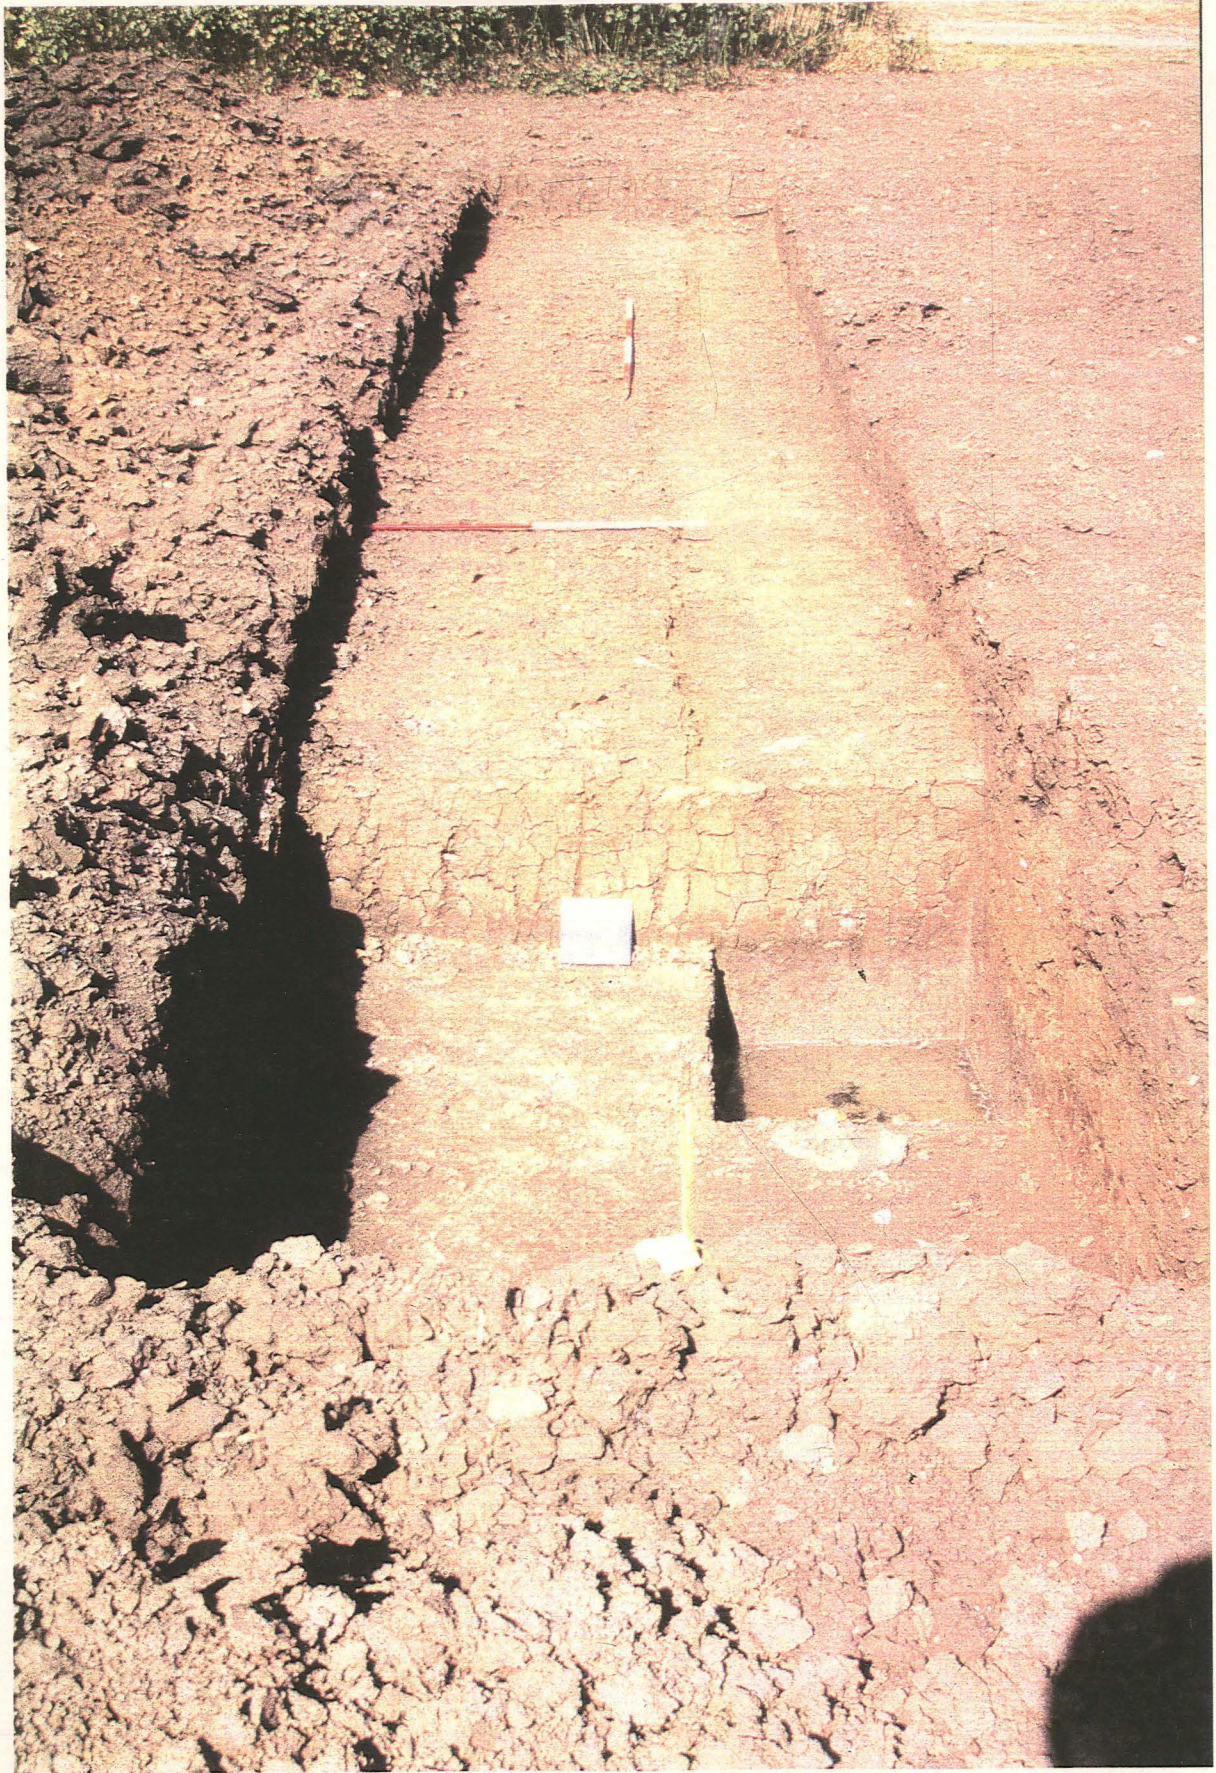
PLATE 3

Above this stream silting material, and occurring elsewhere across the site, were silty clays. One of these was blue-grey in colour, characteristic of deposition in standing water. As a result, these are also interpreted as alluvium, though formed in a bog or marshy environment (Plate 3).

TRENCH A, DETAIL OF BOG-TYPE DEPOSITS
