**SURFACE COLLECTION SURVEY.
PROPOSED ROUTE OF
MALTBY-le-MARSH TO MANBY
REPLACEMENT WATER MAIN**

Site Code: MMF03
 NGR: TF 4120 8705
 to TF 4710 8265
 Planning Ref. N/A
 Accession No. 2003.56

Report prepared for Anglian Water Services Ltd.
by
Alex Brett

April 2003

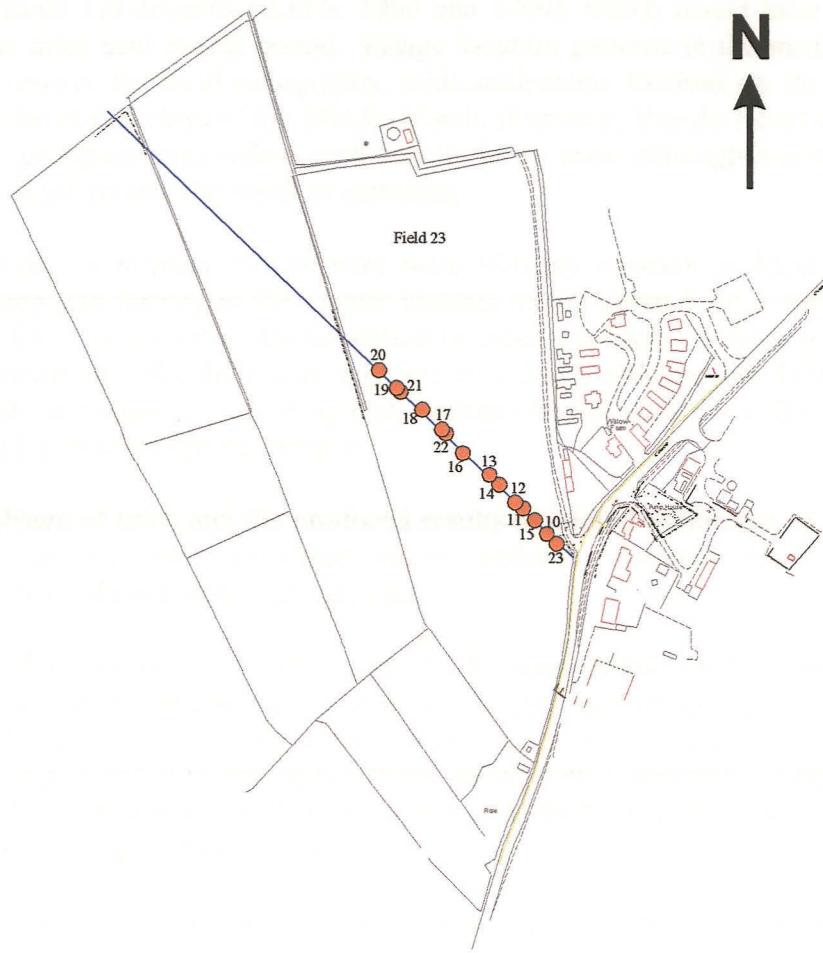
Fig.5 : Close-up of field 23 showing location of brick and tile fragments recovered.
1:5,000

When first examined, this field contained the stubble of a former crop, interspaced with patchy grass. As a result, visibility was only 50%. A single small sherd of unidentifiable pottery was recovered.

During the second visit, the grass had matured, reducing visibility to 40%, however this examination still produced 14 fragments of brick and tile. Of these, 8 could not be dated, and a further 3 were of post-medieval or early modern date. Fragments (12) and (19) could be either Romano-British or post medieval, and both appear to be brick fragments. Fragment (22) was securely dated to the Romano-British period and is identified as a piece of *tegula* (roof tile).

In field 8, four fragments of what may be Romano-British brick were recovered, which could provide evidence for a structure on the edge of the higher and drier till landscape between Walk Farm and Pyewipe farm. Field 23 produced two further fragments of possible Romano-British brick, along with a positively identified *tegula* fragment. These too may be slight evidence of a building in the vicinity, although fragment numbers are extremely low.

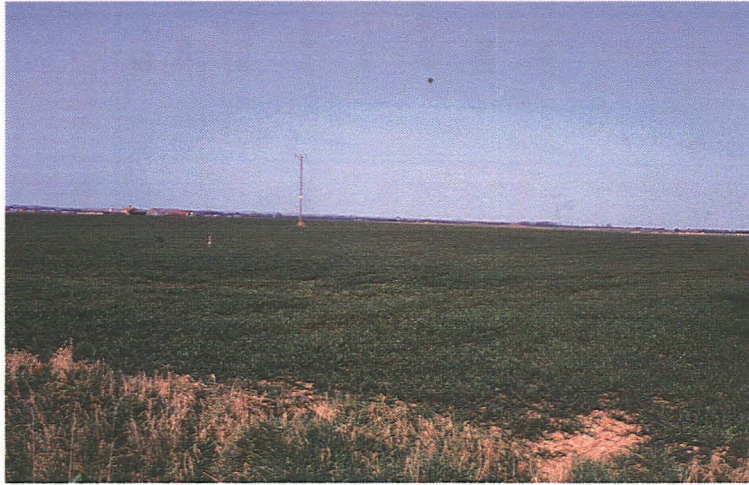
Pl. 1 : Field 15, looking northwest. Note Barfen farm in background.

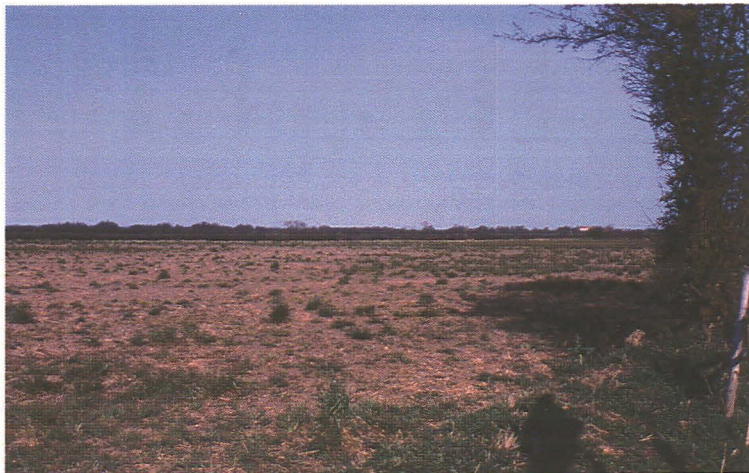
Pl. 2 : Field 23, looking north.
