Wyham Grange, Wyham-cum-Cadeby, Lincs.

Underpinning, Renovation and Construction of a Swimming Pool Extension

Archaeological Watching Brief

LAS Report No. 642

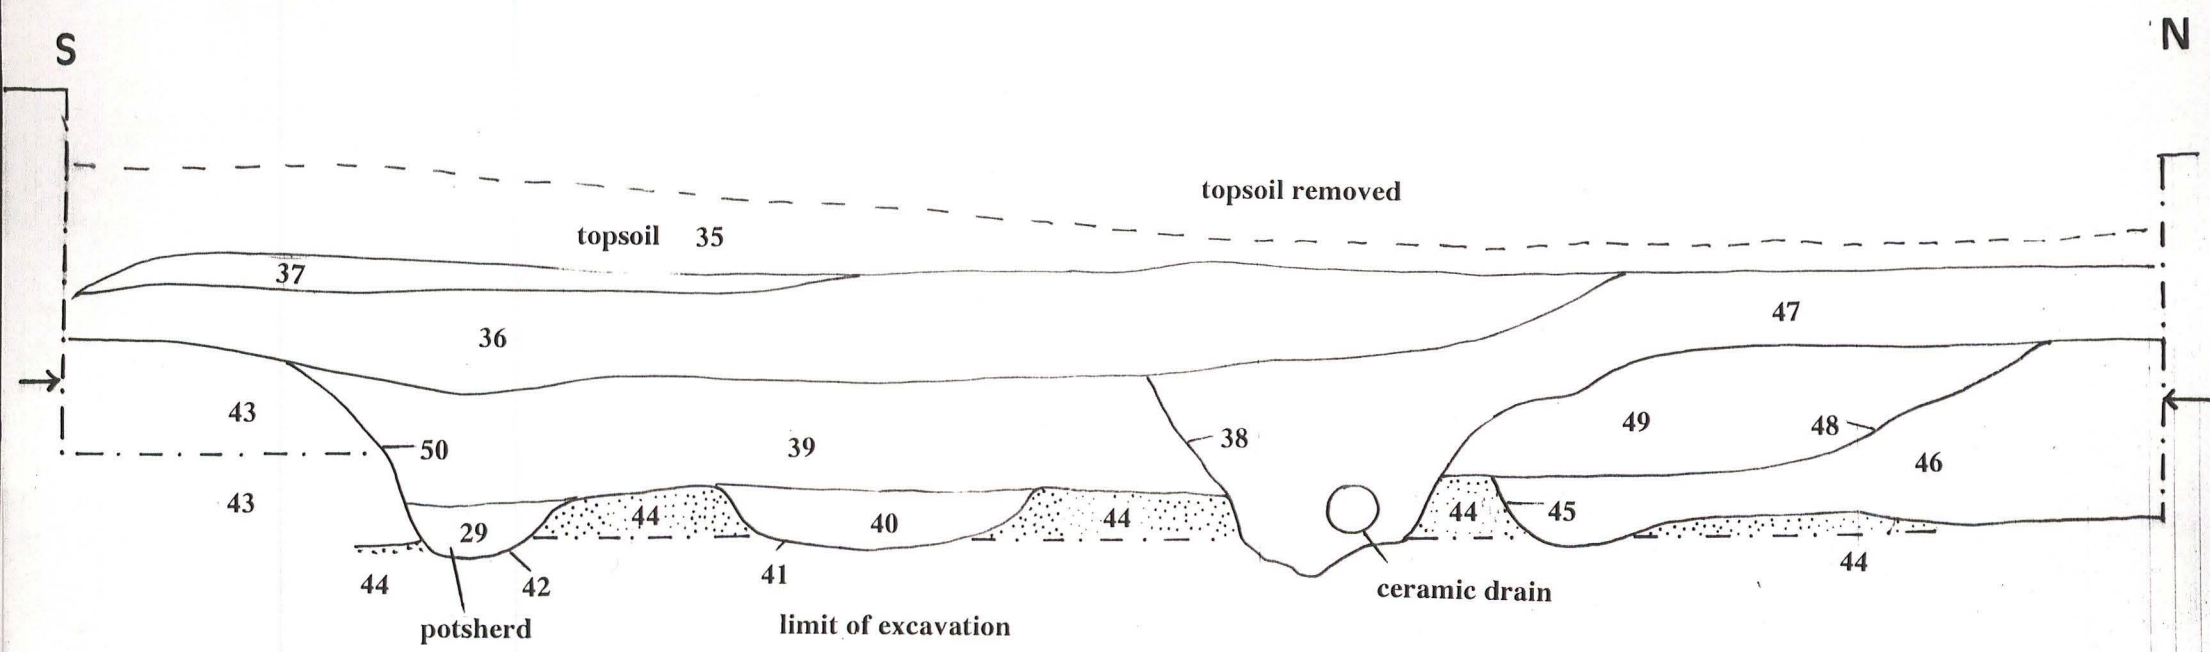
Fig. 6 Deposits visible in the western face of the trial slot across the swimming pool area (Field, after Tann).

A 13m x 6.5m part of the lawn area to the east of the garage was stripped of turf in preparation for construction of a swimming pool. The stripped area lay to the north of the ridge, and occupied the width of the depression. The turf covered a layer of twentieth century levelling material, containing brick rubble, roof tile, etc. The contractor agreed to excavate a 0.6m wide slot across the width of the pool area in order to establish the profile of the natural chalk (Fig. 6).

The ditch had been excavated through a 0.3m thick layer of orange/brown chalky clay **39/49**. This had an even upper and lower surface, and filled a 4.5m wide depression **50/48** cut into chalky brash and clay, with chalk bedrock at the base. The chalky clay layer was interpreted as soil accumulation across the medieval hollow lane leading past the site of Wyham Grange, but no trace of metalling was present. As frequent scouring of dung and mud from roads for use as fertiliser on fields is well-documented, the absence of a road surface is not surprising (Taylor 1979, 146). It sealed two small features, the bases of which cut into the chalk bedrock. Feature **42**, at the southern edge of the depression, was 0.4m wide, and 0.1m of its orange/brown clay fill **29** survived below the overlying layer (Pl. 17). The fill incorporated seventeenth/eighteenth century pottery. 0.4m to the north was another shallow feature **41**, 0.8m wide, filled with light brown brash and clay. These features could represent ruts in the chalk base of the hollow lane.

The southern side of the depression/lane seemed to be well-defined, cut into a 0.5m thick deposit of gritty chalk brash 43. However, the base of this brash was at least 0.1m lower than the adjacent chalk bedrock, and this indicates that it is probably an artificially deposited soil. The same sequence was visible on the northern edge of the depression, but here it was cut into a light brown clay 46. Both deposits were recorded as the fill of more extensive ditches, but reconsideration of the evidence suggests that both are accumulations of plough-moved soil, dropped either side of the lane (as described by Taylor 1979, 141). The trial slot across the stripped area was backfilled for safety reasons.

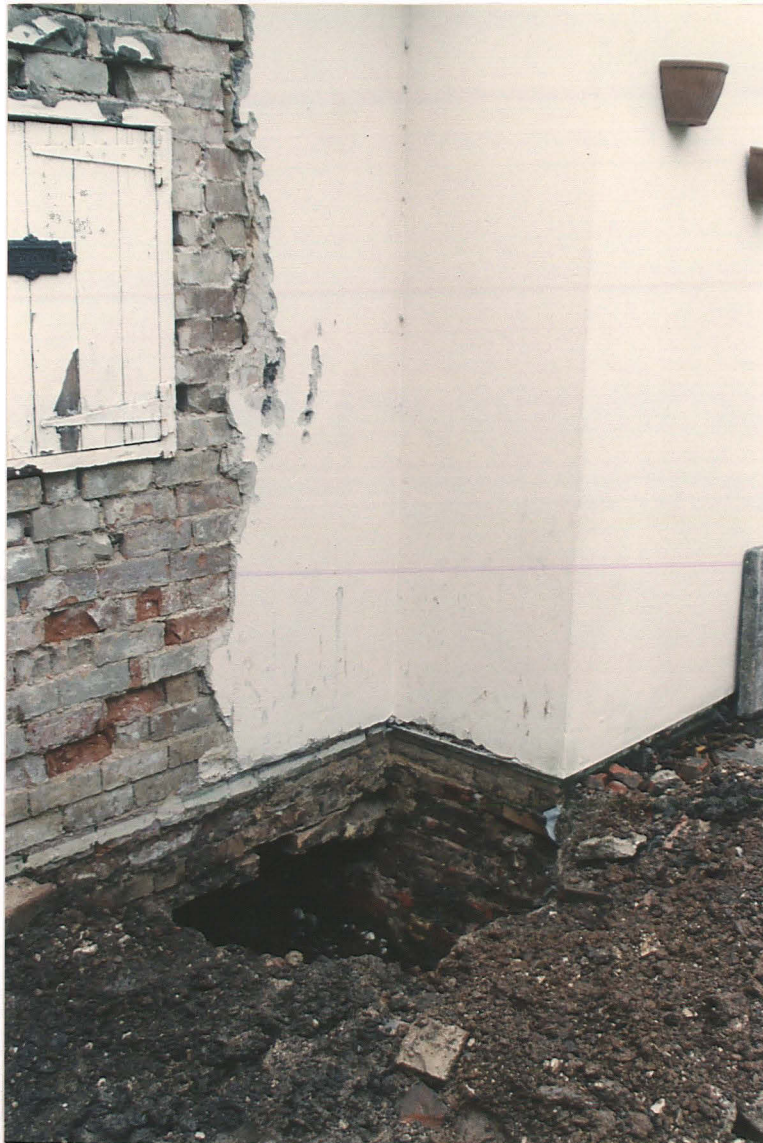
Pl. 2 Trench A, for underpinning existing extension to Wyham Grange (looking SE).

This 0.8m deep trench was 1.3m north-south and 1m wide, extending 0.45m under the north-south aligned brick foundations of an extension to the north of the main house. It was positioned at the angle between that building and a twentieth century house extension (Pl. 2).

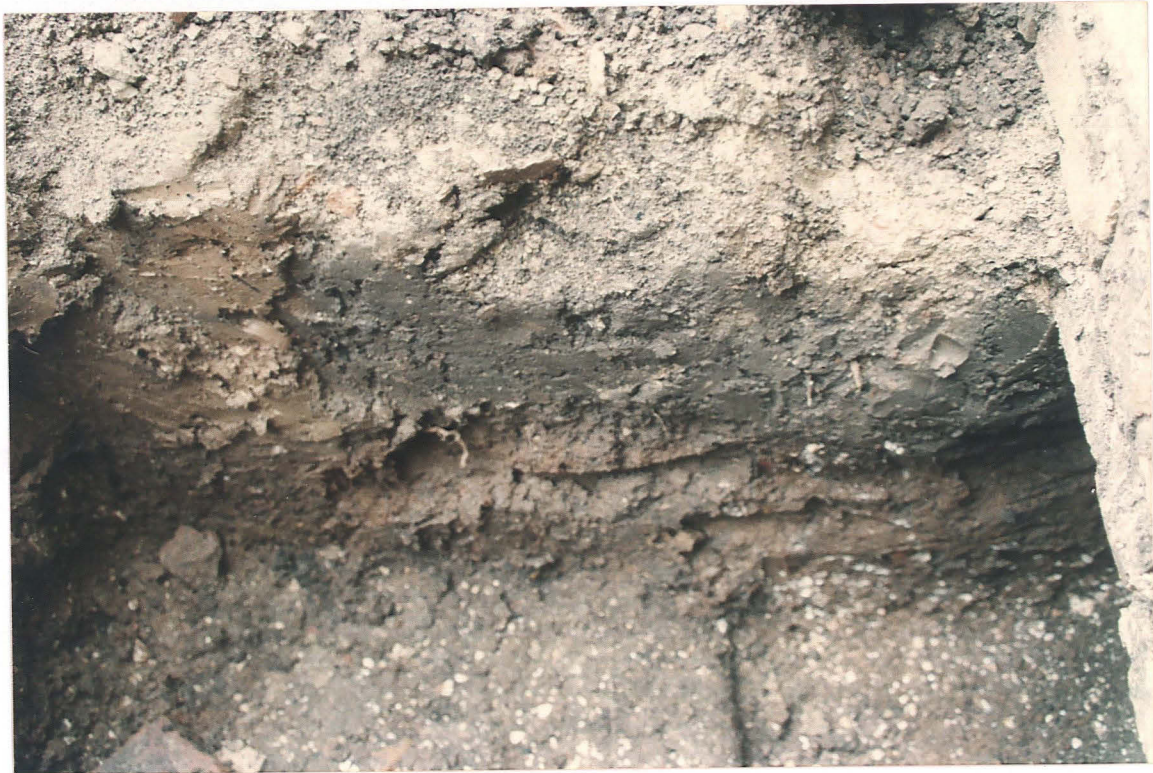
Pl. 3 Dark fill of the extension wall construction trench, Trench A (looking north).

Below the topsoil layer alongside the extension was a 0.15m thick spread of chalk and brick rubble. The 0.28m thick layer of black soil covered by the rubble spread was the fill of wall construction trenches, extending 0.6m from the west wall, and 0.8m from the southern wall (Pl. 3). No stratigraphic relationship was seen between the construction trenches, and they may have been contemporary. They had been excavated through brown clay.

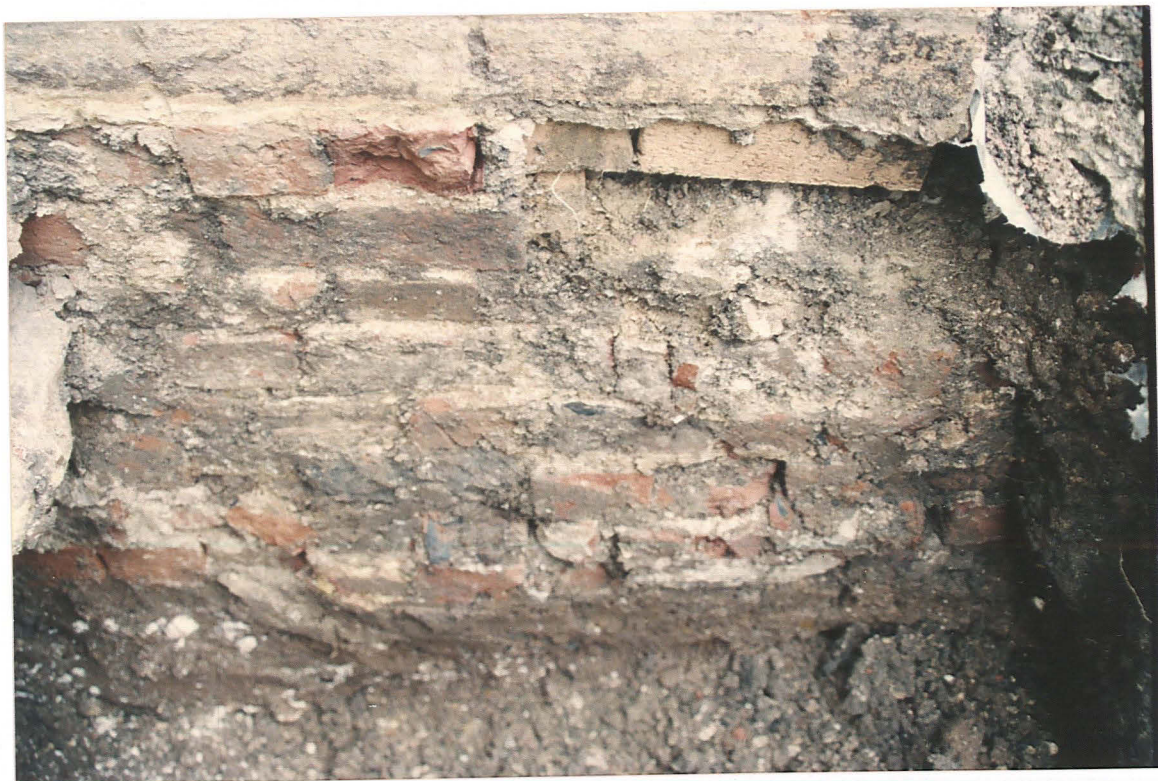
Pl. 4 Brickwork foundations of north wall of cellar, overlain by later brickwork of existing wall. Trench A, looking south.

Eight courses of mortared brickwork were exposed on the southern side of the trench (Pl. 4). These had been cut into in the past, perhaps for a garden border, and then roughly filled prior to construction of the linking building. The bricks, 230mm x 120mm x 75mm, extended to the base of the construction trench. This wall seems to have been from a building over the house cellar; the cellar extended west of the house and outbuildings prior to the recent works. It is likely that the building was contemporary with the outbuilding, but was demolished some years before the existing extension was built. That demolition event could have produced some of the brick rubble sealing the backfilled construction trenches.

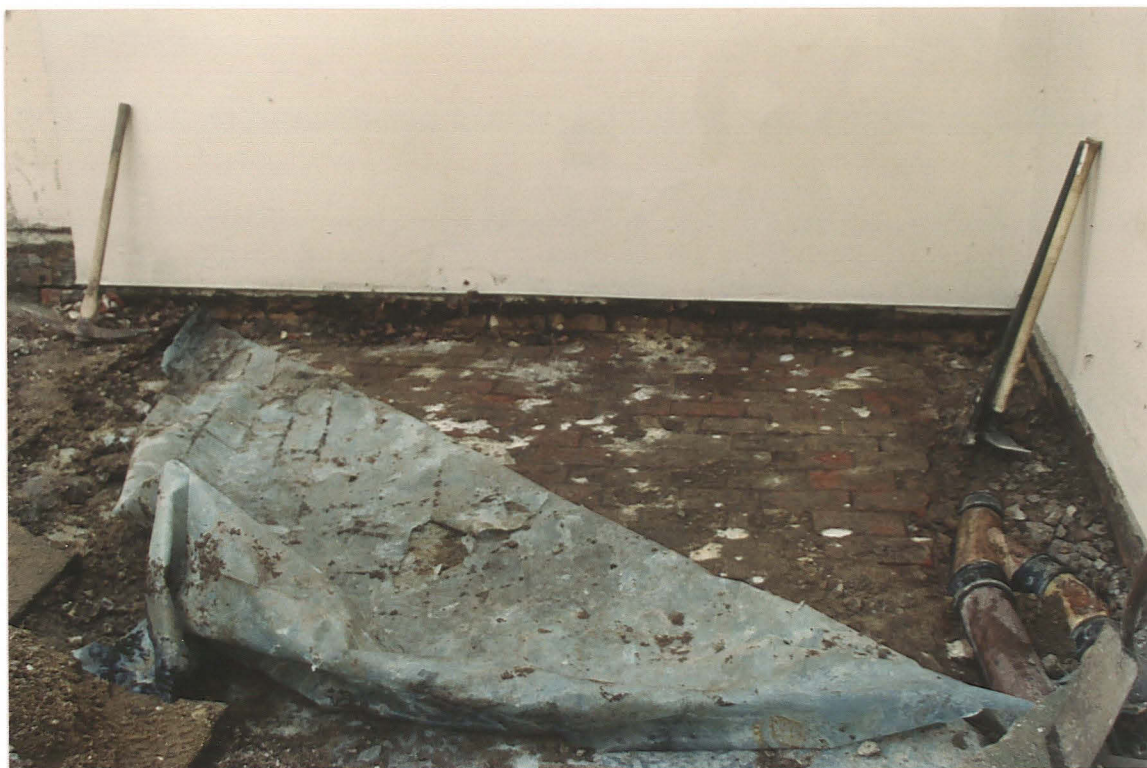
Pl. 5 Buried brickwork of the cellar roof, beside the modern entrance to the house (looking east).

To the south of this trench was a twentieth century extension, linking the earlier outbuilding to the main house. The extension had been built over an earlier cellar, which extended west of the house entrance. Beyond the trench, a 0.08m thick concrete skim covered the brick cellar roof, constructed with bricks 230mm x 115mm x 50mm thick (Pl. 5).

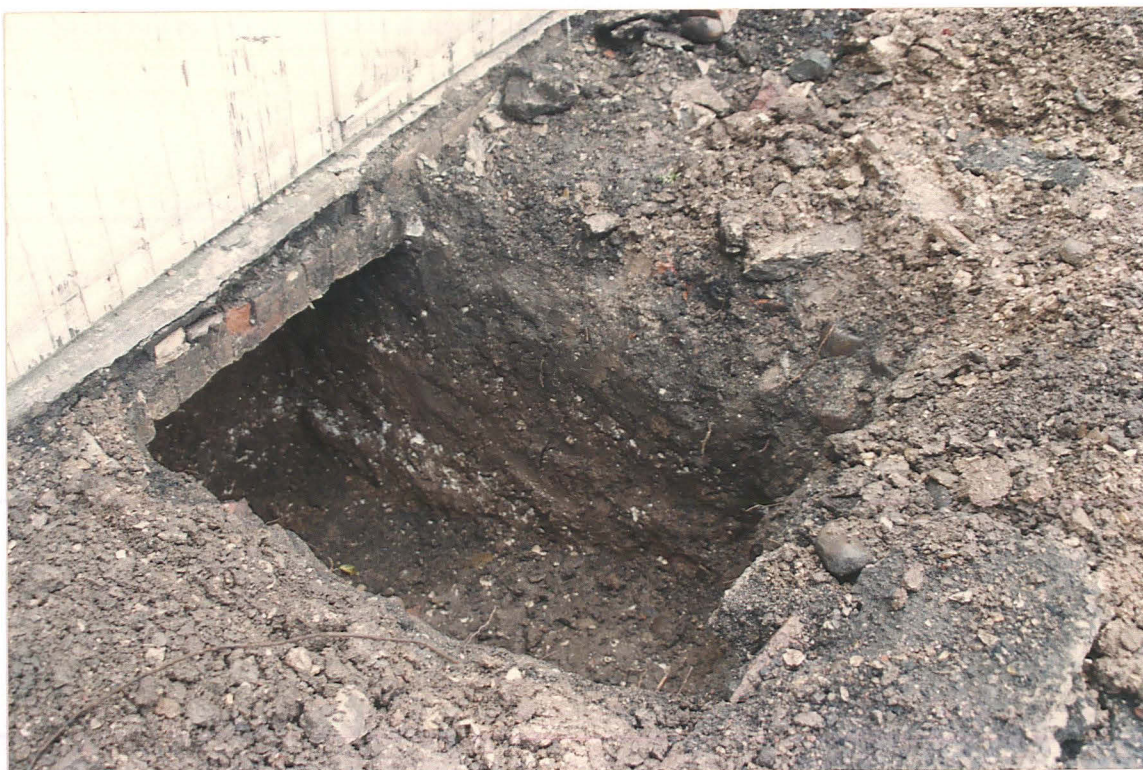
Pl. 6 Horizontal bands of subsoil and topsoil above chalky boulder-clay, Trench B. Looking SE.

The 0.9m wide trench extended 1.2m out from the extension wall. The foundation for that wall was in a 0.5m deep construction trench, filled with a dark brown/black fill, occupying the trench area. Below this was a 0.25m thick brown clay layer, sealing a red/brown chalky clay, which was at least 0.25m thick (Pl. 6). The brown clay appears to be derived from the chalky material, and could be a cultivated soil.

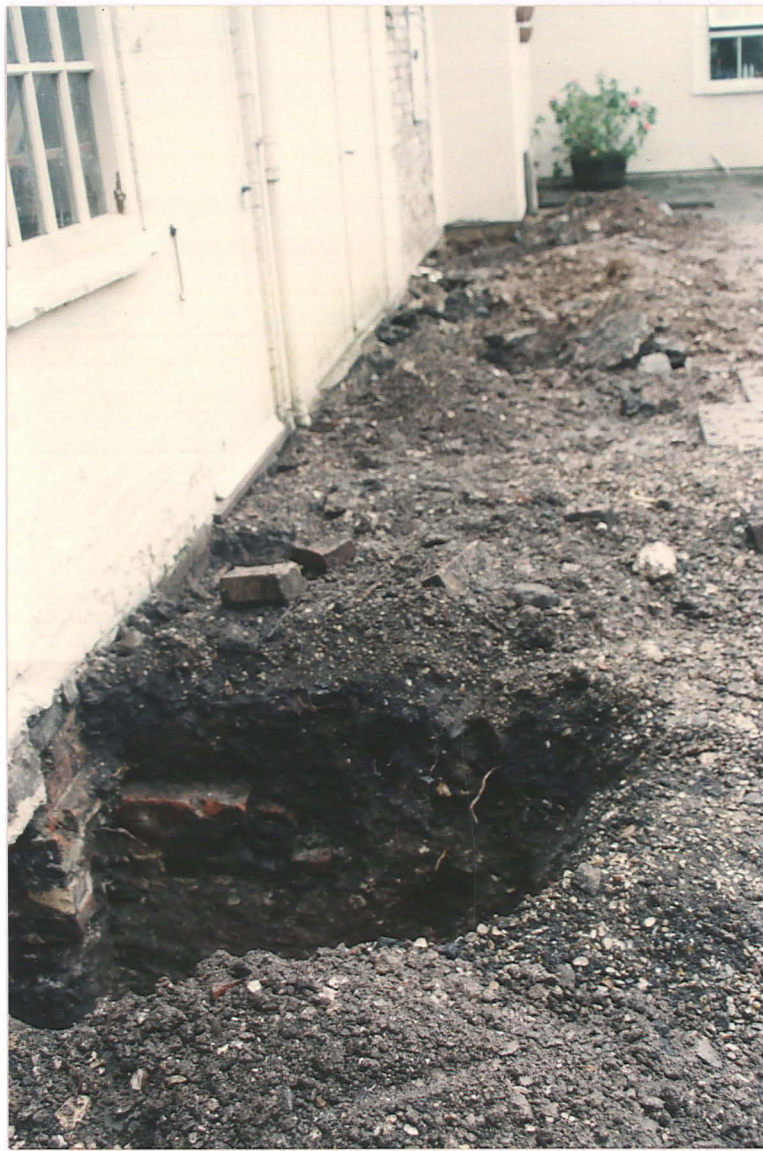
PI. 7 Trench C (foreground), showing the drain in the southern side. Looking south alongside the extension to the house.

This trench was positioned where the modern garage (to the north) abutted the older outbuilding extension. The brick foundations of the NW corner of the outbuilding were exposed at the SE corner of the underpinning trench (Pl. 7). A land drain, aligned north-south alongside the west wall of the outbuilding, entered a brick drain chamber beside the end of the outbuilding, and may have flowed around the northern side before the garage was built.

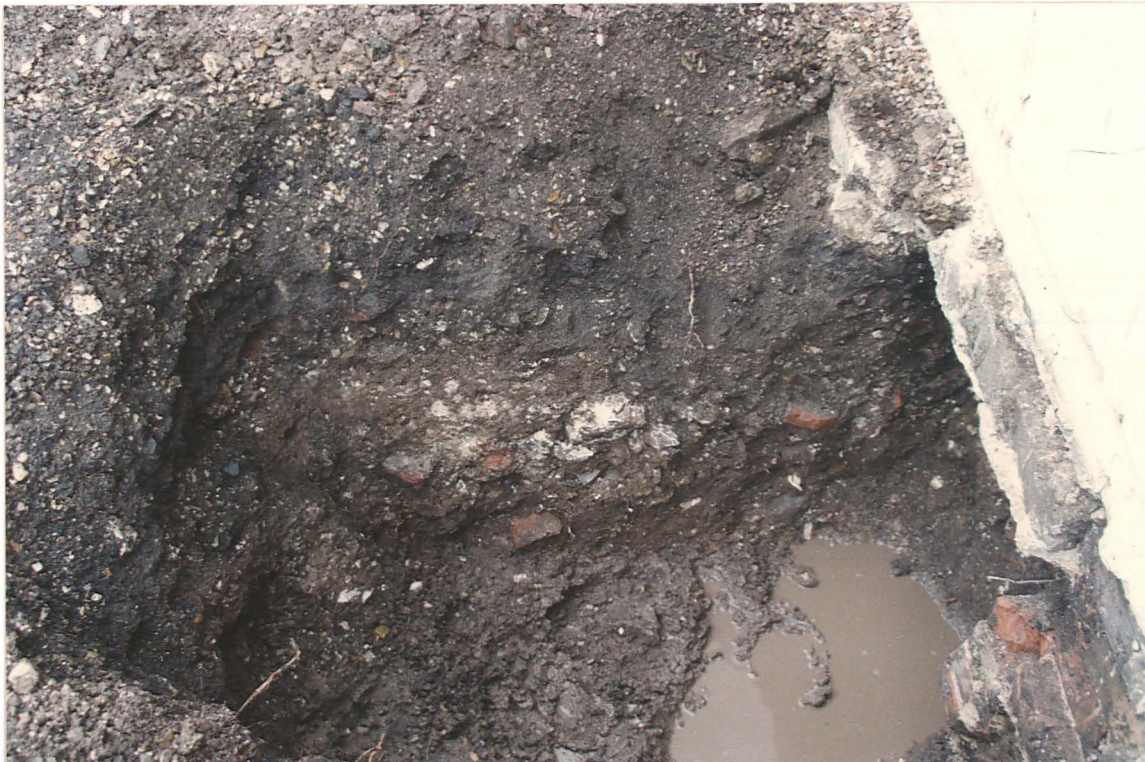
PI. 8 Northern face of Trench C, with dark soil below the garage wall representing fill of the extension foundation trench. This cuts a mixed layer of chalk rubble and tile, as does the possible scaffold hole (left edge of trench).

On the northern side of the trench, the construction trench for the garage was visible, cutting into a mixed layer of brown clay with chalk and brick rubble (Pl. 8). A shallow feature **10** cut into this layer, and was sealed by topsoil. It may have held a scaffold pole during construction of the outbuilding.

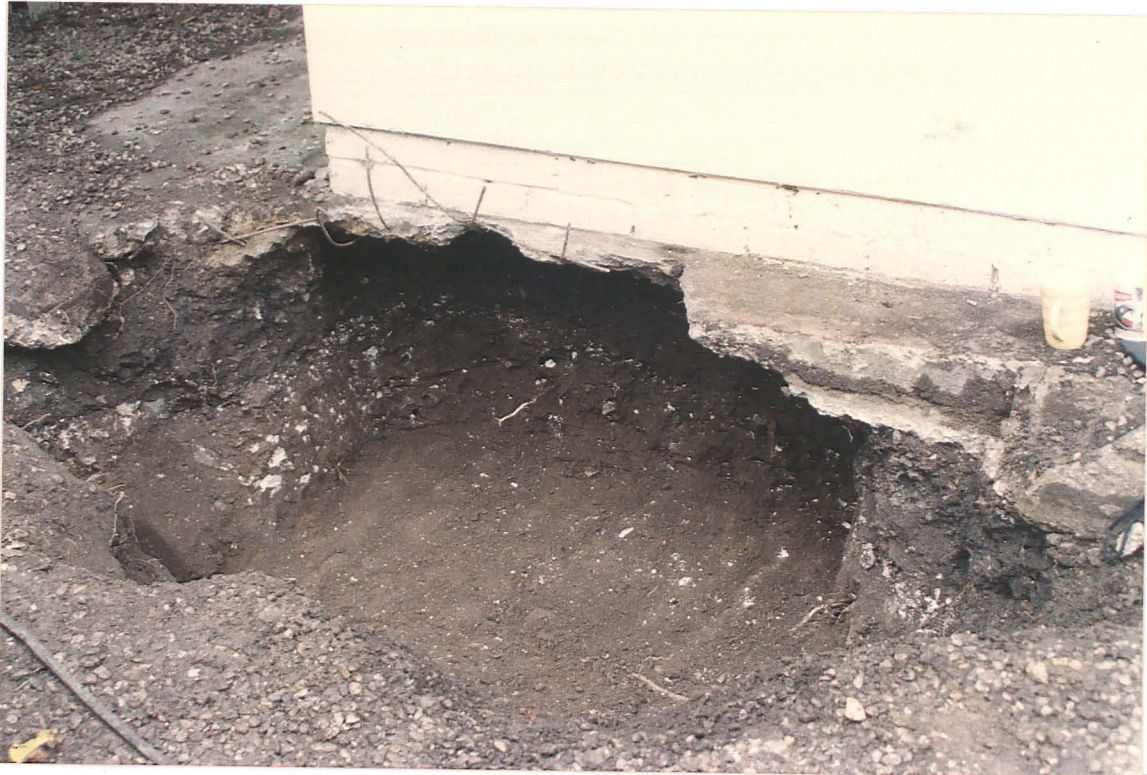
Pl. 9 Trench G at the NW corner of the garage, showing topsoil and subsoil layers sloping down to the south as fill of a linear depression. Looking NE.

At the NW corner of the garage, it was clear that it had been built on ground which had formerly sloped downwards to the south (Pl. 9). The foundations had been laid in a dark topsoil-like material, levelling the feature, with chalky brown clay below. It was unclear whether this was undisturbed clay or an earlier fill.

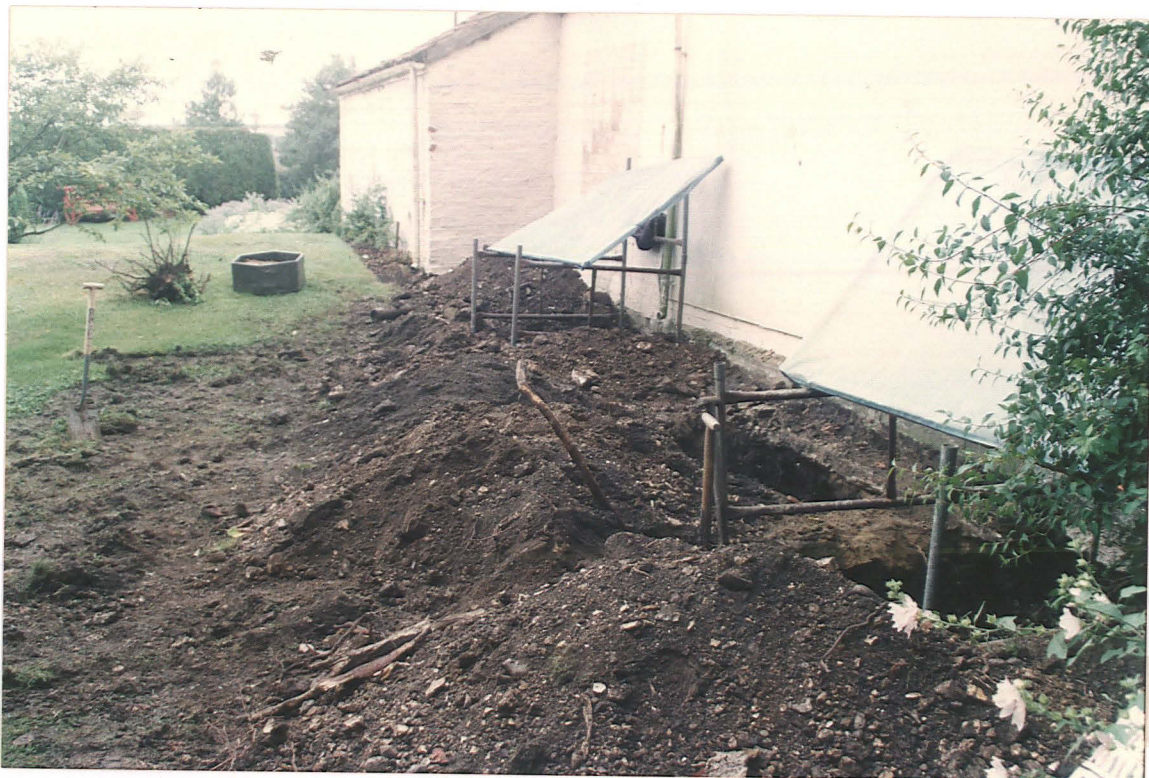
Pl. 10 Underpinning trenches H, J and K (under shelter) to the east of the garage (looking south).

Further trenches were excavated along the rear of the garage and adjoining outbuilding (Pl. 10). At the northern end of the garage, the same sequence was present as at Trench G.

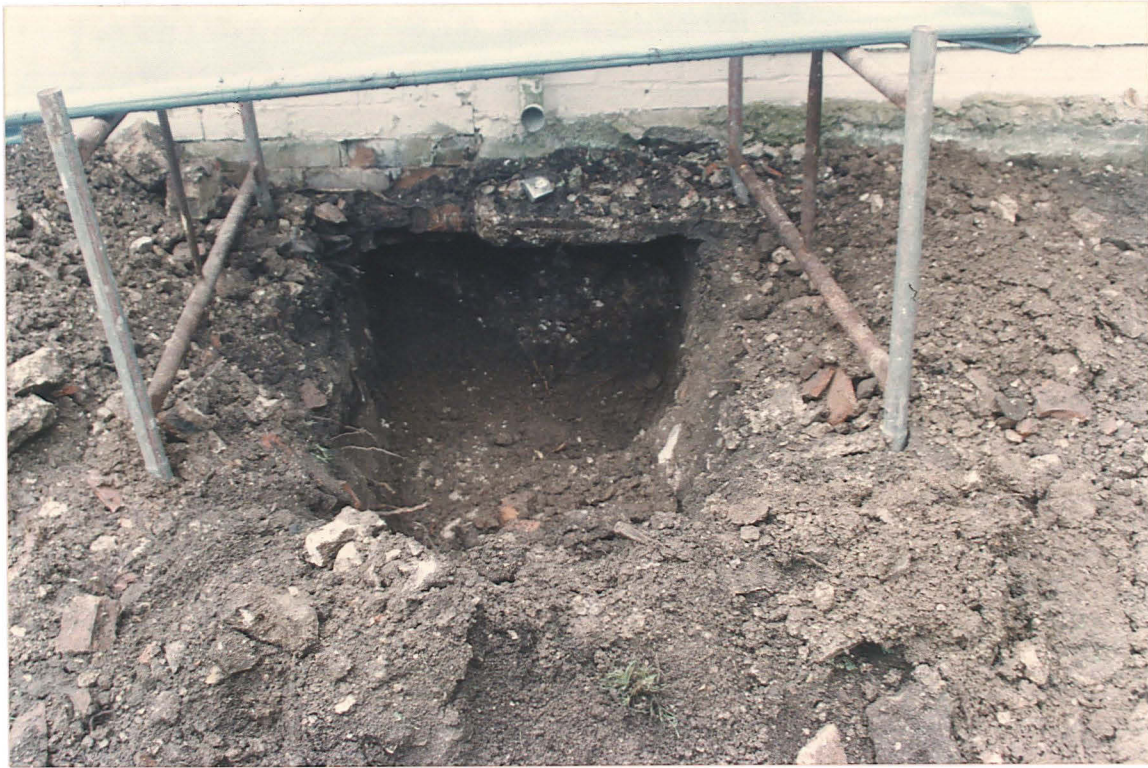
Pl. 11 Deposits in the western face of Trench K below the garage, showing tip-lines at the southern side of the linear depression.

Positioned 5m from the NE corner of the garage, this trench contained the west side of the sloping feature seen in Trenches G and H. Below buried topsoil was a deposit of mortar, chalk and brick rubble, levelling the feature (Pl. 11).

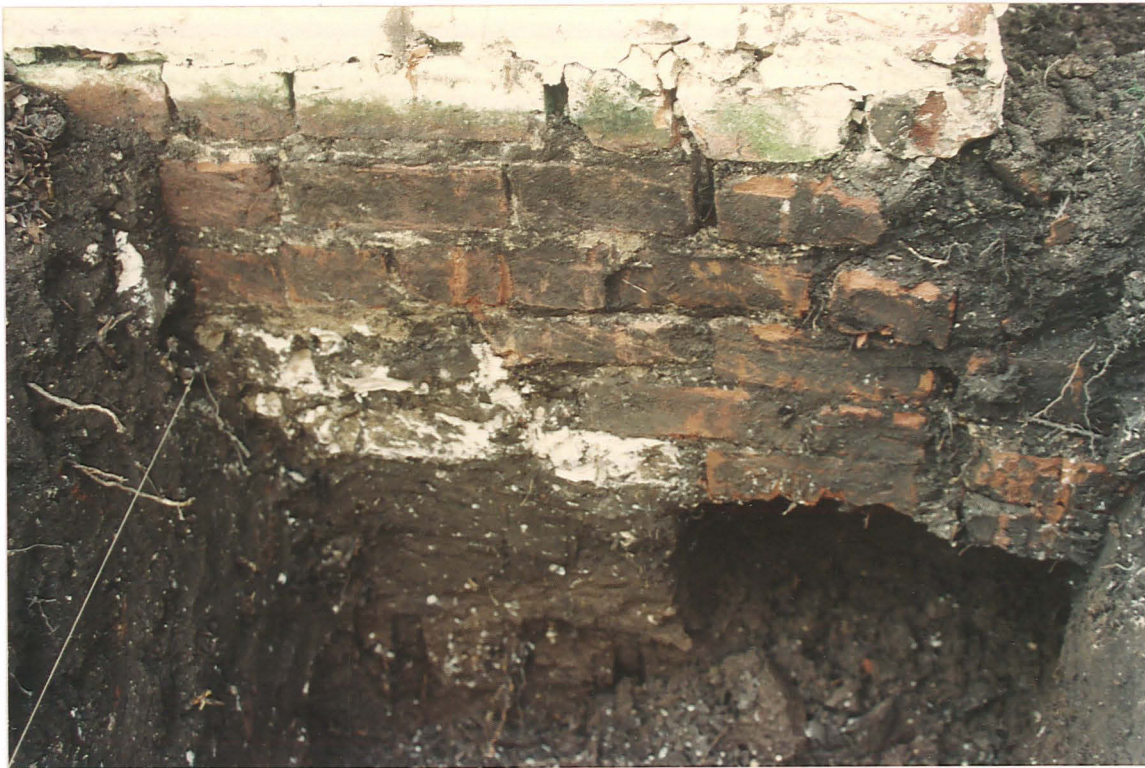
Pl. 12 Foundation courses at the NE corner of the extension (Trench L). The existing brick extension over-rides chalk block foundations of an earlier structure. Looking west.

This trench was sited at the NE corner of the outbuilding, offset 1m to the east of the adjoining garage. The outbuilding wall had been built on two courses of cut chalk rubble blocks, resting on the surface of a dark brown clay loam deposit **22** (Pl. 12). There was no evidence that the exterior of the 0.35m wide chalk foundation had been set in a foundation trench, but traces of a construction trench for the brick wall survived. As the chalk blocks were replaced by bricks at the corner of the building, the chalk may represent the remains of an earlier structure that may have extended slightly further to the north.

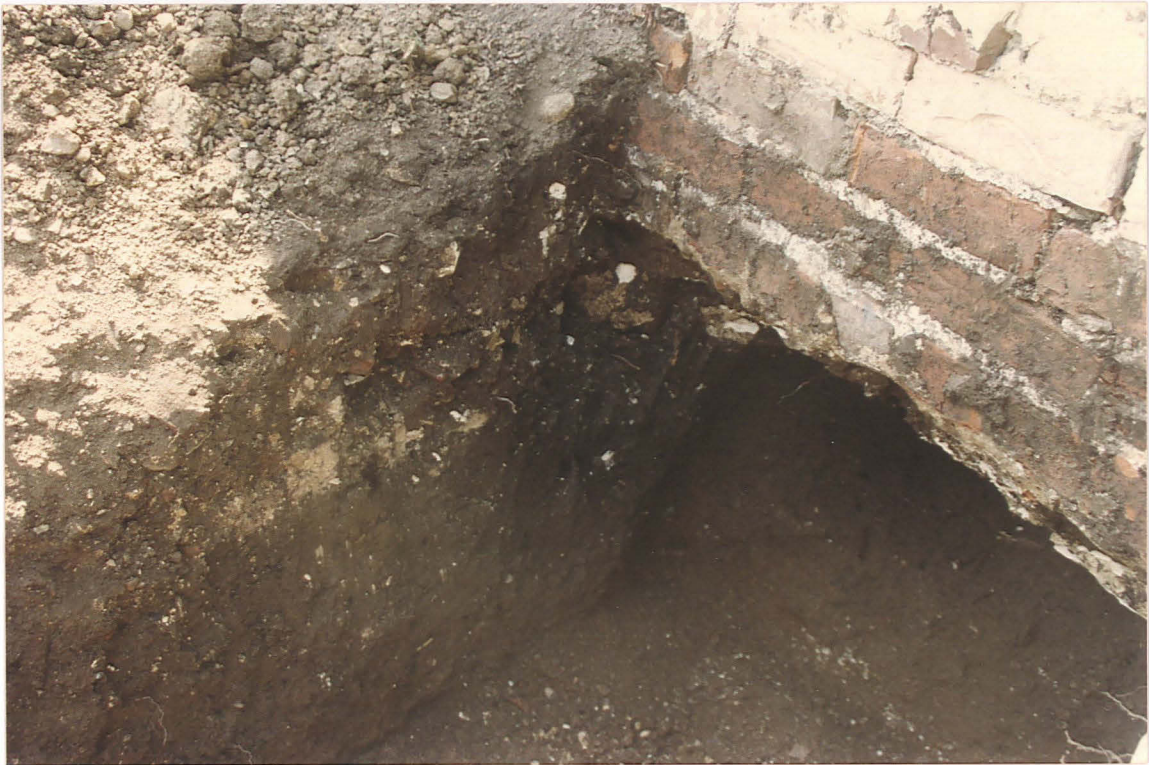
PI. 13 Trench M. The brick foundations of the extension cover vestigial courses of a chalk foundation; the mortar layer alongside the wall is fill of the earlier foundation trench, with clay above it filling the brick foundation trench. The thick brown clay layer is bank material alongside the linear depression. Looking SW.

Alongside Trench M, the wall of the outbuilding was of two distinct phases. The latest phase was entirely above present ground level, and was of bricks, 230mm x 110mm x 70mm, bonded with a cream-coloured mortar. Below this, its upper course protruding slightly above ground level, was an earlier brick wall with white mortar. Three courses were present, with brick dimensions of 225mm x 110mm x 72mm. Two courses of cut chalk survived below the brick courses, with the exposed face considerably eroded (Pl. 13).

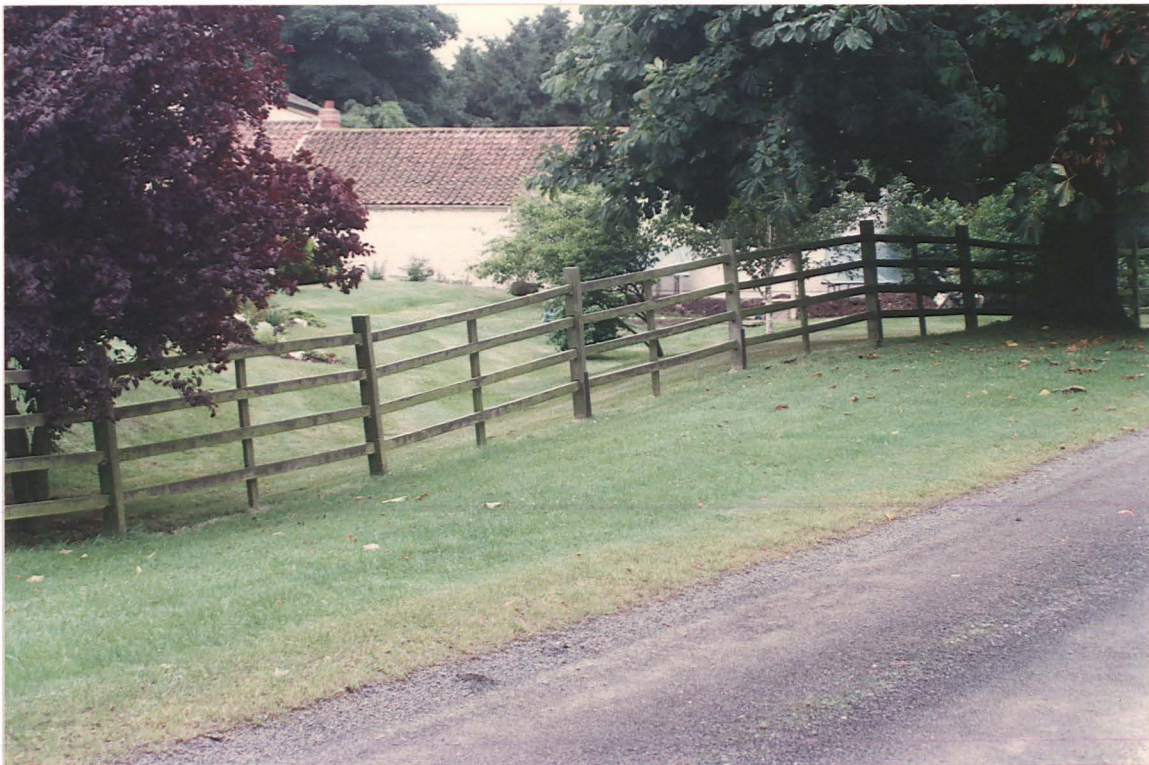
PI. 14 The linear depression is crossed by the drive, but is clearly visible across the eastern lawn (looking west).

An 8-10m wide, NE-SW aligned depression can be seen in the pasture field north of the drive to Wyham House and Wyham Grange. The drive has been constructed across the depression, incompletely filling it and levelling the banks to either side (Pl. 14). To the south of the drive, it can be seen crossing the lawn area east of Wyham Grange, towards the site of the new swimming pool (which replaced a former garden pond).

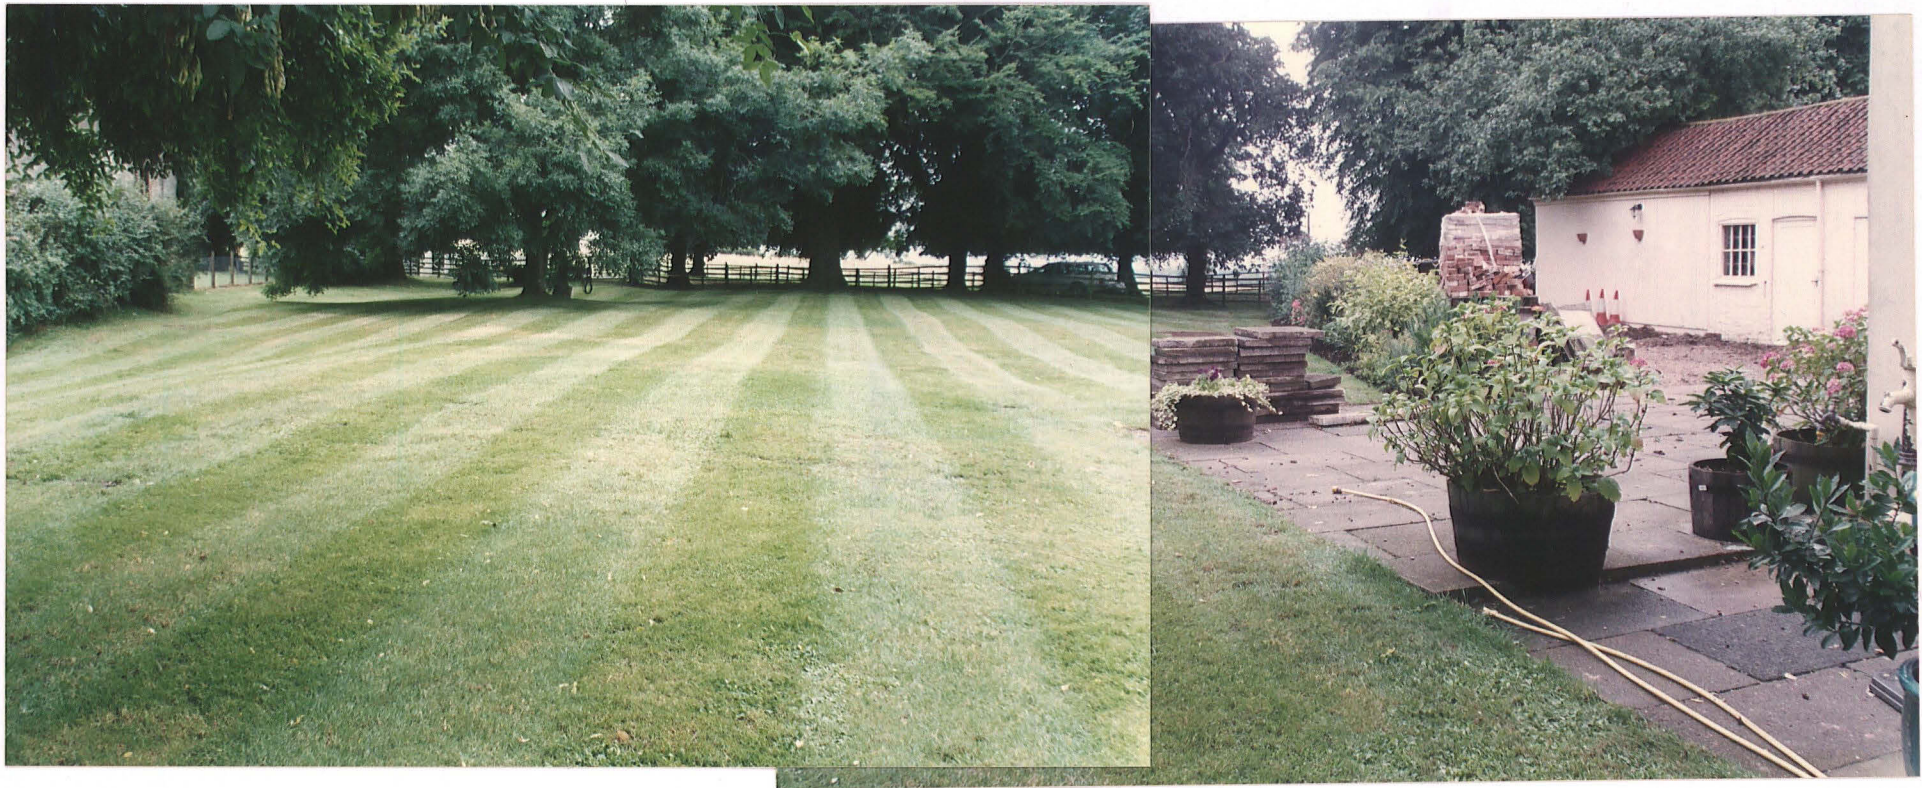
Pl. 15 Slight traces of the linear depression remain visible in the western lawn (looking north).

To the west side of the outbuilding and garage, slight traces of the feature remain in the surface of the lawn, crossing to the western property boundary (Pl. 15). This part of the depression has been virtually levelled, but the adjacent ridge remains. At the west side of the lawn, a north-south aligned broad depression follows the land boundary to the west of Wyham Grange. That feature is deepest SW of

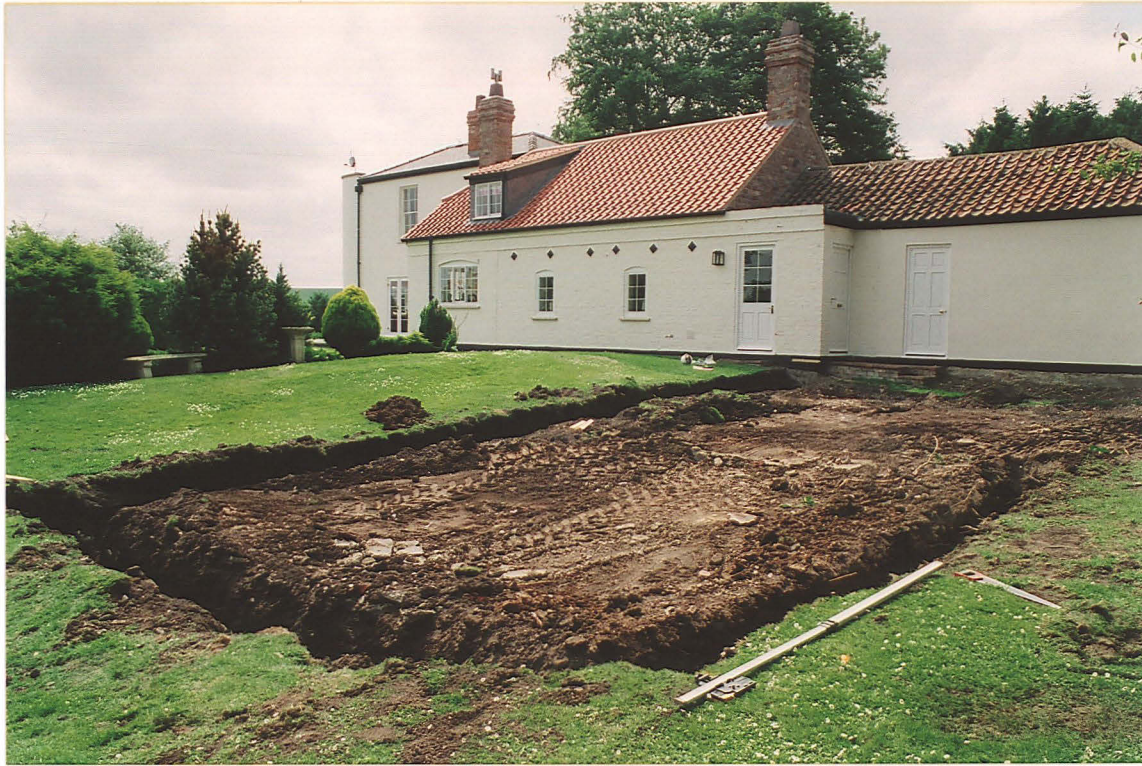
PI. 16 Location of the new pool extension, east of the garage (looking SW). The southern bank of the linear depression survives as a garden feature.

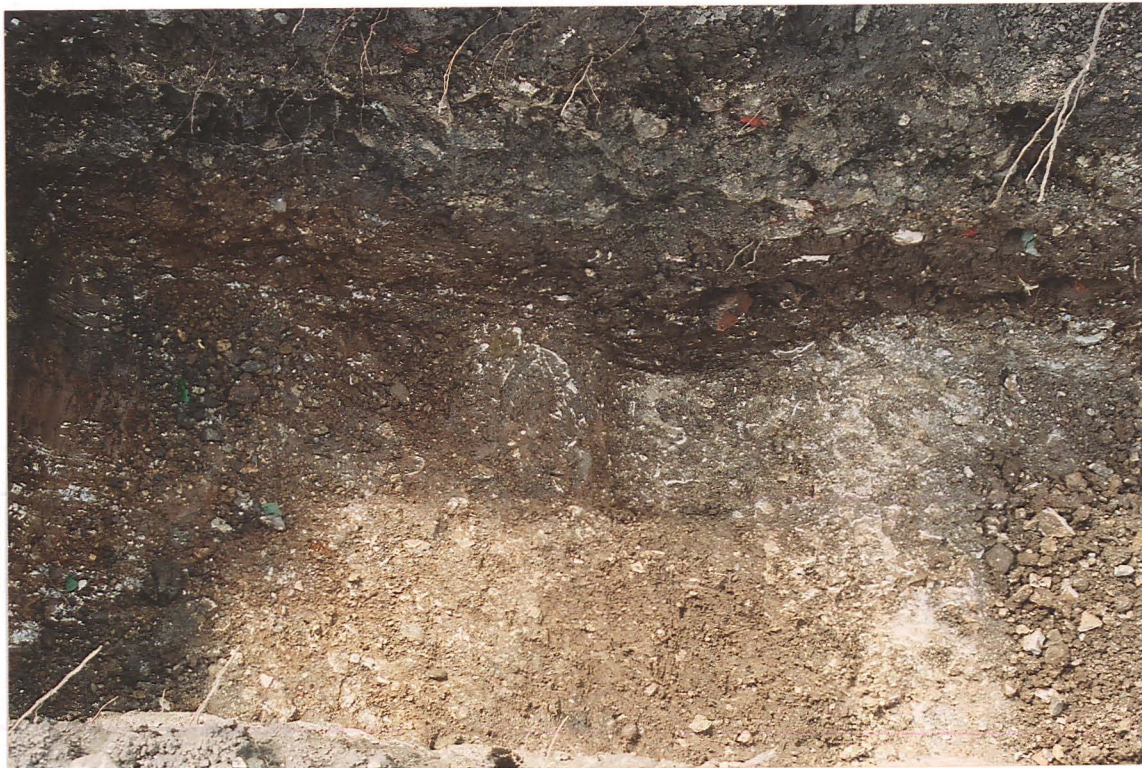
PI. 17 Small segment excavated at the base of ditch 42, in the trial slot across the swimming pool site (looking north). Overlying rubble and soil layers represent attempts to fill the depression.

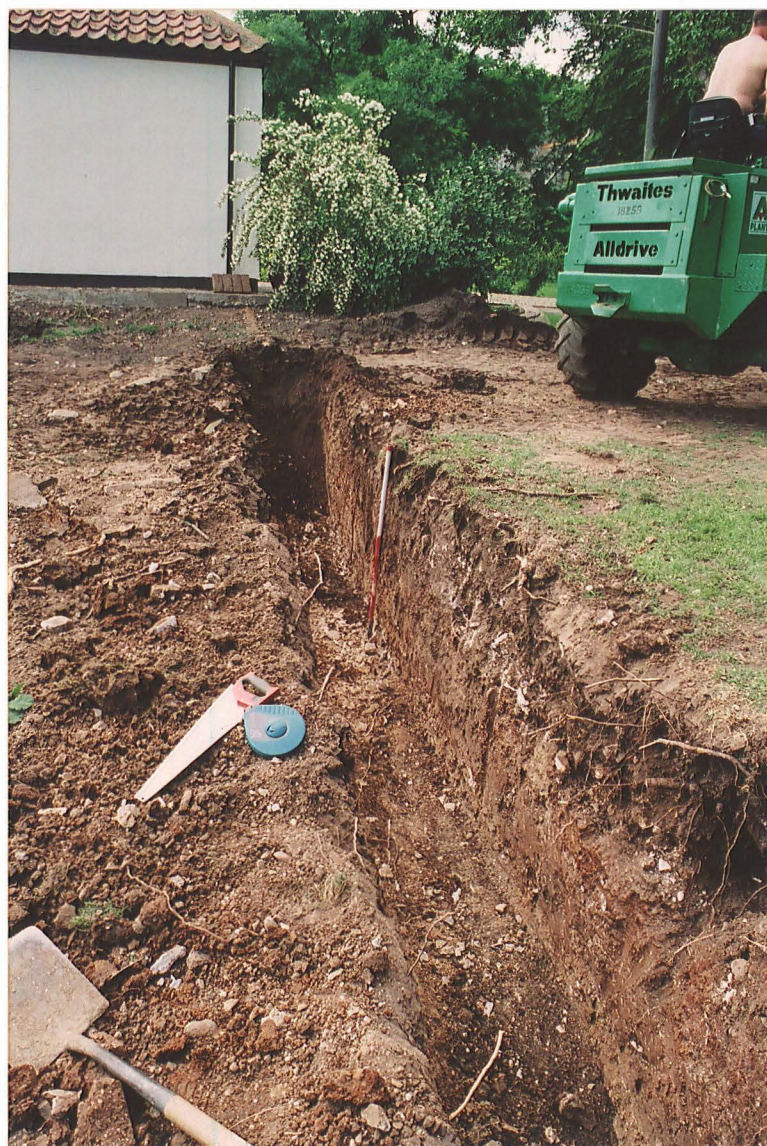
Pl. 18 Northern wall foundation trench for the new swimming pool extension (looking west).

At a later stage in the monitored groundworks, wall foundation trenches were excavated on June 16-17th 2002 around the perimeter of the new swimming pool site, to a depth of 0.7. These encountered 0.55m of dark brown clay loam garden soil, covering red/brown chalky clay, with chalk bedrock at the trench base (Pl. 18). No indications of an archaeological feature were seen in the trench faces at the eastern side of the pool area (Pl. 19). Here the upper fill contained brick and concrete rubble from a former garden pond that had been sited at the edge of the depression; this pond had subsequently been used as a children's sand pit. Sixteenth and eighteenth century pottery was found in the spoil 32 from this trench.

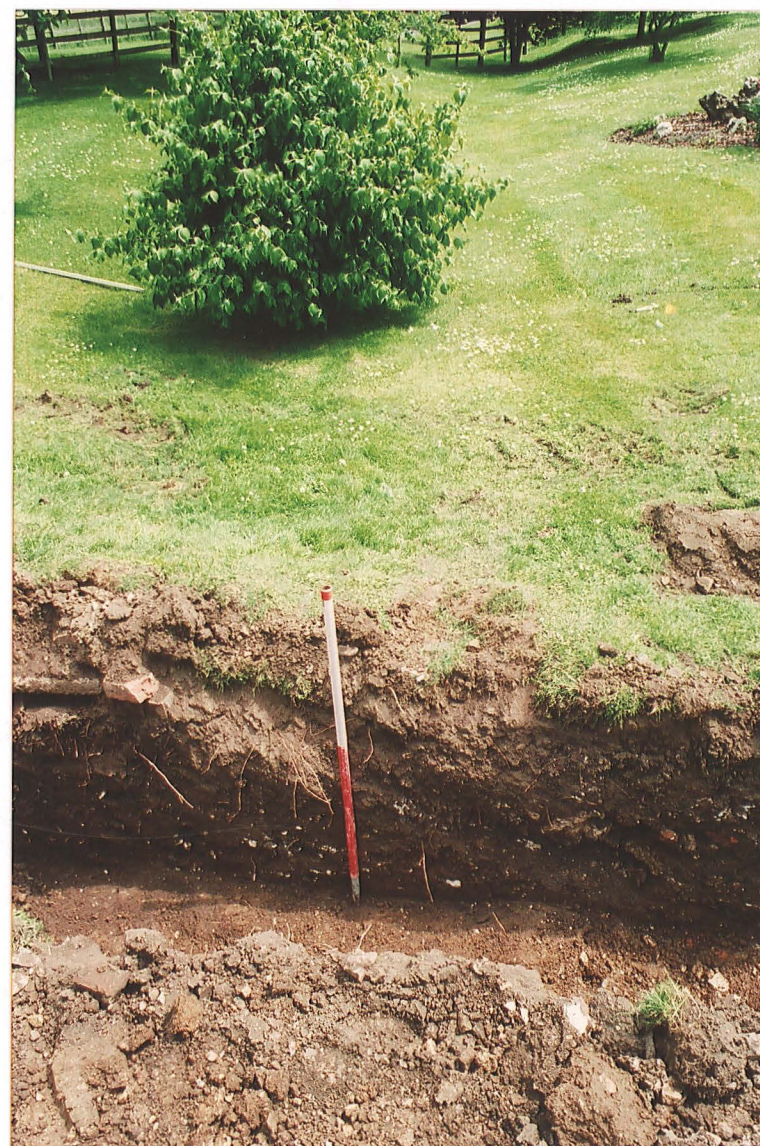
Pl. 19 Tip-lines of fill of the linear depression, showing in the northern wall foundation trench of the swimming pool extension. Looking NE towards the drive.

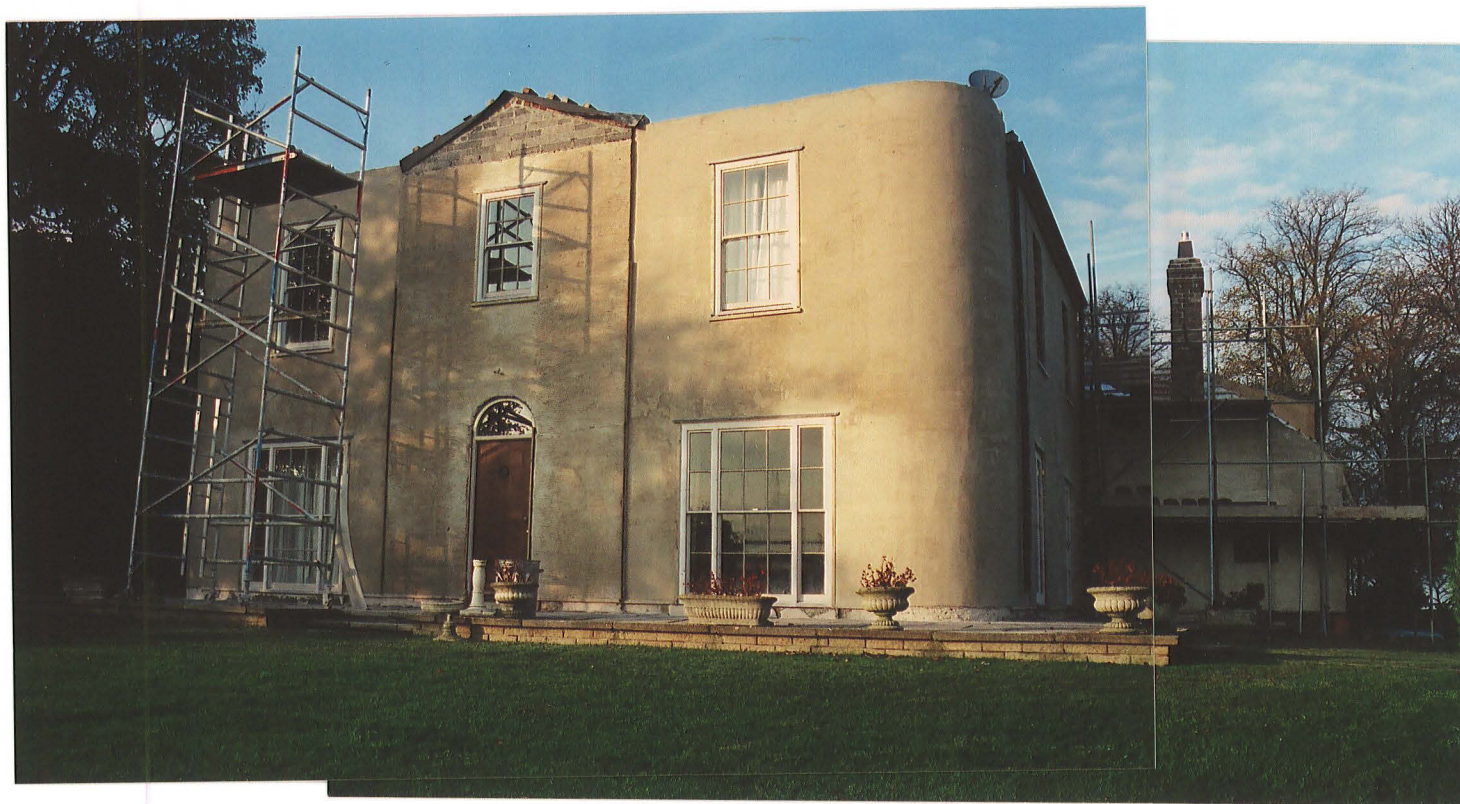
Pl. 20 South and east elevations of Wyham Grange, after recent works. Looking NW.

During the first monitoring visits in August 2001, render had been partially removed from the external western wall of the house. Beneath the render, a variety of phases of brick blockings of earlier windows and doors were seen, some of which Mr Woods described as works by the previous owner. One intention of the renovations was to restore some of the blocked features and to return the appearance of the building closer to its original design.
