Wyham Grange, Wyham-cum-Cadeby, Lincs.

Underpinning, Renovation and Construction of a Swimming Pool Extension

Archaeological Watching Brief

LAS Report No. 642

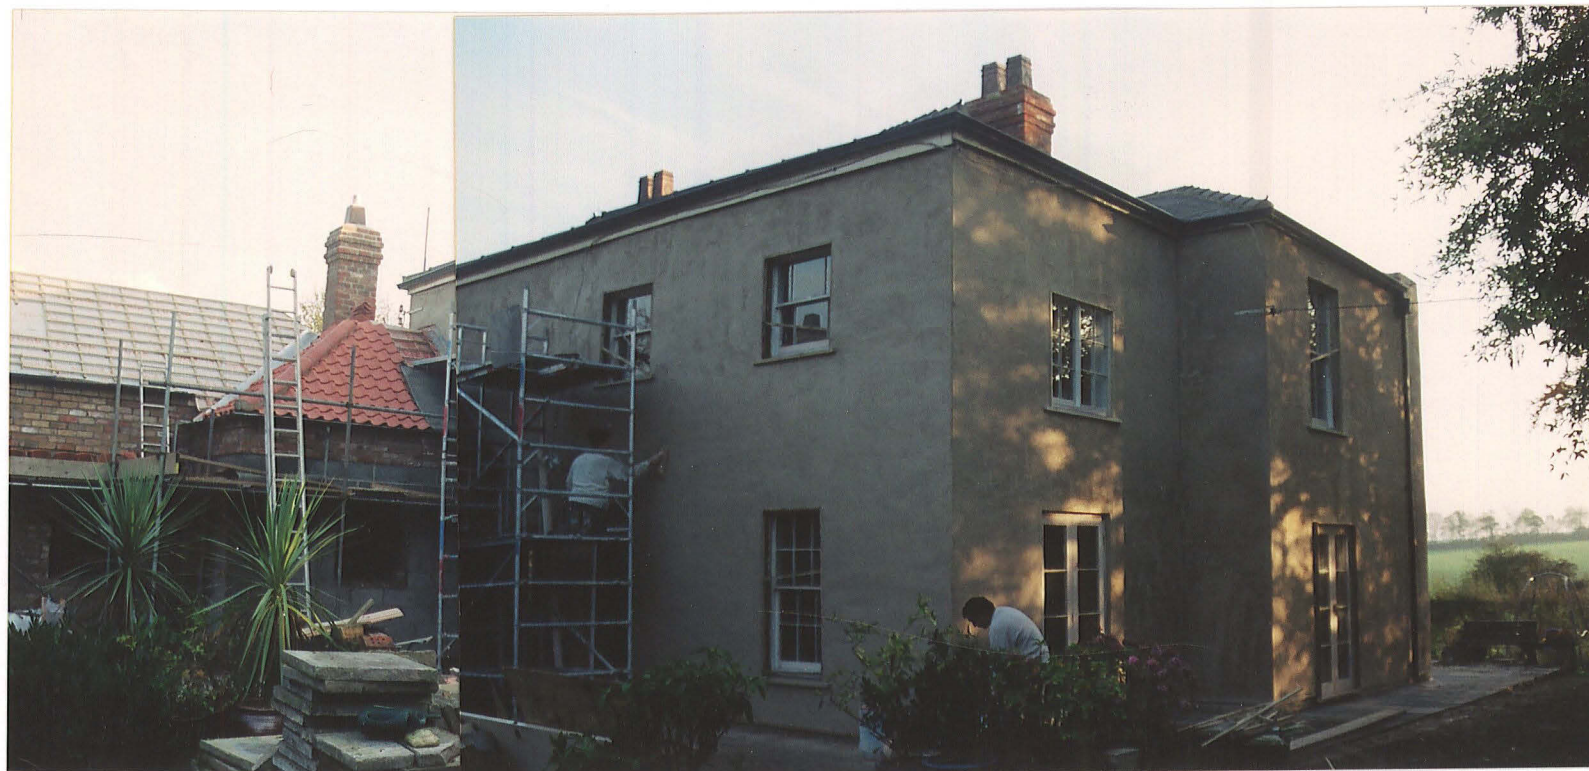
Pl. 21 North and west elevations of Wyham Grange, after renovations. Looking SE.

During the first monitoring visits in August 2001, render had been partially removed from the external western wall of the house. Beneath the render, a variety of phases of brick blockings of earlier windows and doors were seen, some of which Mr Woods described as works by the previous owner. One intention of the renovations was to restore some of the blocked features and to return the appearance of the building closer to its original design.
