**ARCHAEOLOGICAL WATCHING BRIEF
DURING RENOVATION WORK AT**

**THE OLD HALL, SUDBROOK OLD
SUDBROOK,
ANCASTER,
LINCOLNSHIRE
(SHAN 00)**

Work Undertaken For
Mr. S. Campbell

A.P.S. Report No. 18/01

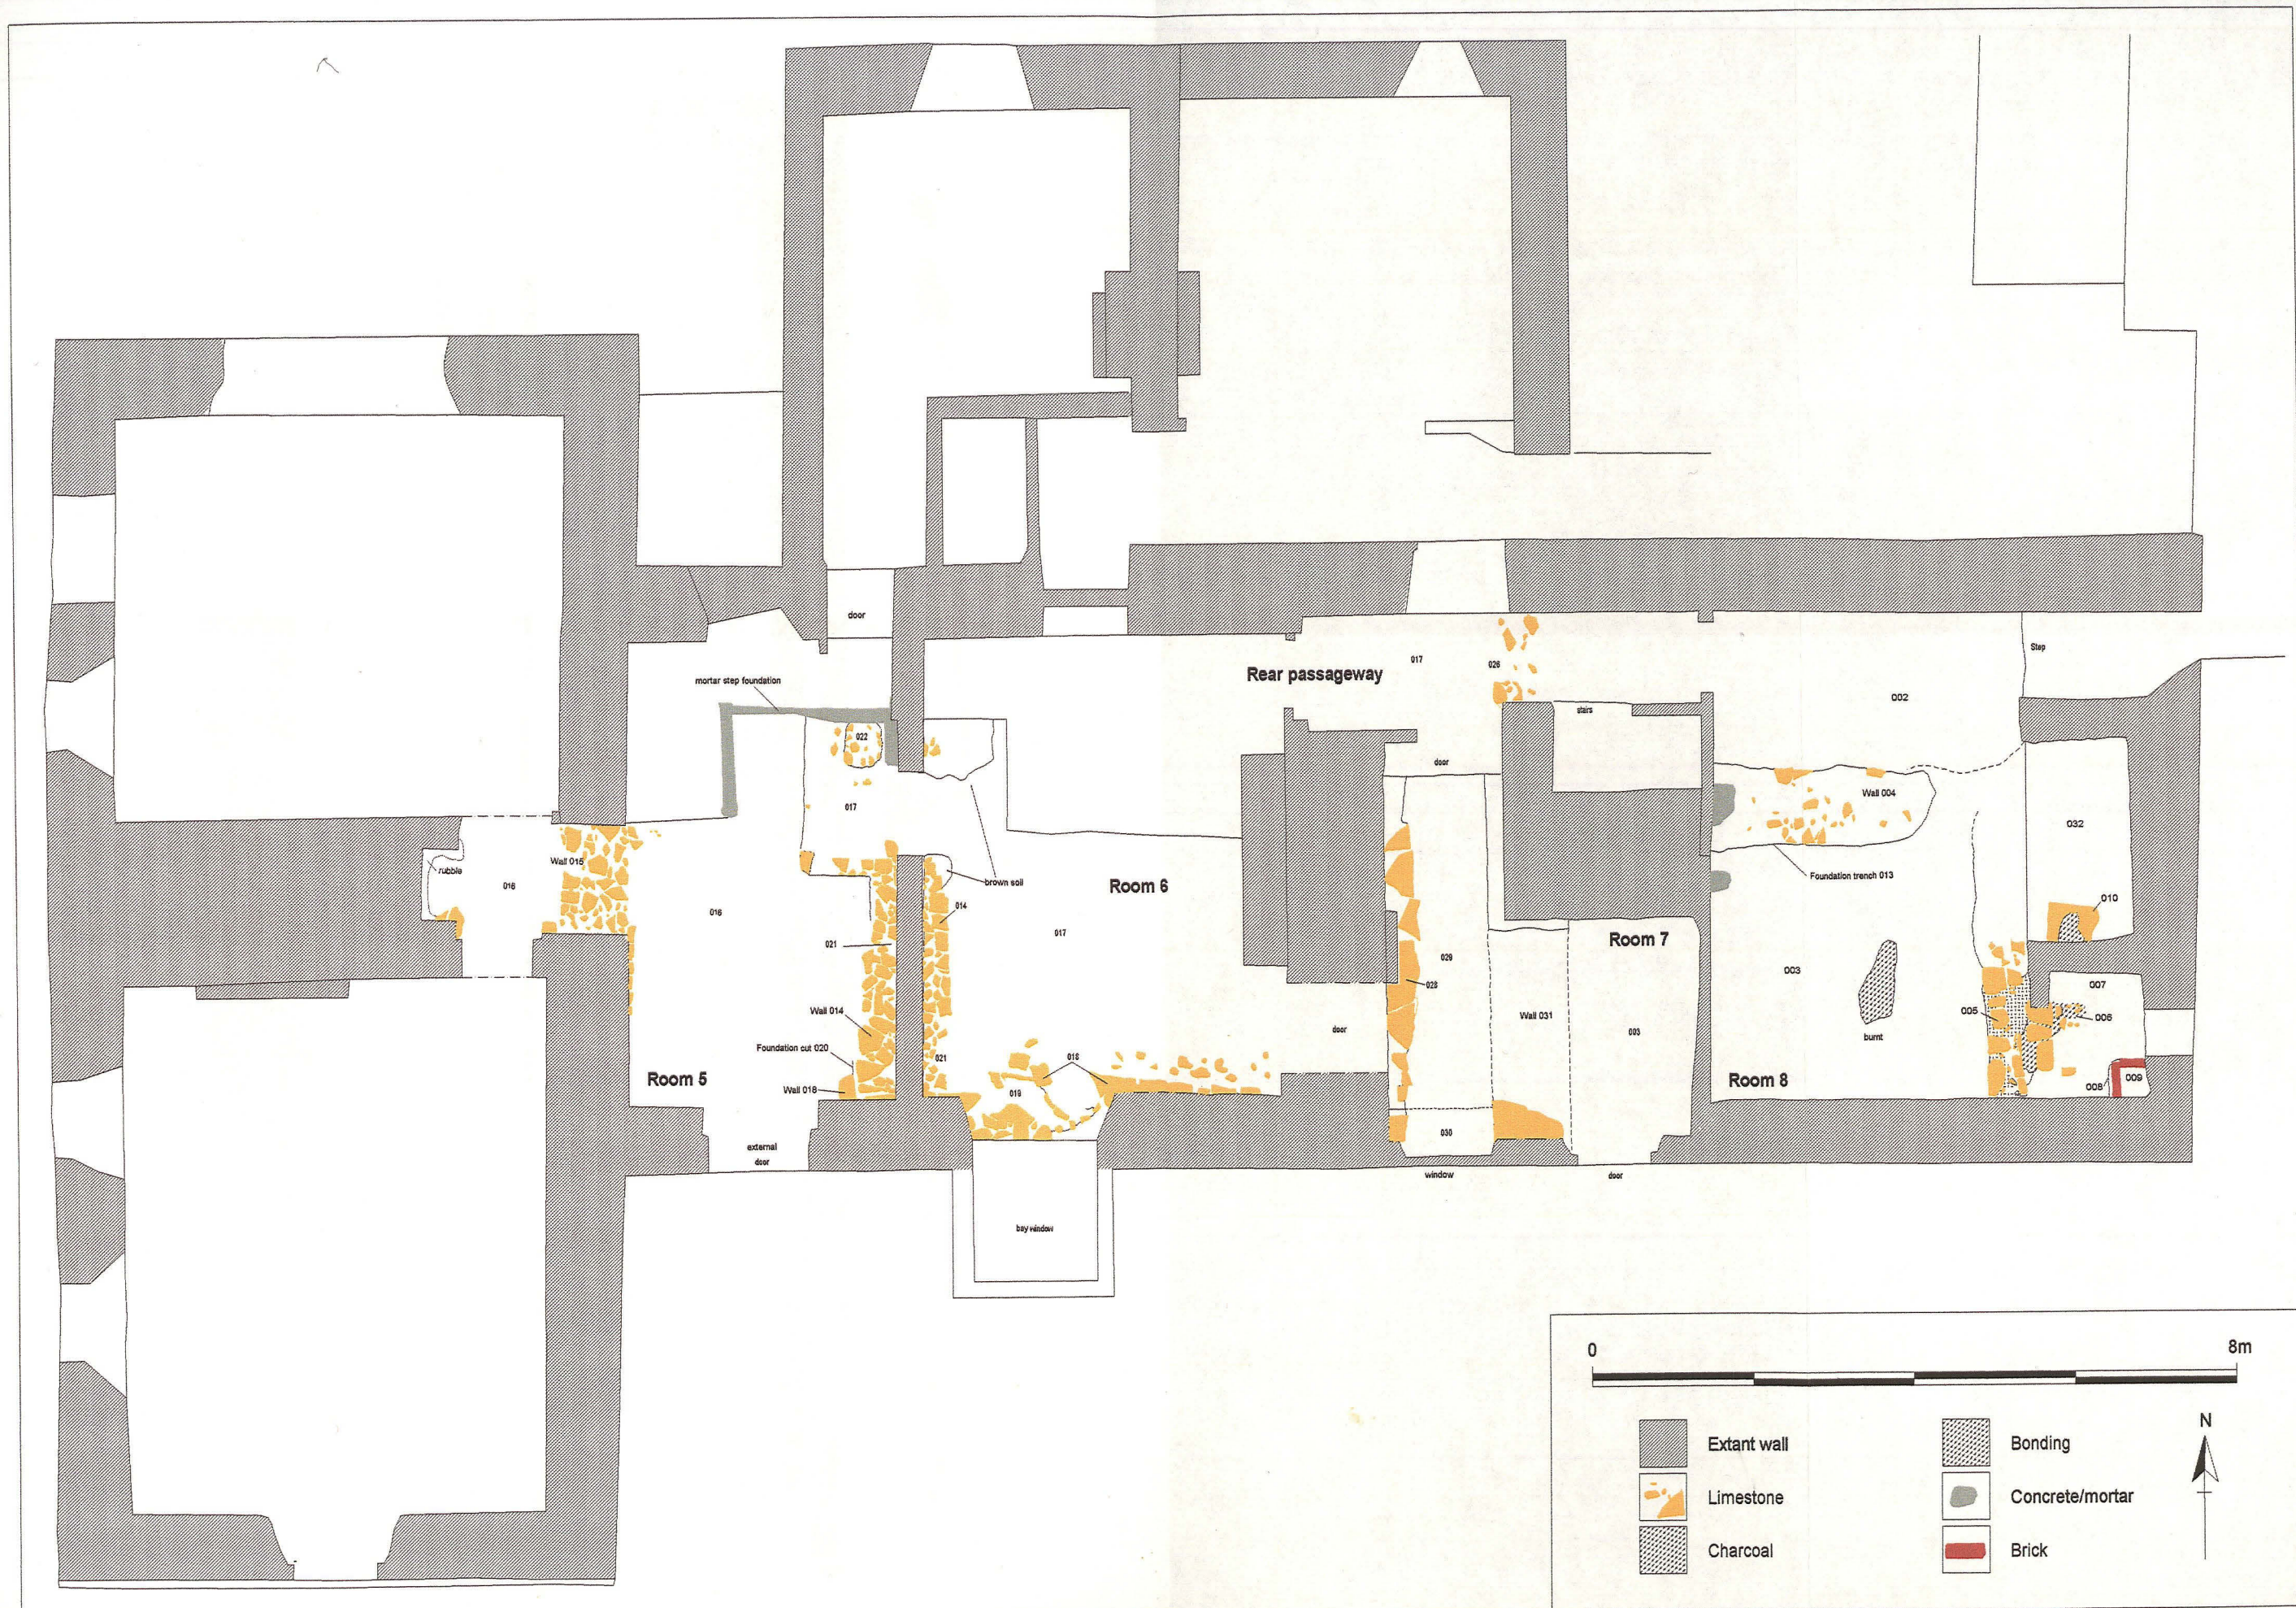
Figure 3 - Plan showing exposed archaeological and architectural features

Figure 3 Plan showing exposed archaeological and architectural features

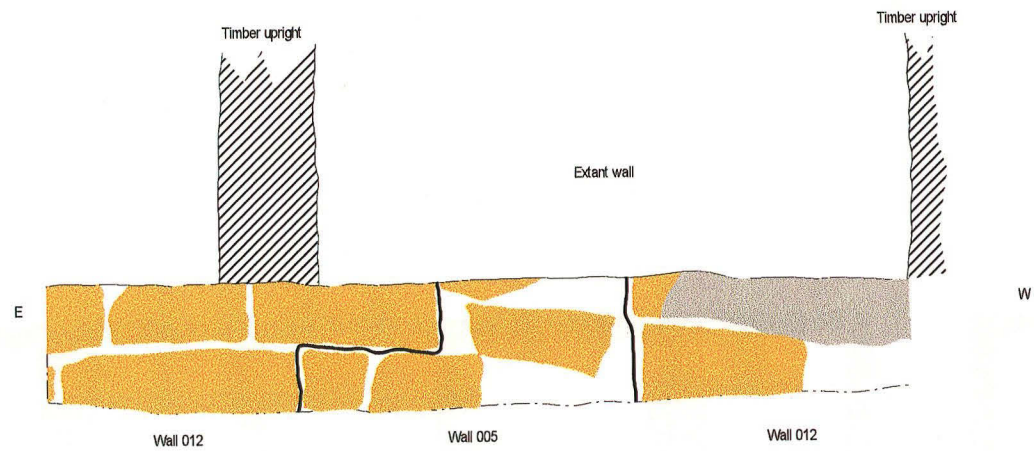
Section 1
Elevation showing the relationships between Walls 005 and 012.

The eastern extent of the floor surfaces was defined by a north-south aligned limestone wall with earth bonding (005). This was 1m wide and 3m long and formed a support to the southwest corner of the fireplace. The relationship between walls (004) and (005) was not clear.

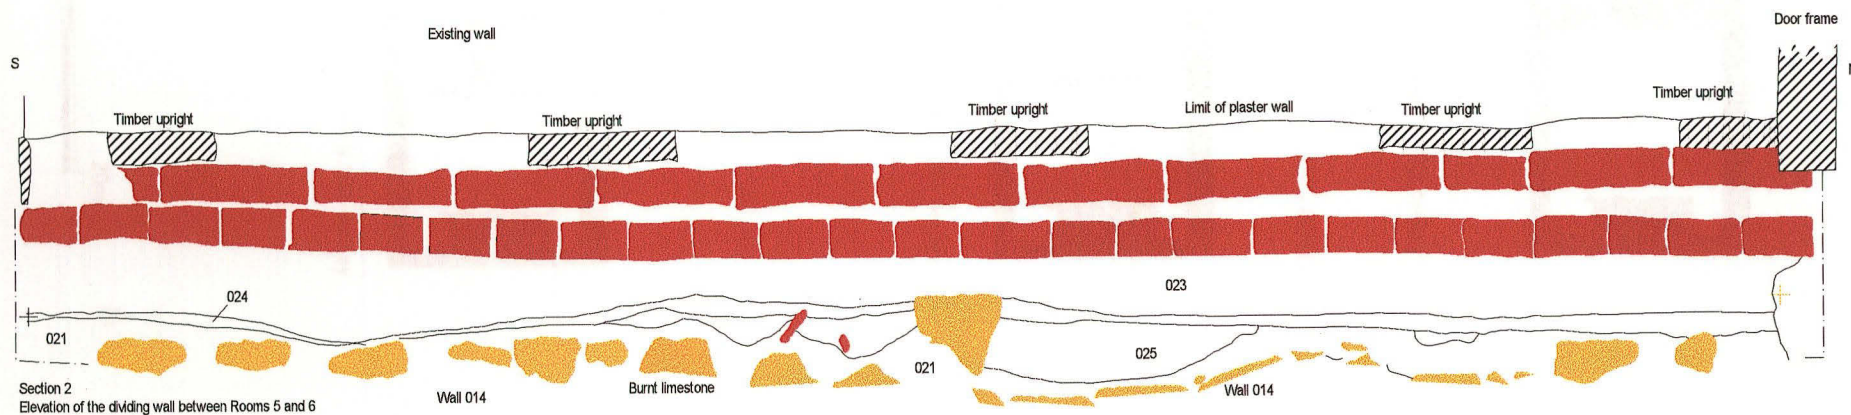
Section 2
Elevation of the dividing wall between Rooms 5 and 6

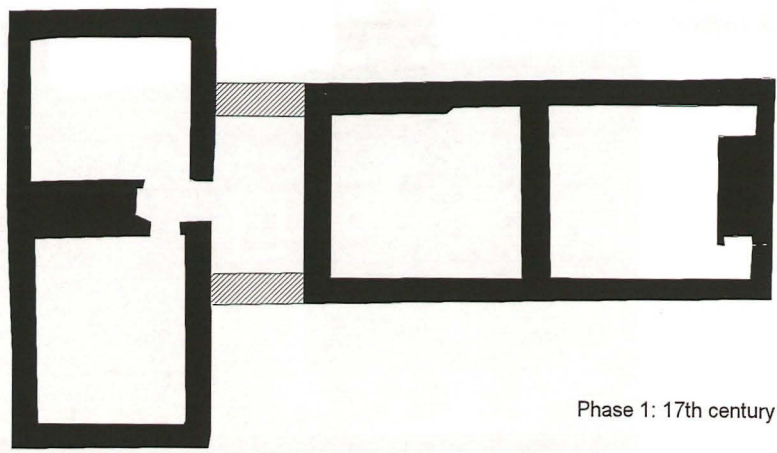
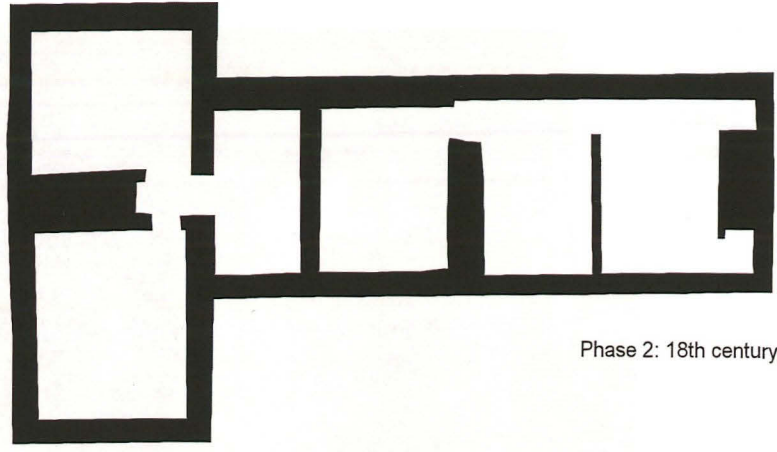
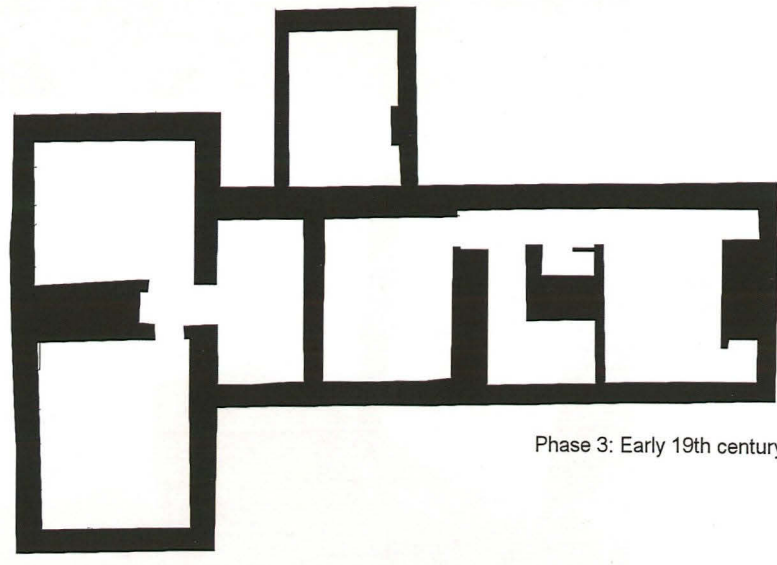
Figure 5 - Possible layouts of Sudbrook Hall, Phases 1 to 3

Phase 1: 17th century

Phase 2: 18th century

Phase 3: Early 19th century

The original structure of the early 17th century (Phase 1) is represented by extant walls in Rooms 2 and 3 and the east wall and fireplace of Room 8 (Lott 2000). An east-west aligned spine beam crossing Room 8 was recorded as finishing in the western extent of the back staircase which probably indicates this eastern room extended as far as the robbed walls (026) and (031). A further room might be indicated between the robbed wall and the foundation course (014) identified beneath the wall dividing Rooms 1 and 5. Room 1 is approximately 3.5m wide which may be too wide for a cross passage and it is possible that Sudbrook Hall originally comprised two structures (Fig. 5).

facade and the north rear wall of the building. Internally, Rooms 5 and 7 have been created by the removal of the north south wall which would then indicate that the floor surfaces (003) belong to the Phase 1 building and also support the possibility of wall (014) being earlier than the main structure. It is possible that the west wall of Room 5 was dismantled during this period. The widespread construction/demolition deposit (017) was possibly formed at this time, as indicated by the date of the artefacts retrieved from this layer.

The rear cellars were added in the 19th century (Phase 3). The dividing wall between Rooms 1 and 5 was reinstated, using as a foundation the original limestone wall but including an additional brick foundation upon which timber uprights were set to form the current wall. Possibly also added was the staircase off the rear passageway, although the relationship of this to excavated remains is unclear.

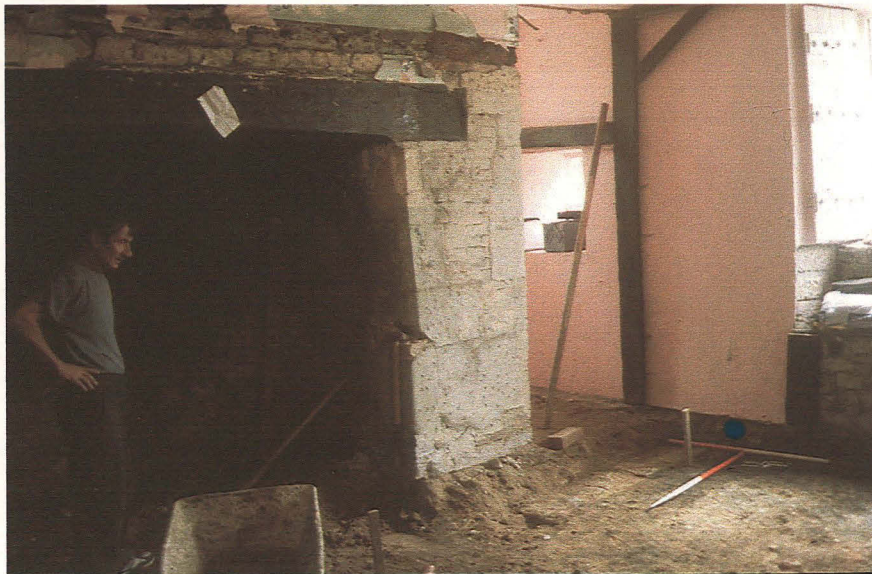
Plate 2 - Exposed fireplace in
Room 8, looking southeast

Within the fireplace, removal of the present concrete floor exposed a displaced burnt limestone slab (010) overlying a deposit of greyish brown silty sand with charcoal and limestone (032).

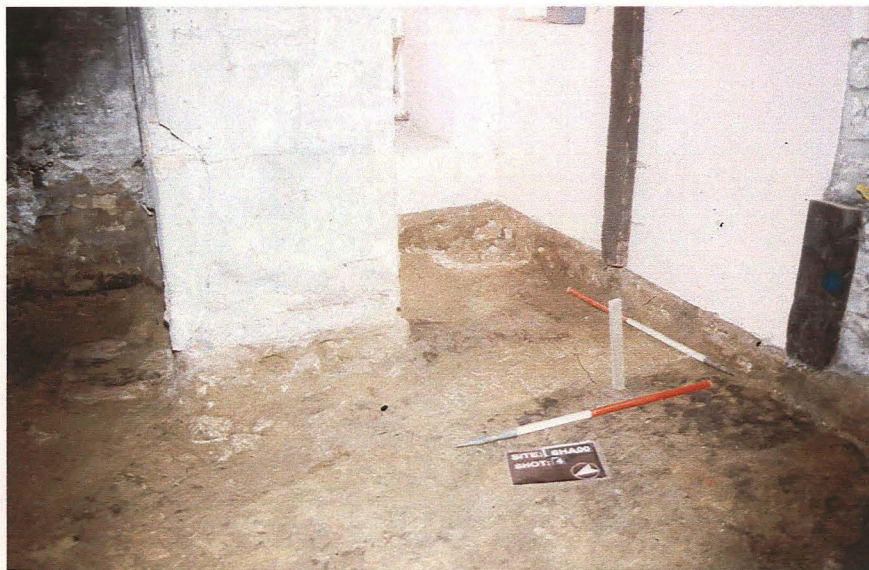
Plate 3 - Wall (005) exposed in
southeast corner of Room 8,
looking southeast

alcove set within the area south of the fireplace. This was defined by the north-south wall (005) to the west and extant walls to the south, east and north. A deposit of greyish brown silty sand with charcoal and small limestone fragments (007) was exposed. This deposit was cut by a near square feature (008) which contained a brick lined drain (009) in the southeast corner.

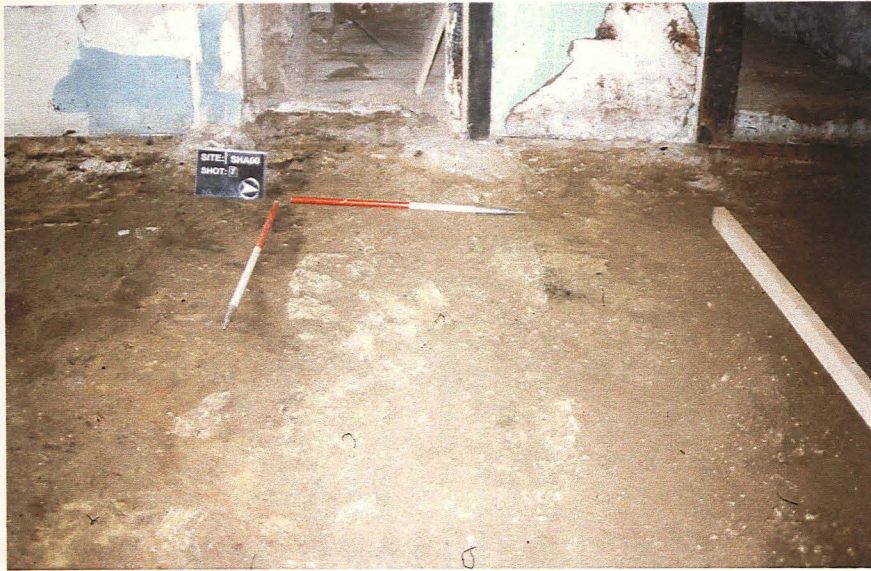
Plate 4 - Wall (004) as exposed, looking west

The truncated floor surfaces (003) extended beneath the dividing wall between Rooms 7 and 8. Their northern extent was limited by a short (2.5m) length of random coursed limestone wall (004). North of this wall a short length of the foundation cut (013) was visible cut into a dark greyish brown silty sand (002) possibly a former external ground surface.

Within this earlier phase, there is one anomaly, this being the short length of wall located in the centre of Room 8. Its position, adjacent to a deposit that is believed to represent a former ground surface, may indicate the presence of an earlier structure. Its alignment with the centre of the fireplace is also suspect if it is considered to be contemporary.

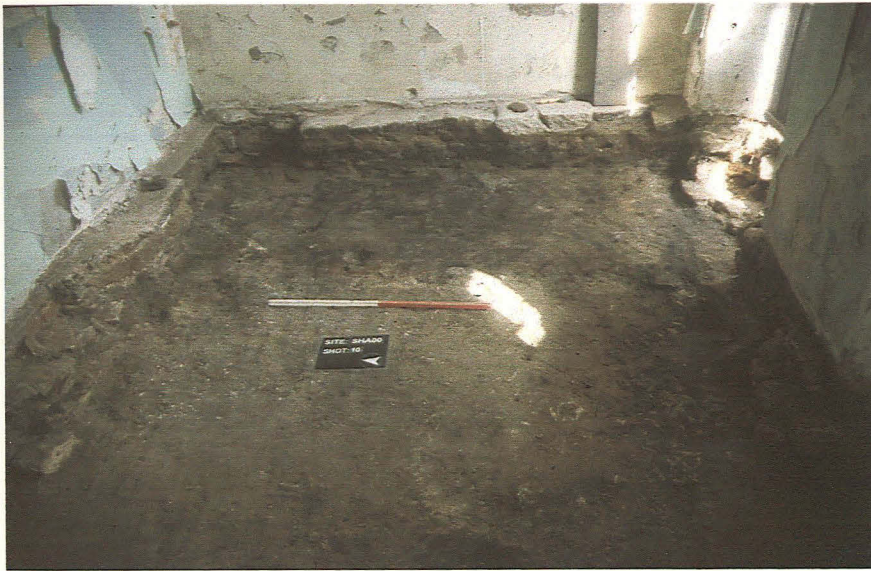
Plate 5 - Room 7 showing the truncated floors (003), looking east

Following the removal of the present floor, layers of black charcoal, white mortar and dark yellow sand (003) were exposed and partially removed. These were identified as truncated and damaged floor surfaces. Following their removal, the foundation course for the wall between Rooms 5 and 7 was exposed (028) this was 2m wide and comprised random coursed limestone with earth bonding.

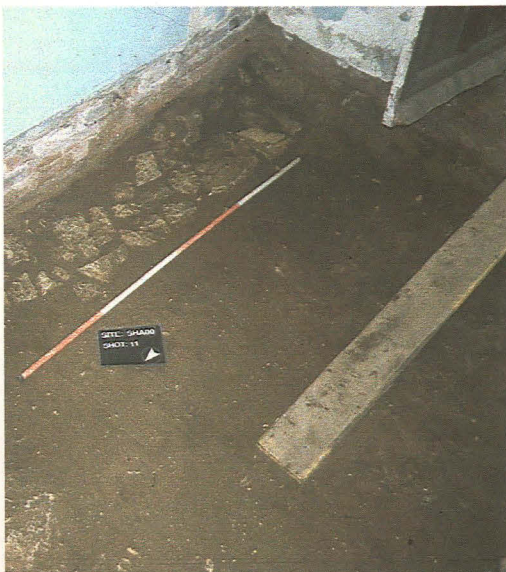
Plate 6 - Phase 1 foundation wall (014), looking southeast

Removal of the construction/demolition deposit (017) exposed the foundation wall to the north-south wall that divided Rooms 1 and 5. Both faces of this regular coursed limestone wall were exposed (014) and were visible for a length of 3m (Fig. 4, Elevation 2). This wall was bonded together with a mid brown silty sand (021) from which probably residual 13th - 14th century pottery was retrieved. In the top of this portion of wall was a red sandy silt deposit with charcoal (025), possibly indicating the position of a fire. This was subsequently overlain by dark greyish brown silt (024) and light yellowish brown sand with limestone (023) which contained a single clay pipe fragment of 17th century date. These deposits provided a foundation deposit for a subsequent brick wall upon which timber upright posts had been set for the extant wall between Rooms 1 and 5.

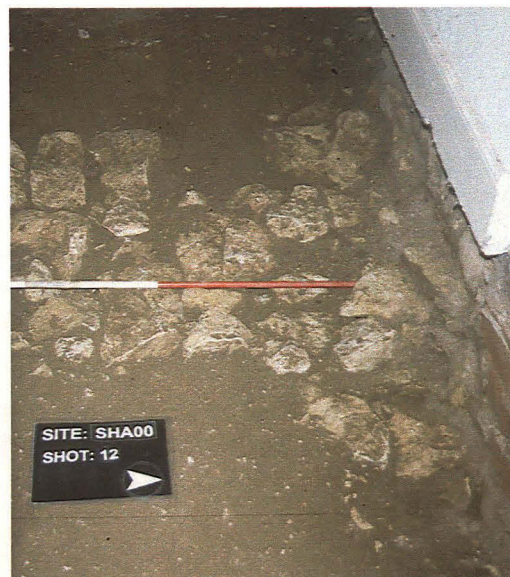
Plate 7 - Wall (015), Phase 1 wall of western range

Beneath this was a portion of limestone wall (015) located across the doorway into the west wing of the building, and therefore a continuation of the extant north-south wall. This wall comprised roughly hewn limestone blocks within an earth matrix and measured 0.8m wide. The dumped deposit (016) continued downwards on either side of this wall and extended into Room 1.
