ARCHAEOLOGICAL WATCHING BRIEF REPORT; MANOR FARM, SCAMPTON LINCOLNSHIRE

SK
NGR: ~~TF~~ 9523 7918
SITE CODE: MFSC02
LCNCC ACC. NO: 2002.481

Report prepared for
Elm Construction
by Chris Clay
June 2003

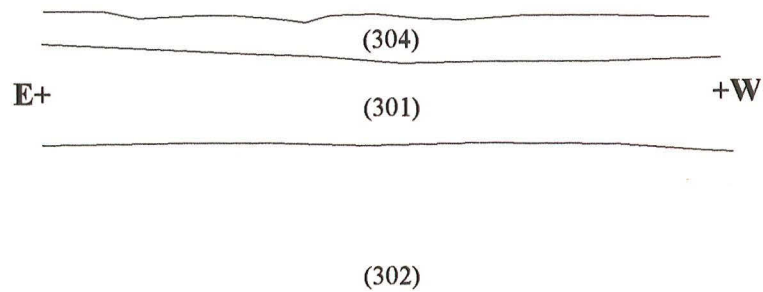
At the very west edge of the plot, a thin layer of topsoil, (300) was exposed, visible only in the east facing section. This had been stripped from the remainder of the plot. The uppermost deposit across the rest of the plot was a dark greyish brown sandy loam, (304), which contained large amounts of rounded limestone pebbles, and may represent the remains of a yard surface. The underlying deposit was a 0.3m deep orange brown clay/sand, representing a colluvium, (301). Beneath this was (302), a compact orange/grey clay, extending to the base of excavation. A 0.3m deep layer of granite chippings, (303), ran south-west to north-east across the plot, indicating a former access road.

Fig. 3: Plot 3 sample section (scale 1:20)

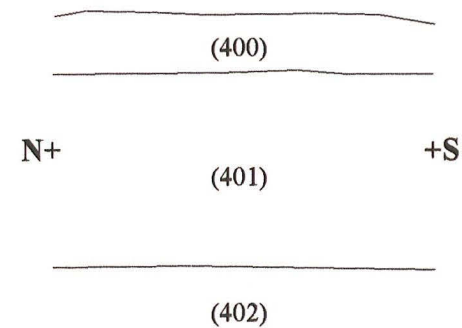
A topsoil deposit, (400), survived to a depth of 0.2m. Over much of this house plot, the topsoil sealed a dark greyish brown sandy loam, containing large quantities of modern building rubble. This deposit extended to the limit of excavation and evidenced considerable recent ground disturbance.

At the south and east extremities of the plot, the topsoil sealed a 0.5m deep layer of yellow/brown slightly clayey sand, (401), probably representing a colluvial deposit; washed down from the adjacent scarp. Beneath (401) was a brownish grey compact clay, 0.3m deep, (402), that extended to the base of excavation, and appeared to represent a natural accumulation.

Fig. 4: Plot 4 sample section (scale 1:20)

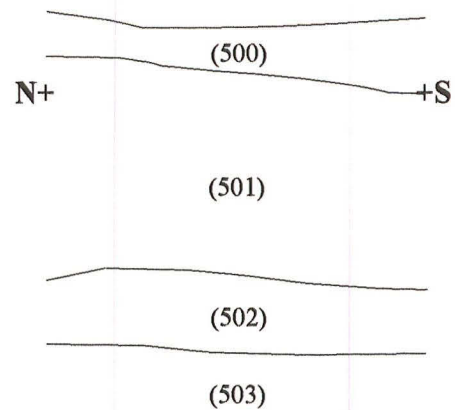
The uppermost deposit was a brownish grey topsoil, (500), incorporating modern building rubble. This had been partially stripped prior to the monitoring of the groundworks and survived to a depth of 0.2m. It sealed an orange brown sandy clay, (501), that was up to 0.7m deep, and represented the same colluvial subsoil deposit observed in Plots 3 and 4. Appearing intermittently throughout the foundation trenches was a grey brown clay, (502), representing a natural deposit. This sealed a further natural accumulation of yellowish brown sandy clay, (503), which extended beyond the base of excavation.

Fig. 5: Plot 5 sample section (scale 1:20)

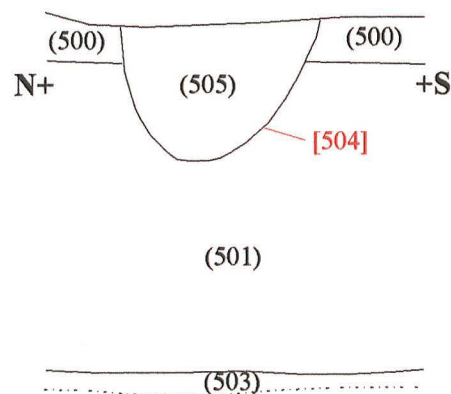
A single small pit-like feature, [504] was observed extending across two foundation trenches towards the centre of the plot. This had been cut through the topsoil, (500), suggesting a recent origin. Its fill, (505) was a dark grey sandy loam, very similar to the topsoil. It contained the disarticulated remains of an adult sheep, suggesting the disposal of an aged or diseased animal associated with Manor Farm.

Fig. 6: Pit [504], Plot 5 (scale 1:20)

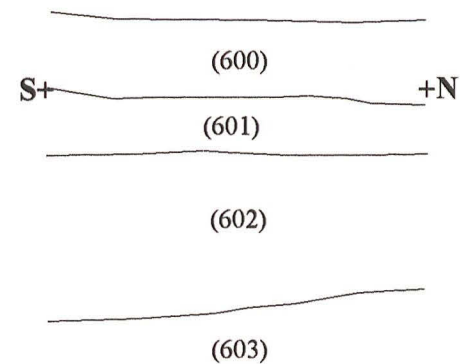
A topsoil deposit, (600), survived to 0.25m, having been partially truncated prior to excavation of the foundation trenches. This sealed three possible colluvial subsoil layers, (601), (602), (603). These consisted of: a grey/brown sandy clay 0.2m deep, an orange brown sandy clay 0.45m deep, and a slightly sandier orange/brown sandy clay, that was 0.2m deep. Beneath these deposits was a natural yellowish brown clay/sand, (604), with occasional lenses of grey sand. This deposit was only exposed on the south side of the plot.

Fig. 7: Plot 6 sample section (scale 1:20)

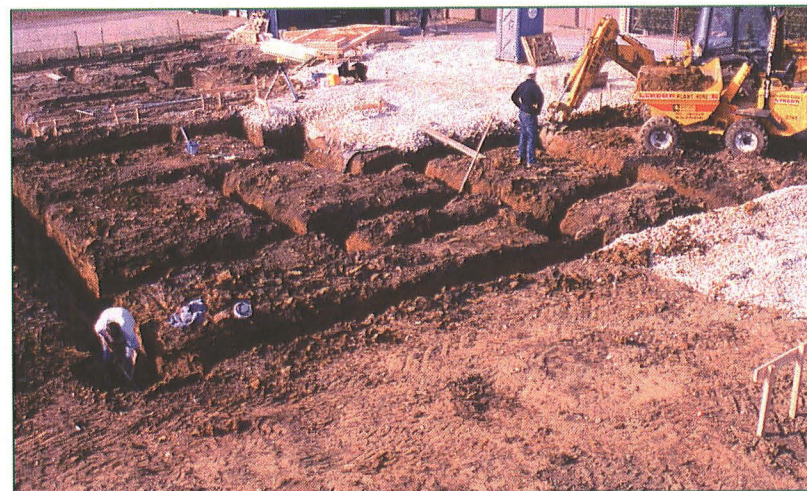
Pl. 2: Working shot, during excavation of Plot 5. Plot 6 is visible in the background. Looking north-west

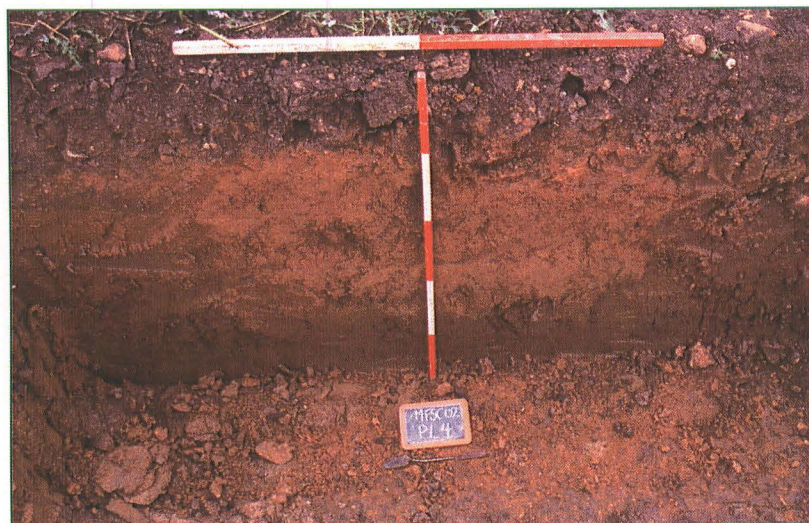
Pl. 3: Plot 4 representative section, looking east

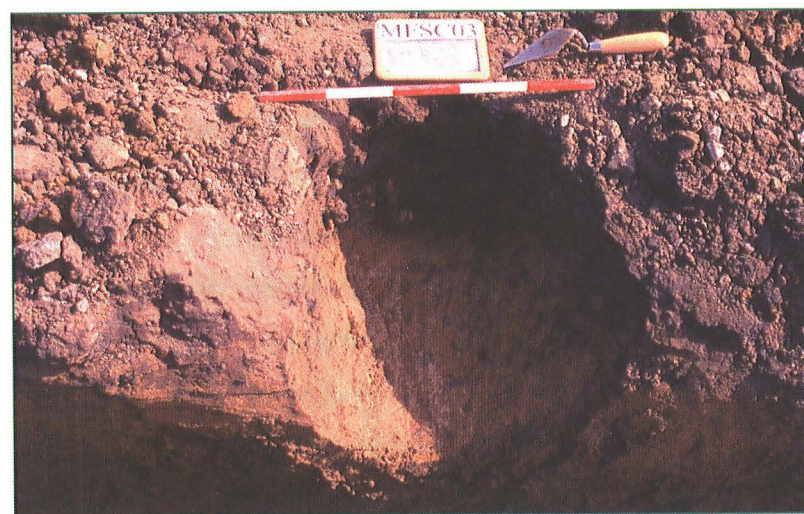
Pl. 4: Pit [504], modern sheep burial, Plot 5, Looking east
