**LEVEL I
BUILDING SURVEY OF
ROSE FARM COTTAGE
OLD FENDYKE
SUTTON ST JAMES
LINCOLNSHIRE
(SOF03)**

**Work Undertaken For
Mr. G.R. Merchant
on behalf of
Mr and Mrs Campling**

May2003

APS Report No. 98/03

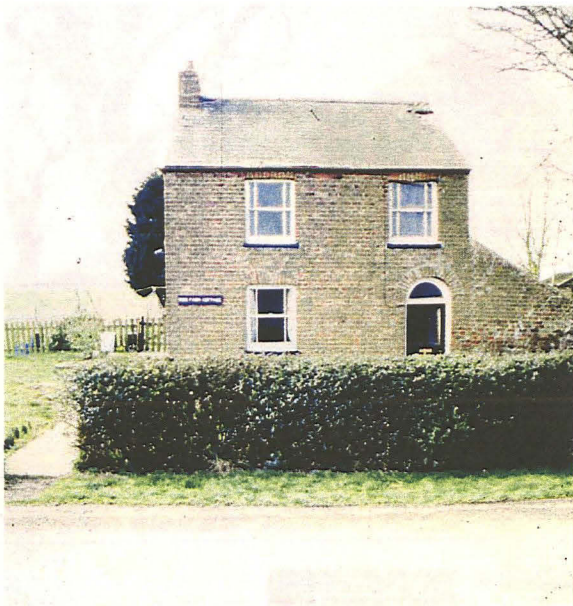
The dwelling is a 2-storey hand made brick-built structure with a slate gabled roof (Plates 1 and 2). The house has two main construction phases, with the later additions of wooden outbuildings and a brick entrance way. The first phase consisting of a square structure. In the northeast elevation of the main house at ground floor level is a wooden framed sash window with stone sill. A wooden door with a single centre arched frame is positioned in the northwestern half of the northeastern elevation. The entry is a four

Plate 1 Northeast facing elevation,
looking southwest

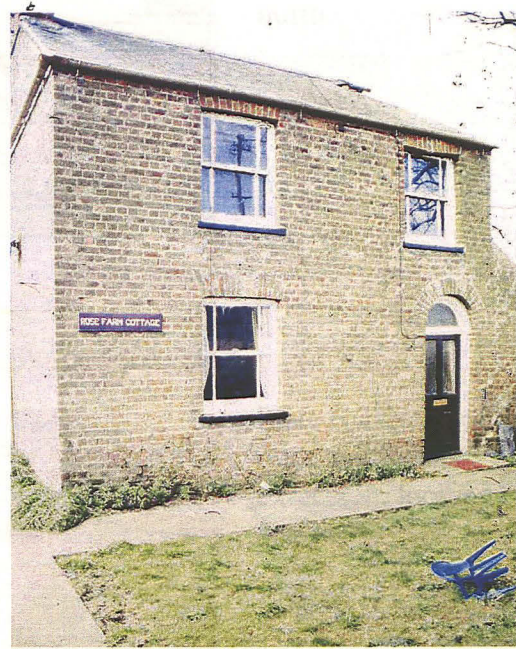
panel door with glass lights in the top half and wooden panels in the lower half. Over the door is a D-shaped fanlight. Directly above the ground floor window and door are two further wooden framed windows with stone sills.

Plate 2 Northeast elevation,
looking west

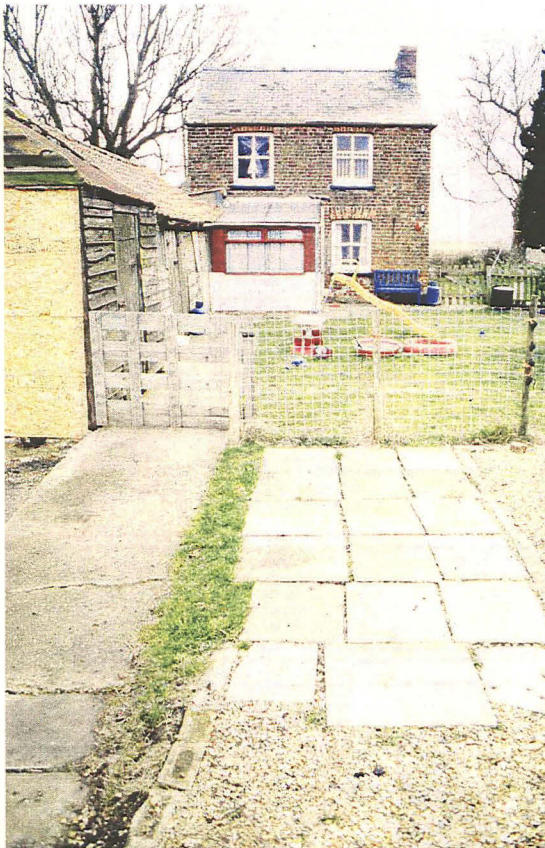
The southwest elevation is almost a mirror image of the northeast elevation, with a brick and timber extension in the form of an entrance way. All the windows in the northeastern and southwestern elevations have near flat arches (they are in fact slightly gauged) of brick.

Plate 3 Southwest elevation,
looking northeast

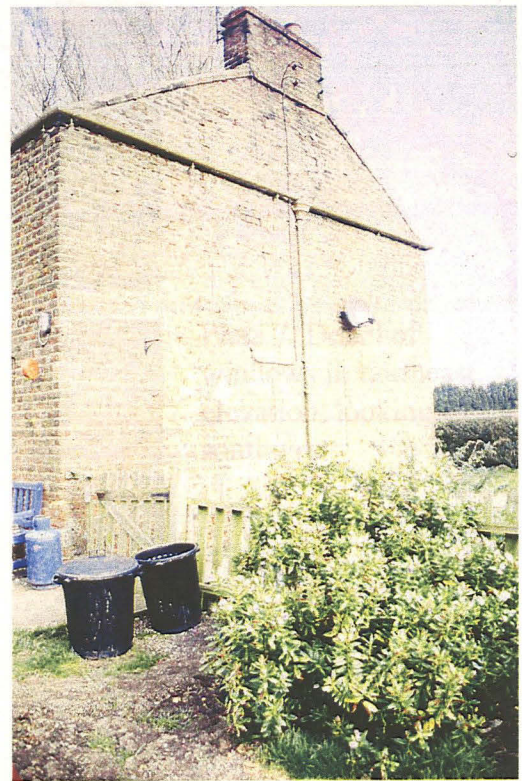
The two flue chimney is positioned in the southeast gable end of the building, which is vacant of any other architectural features.

Plate 4 Southeast elevation with
chimney in gable, looking north

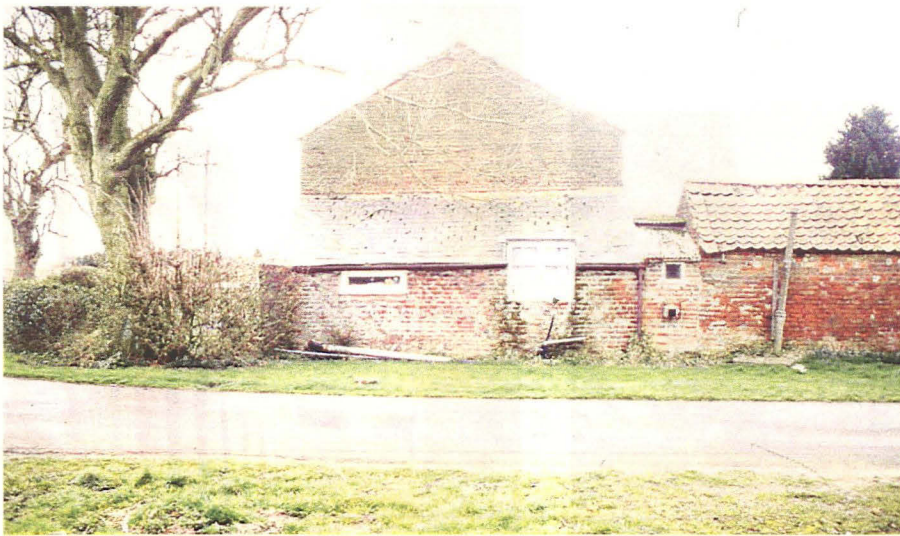
A single floor brick built extension with a single gable pitched roof had been added to the northwest elevation, linking to the main structure with a ragged join. This additional elevation contains a narrow elongated window and a timber framed dormer window.

Plate 5 Northwest elevation, showing extension and additional outbuildings, looking north

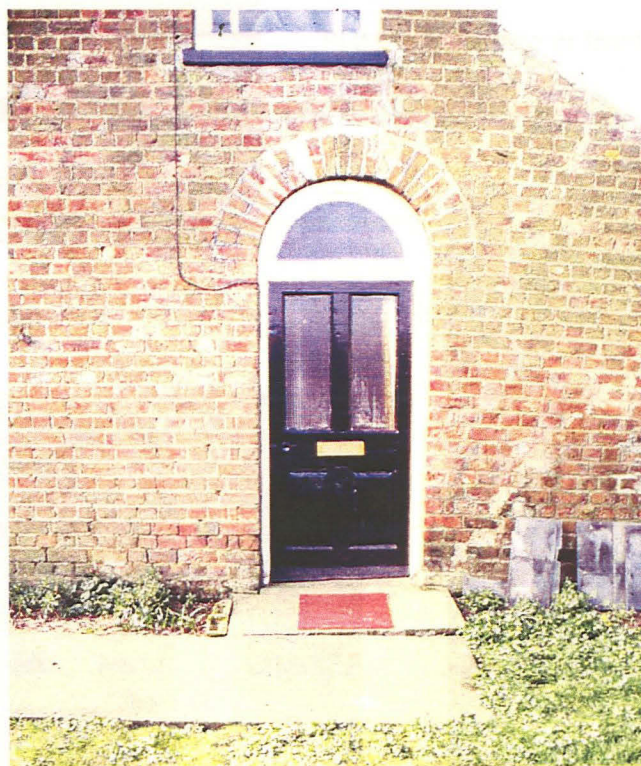
Also, although the door surround appears to be original, the door is probably a later replacement. Four panel doors, as here, were first introduced about 1830 and the letter plate indicates the door is later than the introduction of the penny post (Wedd, 2002)

Plate 6 Details of front door, with lean to extension, looking southeast

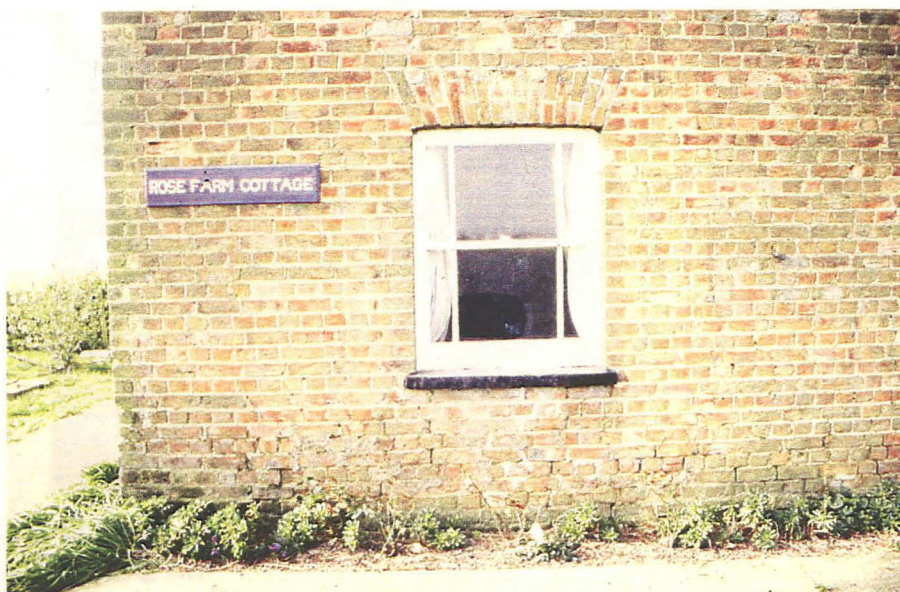
Plate 7 Detail of windows in northeast elevation, looking southwest

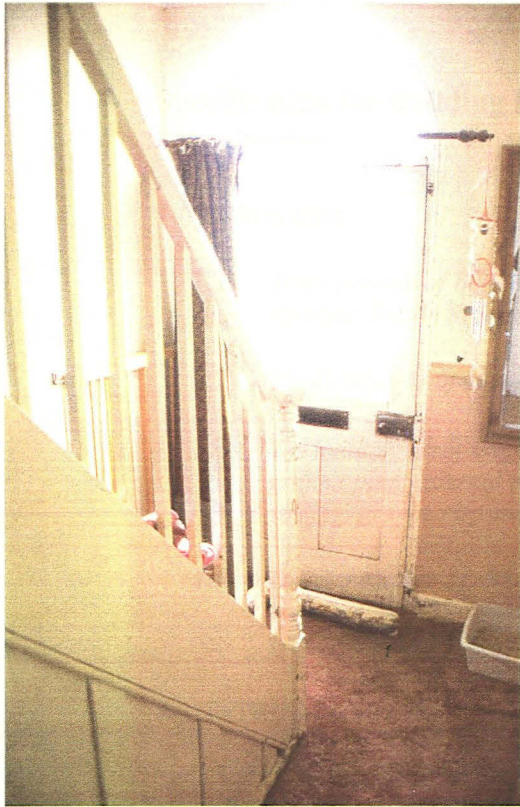
The original structure consisted of a two cell ground floor with a hallway. The staircase is located behind the front door against the northwestern wall of the original structure. The staircase form is riser and tread housed into string with an ornate lathe-turned newel and slender square balusters which date from the late 18th-early 19th century.

Plate 8 Hallway and simple square baluster, looking north

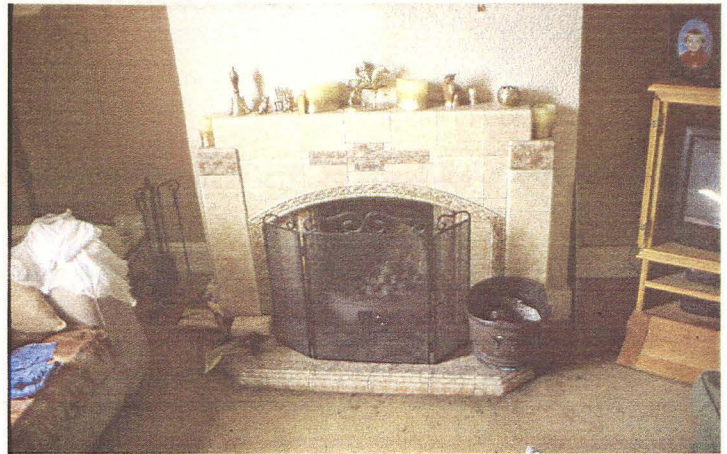
Both the front and back room of the original structure have a fireplace on the southeastern wall. Both the original fireplaces have been replaced, with the front room displaying a typical example of a 1950s tile fire surround. The interior doors in the original structure are wooden panelled.

The staircase, and windows all appear to be original fittings of the house, however the fireplaces have since been replaced by later surrounds in the mid-20th century.

Plate 9 Fireplace in front room, looking southeast

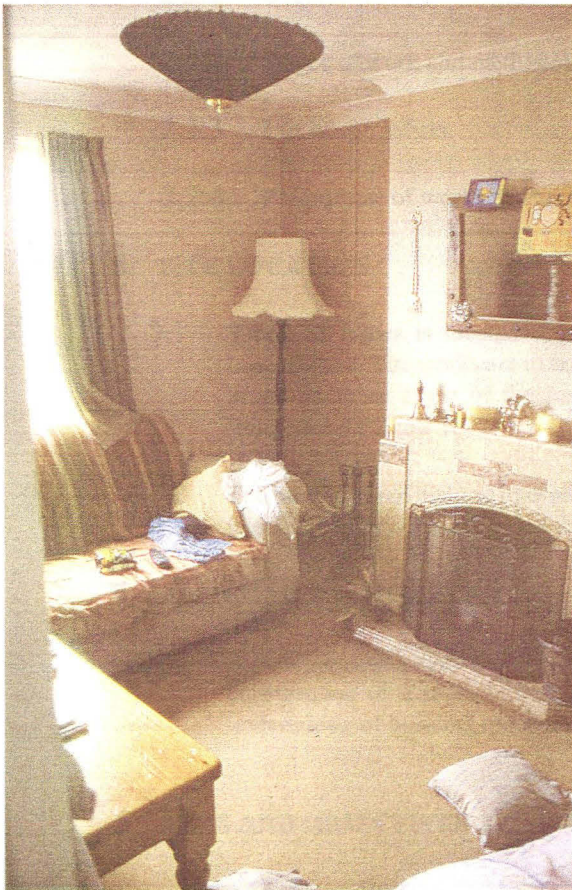
Plate 10 Interior view of front room, looking east

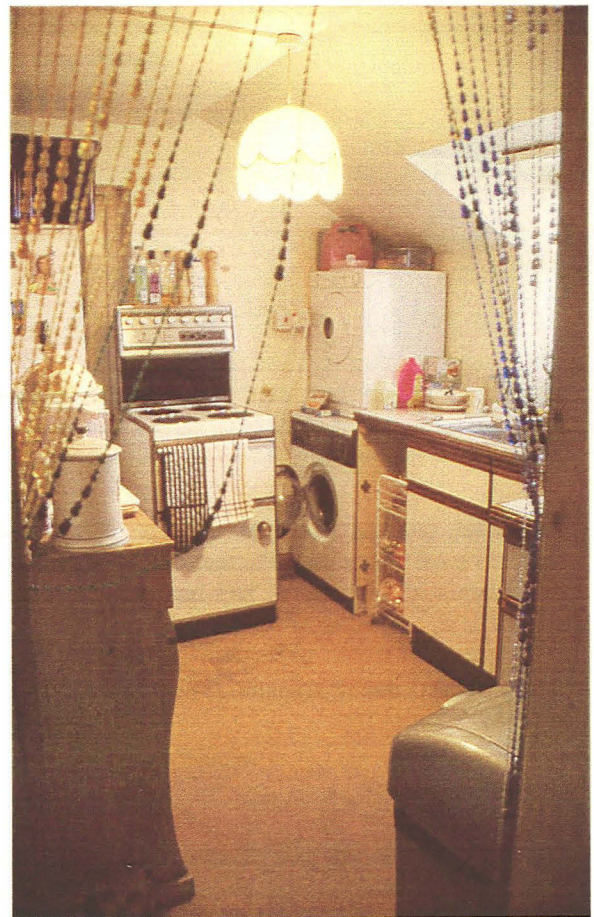
Plate 11 Interior view of kitchen, looking west
