**20-32 Bridge Street, Gainsborough, Lincs.**

**Archaeological Desk-Based Assessment**

**LAS Report No. 679**

**July 2003**

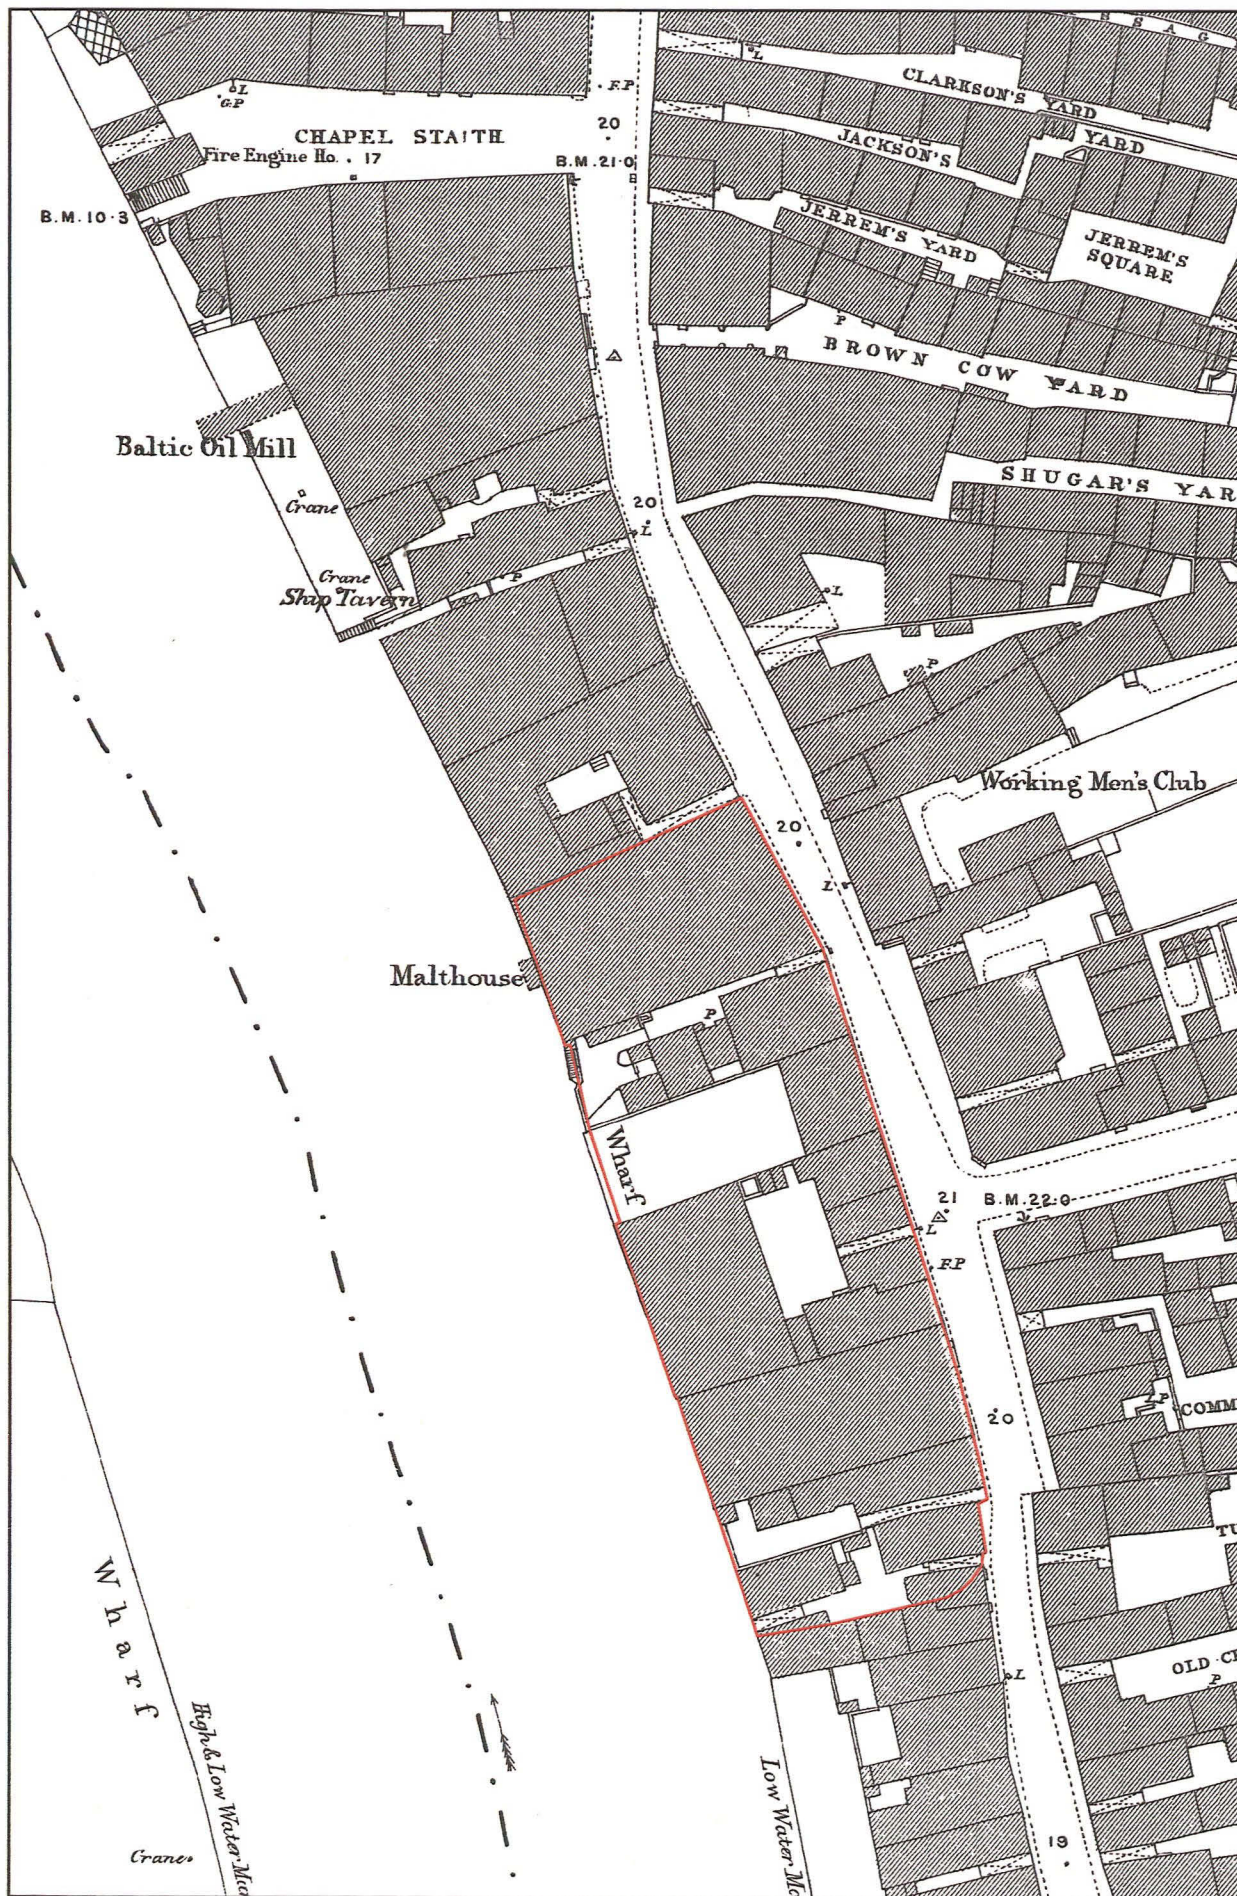
Fig. 6 Extract from the Ordnance Survey 1886 1:500 plan, Lincs. Sheet 42.12.4, reproduced at a reduced scale.

The Ordnance Survey 1:500 map, surveyed in **1885**, is at a much more useful scale (Fig. 6; OS 1886). The northernmost part of the site (equating with No. 20) was occupied by a 15m wide building (labelled as a malthouse), with a small projection into the river. A narrow passageway led from Bridge Street between this building and the narrower unit on No. 22; the yard to the rear had been progressively infilled, but part still remained open. A pump is shown in the yard, about 13m from the river edge. The map appears to show a set of steps leading from the river at the NW edge of this property.

The street frontage of No. 24 was developed, but behind it was an open area 19.5m x 9m, labelled as a wharf. The premises to the south were subdivided into four on the street frontage, (with a central access opposite Hickman Street), but linked by a single building along the western half of the plot. The next unit south was shown as a single block, with a thinner property and access at the southern limit of the application site.

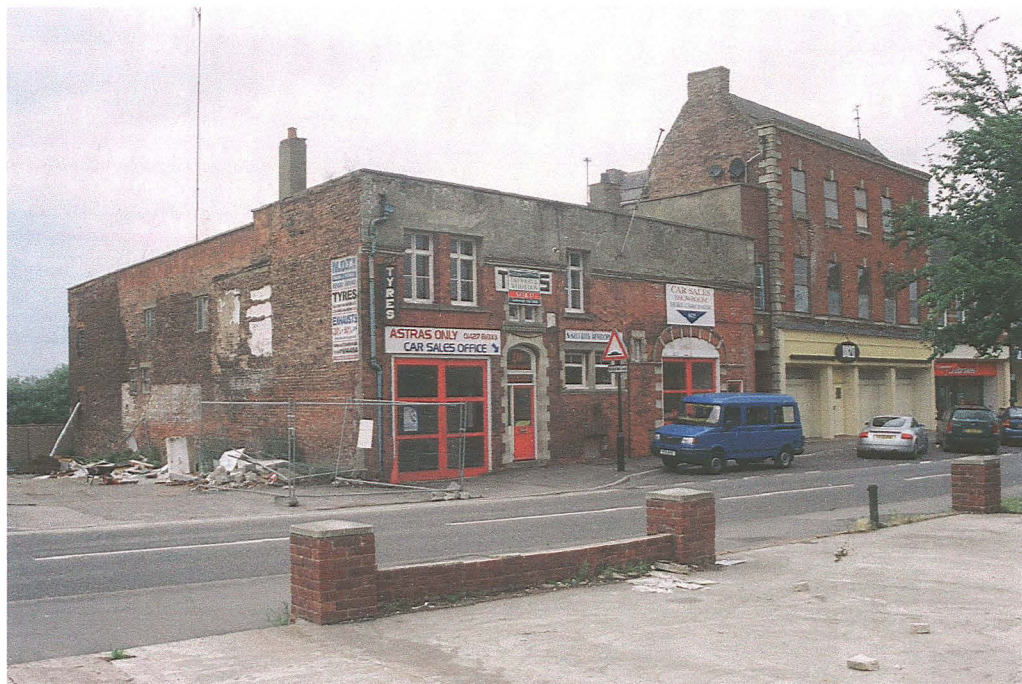
Pl. 2 Former car showroom at the northern end of the site (looking west across Bridge Street).

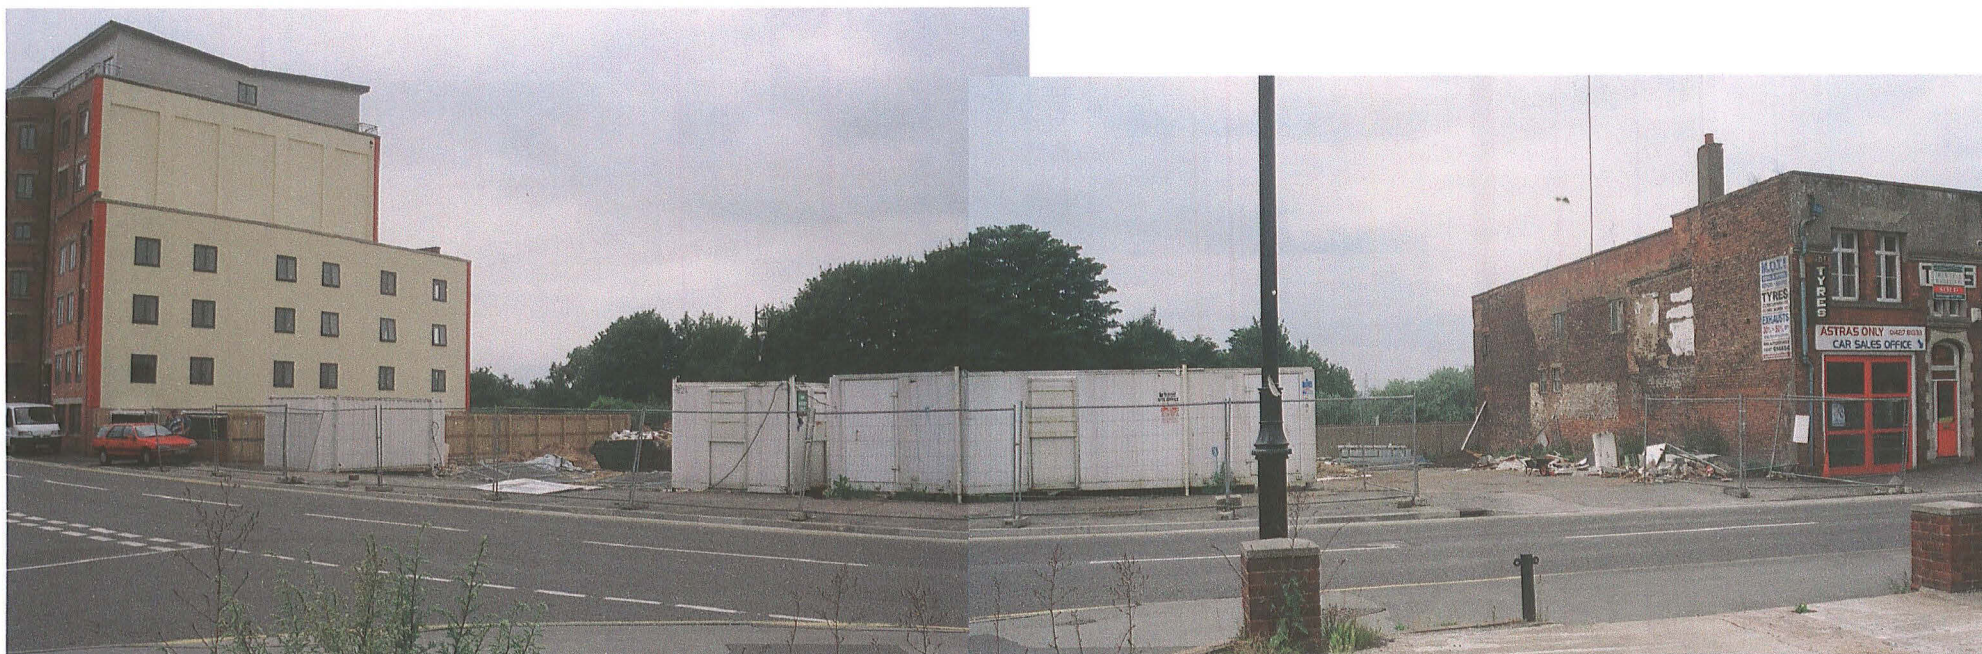
Pl. 3 Recently refurbished buildings at the north side of Whittons Mill from the southern side of the site, with a broad cleared central area (looking west).

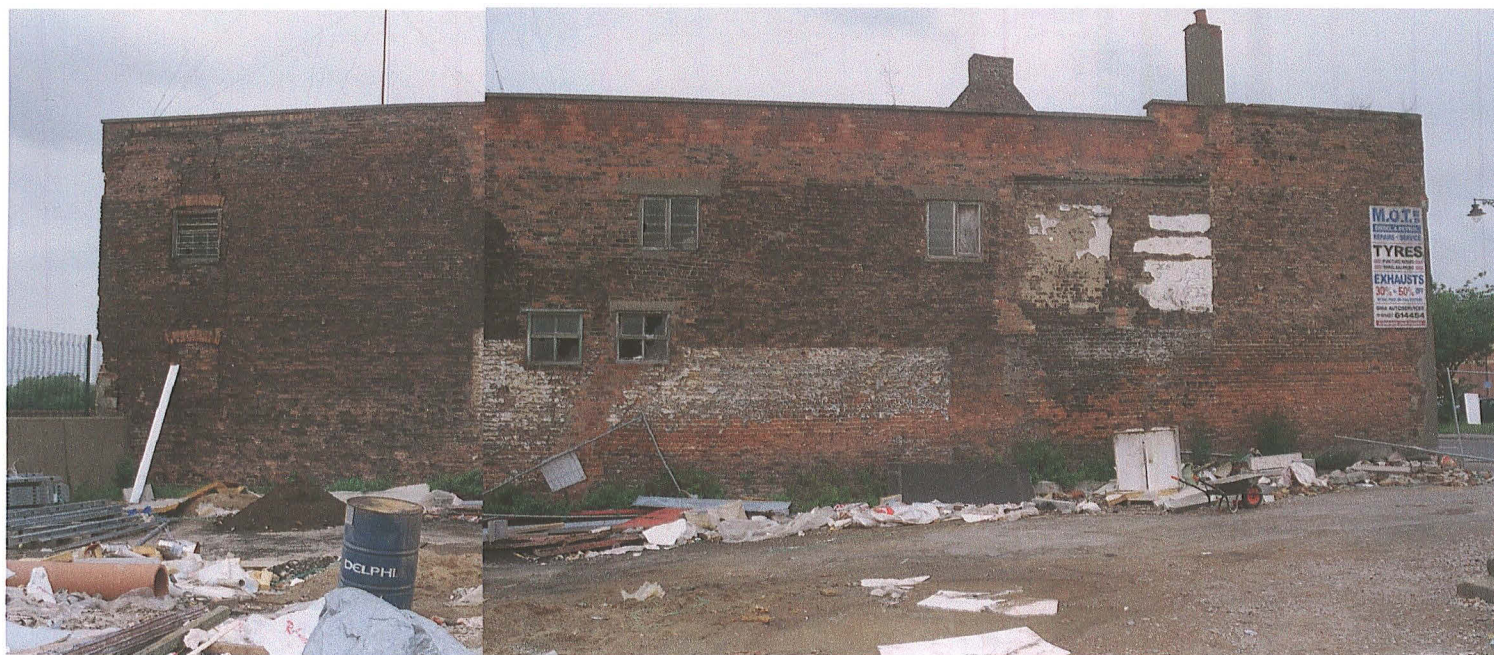
Pl. 4 Southern elevation of the former maltings building (looking north).

The application site was visited by G. Tann on July 4th 2003. Access to the site is from Bridge Street; at present much of the site is enclosed as a contractor's compound, and site offices occupy most of the street frontage (Pls. 1-3). Behind the cabins, building materials, demolition material and other rubbish obscure most of the site surface (Pl. 4).

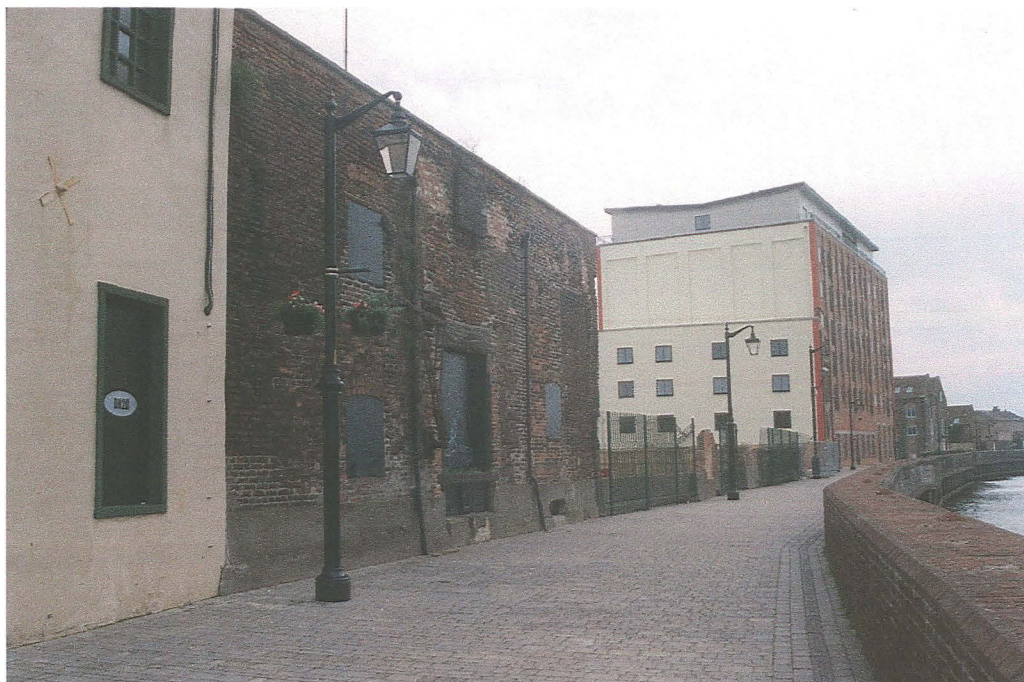
The application site is in three distinct parts. At the northern end is a two-storey brick building, 20 Bridge Street, which has most recently served as a car showroom and tyre repair garage. The Gainsborough Development Trust website refers to this as 'Riverside Garage', but this name was not seen elsewhere. Cars were still stored within the former showroom, and no attempt was made to gain access to this building. Both the west and south elevations appear to be substantially of eighteenth century construction, although all but the two westernmost windows on the south elevation are later insertions. Part of a parapet along the south wall has been rebuilt in the twentieth century. Engineering bricks were seen at the foot of the rear wall, beside the new riverside path; these may be an inserted damp-proof course. Stone quoins survive on the SW corner, but are not present on the NW corner. The elevation facing the river has a central loading bay, with a swinging iron hoist still present, and windows to either side with brick lintel details (Pls. 5 and 6)). Near to ground level is a blocked chute, probably serving rear cellars.

Pl. 5 Riverside elevation of the former maltings (looking towards Whittons Mill from the new riverside path).

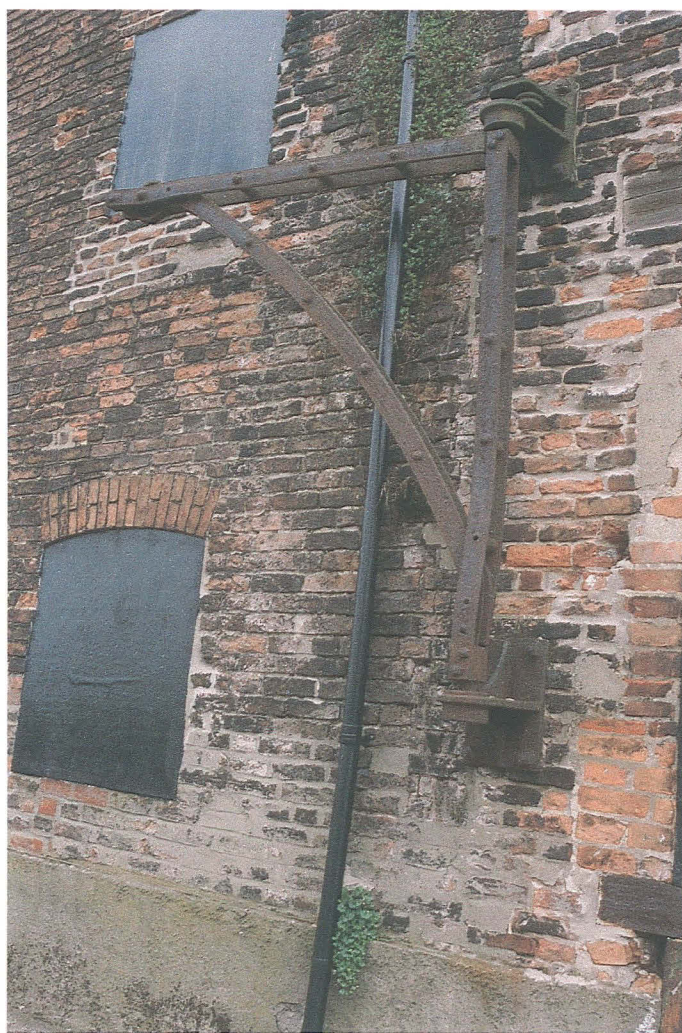
Pl. 6 Detail of the iron hoist on the riverside elevation of the former maltings.

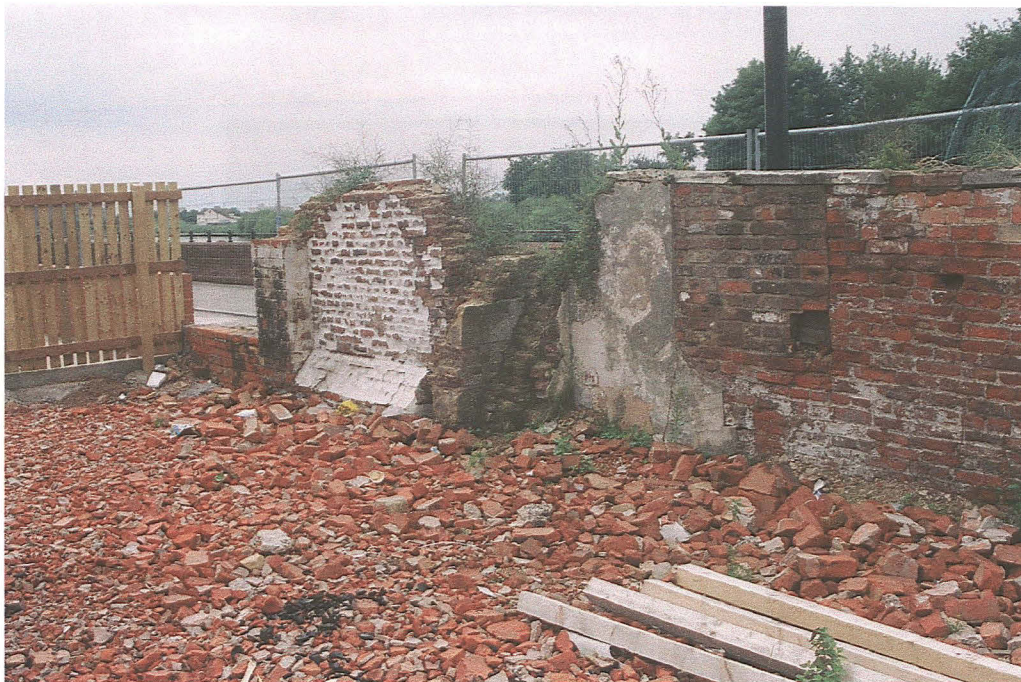
The centre of the site, correlating to Nos. 22-28 Bridge Street, has been cleared of all structures, leaving only small areas of concrete yard surface and the lowered part of the rear wall. Stone quoins survive at the corner of a west-east wall stub near the SW end, and outside the site near its northern end (Pls. 7 and 8). The remainder of the central area is covered with

Pl. 7 Stone detail at the end of a demolished brick wall, near the southern end of the site (looking SW).

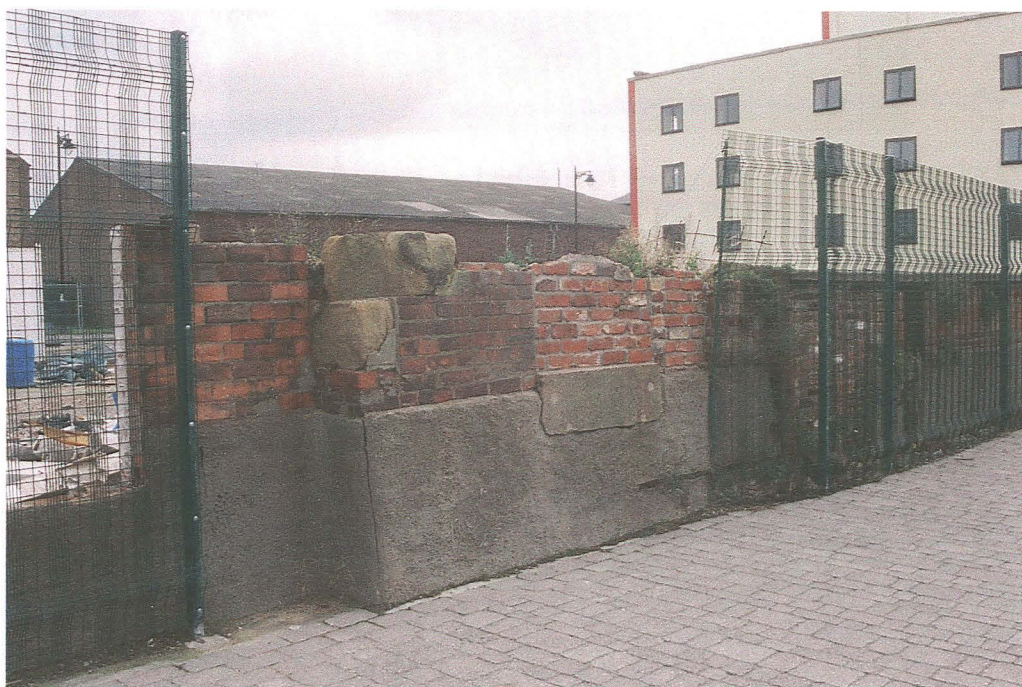
Pl. 8 Stone quoins on the riverside wall (looking SE).

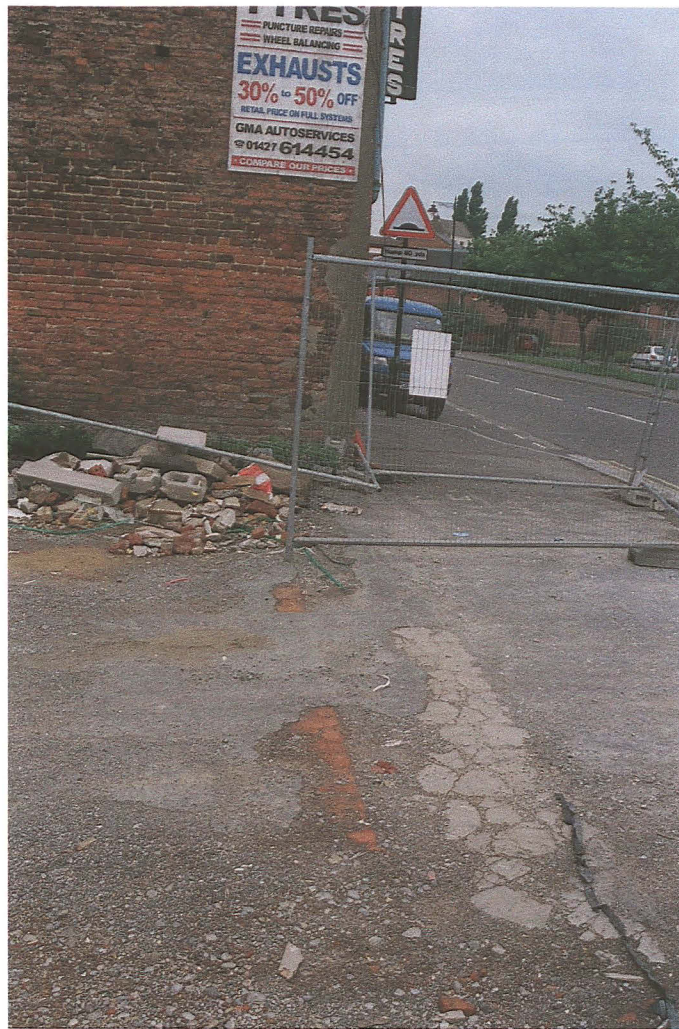
demolition rubble, site cabins and builders' materials. A north-south brick wall foundation is visible at ground level slightly behind the site frontage (Pl. 9).

Pl. 9 Demolished brick wall foundation close to Bridge Street frontage of the site (looking NE).
