**Plot 4, Alford Rd, Huttoft, Lincs.  
Archaeological Watching Brief**

*Site Code: HUAR 03*

**LAS Report No. 669**

**July 2003**

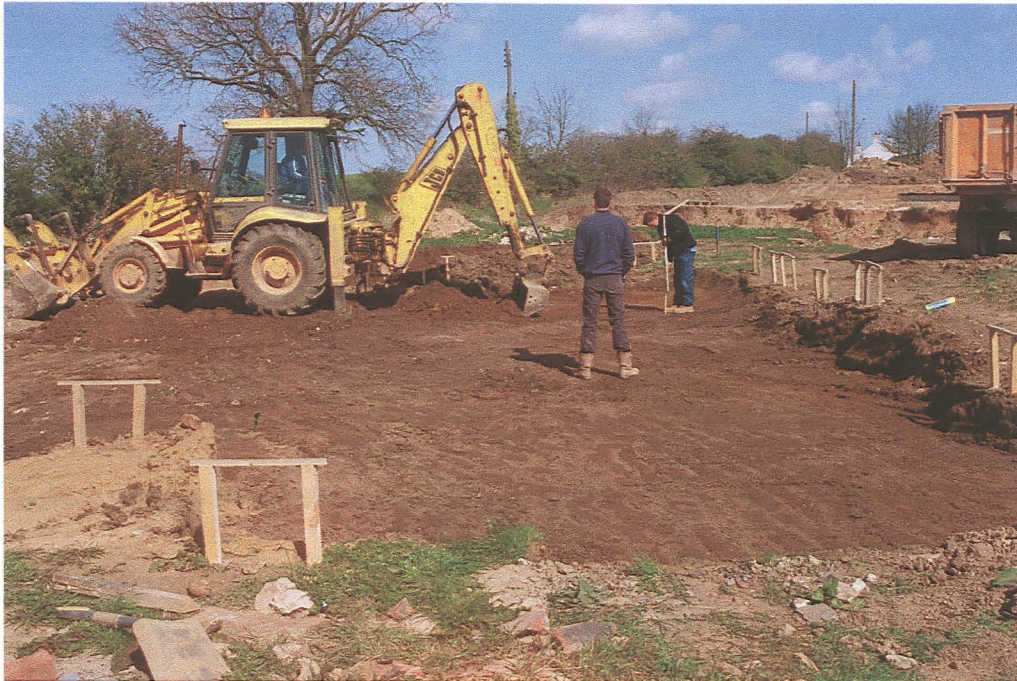
Pl. 1 Site preparation, view looking north-east.

Ground preparation prior to excavation of the foundation trenches was required in order to create a level platform for the house (Pl. 1). Up to 0.30m was removed from the south end of the site using a toothed bucket (the ground was too hard to use a flat blade). Modern pottery and very fragmentary animal bone was seen during this phase of work. The bone was not retained.

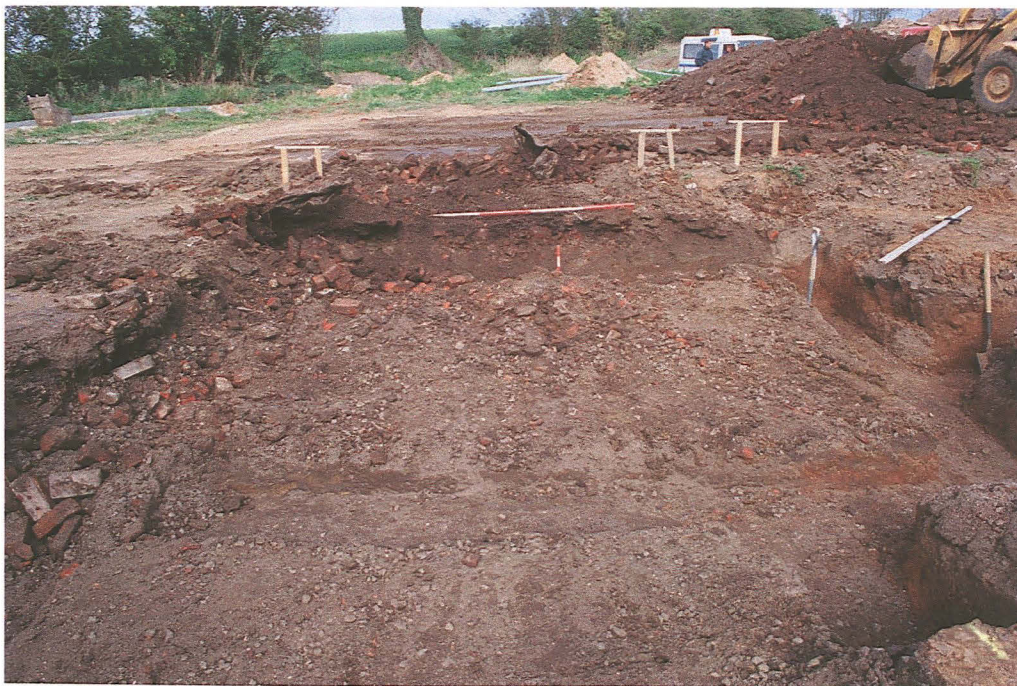
Pl. 2 Excavation of the northern third of the site illustrating the extent of the rubble infill (facing north-east). Scales 2m and 0.5m.

A spread of modern demolition rubble (**102**), probably associated with the former farm building, filled a depression within the northern third of the site, overlying, and partially truncating, the topsoil (Pls 2 and 3). A common stratigraphy was recognised across the plot, consisting of mid-dark brown silty clay topsoil (**100**), with occasional inclusions of grit, to a depth of 0.3m below the existing ground surface. Situated beneath, the subsoil (**101**) comprised light brown silty clay, hard and dry in consistency with iron pan mottling, overlying the natural mid red/brown sandy clay (**103**) (Pls 4 and 5). The depth of the subsoil (**101**) within the eastern half of the trench was such that the natural was only visible within the western half of the foundation footprint. No glacial drift sand, as recorded in Plot 1 (Tann 2003), was present.

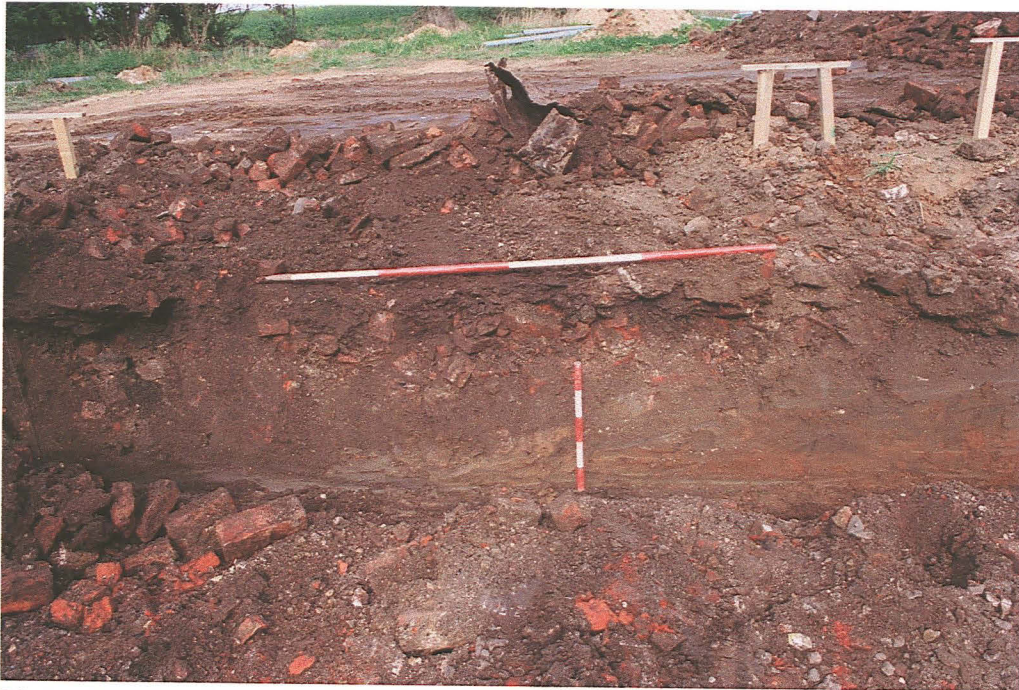
Pl. 3 Section through rubble fill (102) at north end of site, along the north-east rear wall. Scales 2m and 0.5m.

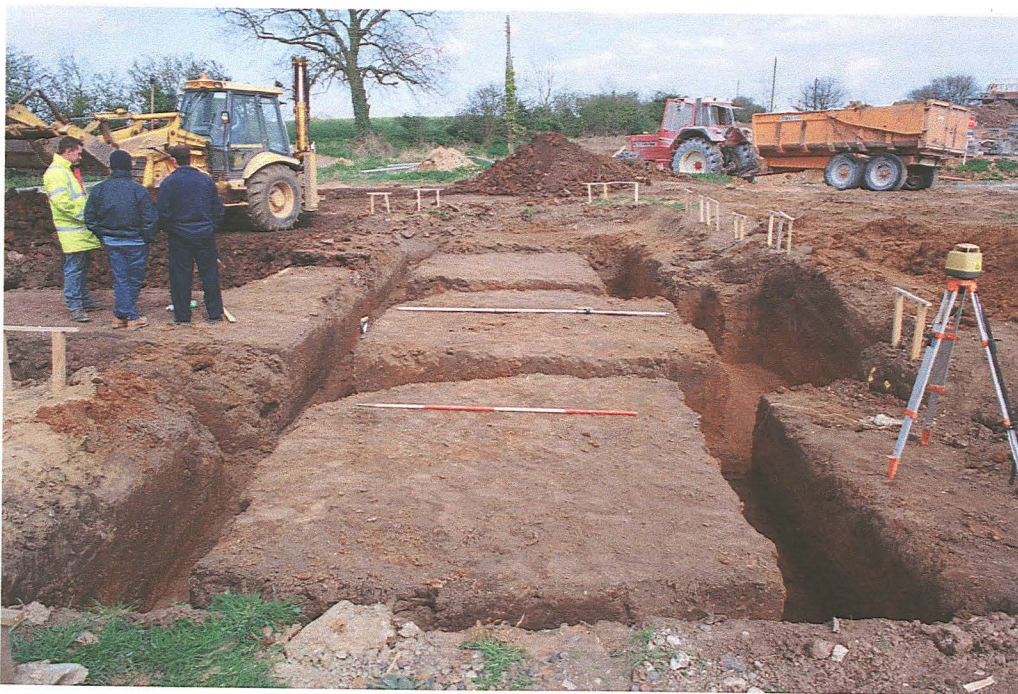
Pl. 4 View of the eastern half of the excavated foundation footprint of Plot 4 (facing north-east). Scale 2m.

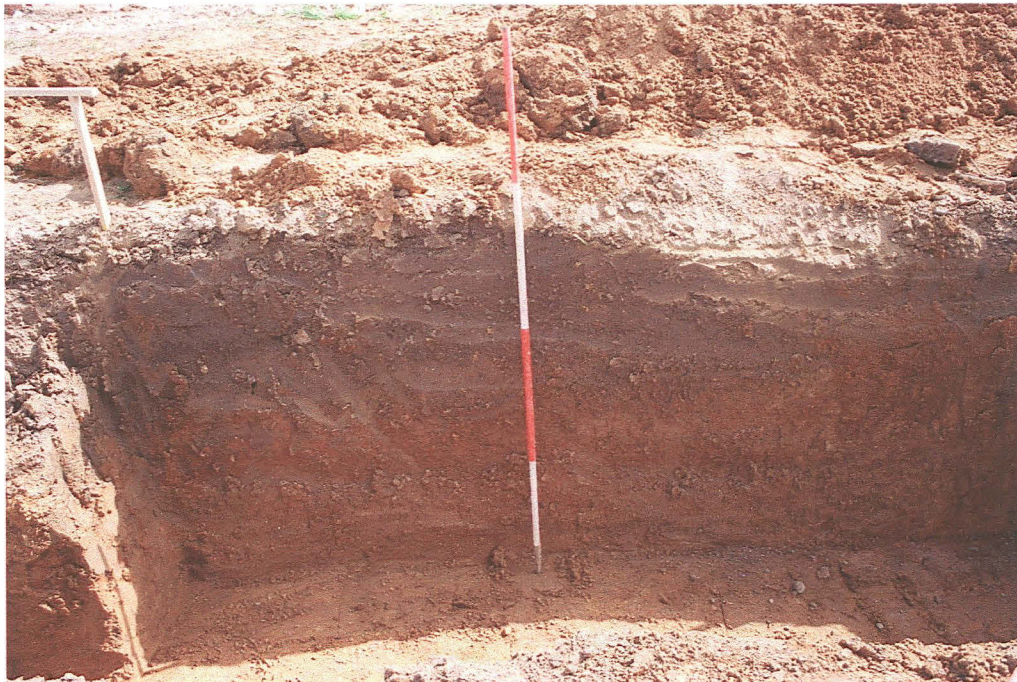
Pl. 5 Common sequence of deposits along the rear eastern wall trench of Plot 4 (facing east). Scale 2m.

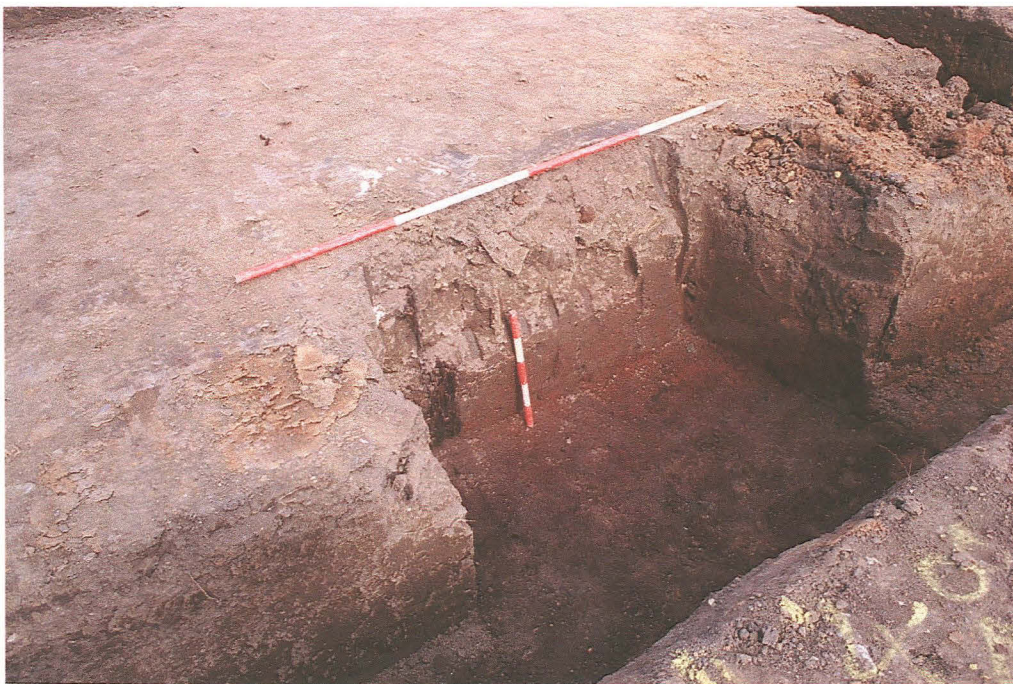
Pl. 6 Spread of burnt natural disappearing beneath the southern baulk edge. Scales 2m and 0.5m.

Situated within the southern end of the foundation, adjacent and within the proposed chimney stack, a spread of burnt natural and charcoal (Pl. 6) presented the possibility of a pit or bonfire (**104**). This deposit was sealed by the overlying subsoil (**101**), appearing to continue beyond the foundation to the north. No finds were associated with this deposit.
