40 MONSON STREET, LINCOLN

ARCHAEOLOGICAL WATCHING BRIEF AND ENVIRONMENTAL SAMPLING REPORT

S.A. Savage

August 2003

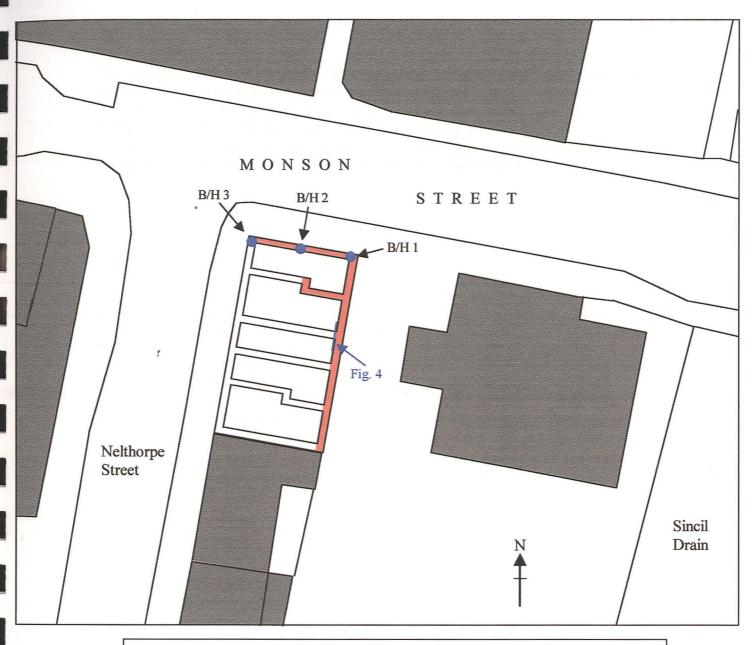
Fig. 3: Plan showing the foundation trenches for the new development and the positions of the auger holes. The area shaded red shows the trenches excavated before the foundation strategy changed. Scale 1:250

The site was visited on 24.6.2003, when foundation trenches were begun as part of the redevelopment. This work was undertaken using a mini-excavator employing a 0.65m wide bucket. The foundation trenches were generally 0.7m wide and 1.2m deep. This work was monitored continuously to ensure that any archaeological features or deposits exposed were identified and recorded.

Work commenced at the south end of the site for the east wall of the building and continued northwards, terminating with a trench for the north wall. Some reservations had been expressed about the load-bearing capabilities of the ground, and soon after the foundation trench for the dividing wall to the south of the latter was begun, the site engineer visited and decided to abandon this construction method. The trenches were subsequently backfilled and a less-intrusive raft-based foundation strategy was then employed.

A row of three boreholes was sampled, located in the foundation trench for the north wall of the building (this trench being the only one meeting the specifications laid out in the brief: the row being perpendicular to the course of the Sincil Drain).

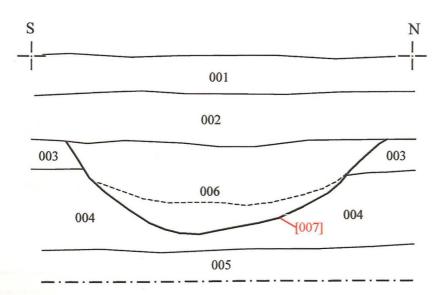
Fig. 4: East facing section showing pit [007]. Scale 1:20

Only one feature was seen in the sections of the foundation trenches, and this was pit [007]. It was located towards the centre of the east wall foundation trench, in the western section. It had shallow sides, breaking gently to a 'U'-shaped base and was filled by 006: a dark greyish brown sandy clay with a lens of mid-yellow clean sandy clay at the base. This fill yielded fragments of a 19th /20th century stoneware flagon.

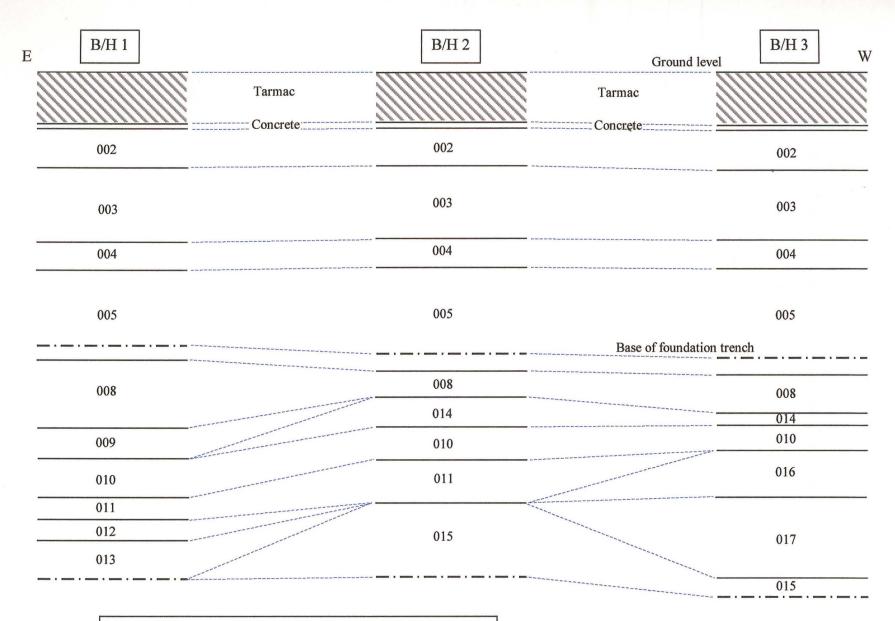
Fig. 5: Interpreted east-west soil profile across the site, showing the results of the auger holes (B/H 1-3) in black. Vertical scale 1:20, Horizontal scale – none.

As the boreholes were cut from the base of the foundation trench, the uppermost layer seen in all three was context 005. In borehole 1, this layer sealed 008, a very dark brown/black laminated silty peat 0.35m in thickness, which in turn lay over 009, a 0.16m thick layer of sandy dark brown peat containing occasional charcoal flecks.

Beneath these peat layers was a series of sand deposits, the uppermost of which was 010, a light grey fine sand layer containing occasional fragments of wood, which was 0.2m thick. Beneath this layer was a thin (0.1m) layer of mid/ light brown mottled sand -011, below which lay 012, a 0.1m thick dark grey medium sand. Layer 012 lay above 013, mid-brown medium sand.

The ground water content of these layers increased with depth, and at a depth of 1.2m below the base of the foundation trench, the material was so wet that it flowed out of the auger before it could be withdrawn from the hole.

The sequence of layers in this borehole more or less mirrored those seen in borehole1. Peat layer 008 was much thinner here (0.15m), and layer 009 was not present; instead a 0.25m thick layer of mid-grey sand containing occasional small patches of orange clay (014) separated 008 from 010. Layer 011 was thicker in this borehole (0.25m) and below this lay 015, a mixture of clean mid-orange sand and gravel.

Again, the sequence of layers in this borehole resembled that observed in borehole 2. However, below layer 010 lay 016 - a mottled yellow/grey slightly silty sand, 0.25m in thickness, beneath which lay 017, a 0.45m thick mid brown medium sand similar to 013, but grittier.

Boreholes 1-3 displayed basal deposits of river derived sands and clays (010-017) followed by peat horizons (008, 009) and the bulk fill (005); probably dumped to raise the ground level in this area after the draining of the marshy ground.

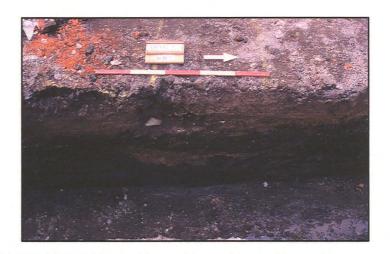
Plate 3(above): East-facing section showing Pit [007].
