**FORMER EASTGATE MOTORS CAR PARK,
WRAGBY ROAD, LINCOLN**

**ARCHAEOLOGICAL
TRIAL EXCAVATION REPORT**

Site code	EMCP 03
NGR:	SK 98270 71981
Planning Ref:	2003/403
LCCM Acc No:	2003.307

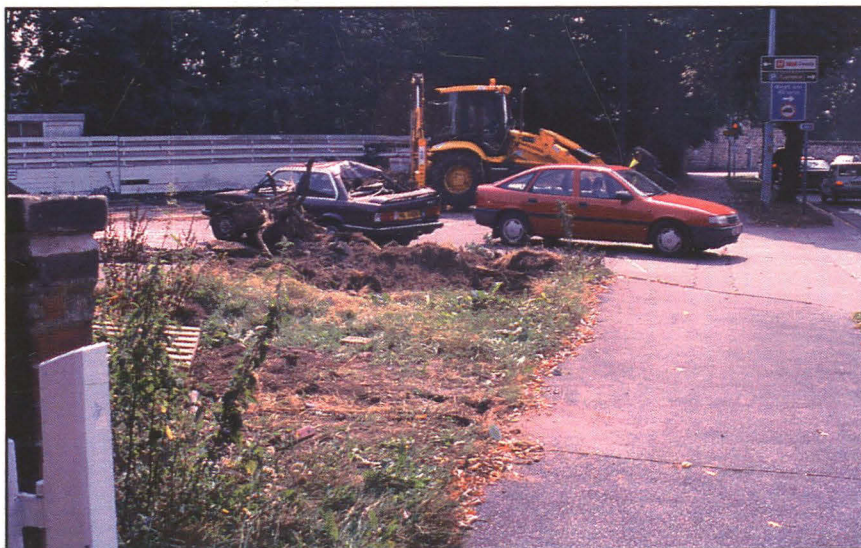
Plate 2 (right):
General shot of the
development area
taken during the
machining of the
evaluation trench,
looking south-east.

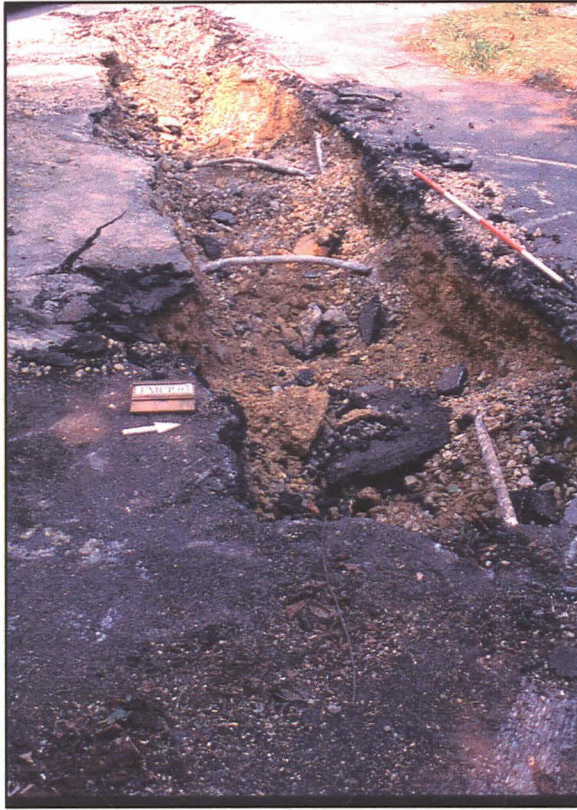
Plate 4 (left): General view of the trench excavated in the preferred area, looking south-west. The fuel tanks (covered with concrete) and associated pipework can be seen throughout.

The specification of the project required the excavation of one trench, 15m x 1.6m, within the former Eastgate Motors car park, set perpendicular to Wragby Road (fig. 3). The positioning of this trench proved problematic, as the favoured location (between the northern two house plots, to prevent undermining future foundations) exposed a series of large, modern fuel tanks. Consequently, the trench was positioned 12m to the south, between the southern two house plots.

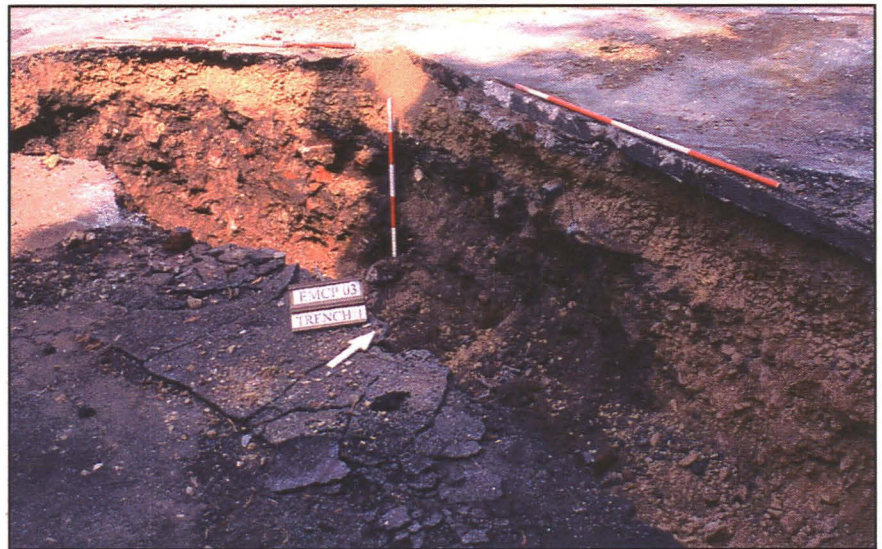
Plate 5 (right): South and south-east facing section of the eastern half of the evaluation trench, looking north-west.

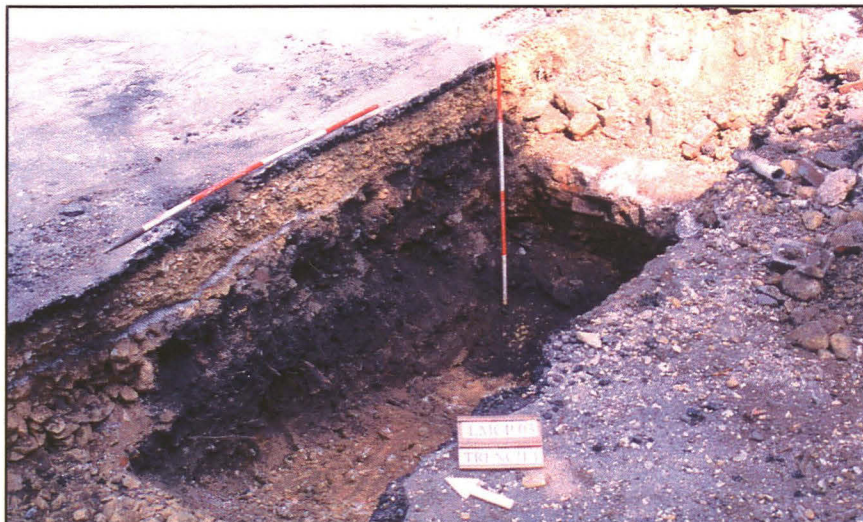
Plate 6 (left): South facing section of the western half of the evaluation trench, looking north-east.
