**FORMER TYRE DEPOT, SWAN STREET,
SPALDING, LINCOLNSHIRE**

**ARCHAEOLOGICAL WATCHING
BRIEF REPORT**

Site code	FTSS 03
NGR:	TF 2461 2275
Planning Ref:	H16/1011/02
LCCM Acc No:	2003.240

September 2003

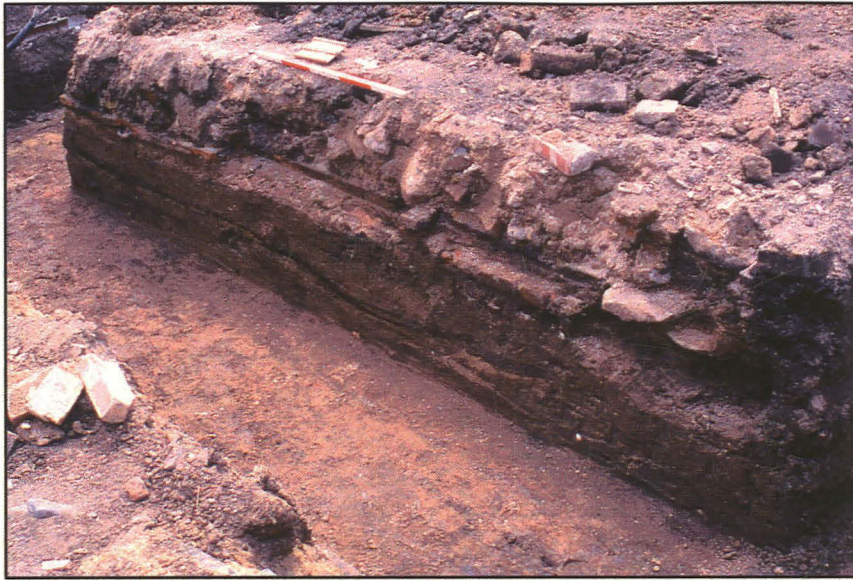
Plate 4 (left):
Section of the south
end of the foundation
trench for the east
wall of the new
building, looking
south-west.

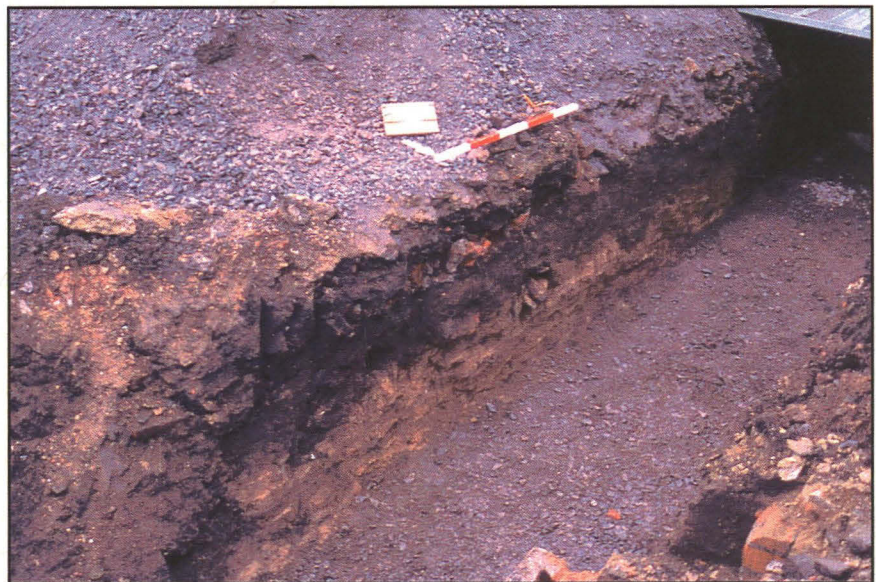
Plate 5 (right): North
facing section of the
foundation trench for
the north wall of the
new building, looking
south-west.
