BURGHersh CHANTRY, 17 JAMES
STREET, LINCOLN

ARCHAEOLOGICAL RECORDING

CLAU ARCHAEOLOGICAL REPORT NO: 98

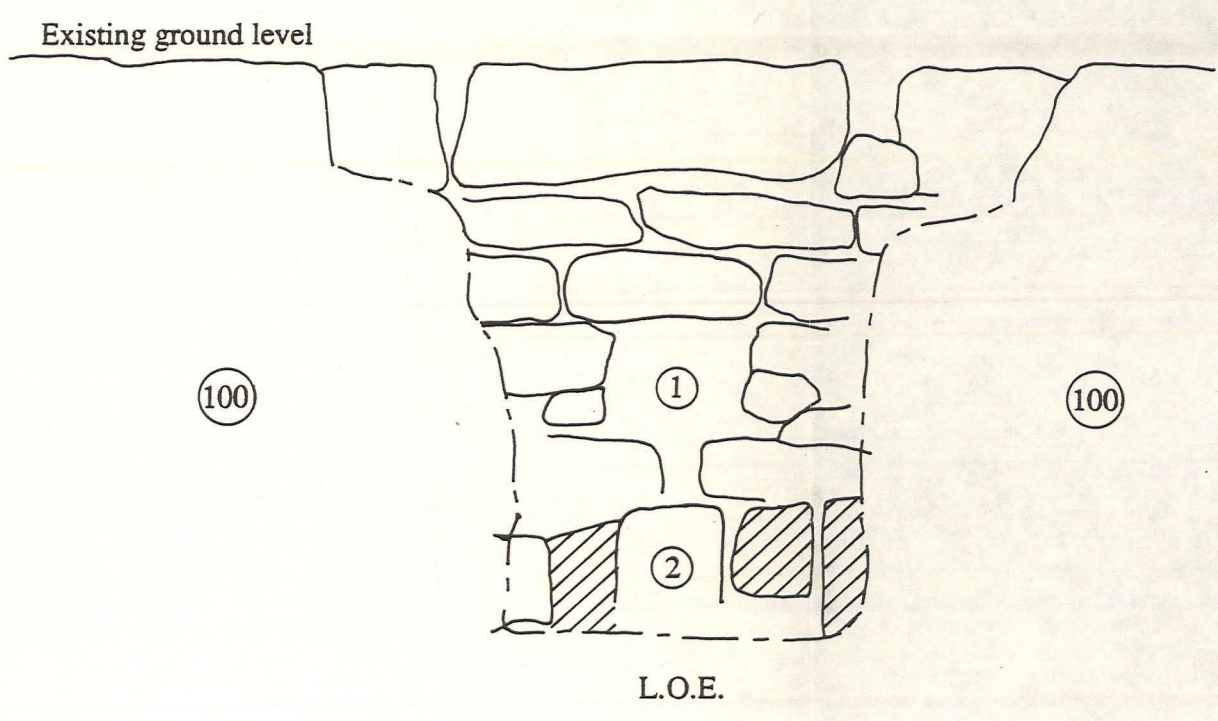
Fig.3

- ① Existing void for drainpipe
- ② Drainpipe
-
