**Lincoln College, Monks Road, Lincoln
Archaeological Trial Trench**

Report

LAS Report No: 709

November 2003

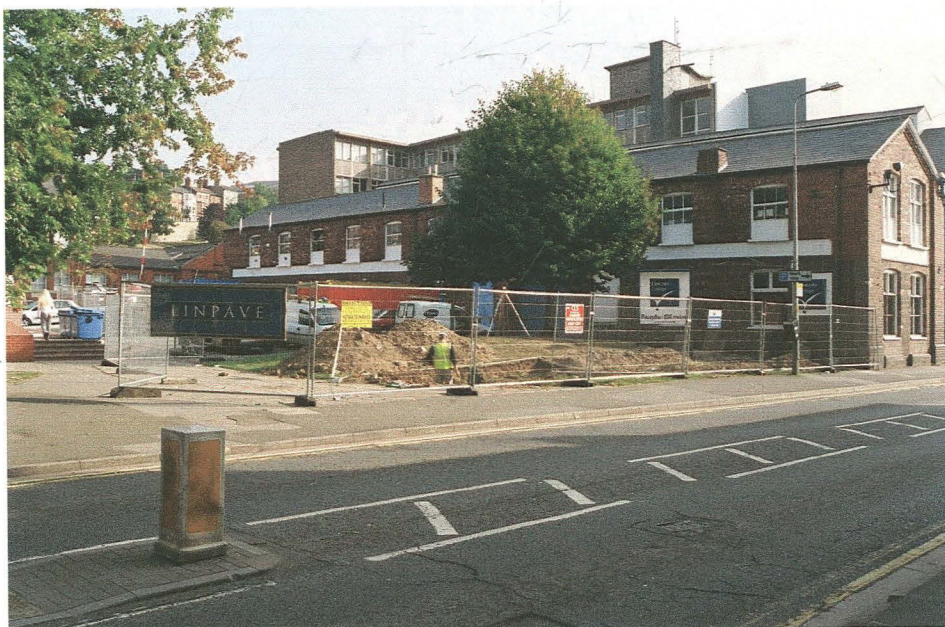
Pl.1 Location of Trench 1. Looking north-east.

Trench 1 was positioned to evaluate the area of land to be disturbed by the proposed development, immediately west of the Temple Building. The trench was positioned over a surviving area of topsoil rather than through the path area of the site still used by the college and likely to be disturbed by modern activity. Modern topsoil, **1000**, 0.10m deep, overlay a 0.20m deep subsoil, **1001**, which in turn sealed a modern levelling deposit which had brick, mortar, plaster, tile and oyster shell within it, **1002**, 0.60m deep, which butted against concrete.

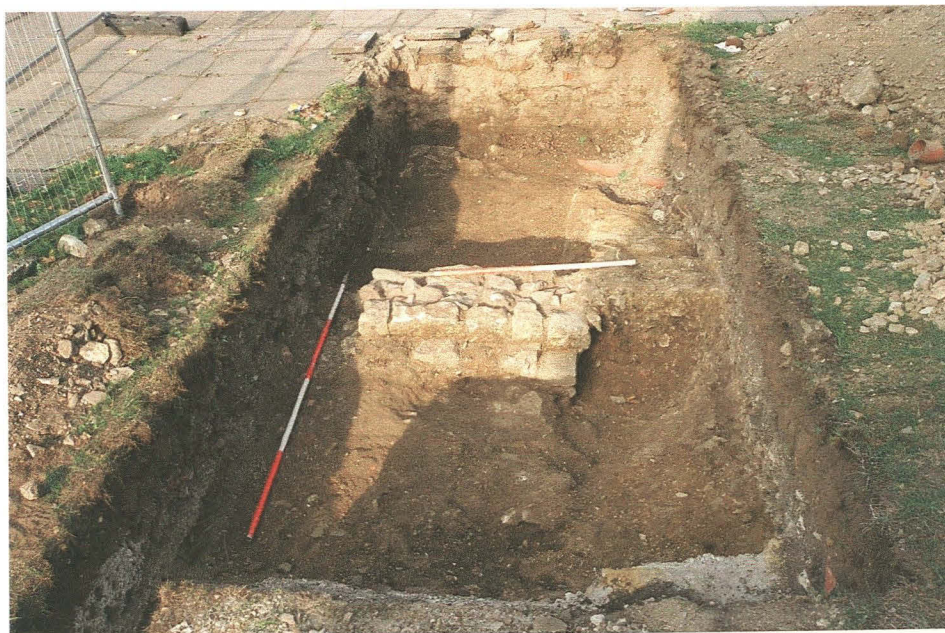
Pl.2 The trench, post-excavation, looking west. Scales 1m and 2m.

Below the modern deposits was a 0.70m wide, vertical sided, east/west aligned, robber trench, **1003** (Pl. 2), which ran the length of the trench. It was filled with **1004**, a mixed orange

sand mortar containing limestone and tile inclusions of 14 – 15th century date. Little remained of robbed wall foundations, **1005** (Pl. 3), other than a, c.1m long, stretch of limestone pieces, up to 0.34m in length. Two limestone blocks, **1009** (Pl. 3), 0.50m long, roughly faced, were the possible wall remains. The depth of the wall footings and robber trench and the width of the wall could not be ascertained within the narrow confines of the trench. The wall cut into a loose dark grey brown silt, **1010** (Pl. 2), probably a former topsoil whose finds dated from the late 13th century to early/mid 14th century.

c.2m, east of **1007** was a north/south aligned stepped wall foundation, **1006** (Pl. 2). It was 0.60m wide, with two surviving course of stones up to 0.34m in size. The lower course of foundation stones was offset by 0.10m on the east side of **1006**. Tile from the wall construction was 12th – 13th century in date. The height of the lower course of footings, 16.92m O.D., suggests that **1005** was not built the same time as **1005** and **1007**. Wall **1006** was sealed by a grey brown silt demolition layer, **1008** (Pl. 2), which contained tile and mortar fragments of late 14th to mid 15th century date.

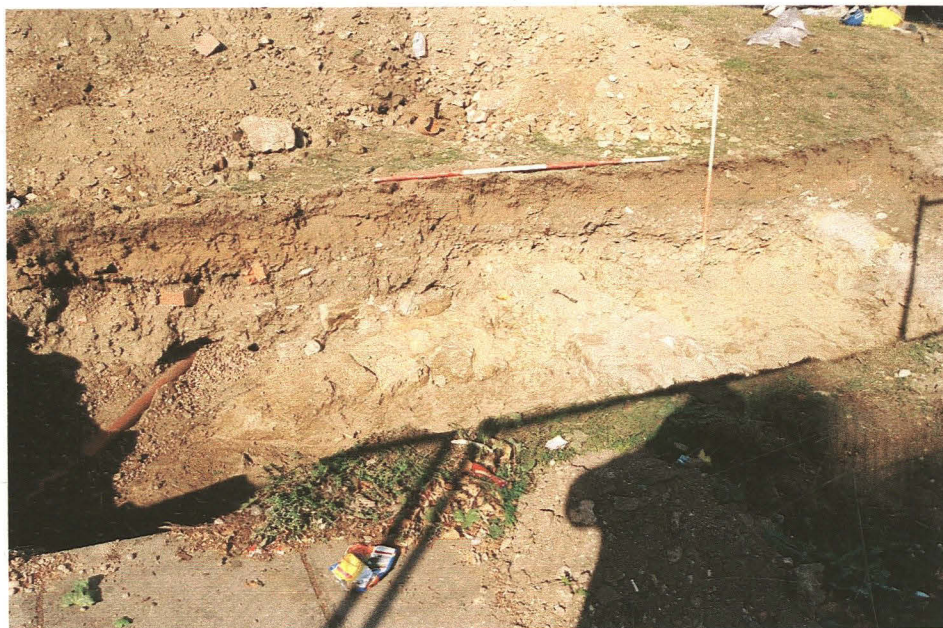
P1.3 Wall 1009 and foundation 1005. Horizontal scale 2m, vertical scale 1m.

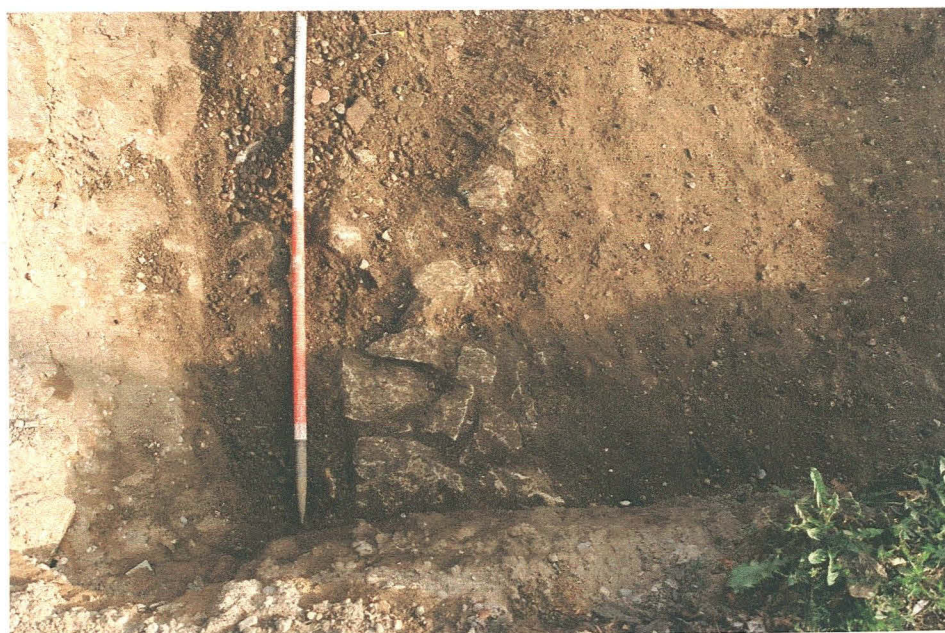
P1.4 Wall foundation 1007, from above. Scale 1m.

A possible north/south return wall, **1007** (Pl. 4), was noted to the west of **1005**. Only one course of wall **1007** foundation's survived. The limestone pieces comprising the 0.60m wide footings were up to 0.25m in length. The walls may be contemporary because the height of the footings are approximately the same (16.77m O.D.). The northern 1.70m of wall **1007**, was robbed, **1011**.
