**Wigford House, Brayford Wharf, Lincoln  
Archaeological Evaluation**

**LCNCC Accn No.: 2003.321  
Site Code: WHBW03  
NGR SK: 97347 71015  
Planning Application: 2003/0269/F**

**LAS Report No. 702**

**November 2003**

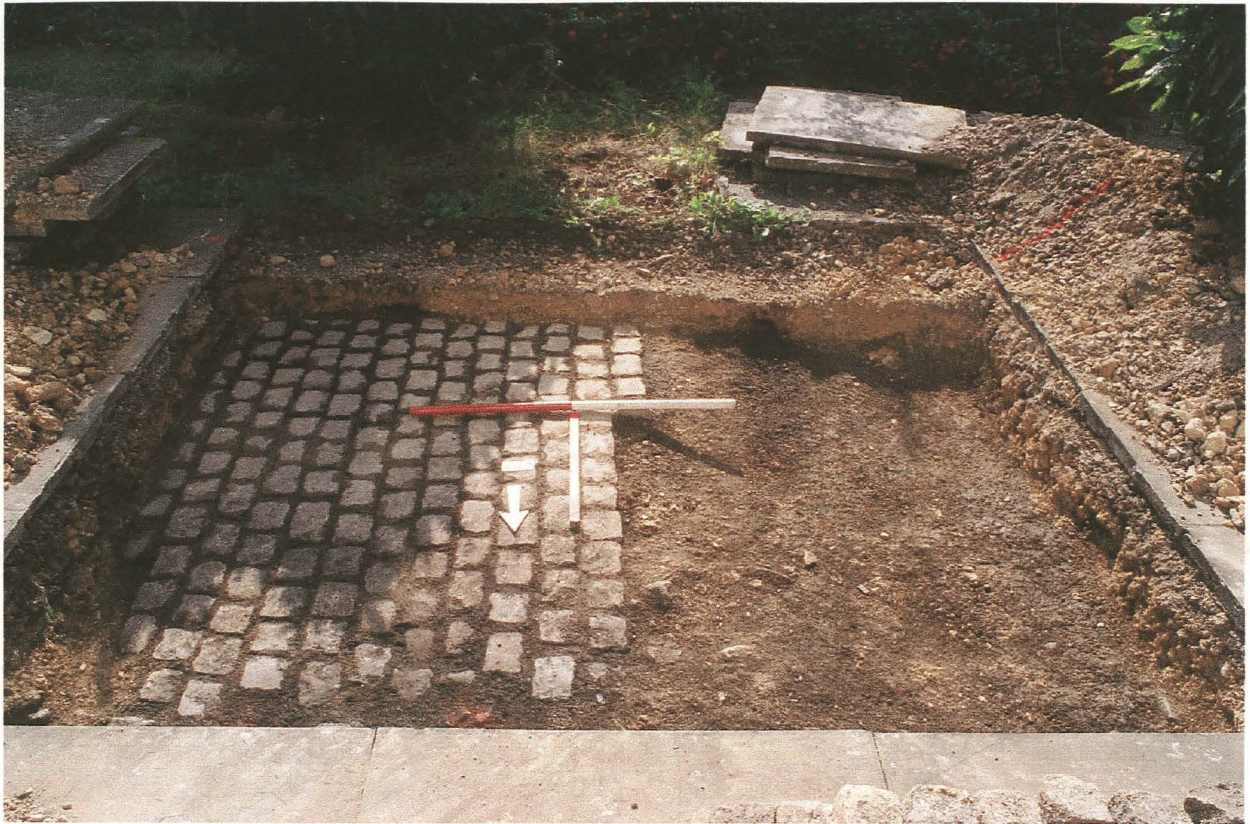
Pl.3 Trench 1 cobbled surface 101. Scales 1m and 0.50m

The concrete paving slabs and compacted make-up material **100** were removed to reveal a granite cobbled surface **101** covering roughly half of the trench. The remaining half consisted of compacted sharp sand **102** that ran underneath the cobbles (Pl. 3). The cobbles and the sand layer were removed by hand. At 0.50m below the present ground surface concrete **103** was encountered (Pl. 4). Concrete layer **103** could not be broken using hand tools and the confined location of the site made access for machines or compressors impossible, consequently, further work on Trench 1 was abandoned at this point.

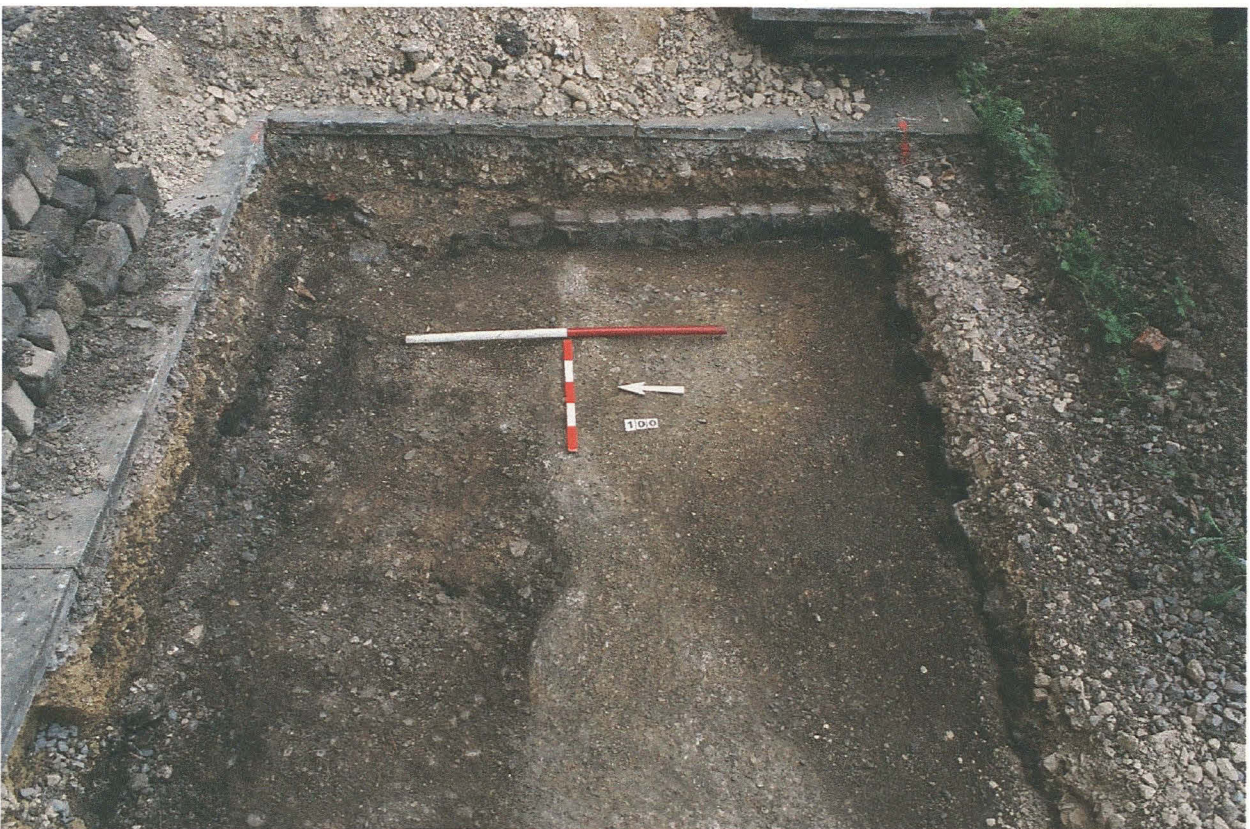
Pl. 4 Trench 1 concrete layer 103. Scales 1m and 0.50m

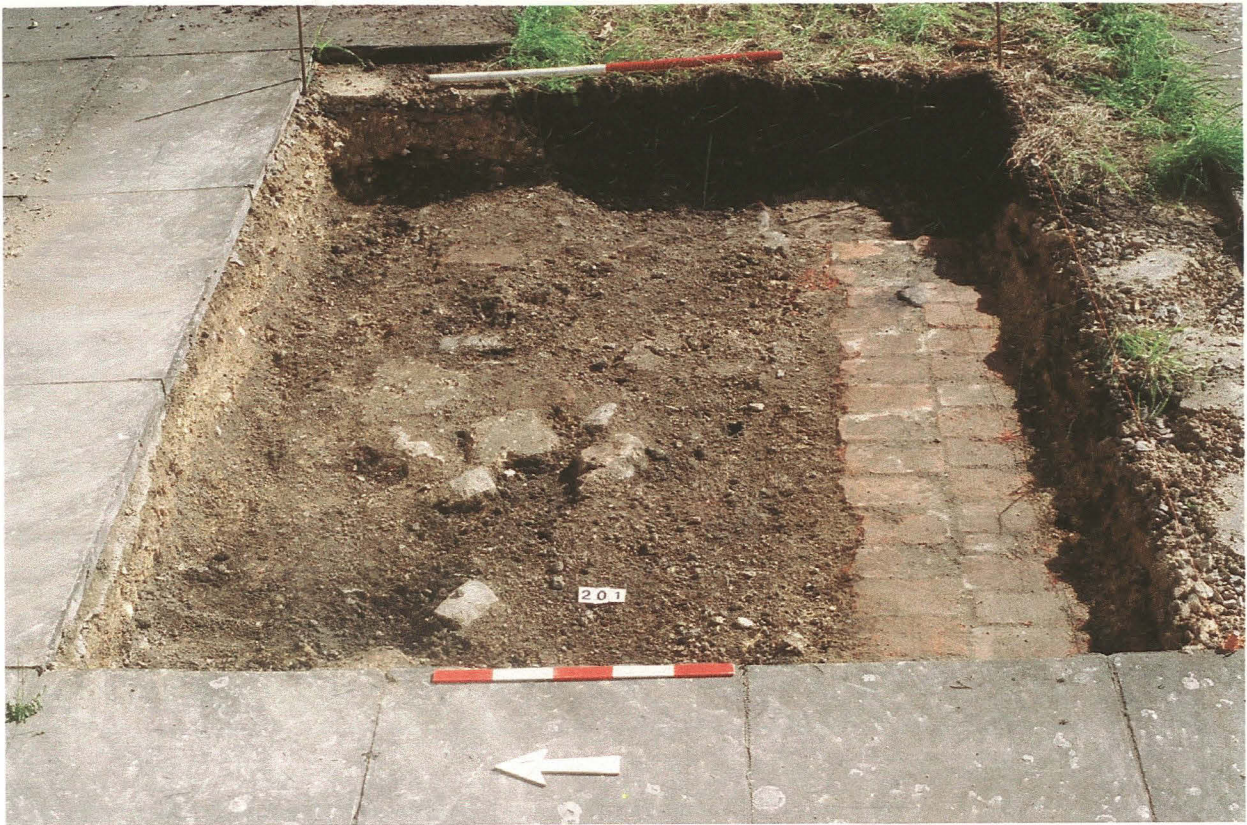
Pl. 5 Trench 2 top of 19th century demolition layers. Scales 1m and 0.50m

The concrete paving slabs and compacted make-up material **200** were removed to reveal a substantial red brick structural fragment **202** that covered almost half of the trench. The remaining half consisted of various layers of modern demolition material in a dark grey/brown sandy silt matrix **203** (Pl. 5). Structural fragment **202** had stepped foundations and continued to a depth in excess of the trenches final depth of 1.20m below the present ground surface (Pl. 6, 7). Modern demolition layers **203** also continued to a depth in excess of 1.20m below the present ground surface. A small area of soft dark grey/brown silt **204** was observed in the base of the trench. A small 0.40m x 0.40m sondage was excavated into this deposit which had a depth in excess of 0.50m. Six fragments of roof tile were retrieved from this layer, which could only be dated to the period between the 12<sup>th</sup> and 15<sup>th</sup> centuries.

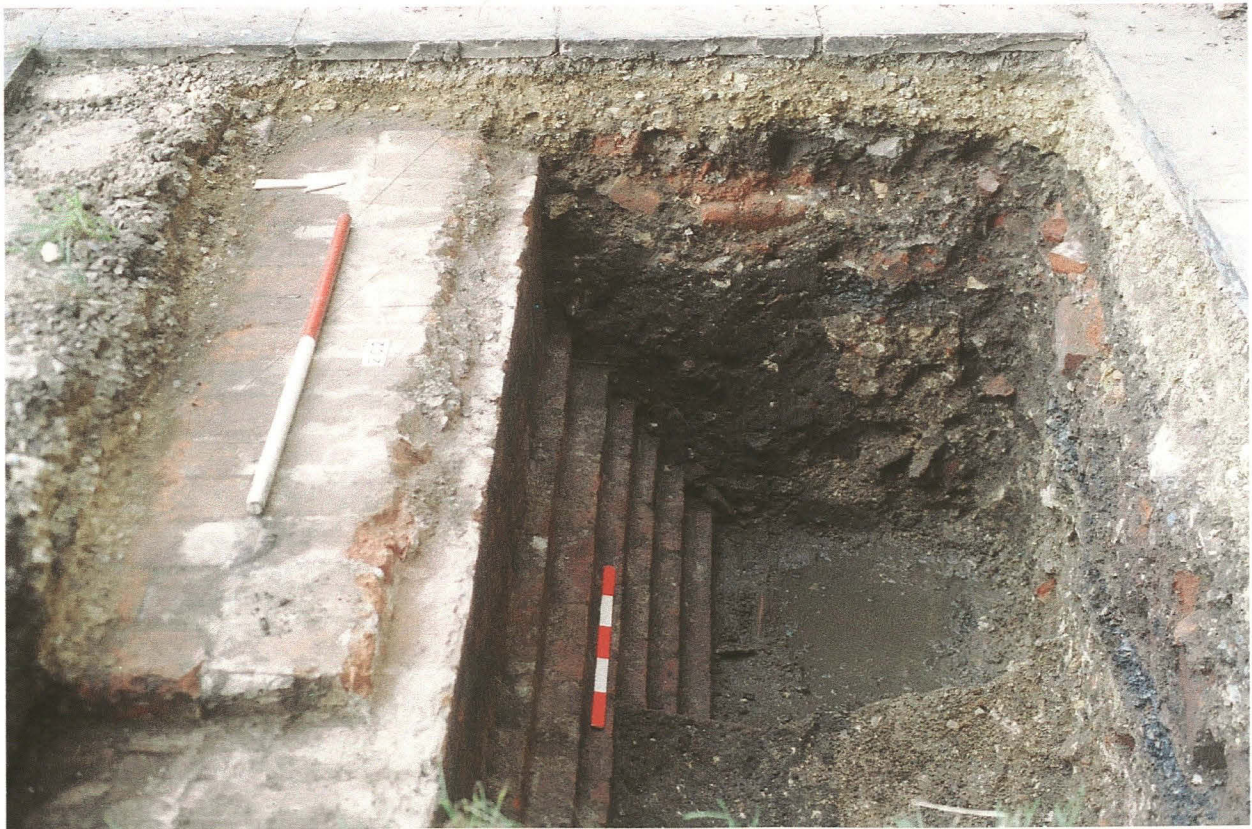
Pl.6 Trench 2 Looking west across the stepped foundations 202. Scales 1m and 0.50m.

The substantial stepped brick building foundations noted in Trench 1 probably relate to Seely's Mill built in 1839 and demolished in 1970. Seely's Mill, later to be known as Holmes Grain Warehouse, was an imposing red brick building standing seven stories in height. Stepped foundations of the considerable width encountered during the recent excavation would not be unusual for such a large building constructed on waterlogged silts. The cobbled area noted in Trench 2 probably represents an exterior surface linked either to the warehouse itself or the railway to the south.

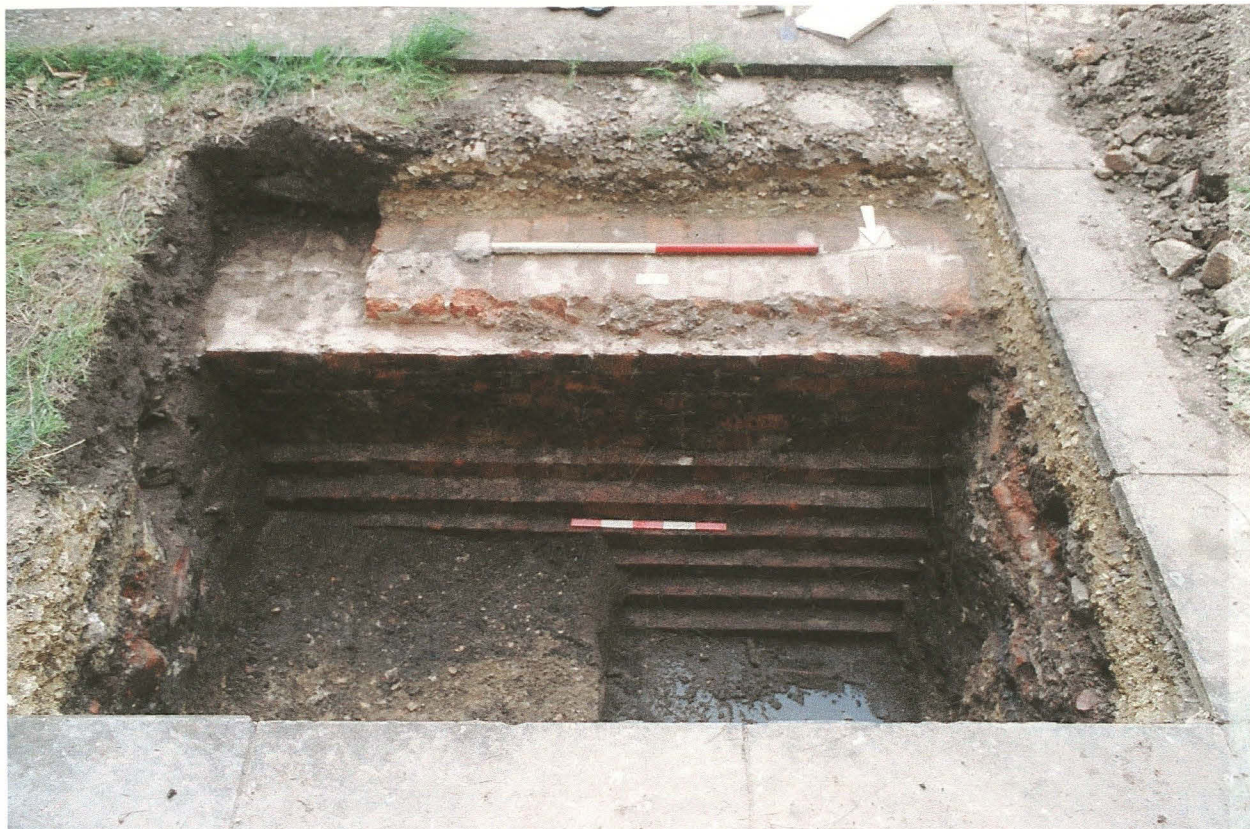
Pl. 7 Trench 2, foundations 202 looking north Scales 1m and 0.50m.

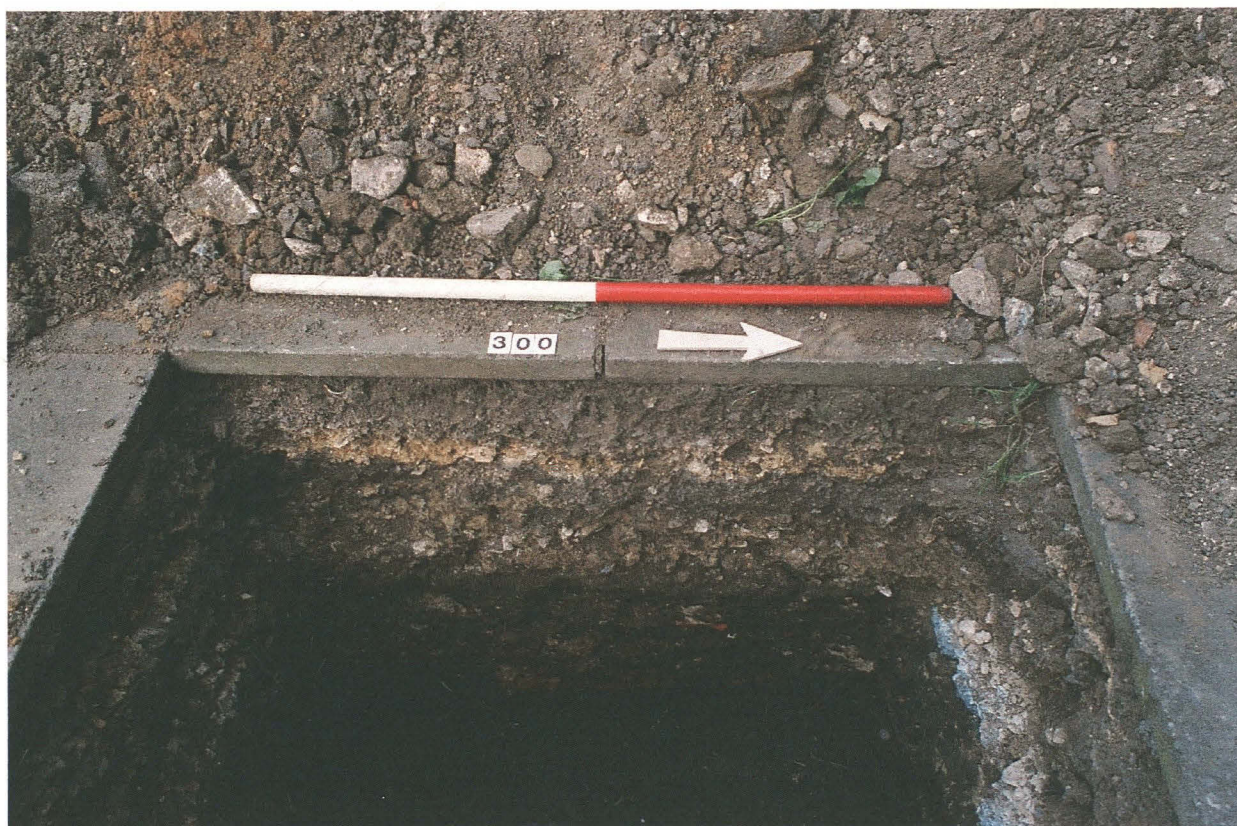
Pl. 8 Trench 3, showing sequence of deposits. Scale 1m .

Due to the abandonment of Trench 1, the City Archaeological Officer, Michael Jones requested that a small test pit should be excavated away from the cobbled surface and the foundation fragments encountered in Trenches 1 and 2. The third trench was positioned further towards the west of the site in one of the small gardens interspersed within the paved area. The stratigraphy of Trench 3 consisted generally of modern make-up **300** overlying 19<sup>th</sup> century demolition debris **301**, similar to that previously encountered in Trenches 1 and 2. A thin layer of sharp sand **302** was observed lying directly beneath **301**. Two pottery sherds (one medieval, one 18<sup>th</sup> century in date) and a sherd medieval roof tile were found. The deepest deposit noted in Trench 3 appeared at around 0.80m below the current ground surface and was a very dark grey/brown silt **303**, very similar to **204** noted in the base of Trench 2 (Pl. 8).
