Heapham Rd, Gainsborough, Lincs

Archaeological Watching Brief

**LAS Report No. 714
November 2003**

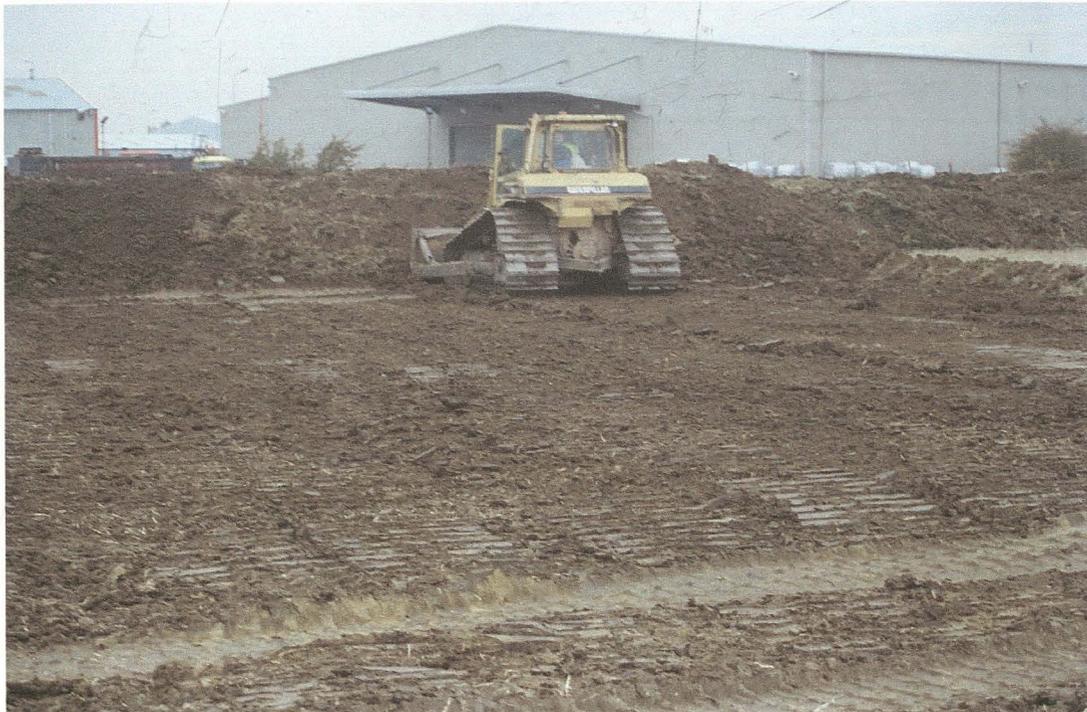
Topsoil stripping over the south western area of the lagoon and the access roads was undertaken to reduce the ground level. This was done with a tracked bulldozer which hampered the recognition of any archaeological features. The soil reduced comprised a grey brown silty clay topsoil, **101**, leaving a trampled deposit of **101** and the underlying clay **102**, mid orange brown clay natural. Although one sherd of medieval pottery was retrieved from **101** at the eastern extent of the lagoon the areas being stripped the topsoil produced a pottery deposit conducive with 19th to 20th century activity.

PI.1 Surface produced by tracked bulldozer, looking north west

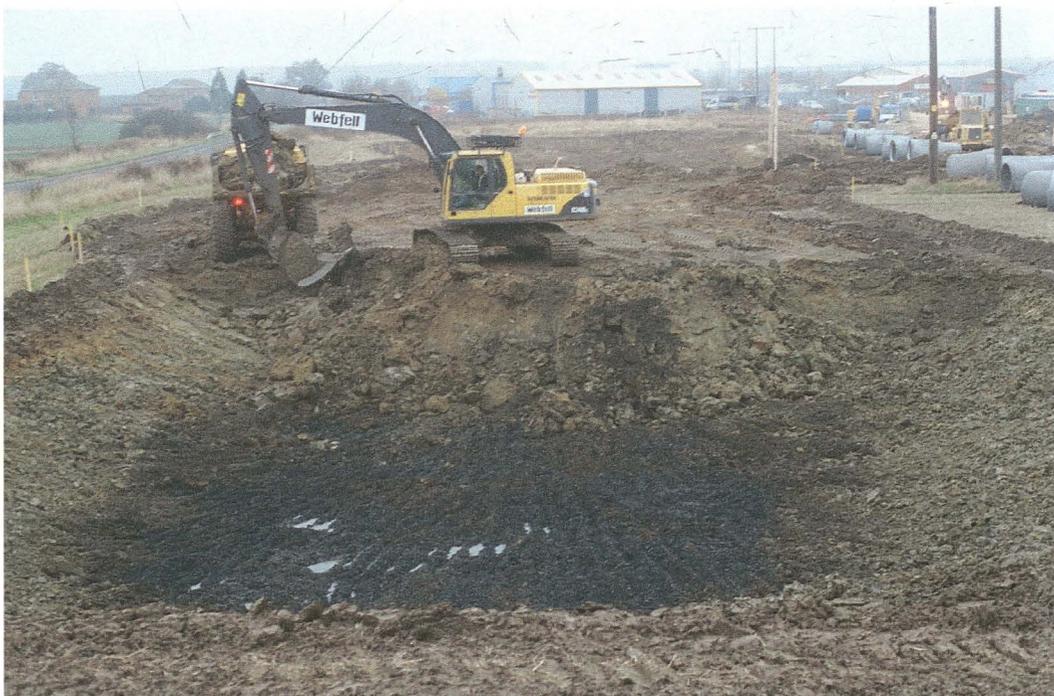
The excavation of the eastern end of the lagoon was undertaken with a 360° mechanical excavator with a toothed bucket.

PI.2 The excavation of the lagoon, looking west.

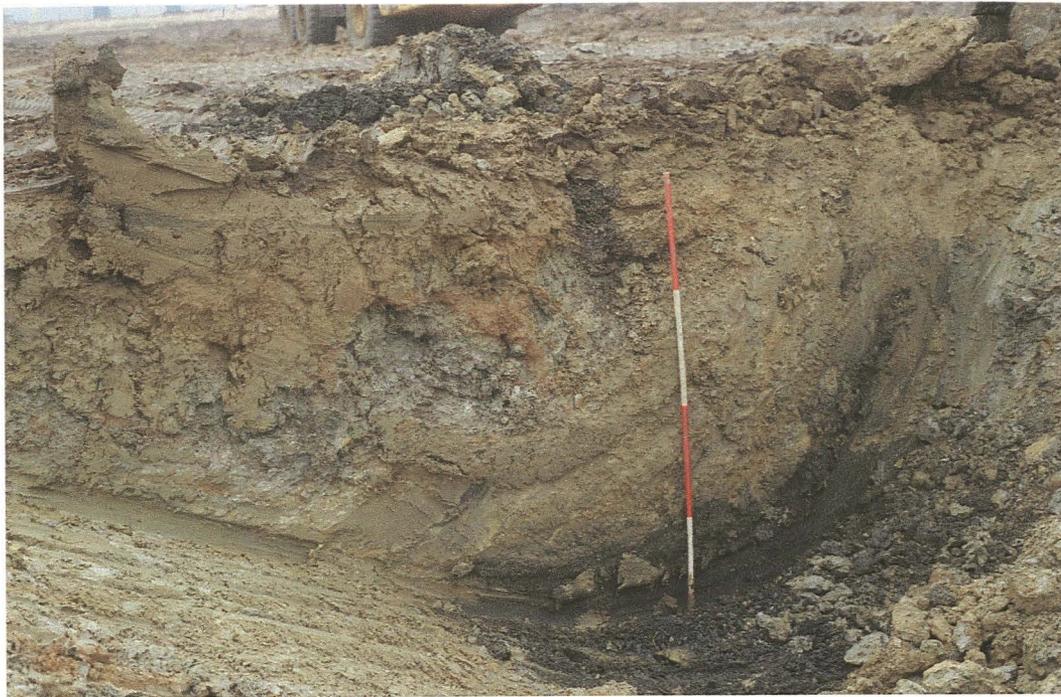
The deposits at the east of the lagoon (Pl. 3) consisted of

0.00m- 0.40m **101**

0.40m- 1.10m **102**

1.10m – 2.30m **103** Blue green clay

2.30m- 2.55m **104** Grey silty sand with laminar shale fragments c. 40mm x40mmx5mm

PI.4 Sample section cut during the excavation of the lagoon, looking west.

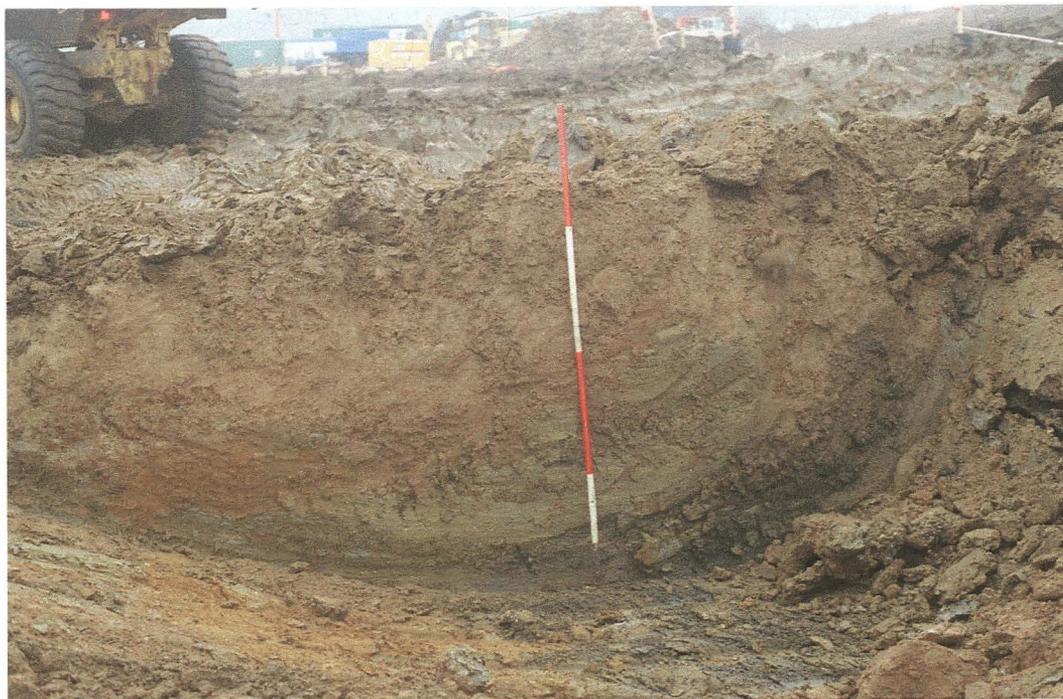
A change in the natural deposit was observed 40m from the eastern edge of the lagoon (Pl.4).

0.00m- 0.4m **101**

0.40m- 1.4m **105** Orange clay sand

1.4m- 2.10m **103**

2.10m- 2.20m **104**

No archaeological features were observed though two modern field drains were noted running down slope from east to west. This was the only area of the site where excavation penetrated the clays.

PI.4 Sample section 40m from the eastern edge of the lagoon, looking west.

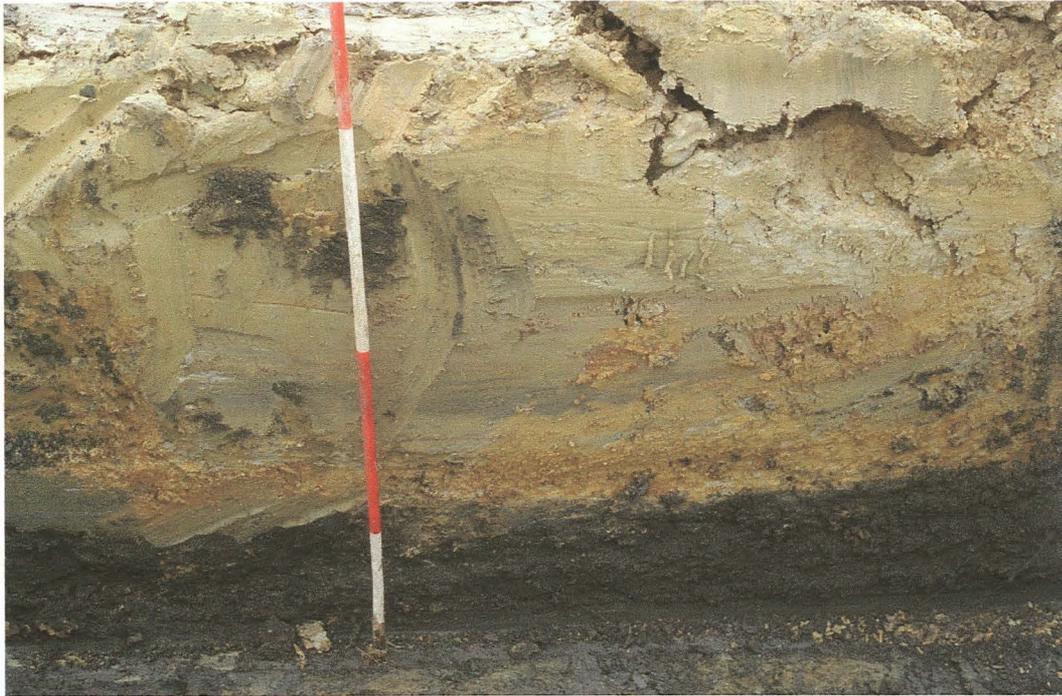
Sample section taken from foul pipe trench (Pl. 5)

0.00m- 0.55m **102**

0.55m- 1.30m **103**

1.30m- 1.60m **106** Dark grey brown clay

Pl. 5 Sample section of deposit in foul pipe trench 8m south west of the most south easterly manhole, looking north west.
