**Westgate, Lincoln
Water Mains Replacement Scheme**

Archaeological Monitoring

**Report prepared for
Anglian Water Services Ltd**

**LAS Report No. 693
December 2003**

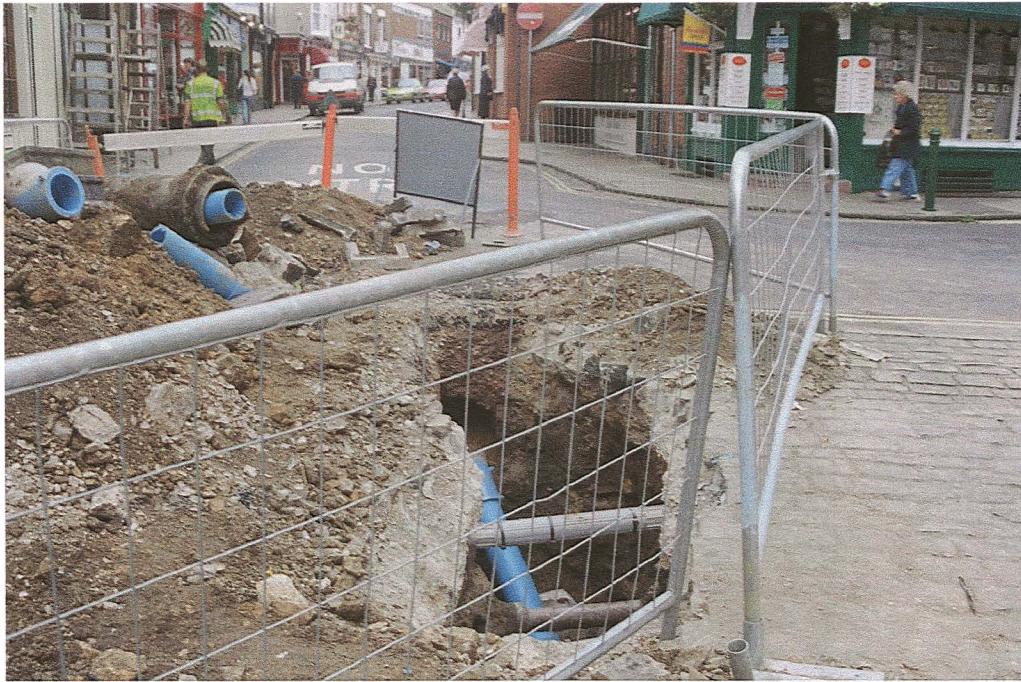
Pl. 1 Position of the trench at 1, near the junction of Bailgate and Eastgate (right) (looking north).

2. To the south of 1, a 2.1m deep, 3m x 1m trench cut through a series of 0.05m thick bands of orange material, possible Roman road metalling surfaces, about 1m below the modern surface (Pls. 1 and 2). They covered a deposit of loose stone rubble, which had been removed on the eastern side and replaced by a dark green/brown clay fill. This fill lay directly below a modern pipe, and may have been backfill of a deeper relatively recent trench, or a feature associated with the Roman surfaces.

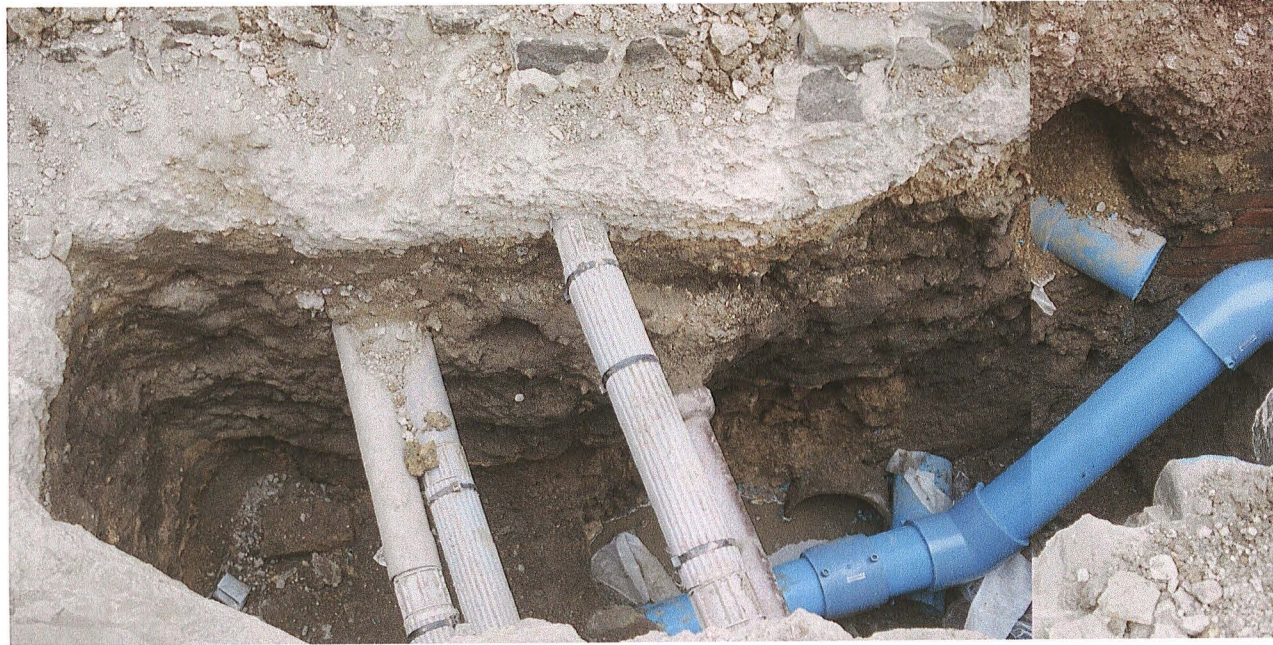
1. Close to the northern end of the White Hart Hotel, two trenches were excavated. The most northerly was 0.5m x 0.25m, positioned at the junction of Bailgate with Eastgate; a fragment of Roman tile was found in the spoil heap, together with a 0.10m thick lump of multiple floor surfaces (Appendix 1). In the midst of the floor surfaces is a *opus signinum* floor layer, between mortar layers of varying density. *Opus signinum*, a pale red mortar incorporating crushed tile fragments, is found in Roman buildings in association with water, such as in bath-houses; the surface appears to have been waterproof.

These layers suggest that the trench here was to the side of the Roman street, and had disturbed remains of floor surfaces within a Roman building.

Pl. 2 Deposits seen in the trench face at 1 included thin layers of ash and mortar (extreme left) which may represent Roman floor surfaces (looking west).

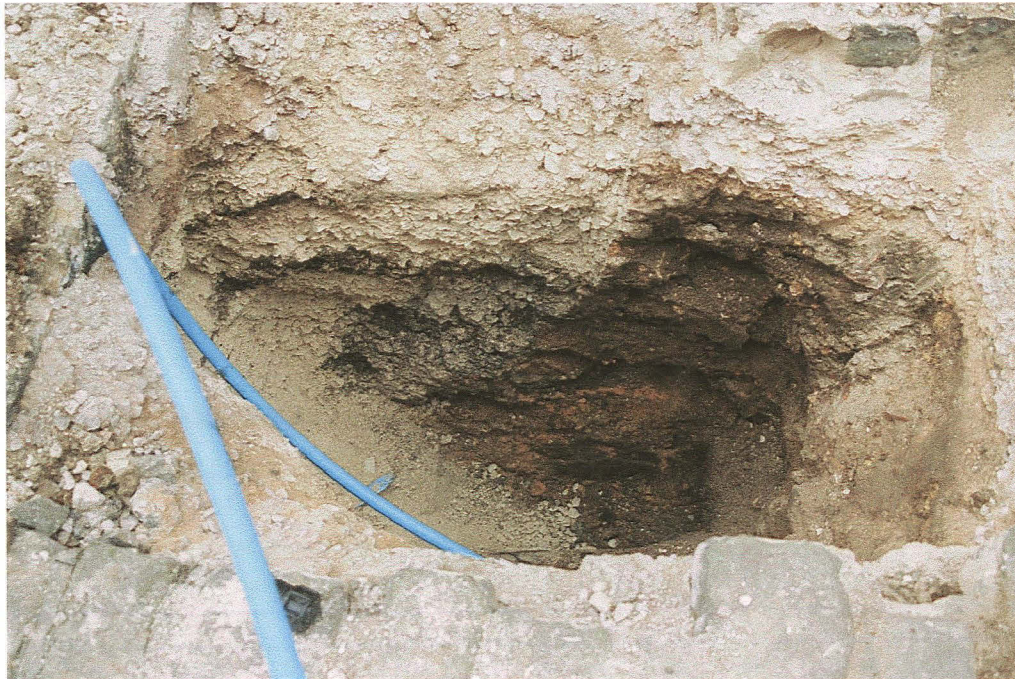
3. In front of the entrance to the White Hart Hotel, a 0.9m x 1.4m trench was cut to a depth of up to 1.8m, through a dark green/brown clay layer containing occasional fragments of brick and tile (Pl. 3).

Pl. 3 Deposits visible in the side of 3 (looking east).

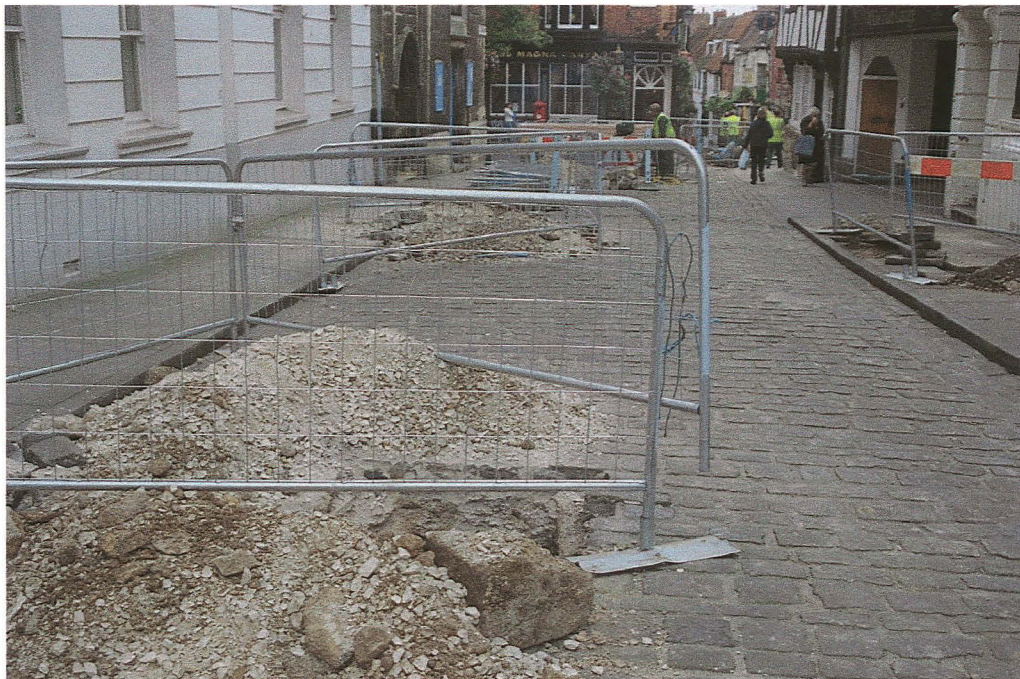
Pl. 4 Positions of the trenches in Bailgate at 4, 5, 8 and 9 (left side), 6 and 7 (to right) (looking south).

5. Opposite No. 4, the dark green/brown clay lay below a disturbed mixed gravel layer, possibly representing metalling redeposited from a road surface (Pls. 4-6). Further fragments of cut limestone blocks were found in orange clay in the spoil heap.

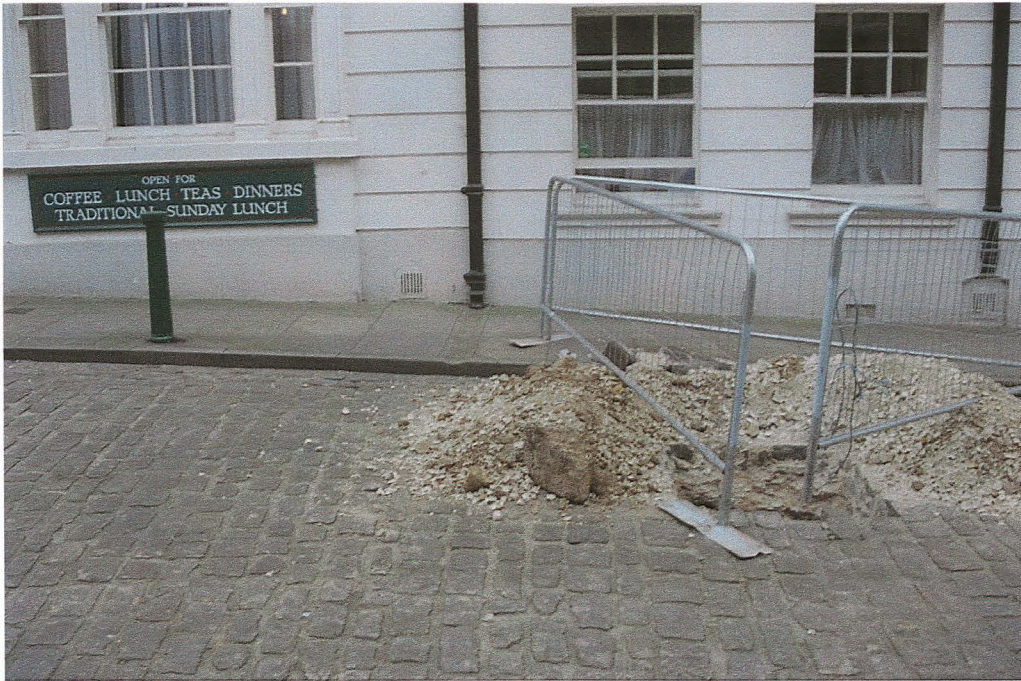
Pl. 5 Position of 4, in front of the White Hart Hotel (looking east).

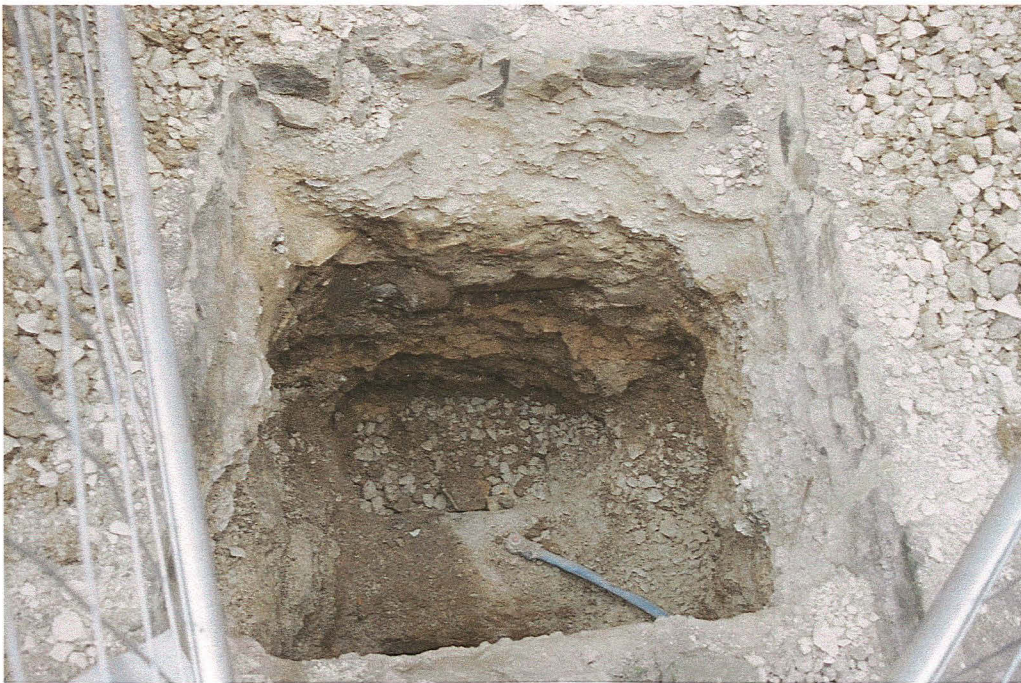
Pl. 6 Previously disturbed deposits and rubble at 4 (looking east).

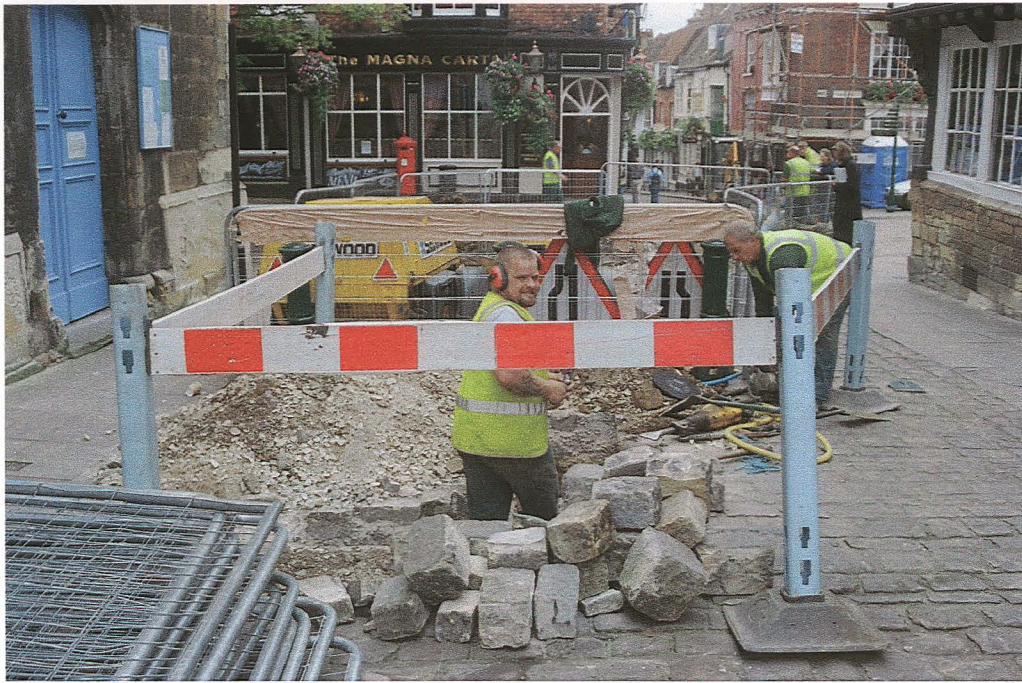
Pl. 7 Position of 8 (foreground), with 9 beyond (looking south).

7. A disturbed deposit, incorporating stone rubble, overlay a thick dark clay loam.
8. Close to St. Mary Magdalene Church, a trench cut through deposits containing frequent stone rubble (Pls. 7 and 8).

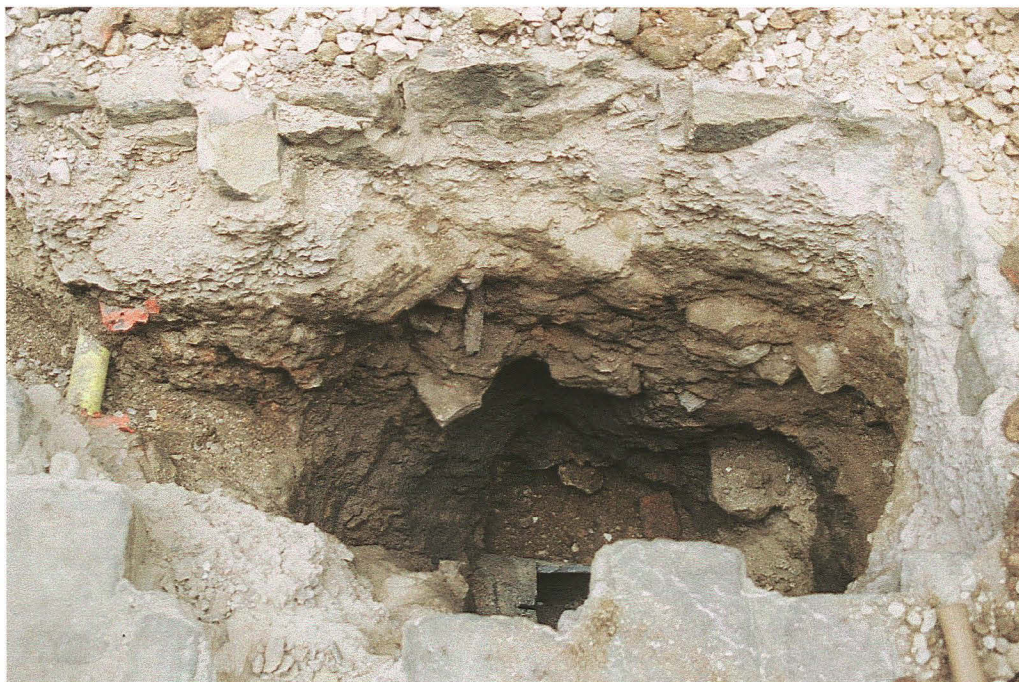
Pl. 8 Stone rubble and clay in lower part of 8 (looking east).

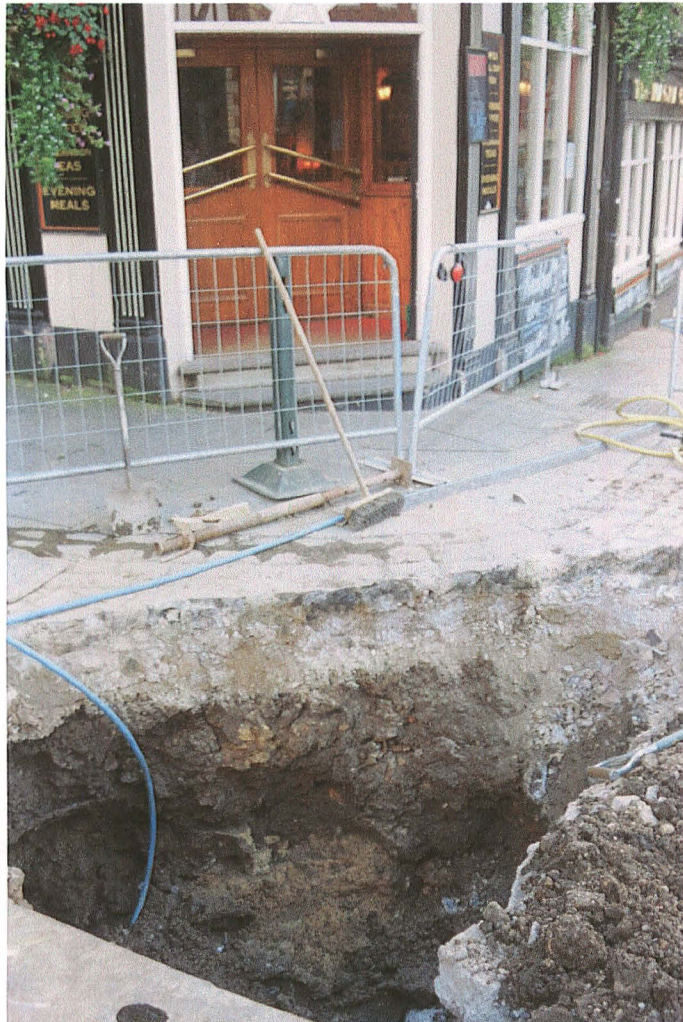
9. A large trench was excavated to the SE of No. 1 Bailgate, in the junction of Exchequergate, Bailgate and Castle Square. At its SE corner, three courses of mortared masonry were seen in the trench face, between 1.15m and 1.9m below the modern road (Pls. 9 and 10). Each course contained 0.2m roughly squared limestone blocks about 0.22m thick, with cut surfaces. The uppermost course was covered by a 0.37m thick clay loam deposit which appeared to be of some antiquity. The lower course continued below the base of the visible trench. It has been assumed that these building remains are of Roman date.

Pl. 9 SE corner of trench at 9, showing the mortared masonry in relation to existing buildings on Steep Hill (looking SE to the Magna Carta public house entrance).

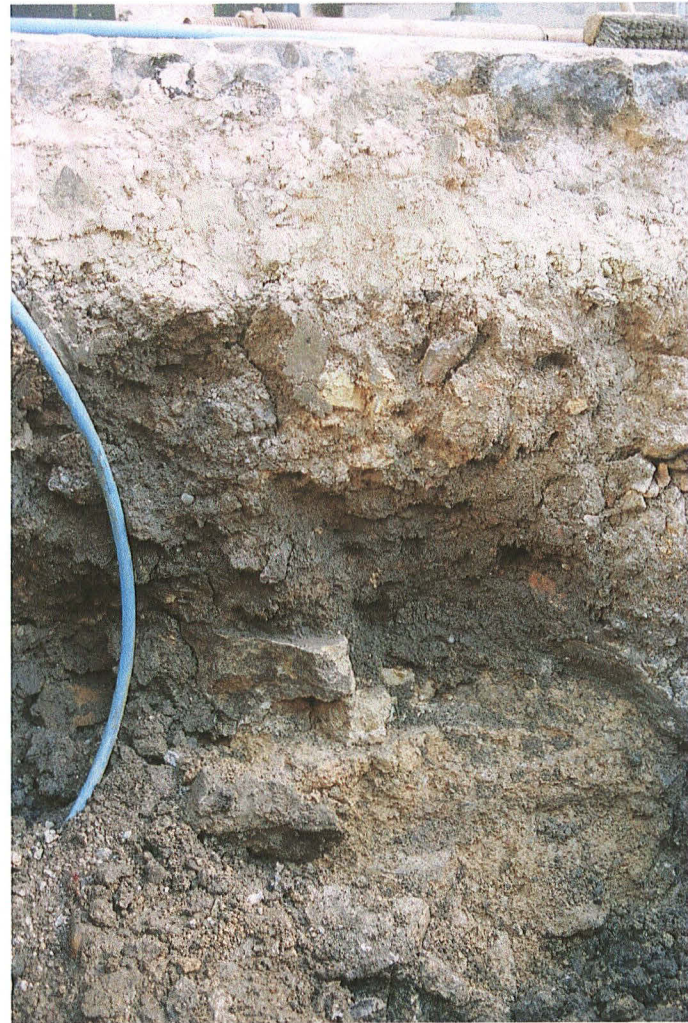
Pl.10 Detail of the three exposed limestone courses and overlaying deposits, at the SE corner of 9 (looking SE).

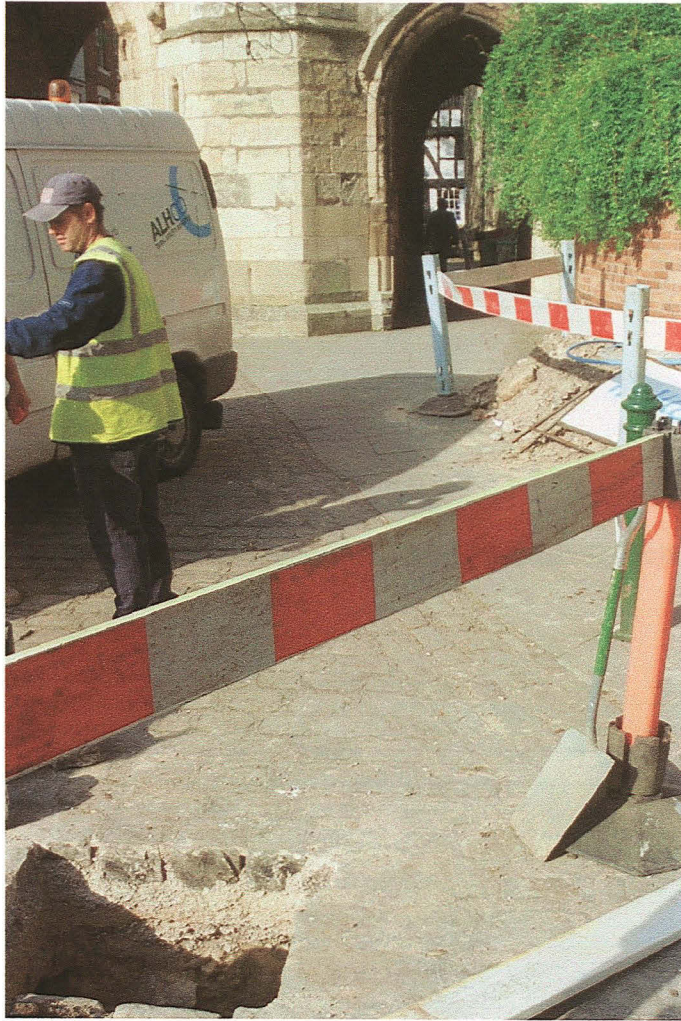
Pl. 11 Position of 15, in Minster Yard, east of Exchequer Gate (looking west).

15-17. At a later stage, the contractors reported seeing human skeletal remains in a stone coffin exposed by another trench **15**, in the roadway of Minster Yard (Pls. 11-13). A site visit found that although one corner of a stone coffin had been slightly disturbed, the skeleton remained inaccessible. It appeared that the grave was lined and covered with stone slabs, not within a fashioned coffin, but too little was exposed to confirm this. Subsequent recording in this trench identified a second stone-covered and stone-lined grave, separated from the other horizontally by about 0.4m. The coffins were not parallel, one being aligned approximately east-west, and the other NE-SW.

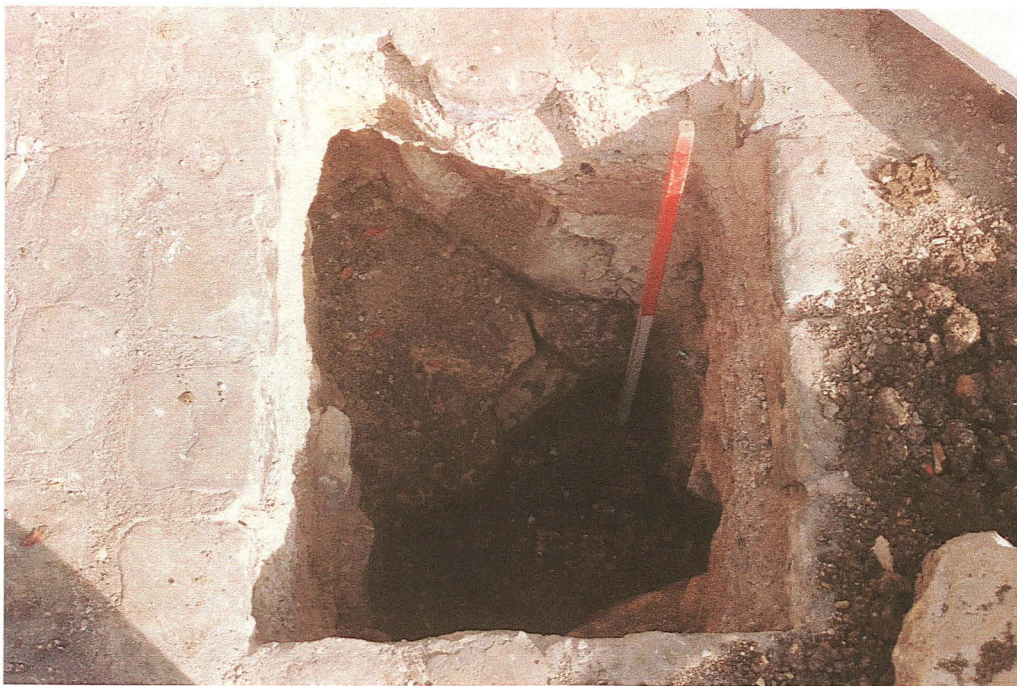
Pl. 12 Trench 15, showing the space between two stone-lined graves; a small gap in the stone cover is visible to the left of the 1m scale (looking east).

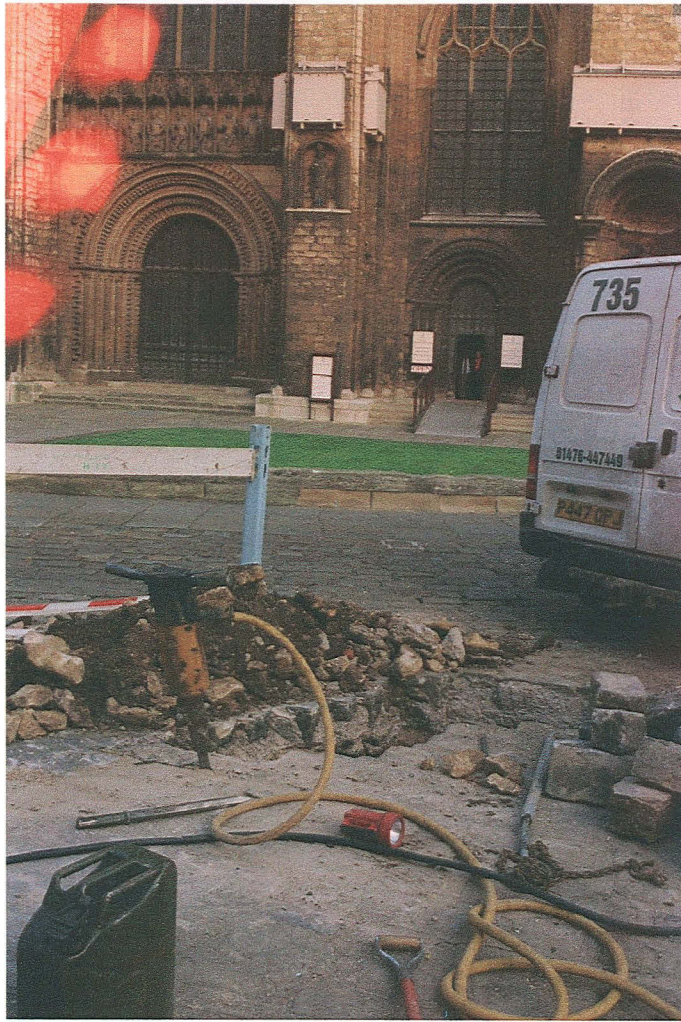
Pl. 13 Position of 16, in Minster Yard, east of Exchequer Gate (looking east).

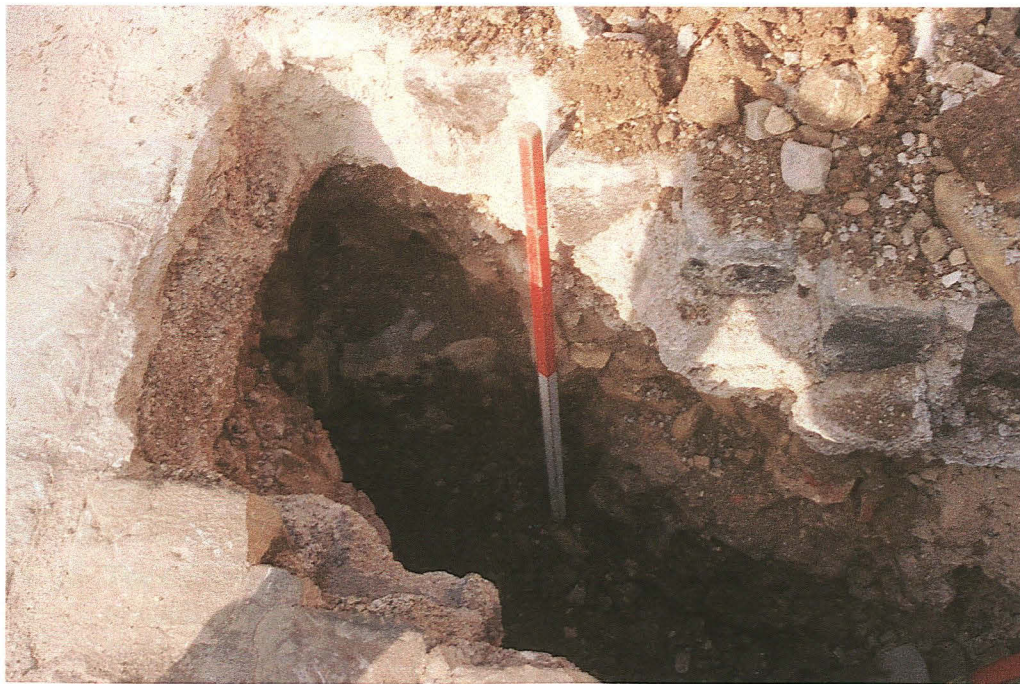
Further work was closely monitored, and another stone-lined grave was found in **16**, about 2m further east. The contractors were able to insert the new pipe above the coffins, and there was no disturbance to the human remains. LAS understands that during installation of a previous water main in this area (monitored by the City of Lincoln Archaeology Unit), numerous coffins were encountered.

Pl. 14 Stone slabs beside grave at 16 (looking NW, scale 1m).

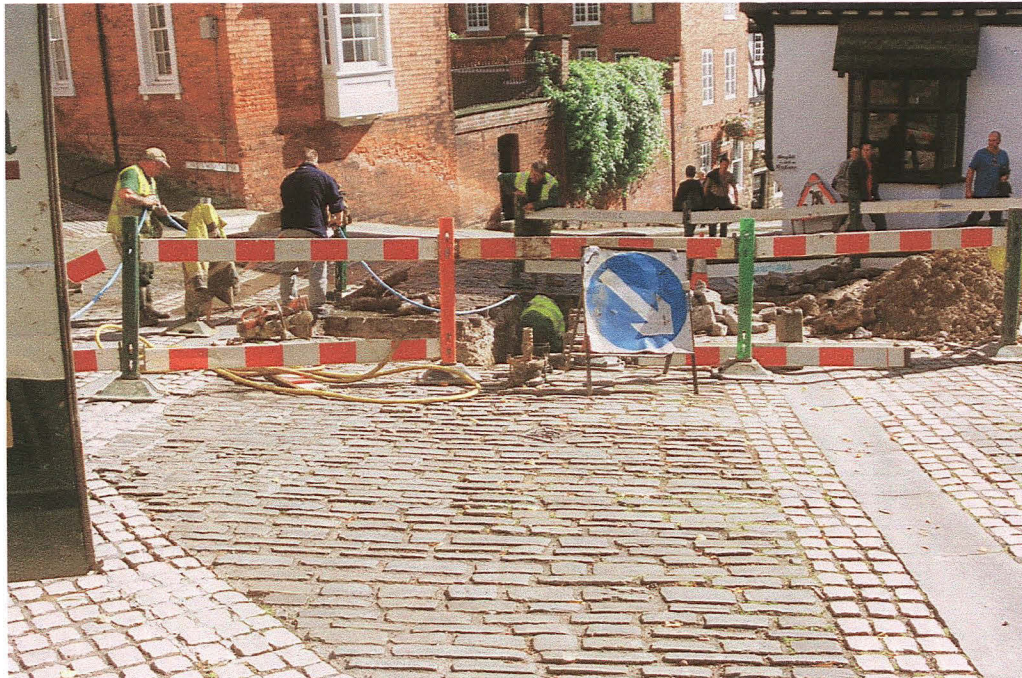
Pl. 15 Location of the trench at 20, across Steep Hill at the junction with Michaelgate (looking SE down Steep Hill).

20. A large trench was opened at the junction of Steep Hill, Michaelgate, and Christ's Hospital Terrace (Pl. 15). The trench encountered a series of possible road metalling layers at between 0.4m and 0.8m deep, with limestone bedrock 1m below the modern road surface (Pl. 16). The southern edge of this metalling seemed to coincide with the existing surface culvert marking the side of the Steep Hill carriageway; immediately below this was a 1.1m wide, 0.85m deep ditch, filled with a mixed dark grey/brown stoney clay loam (Pls. 17 and 18). Apart from recent disturbances, the trench showed deposits to the SW below 0.75m to be apparently

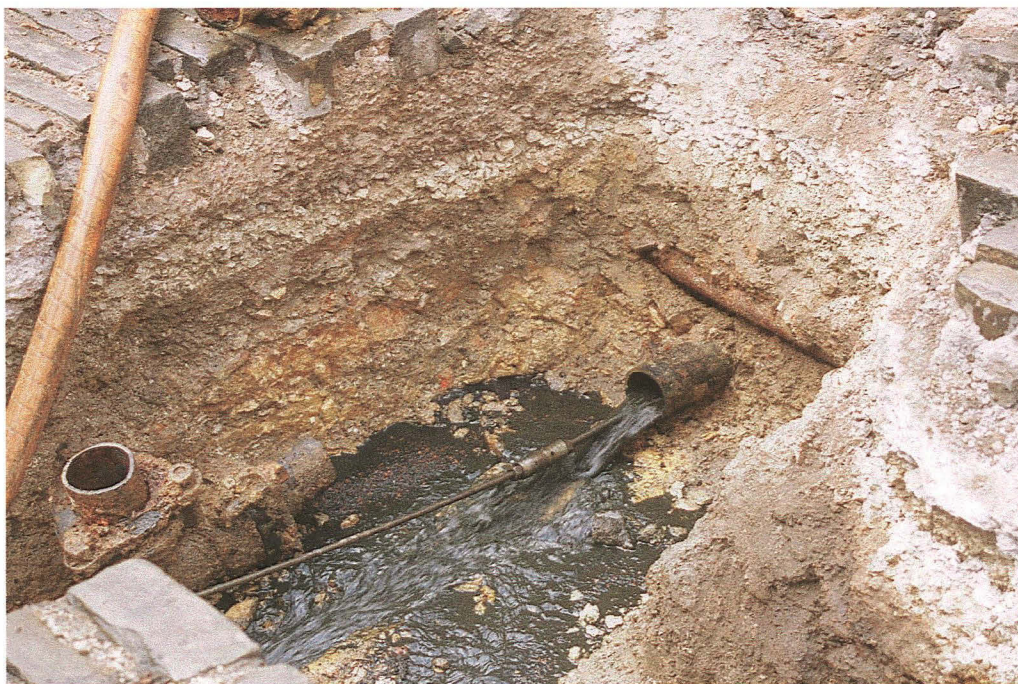
Pl. 16 The existing pipe at 20, being scraped and flushed, was laid immediately above limestone. Beyond the trench backfill are layers of stone chips and rubble, which may represent Roman or medieval metalling of Steep Hill (looking west).

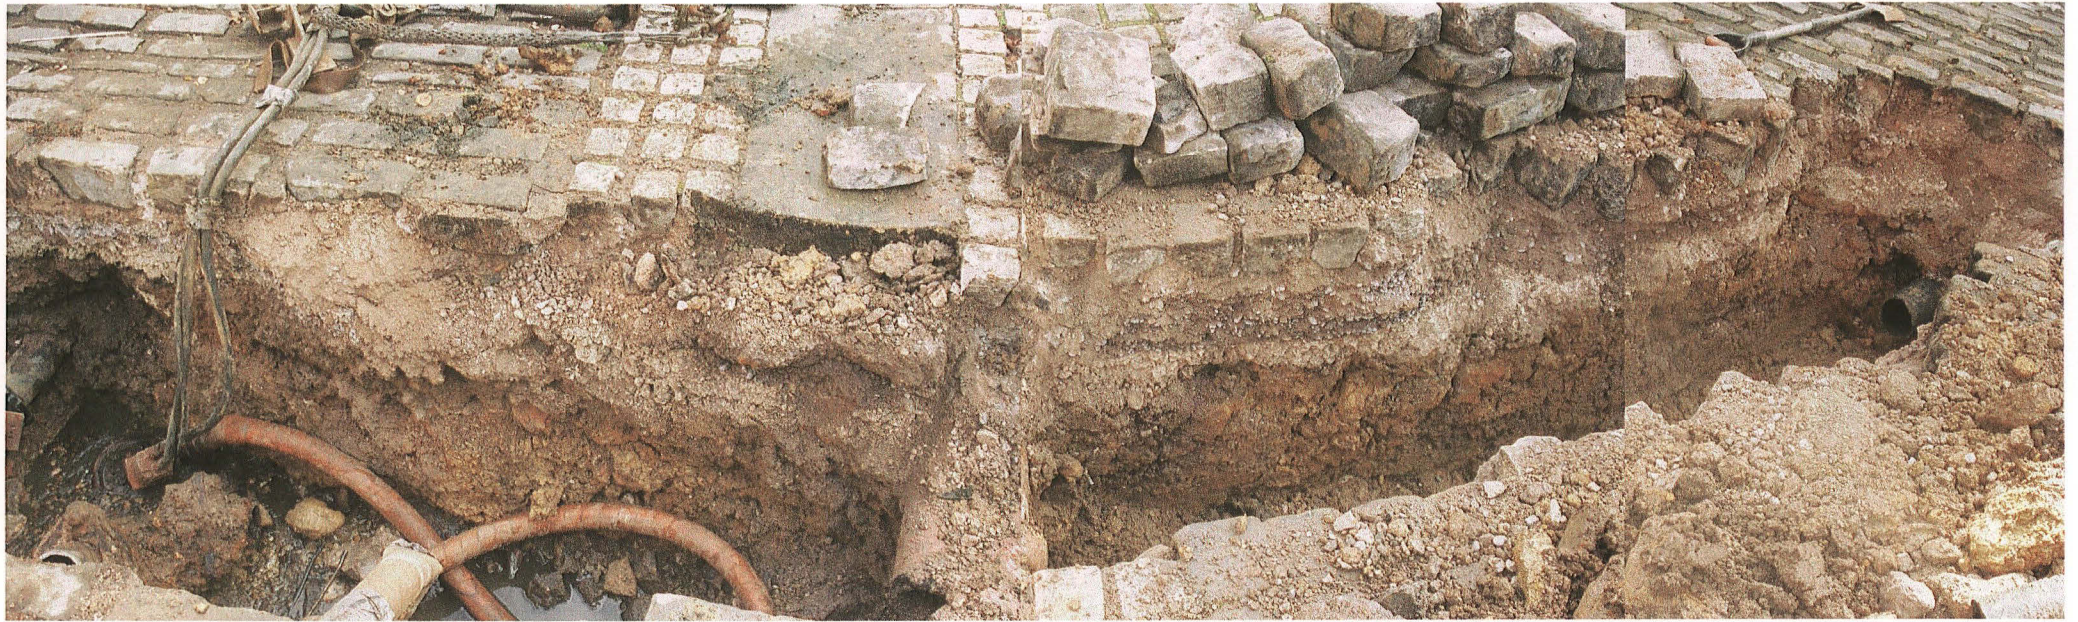
Pl. 17 Composite photograph showing deposits in the SE trench face at 20. Note the dark clay below the double ceramic pipe, thought to be ditch fill with apparently undisturbed clay to the right (looking SE at the junction of Michaelgate and Steep Hill).

undisturbed yellow clay. If these observations are correct, the metalled road down Steep Hill was positioned at the southern edge of a limestone exposure.

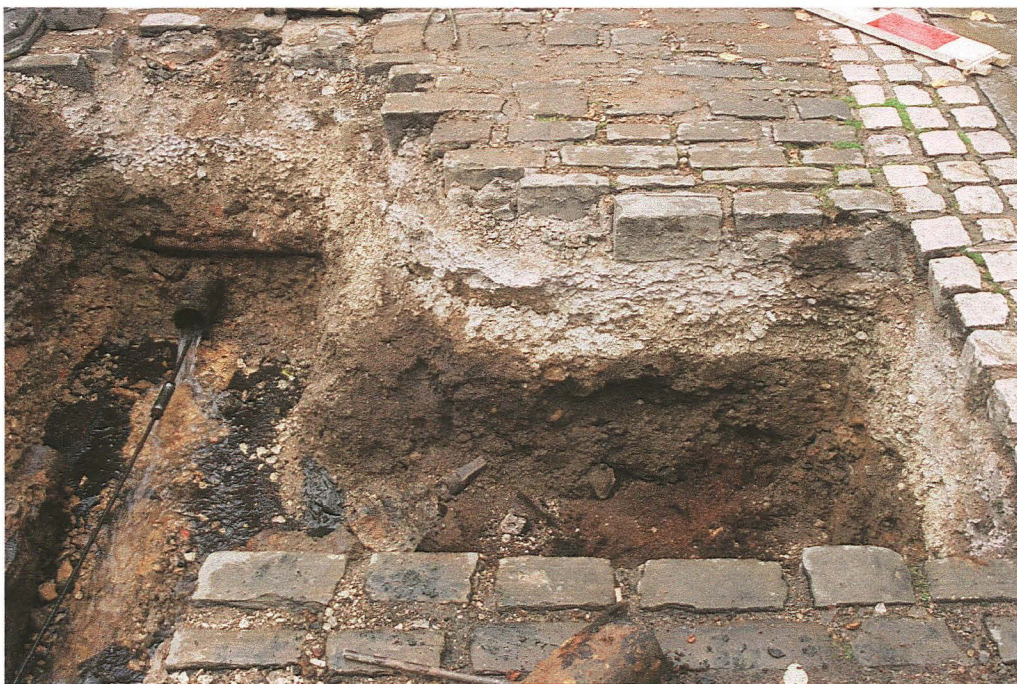
To the east of the trench (in the centre of the modern Steep Hill carriageway), metalling was absent, but a 0.5m thick deposit of dark silt and gravel could represent disturbance of the road (Pl. 19).

Pl. 19 Disturbed deposits below the centre of Steep Hill at 20 (looking NW).

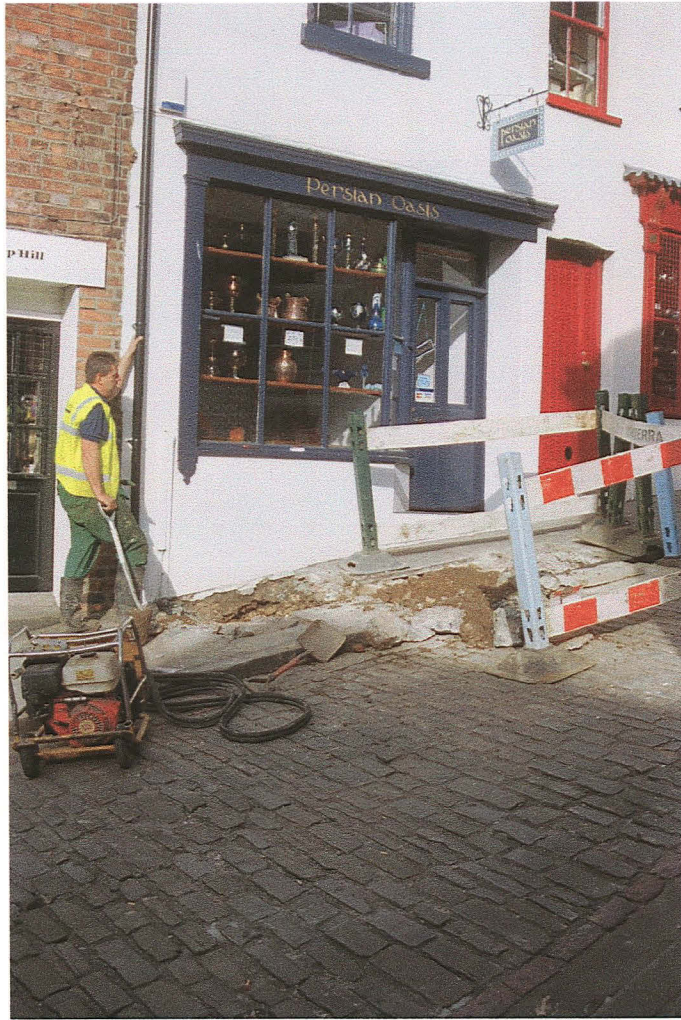
Pl. 20 Location of trench 21 in the western pavement of Steep Hill (looking NW).

21. A trench excavated to locate the existing main below the western footpath, beside No. 15 (Persian Oasis), revealed dark grey clay (Pls. 20 and 21). An extension of this trench, beside the shop wall, found that a loose rubble layer extended below the shopfront, to a depth of 0.5m below the path (Pl. 22). Beneath this was a dark yellow clay loam, 0.4m thick, containing early-mid second century Roman pottery, and animal bone fragments. This appeared to be a Roman horizon, with bedrock beneath it. The pottery is a high status group, and has been identified as indicating Hadrianic occupation from the early second century AD, possibly from the early part of the *colonia* status of Lincoln (Appendix 2).

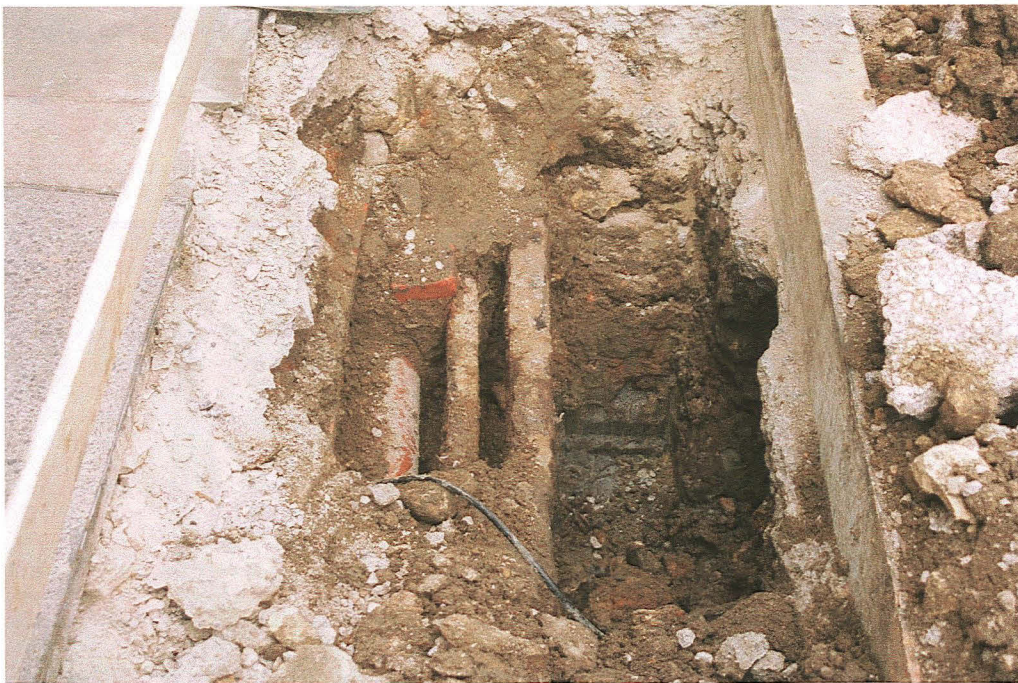
Pl. 21 Dark grey clay at the trench base beside the road at 21.

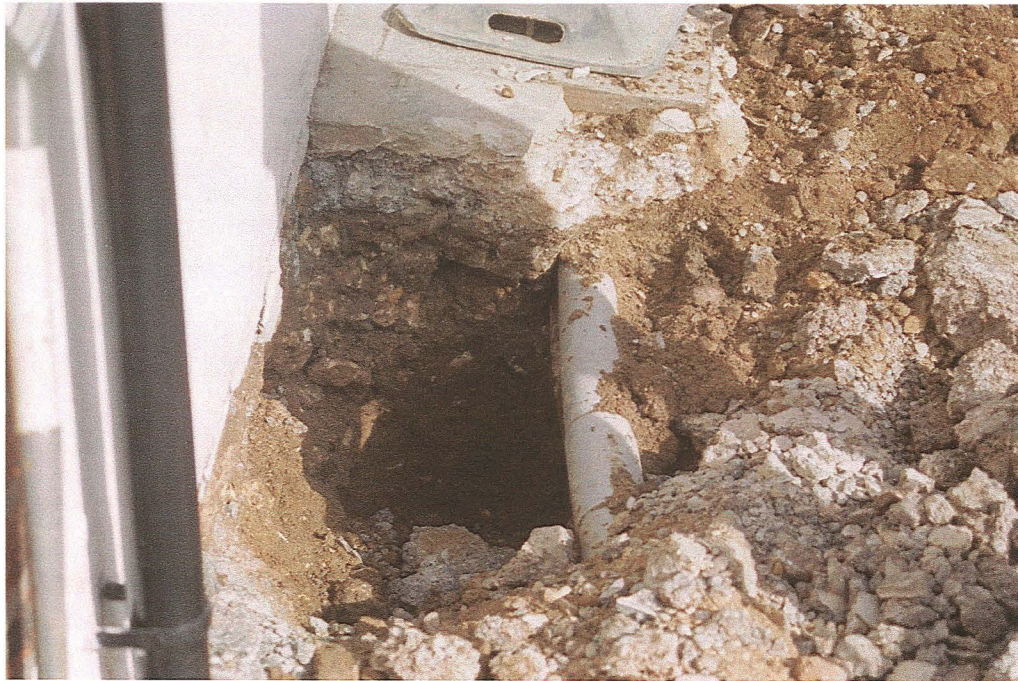
Pl. 22 Limestone rubble extending below the front wall of 'Persian Oasis' at 21. Roman material was found in the mixed deposit below (looking north).

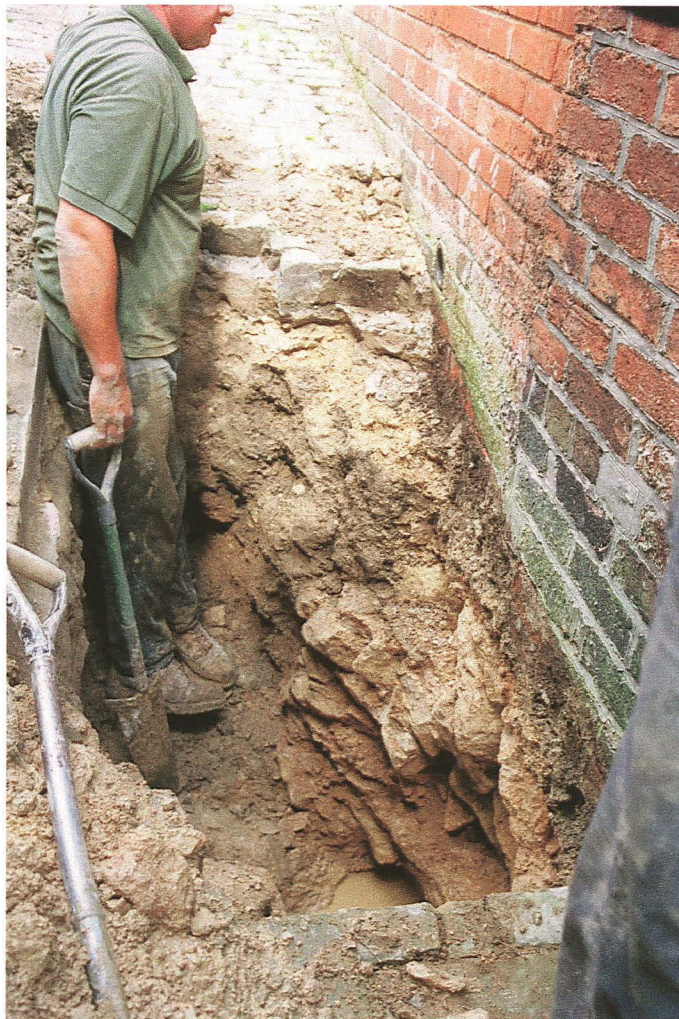
25. A small trench close to the rear pedestrian entrance to Relay House revealed limestone rubble in an unfaced wall below the existing brick property boundary wall (Pl. 23). Fragments of Roman tile were disturbed at the same location, 1.3m below the lane surface. The stone rubble is assumed to be part of the core of the Roman city defences, which continue on this alignment beyond City Hall.

Pl. 23 Setts covering stone rubble core of the Roman wall in Motherby Hill 25 (looking NE).
