**KIRKBY LA THORPE CHURCH OF ENGLAND SCHOOL
KIRKBY LA THORPE, LINCOLNSHIRE**

**ARCHAEOLOGICAL WATCHING BRIEF
REPORT**

Site code	KLTS 03
NGR:	TF 0994 4598
LCCM Acc No:	2003.362
Planning ref.	N/34/0825/03

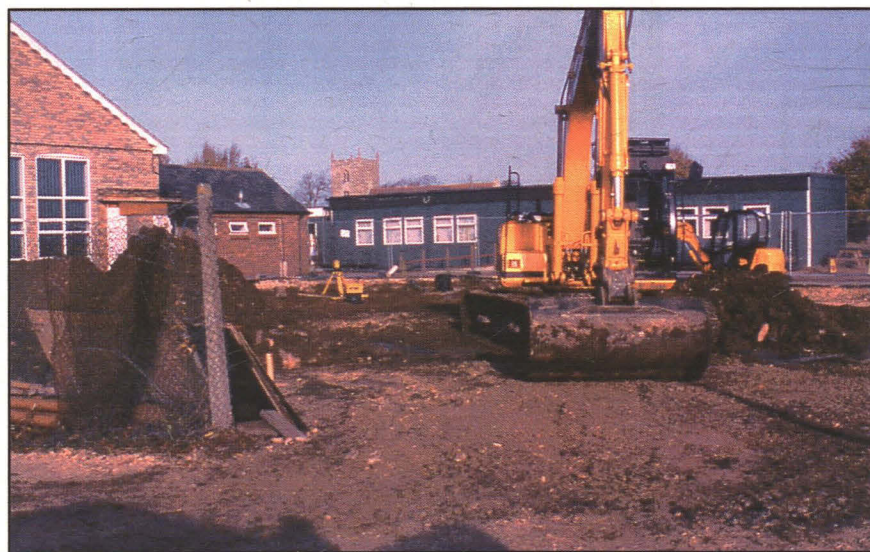
Plate 2 (left): General shot of the development site during excavation of the foundation trenches, looking NW.

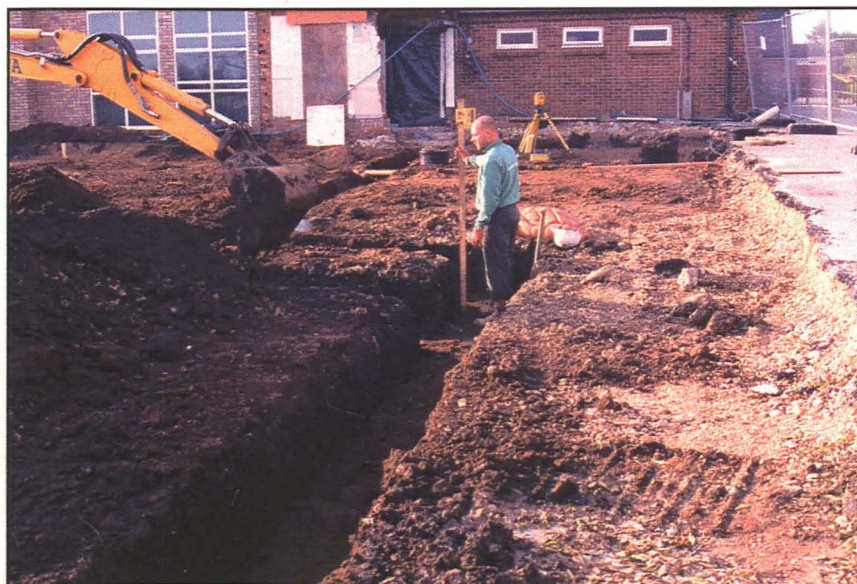
Plate 4 (above): W facing section of cess-pit after removal of brick structure, looking E.

On the east side of the drainage run, excavations for the foundation trenches encountered a redundant earthenware drainpipe within a brick inspection chamber, which proved to be sunk into the brick rubble filling a larger structure. This cistern-like structure measured approx. 2.7m x 2.4m x 1.8m, was built of modern machine-made brick with a concrete base and lid, and was partially flooded: it appeared to be the cess-pit pertaining to the outside toilets of the original school building. A brick-

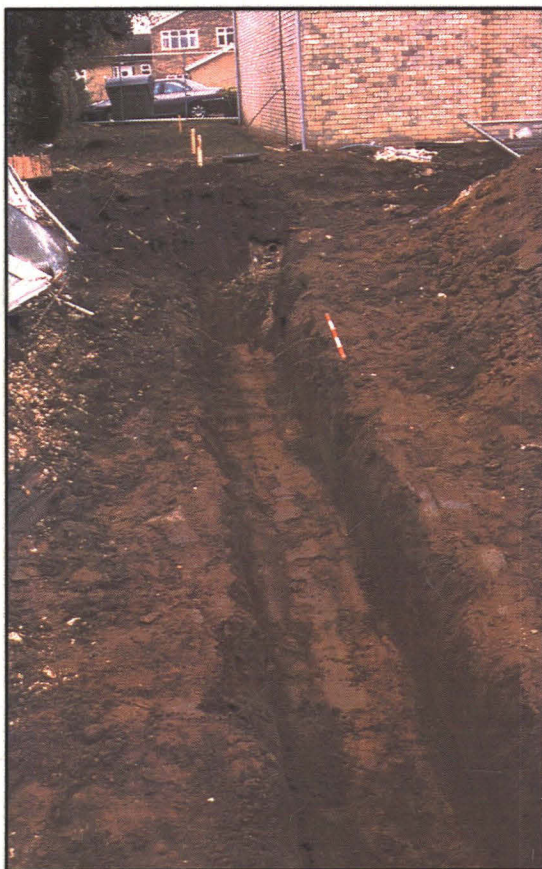
Plate 5 (left): Foundation trench on the S side of the site, showing sand natural 002 in base of trench and modern soakaway pit at rear, looking W.

lined soakaway pit associated with a more recent drainage system was encountered in the SW corner of the site; a small dump of modern refuse (glass bottles, transfer-printed china and fragments of iron) in the topsoil directly NE of this pit extended into its backfill. No features were seen in the sections of either pit.
