**Mountbridge Works, Fishtoft Road, Boston, Lincs.
Archaeological Evaluation**

Site Code: MBWB03

Chestnut Homes Limited

**LAS Report No. 713
December 2003**

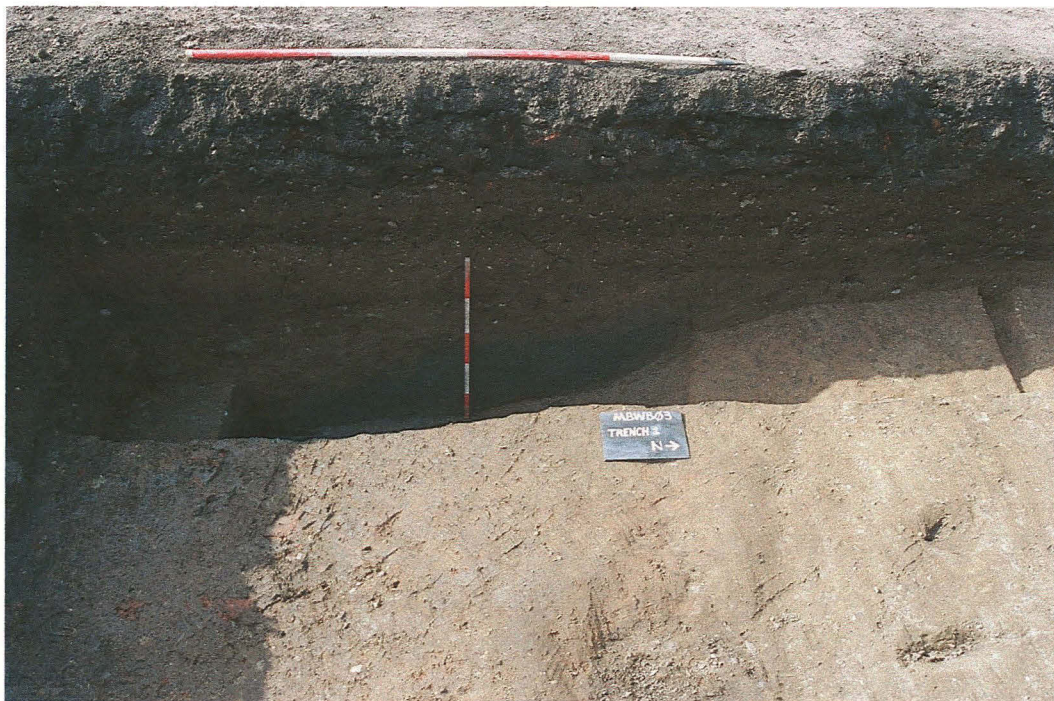
Pl. 2 Channel [104] looking west

A silt-filled former water channel [104], was located in the southern part of the trench which is possibly contemporary with (124) and earlier than the plough scores sealed by (123). The feature contained fills (122) and (121) which were overlain by the buried soil (123) indicating a period of stabilisation at this point. Further fills 120, 119 and 118 followed this period of stabilisation. Fills (119) and (120), both contained handmade bricks, dating to between the 14th and 16th centuries.

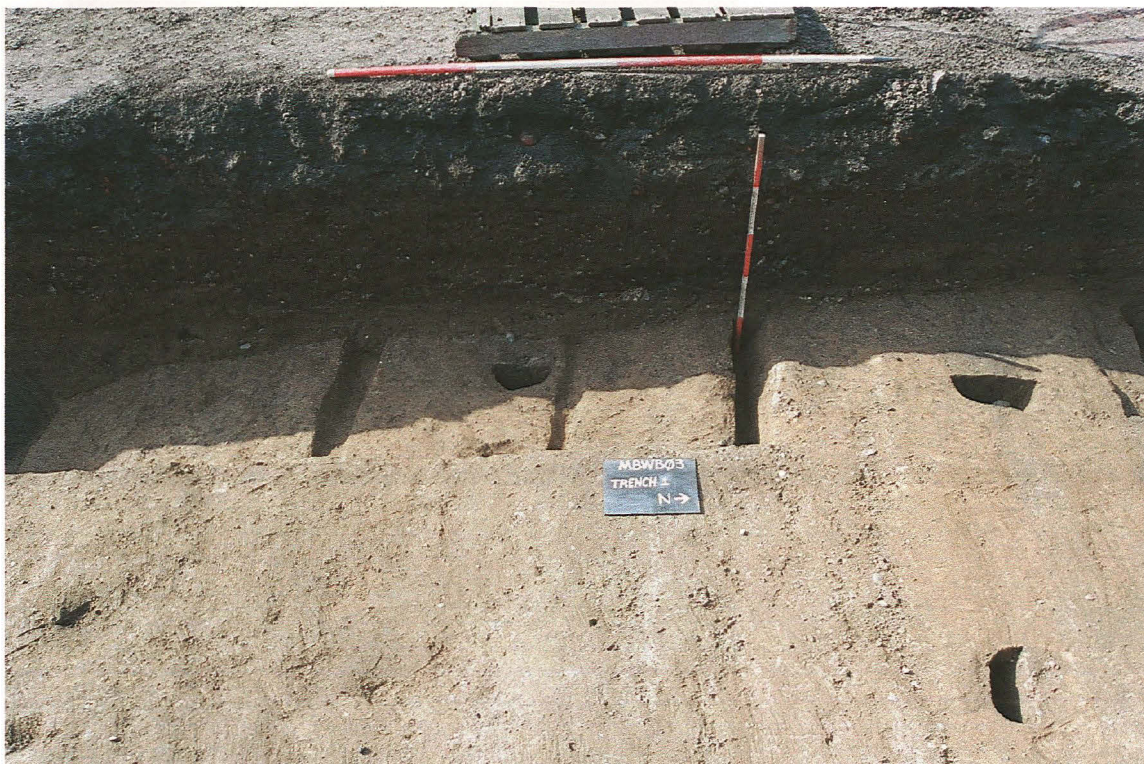
Pl. 3 Plough marks and post holes located within the central area of Trench 1

Layer (123) continued south, sealing four additional plough scores within the centre of the trench, [158] [112], [150] and [149]. All four of the plough scars had been filled by (123), and cut through underlying natural silts (124) and (142).

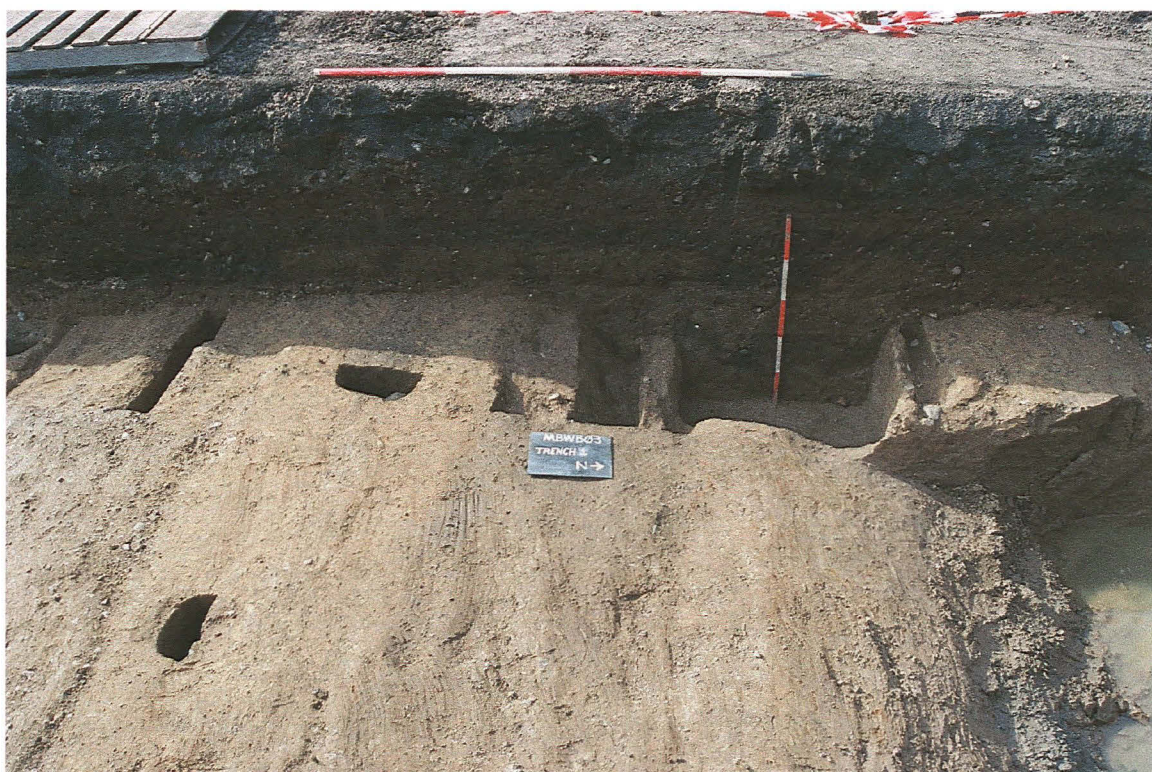
Pl. 4 Plough marks and pits located within the northern area of Trench 1

Directly below, and filled by (129), were three parallel depressions interpreted as possible plough scores. Features [154] and [156] were visible in Profile 1 and on plan, [155] is only visible on plan (see Fig. 5). They were only 0.03m deep and 0.05-0.07m wide but were similar in dimensions and alignment to more convincing plough scores to the south which suggests that they were not natural in origin.

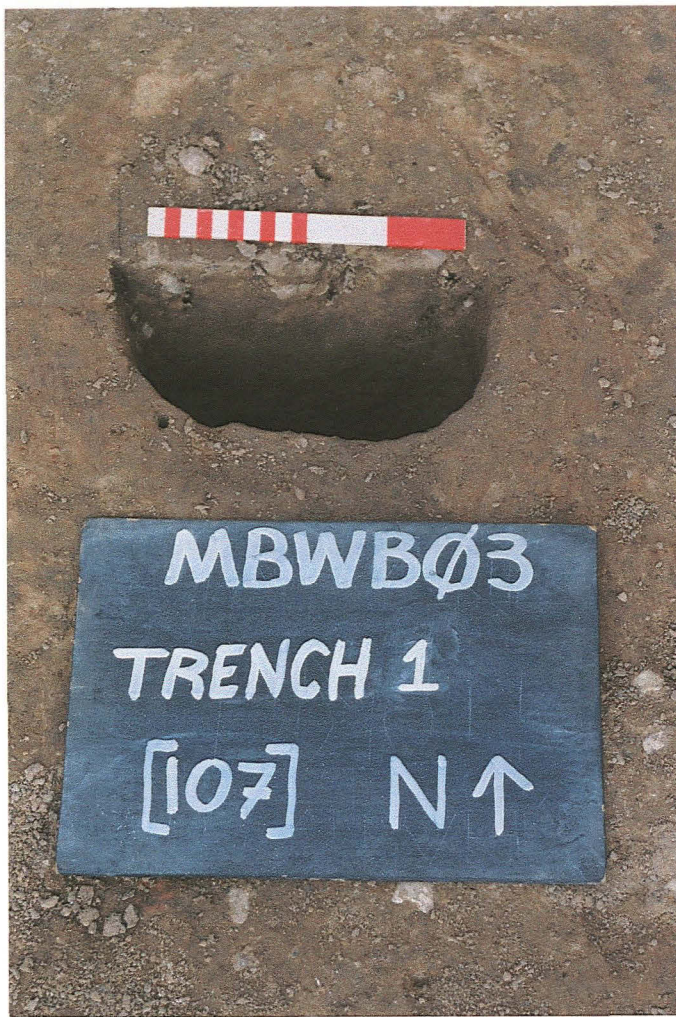
Pl. 5 Feature [107], Section 2

Located approximately 1m north of [106] was post hole [107]. It was also square in plan with slightly rounded corners, and measured 0.55m in width with a depth of 0.09m. The single fill, (136) consisted of very pale yellow brown and grey brown mottled sandy clay with no inclusions. A very shallow depression, [108], located within the centre of the trench against the eastern baulk edge, may have been the truncated base of a square cut post hole. With a width of 0.45m and depth of 0.03m, this feature contained a very pale yellow brown and grey brown mottled sandy clay fill with no inclusions (137), very similar to (136).

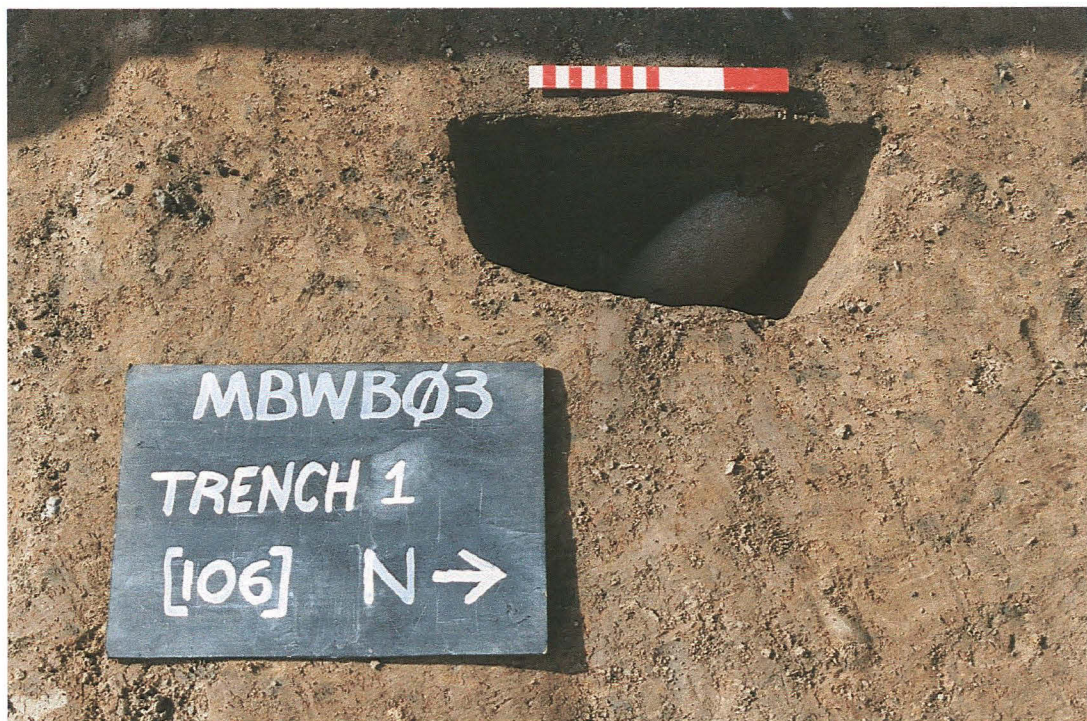
Pl. 6 Feature [106], Section 1

Post hole [106], by far the largest within the trench, measured 0.34m square with a depth of 0.27m) truncated plough scar [158]. It contained two packing stones and two fills (134) and (135) comprising sandy clays and silt. Layer (123) also sealed post hole or possible shallow pit, [140] in the centre of the trench. It was only partially exposed in the deeper slot dug on the west side of Trench 1, but measured 0.25m in diameter and was 0.05m deep.

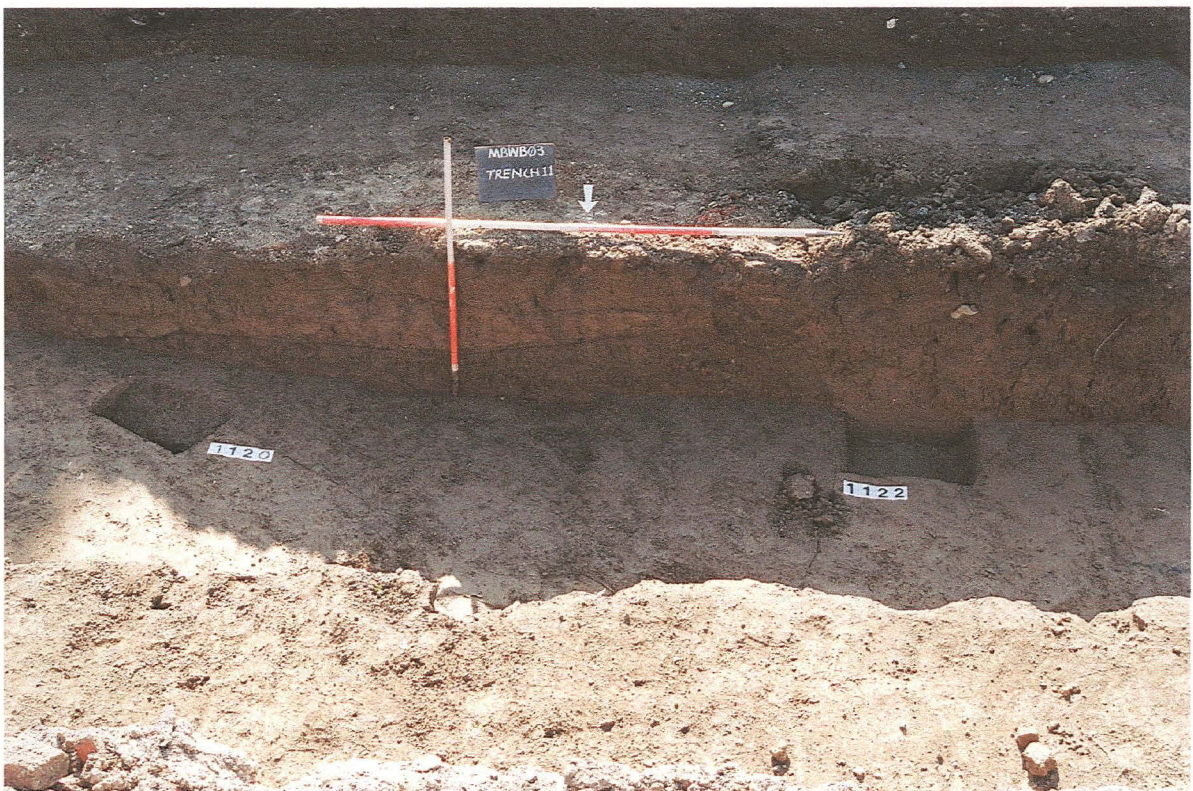
Pl. 15. Palaeochannels [1120] & [1122]

Due to the depth of the stepped excavation, deeper excavation would have breached health and safety recommendations. A hand auger was therefore used in order to determine the nature of deeper alluvial deposits associated with channel [1122]. The examination of channel [1122] confirmed deep stratified alluvial deposits to a depth greater than -0.36m AOD. Deposit (1123), which underlies the eastern extent of the channel, was recorded at 1.13m AOD, on top of which a sterile primary fill (1155) and two alluvial deposits with a high organic content (1154 and 1155) would suggest a channel depth of 1.36m. Earlier phases of inundation are visible in (1156) and (1157).
