**ARCHAEOLOGICAL EVALUATION
ON LAND AT 138 - 142 HIGH STREET,
BOSTON,
LINCOLNSHIRE
(HSBA03)**

Work Undertaken For
SMG Development Co. Ltd.

December 2003

A.P.S. Report No. 195/03

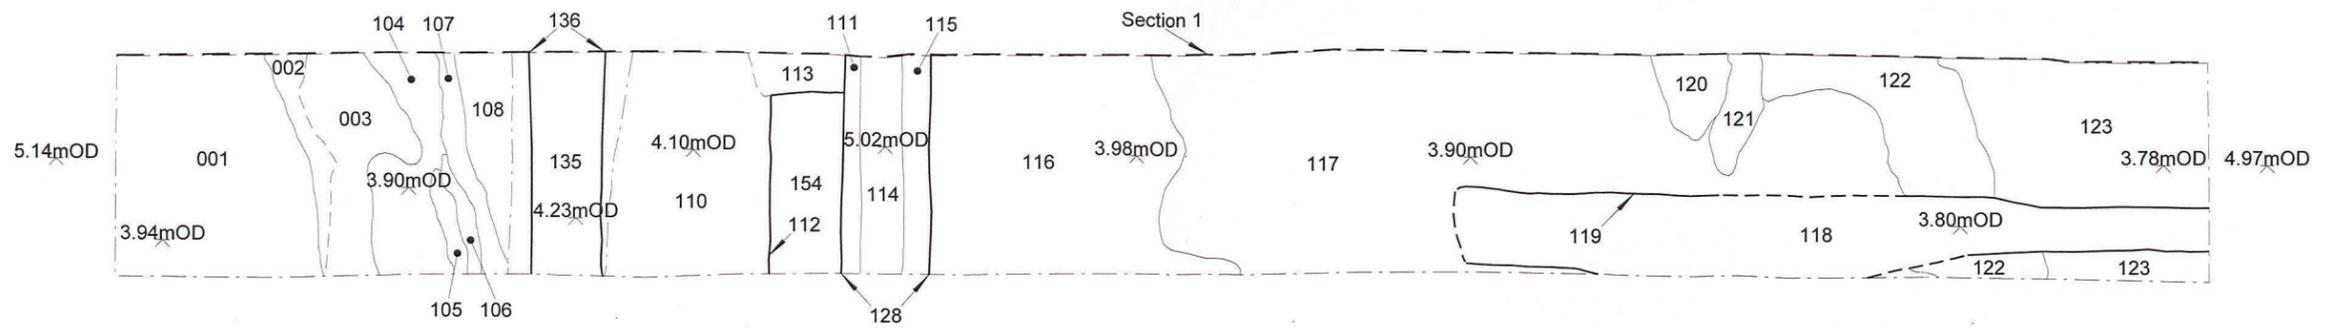
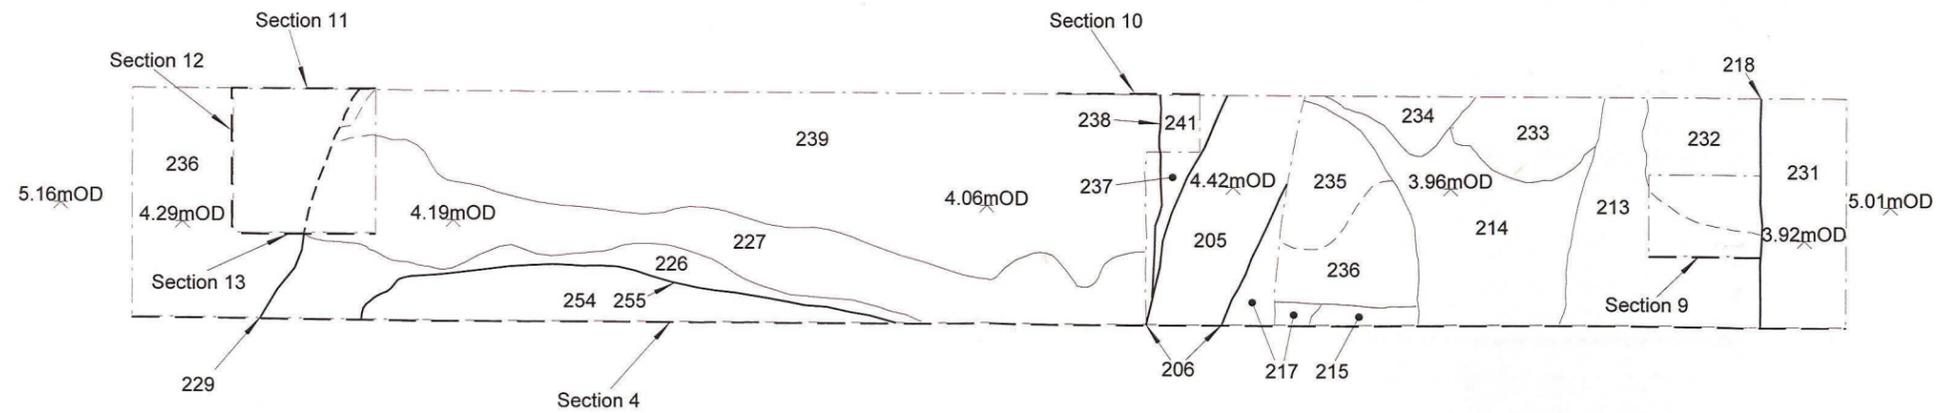
Figure 4 Trenches 1 and 2.

Trench 1

Trench 2

Cutting through layer (126 and 148) were a number of services trenches and construction cuts. At the east end was an east-west orientated service trench (119) with a mottled grey and brown sandy fill (118). Further to the west was a north-south construction cut (112) and fill (154), with a second construction cut (128) above containing a concrete foundation (111 and 115), a brick wall (114) and a brown silty fill (127).

At the north end of the trench three lenses of brown silty sand (209), brick rubble (210) and crushed lime (211) were observed, overlying layer (212). Sealing the lenses was a 0.20m thick grey-brown sandy silt (208), which was overlain by 0.10m of pale brown sand (207).

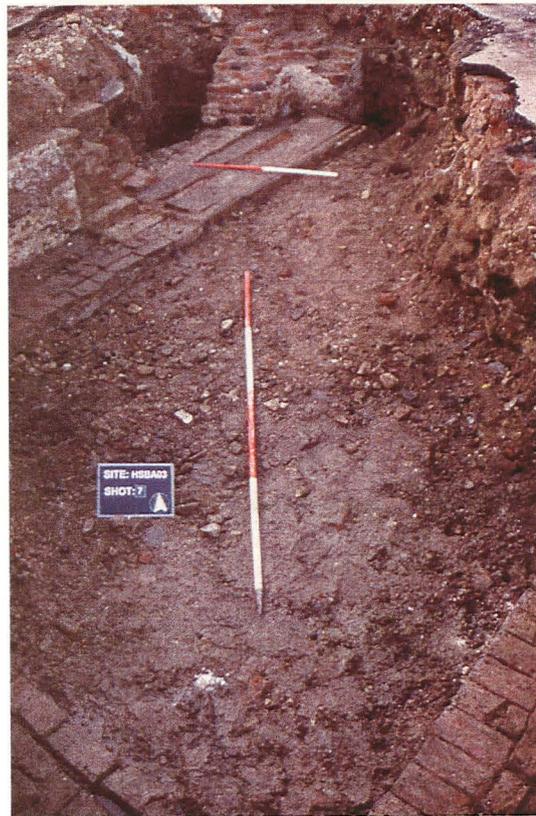
Plate 6 Cellar structures in Trench 3, looking west.

The most complete building remains found on the site were the cellar structures located in Trench 3. These were probably of 19th century date (which is consistent with the map evidence) and have been interpreted as a beer cellar; brick platform (308 and 321) forming a stand for the barrels and platform (307) and piers (322 and 323) supporting a timber structure, possibly for raising or lowering barrels.

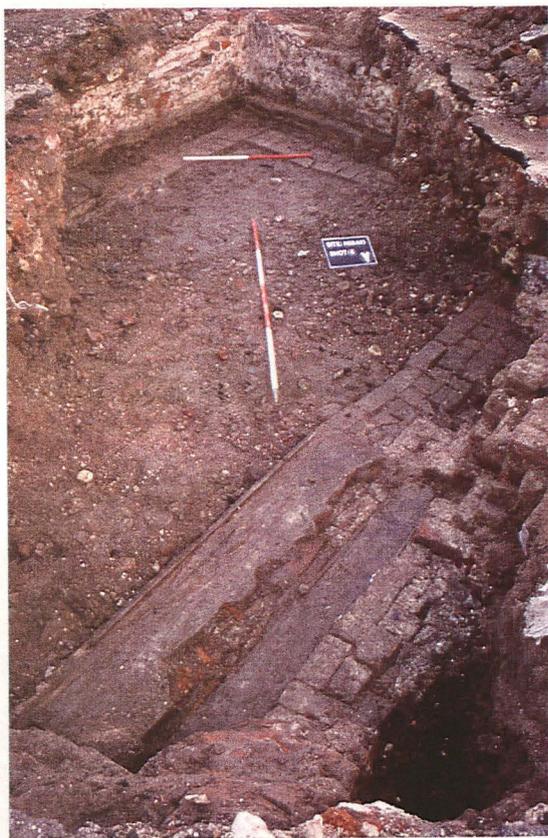
Plate 7 Cellar structures in Trench 3, looking east.

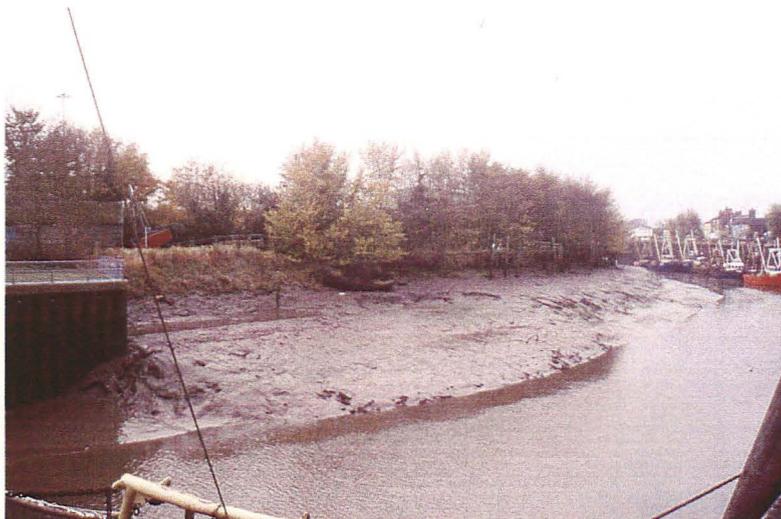
Plate 12 General view of Boston Haven at low tide, showing the natural form of an unshored bank, looking southeast.
