**RESULTS OF AN ARCHAEOLOGICAL WATCHING BRIEF:
PHASE 2, (INCLUDES PLOT 12) HOME FARM, BIGBY, LINCOLNSHIRE**

**RENEWAL OF PLANNING APPLICATION REFERENCE: M02/P/0692
NGR: TA 05890 07291**

**Site Code: HFB 02
Accession No.: LCNCC 2003.459**

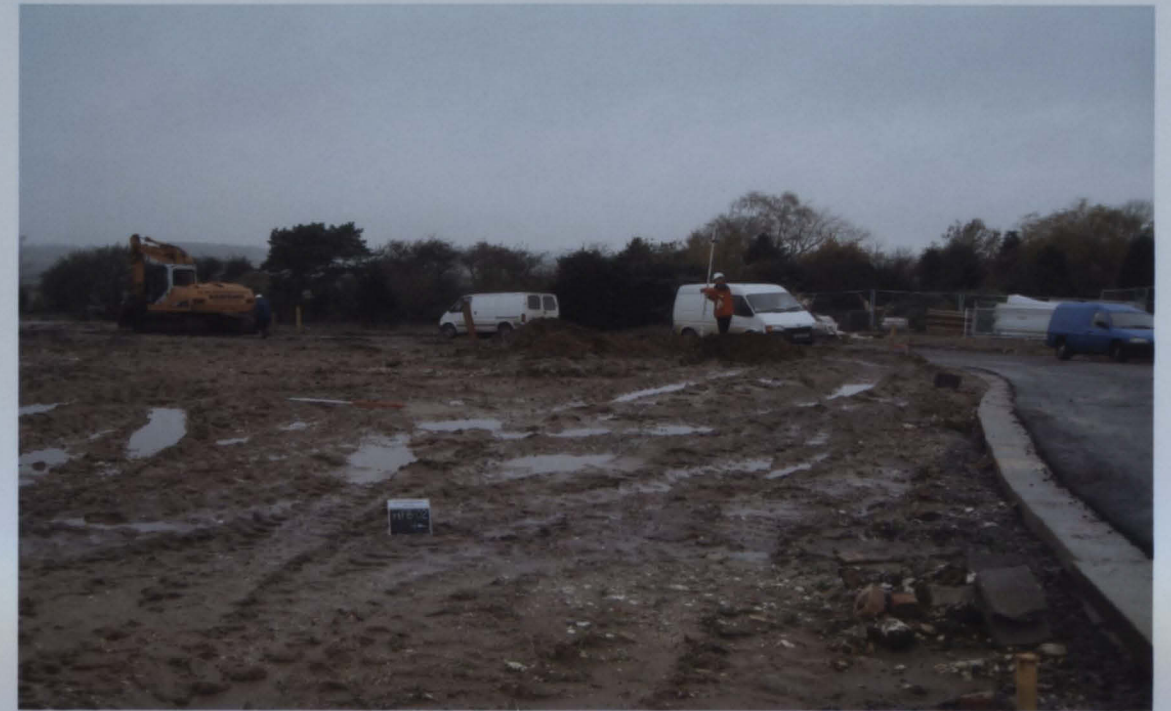
Plate 1. General shot of site looking west.

- 6.1 An archaeological watching brief was undertaken during ground works associated with the development. Ground works included the stripping of topsoil/subsoil to a depth of 0.8m-1m and the monitoring of strip foundation excavation for the new dwellings. The strip foundations were excavated to a maximum depth of 1m and width of 0.7m (see Plates 1-2 for general shots).

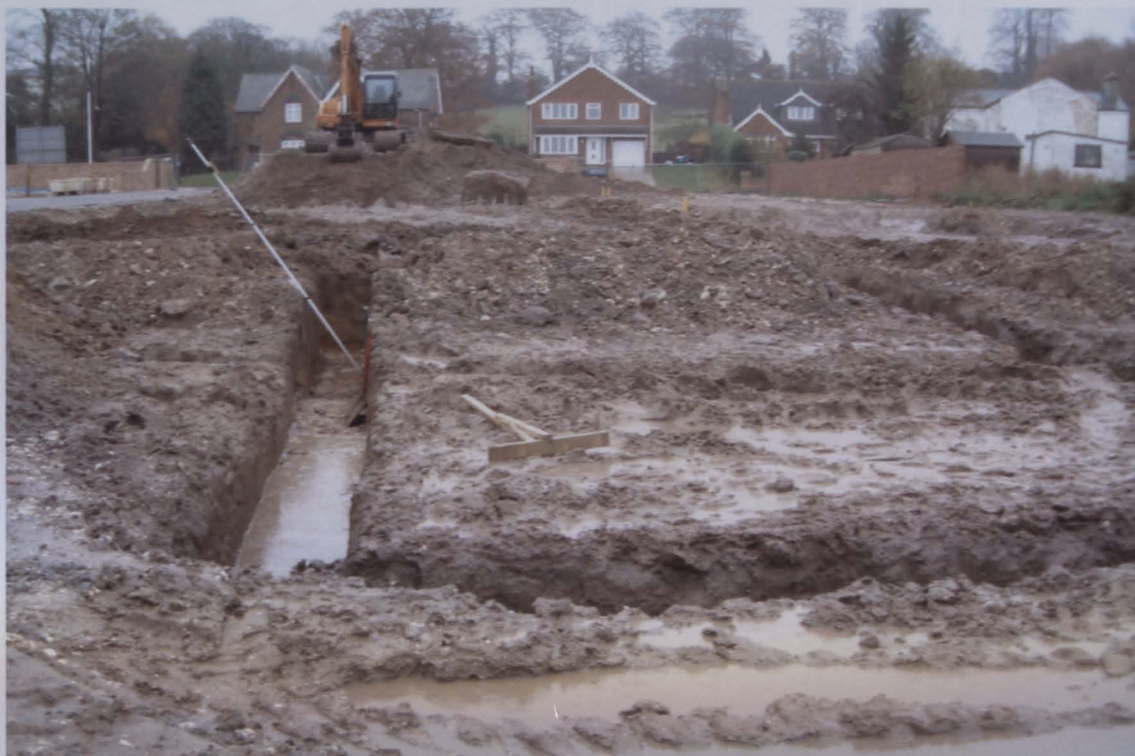
Plate 3. Footings shot in Plot 25.

- 6.2 After the removal of 0.8m of modern overburden and topsoil in the area of Plot 25, excavation of the footings commenced. Excavation of the strip foundations for Plot 25 revealed a 0.3m thick layer of mid brown silty clay subsoil (102) which petered out as the footings proceeded eastwards. Occasional modern rubble filled holes representing possible sumps/soakaways were encountered cutting through the subsoil. The subsoil overlay a layer of orange yellow sandy silt natural (103).

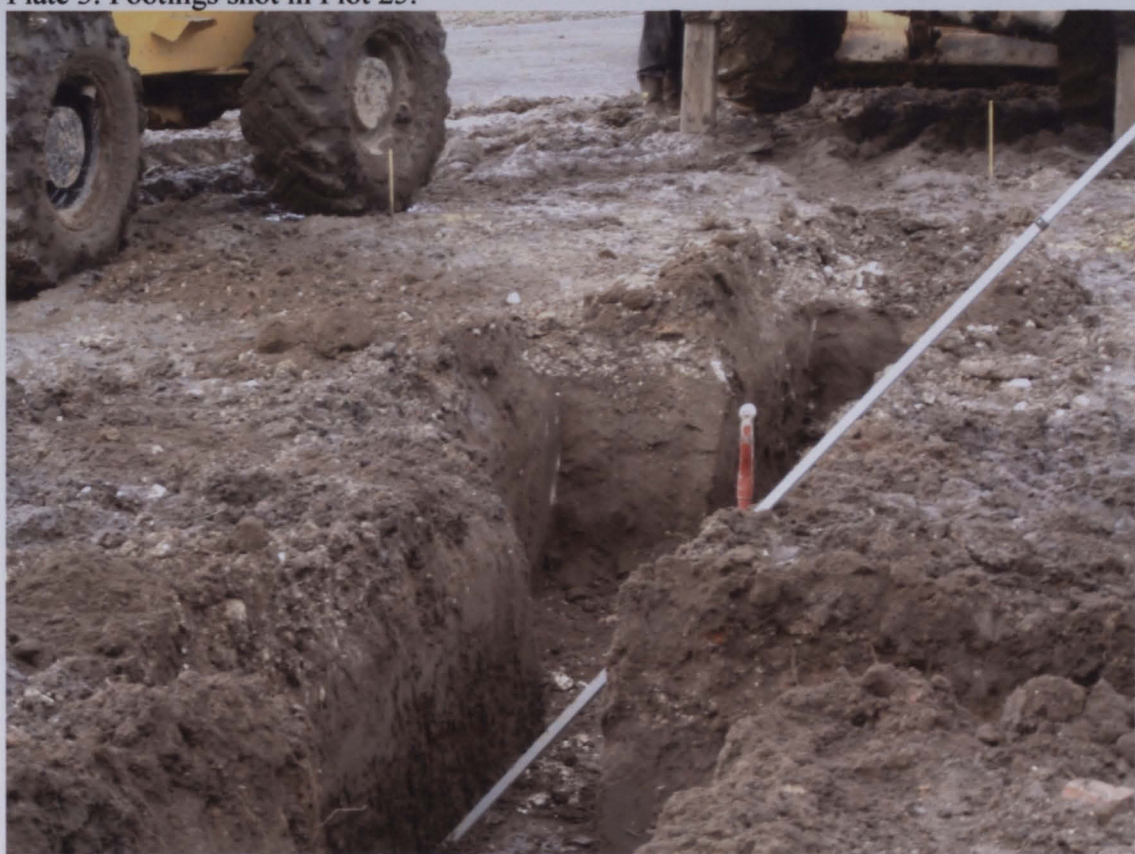
Plate 4. General shot of footings in Plot 24.

- 6.3 The ground within the footing layout of Plot 24 (see Figure 2 for location) was found to be 1m above the finished floor level required. Therefore the plot was stripped of soil before excavation of the strip foundations. The upper layer of soil removed comprised 0.25m limestone chippings and brick rubble (100) which had derived from the new road construction and demolished farm buildings. Below

this was a 0.40m-0.45m thick layer of soft dark brown silty clay loam (101) which was the modern topsoil present across the site.

6.4 Below the topsoil, the soil strip exposed a linear ditch feature, filled with limestone fragments and rubble. Close inspection showed asbestos sheet fragments and 75mm diameter flexible plastic pipe. The feature was further inspected and there was no trace of any sedimentation or evidence of re-working. It was concluded that the feature was a surface water drainage channel of modern construction.

6.5 Excavation of the strip foundations revealed the topsoil sealed a 0.7m thick layer of mid brown silty clay sub-soil (102) which overlay a 0.2 - 0.3m thick layer of yellow grey sandy silt (103) which represents natural geology.

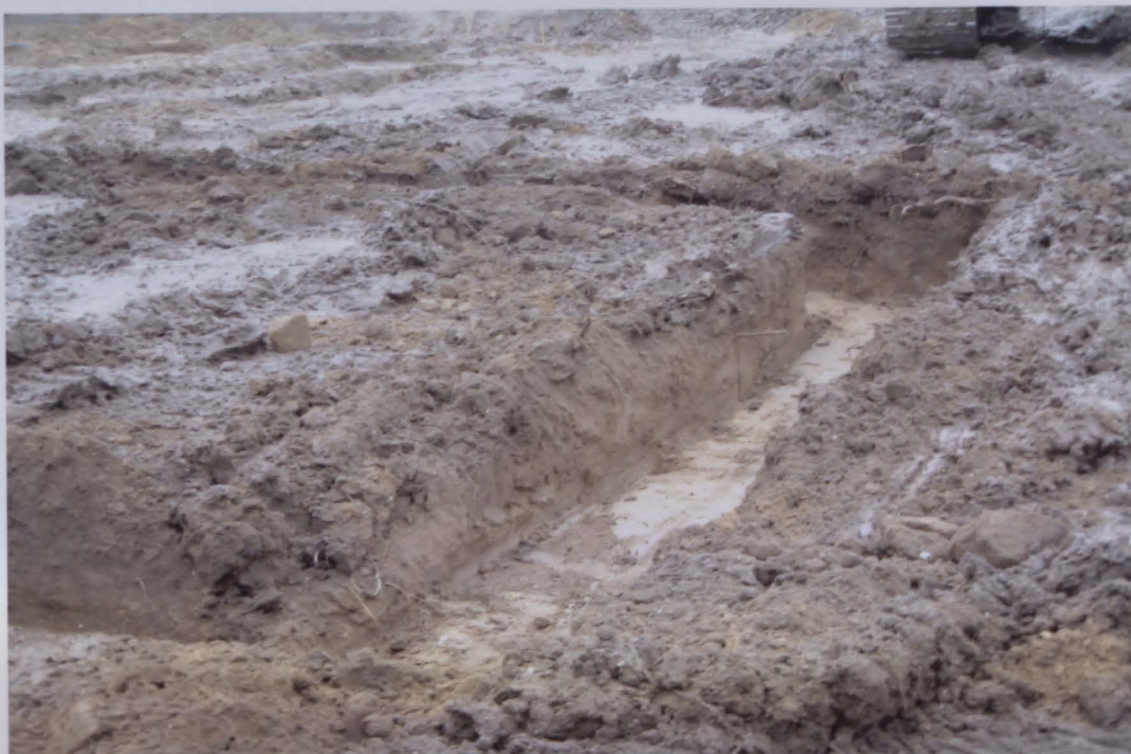
Plate 5. Footings shot of Plot 10.

6.6 Excavation of Plots 10 & 11 (see Figure 2 for location) revealed similar deposits. The depth of footings varied between 0.6-0.8m. These comprised of 0.35m dark brown loamy top-soil (101) and 0.55m of mid-brown silty clay sub-soil (102) in the foundation trenches. The subsoil overlay the natural yellow orange sand (103) These deposits were disturbed by occasional intrusions of tree roots from the existing orchard area. No finds or features were encountered.

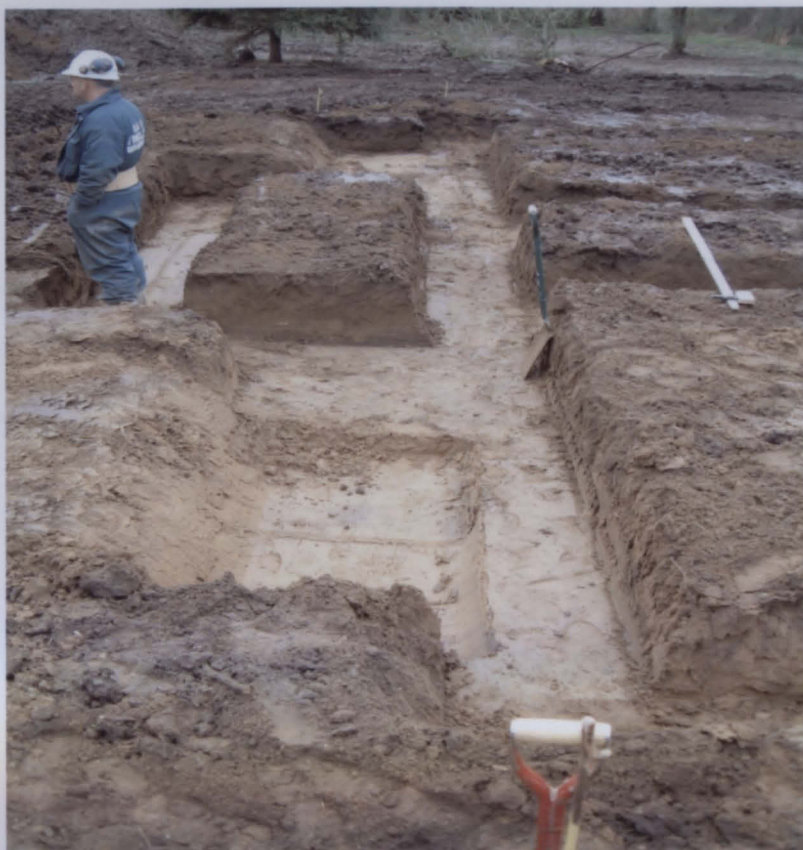
Plate 7. Footings shot of Plot 12.

6.7 Due to the sloping nature of the land it was necessary to create a level plot during excavation of Plot 12. Approximately 0.7m of material comprising of 0.4m of dark loamy topsoil (101) and 0.3m of mid-brown silty clay sub-soil was removed on the eastern side of the plot and none on the west. The natural geology comprising a yellow brown sandy clay (103) was reached at a depth of approximately 0.7m. The stratigraphy recorded followed the natural slope of the land and the western end of the plot ceased at the natural grey orange yellow sand which became yellow orange in colour with depth.

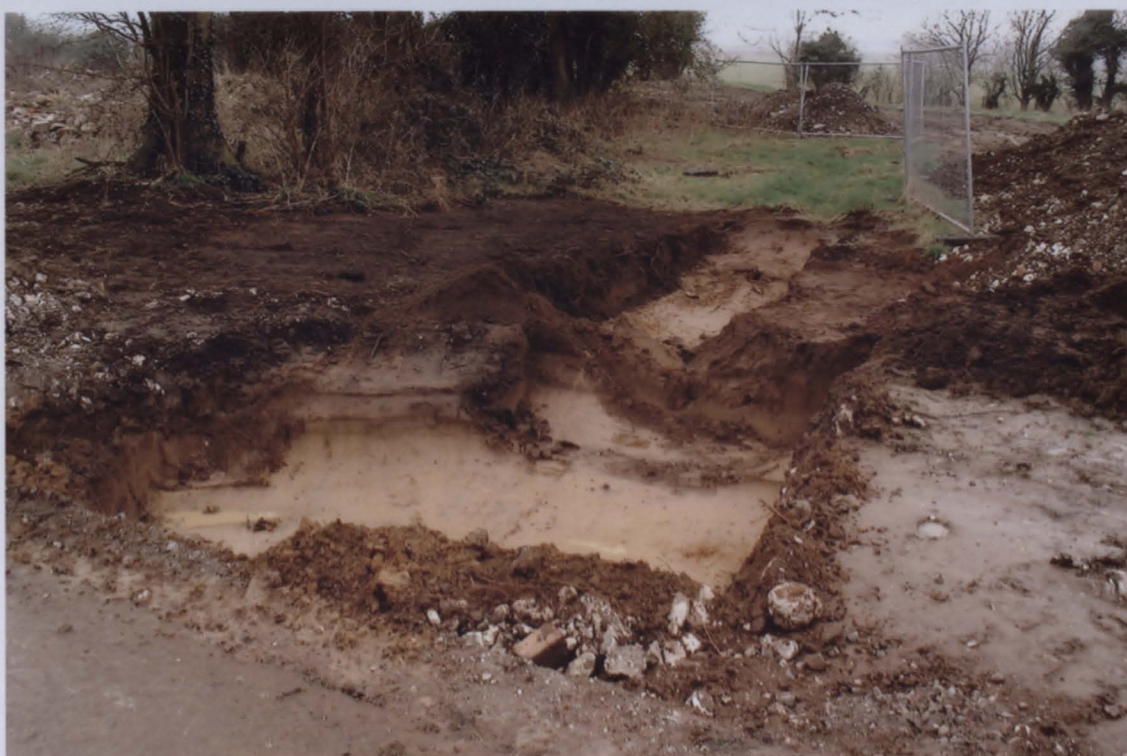
Plate 8. Showing area of old sheep dip.

6.9 An area to the south of plot 12 contained an old site of a sheep dip. This was removed by machine and a photograph taken. There were no archaeological finds recovered from this feature.
