**LAND OFF CHURCH LANE,
MANBY, LINCOLNSHIRE**

**ARCHAEOLOGICAL WATCHING BRIEF
REPORT**

Site code	CLM 03
NGR:	TF 39922 86765
LCCM Acc No:	2003.114
Planning ref.	N/113/1016/99

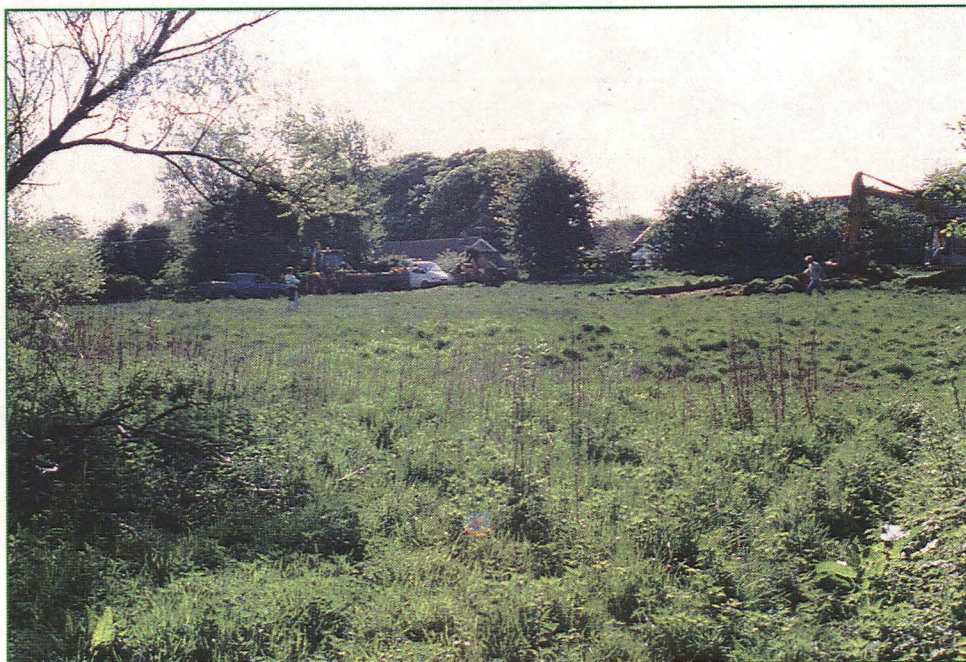
Plate 1: General shot of the development area at the beginning of machining, looking SW. Raised earthworks are visible in the field.

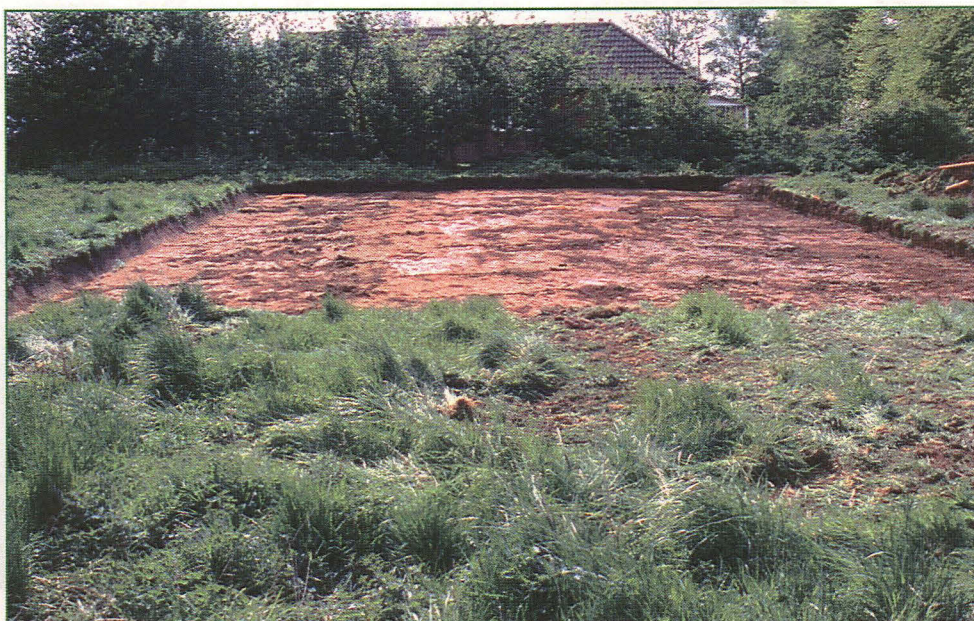
Plate 2: House plot 1 after completion of the topsoil strip, looking W.

The stripping of Plots 1 – 3 extended to a maximum of 0.3m below the modern ground surface. The house plots were stripped in two separate units; one incorporating the footprint of Plot 1, and the other incorporating the footprint of Plots 2 and 3. The stripping of the access road extended to a maximum depth of 0.2m. This phase of groundworks revealed a dark brown silty loam topsoil, (001). This was relatively homogenous across the development area, although in the eastern portion of the access road, the topsoil contained large amounts of 19th/20th pottery, brick and tile. This material was also observed in the topsoil of Trench 3 of the previous evaluation. In the depression at the west side of Plot 2, the topsoil was moister and slightly siltier than elsewhere.

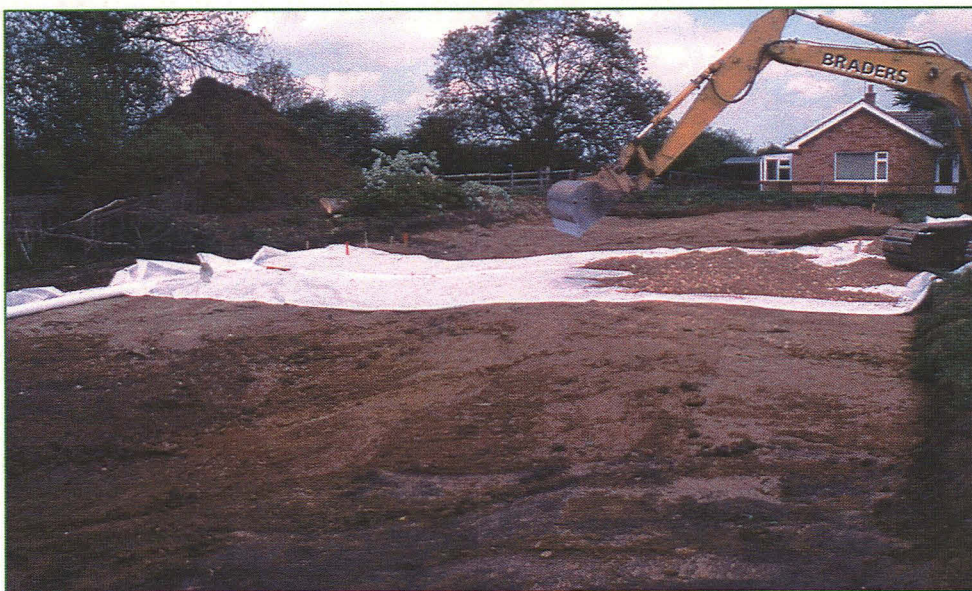
Plate 3: Laying geotextile and hardcore in the footprint of house plot 3, looking S.

Stripping of Plot 3 revealed the backfilled Trench 1 of the 1997 evaluation. This had subsided since its original backfilling, and it was deemed necessary to remove the backfill to prevent further subsidence in the completed house. The trench was excavated to approximately 0.8m below the stripped area, down to the natural horizon to which the trench had originally been excavated. This was then lined with 'Terram' geotextile, and filled in with limestone hardcore.

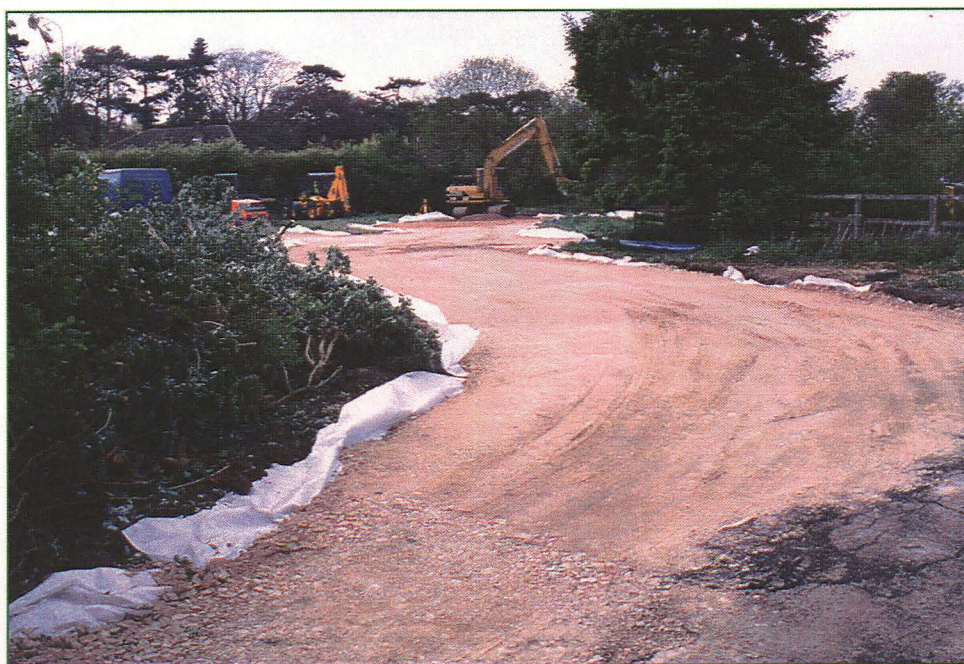
Plate 4: Hardcore and geotextile laid in the access road strip, looking NE towards house plot 3.
