**ARCHAEOLOGICAL
WATCHING BRIEF.
NEW RECTORY, WEST STREET
FOLKINGHAM, LINCOLNSHIRE**

NGR: 507070 333692
SITE CODE: NRW04
LCNCC ACC. NO: 2004.62

Report prepared for
Stephen Roberts Associates
by William Munford
Feb 2004

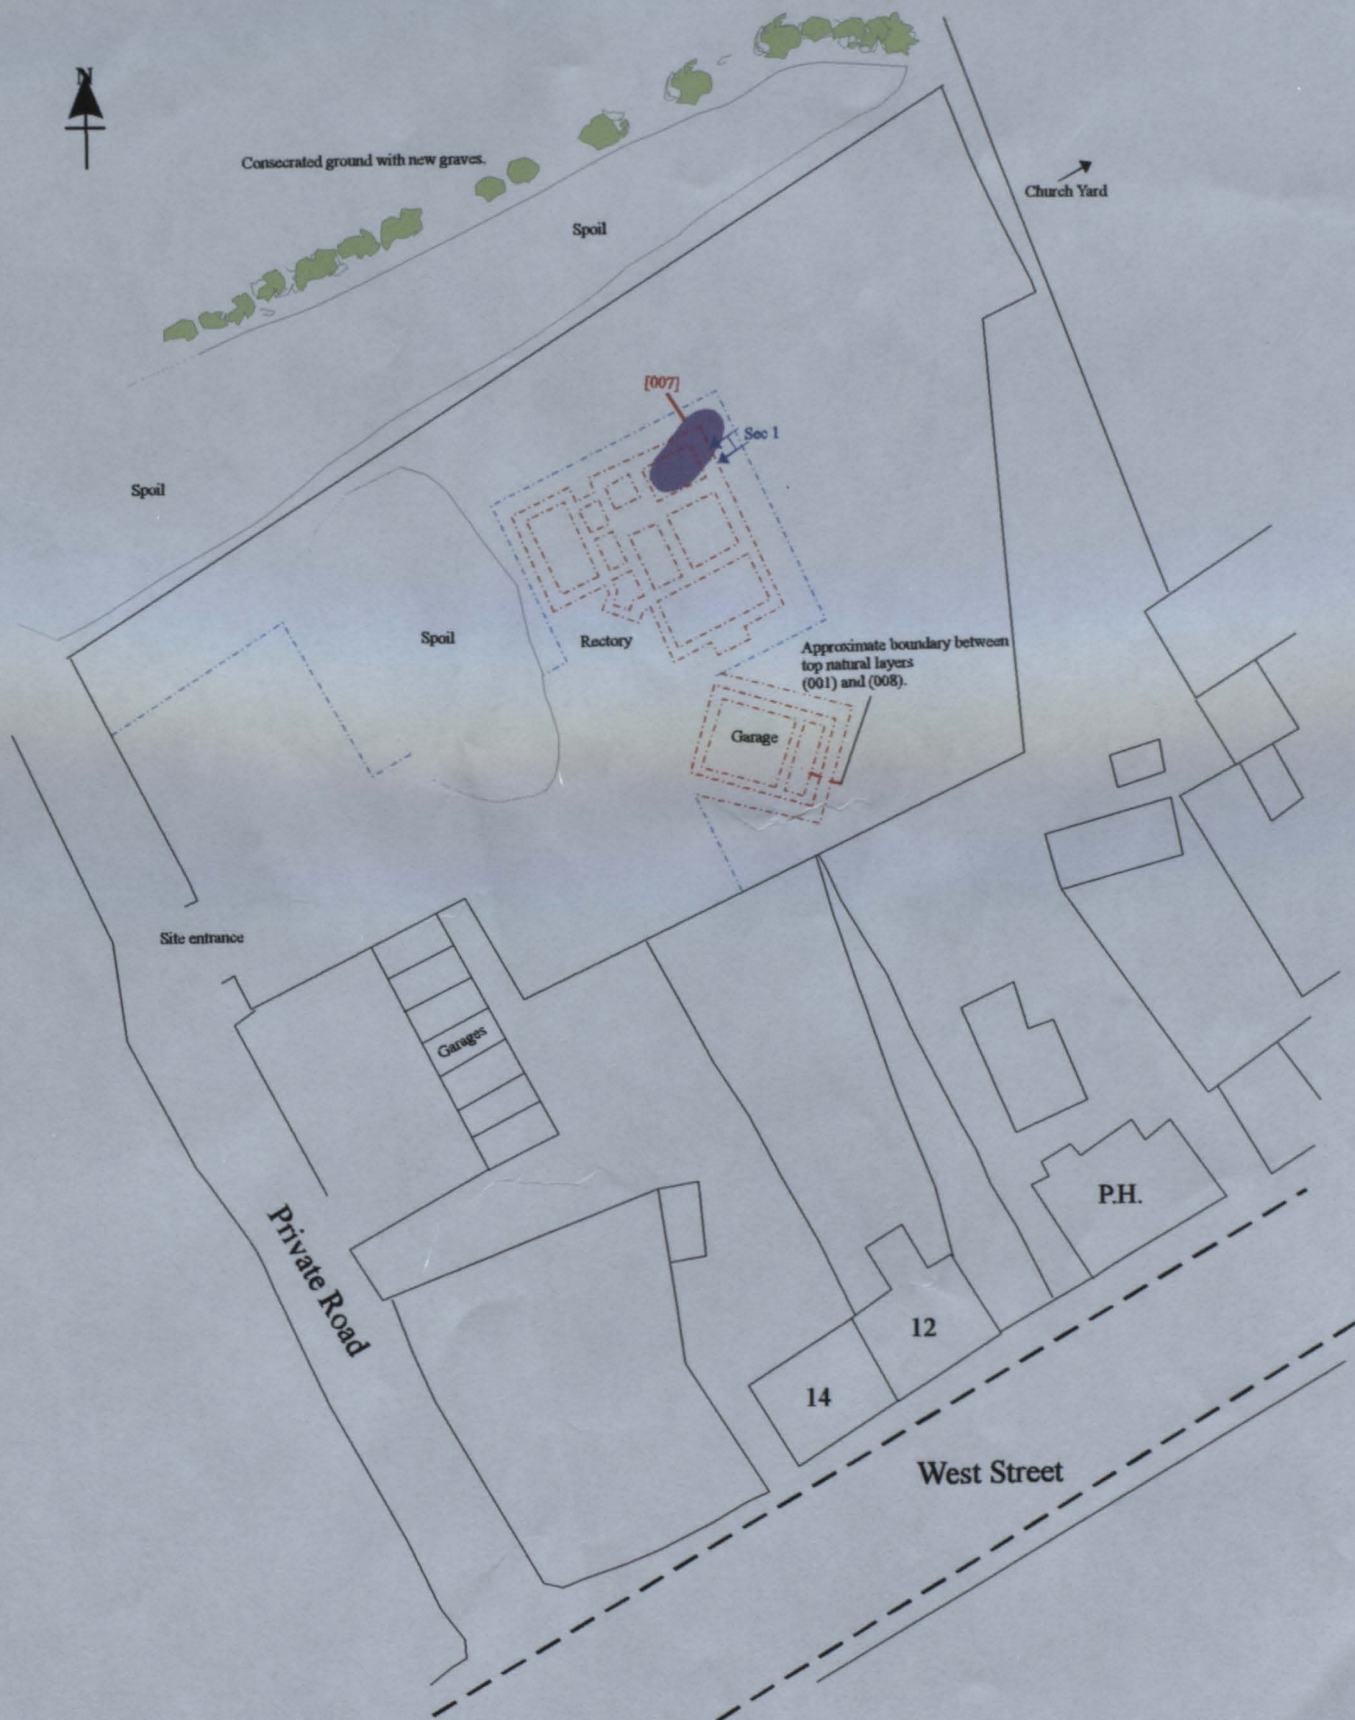
Site map showing groundworks monitored during the watching brief in brown, the position of the modern filled pond in purple and the area stripped prior to archaeological monitoring in blue. (Scale 1:500)

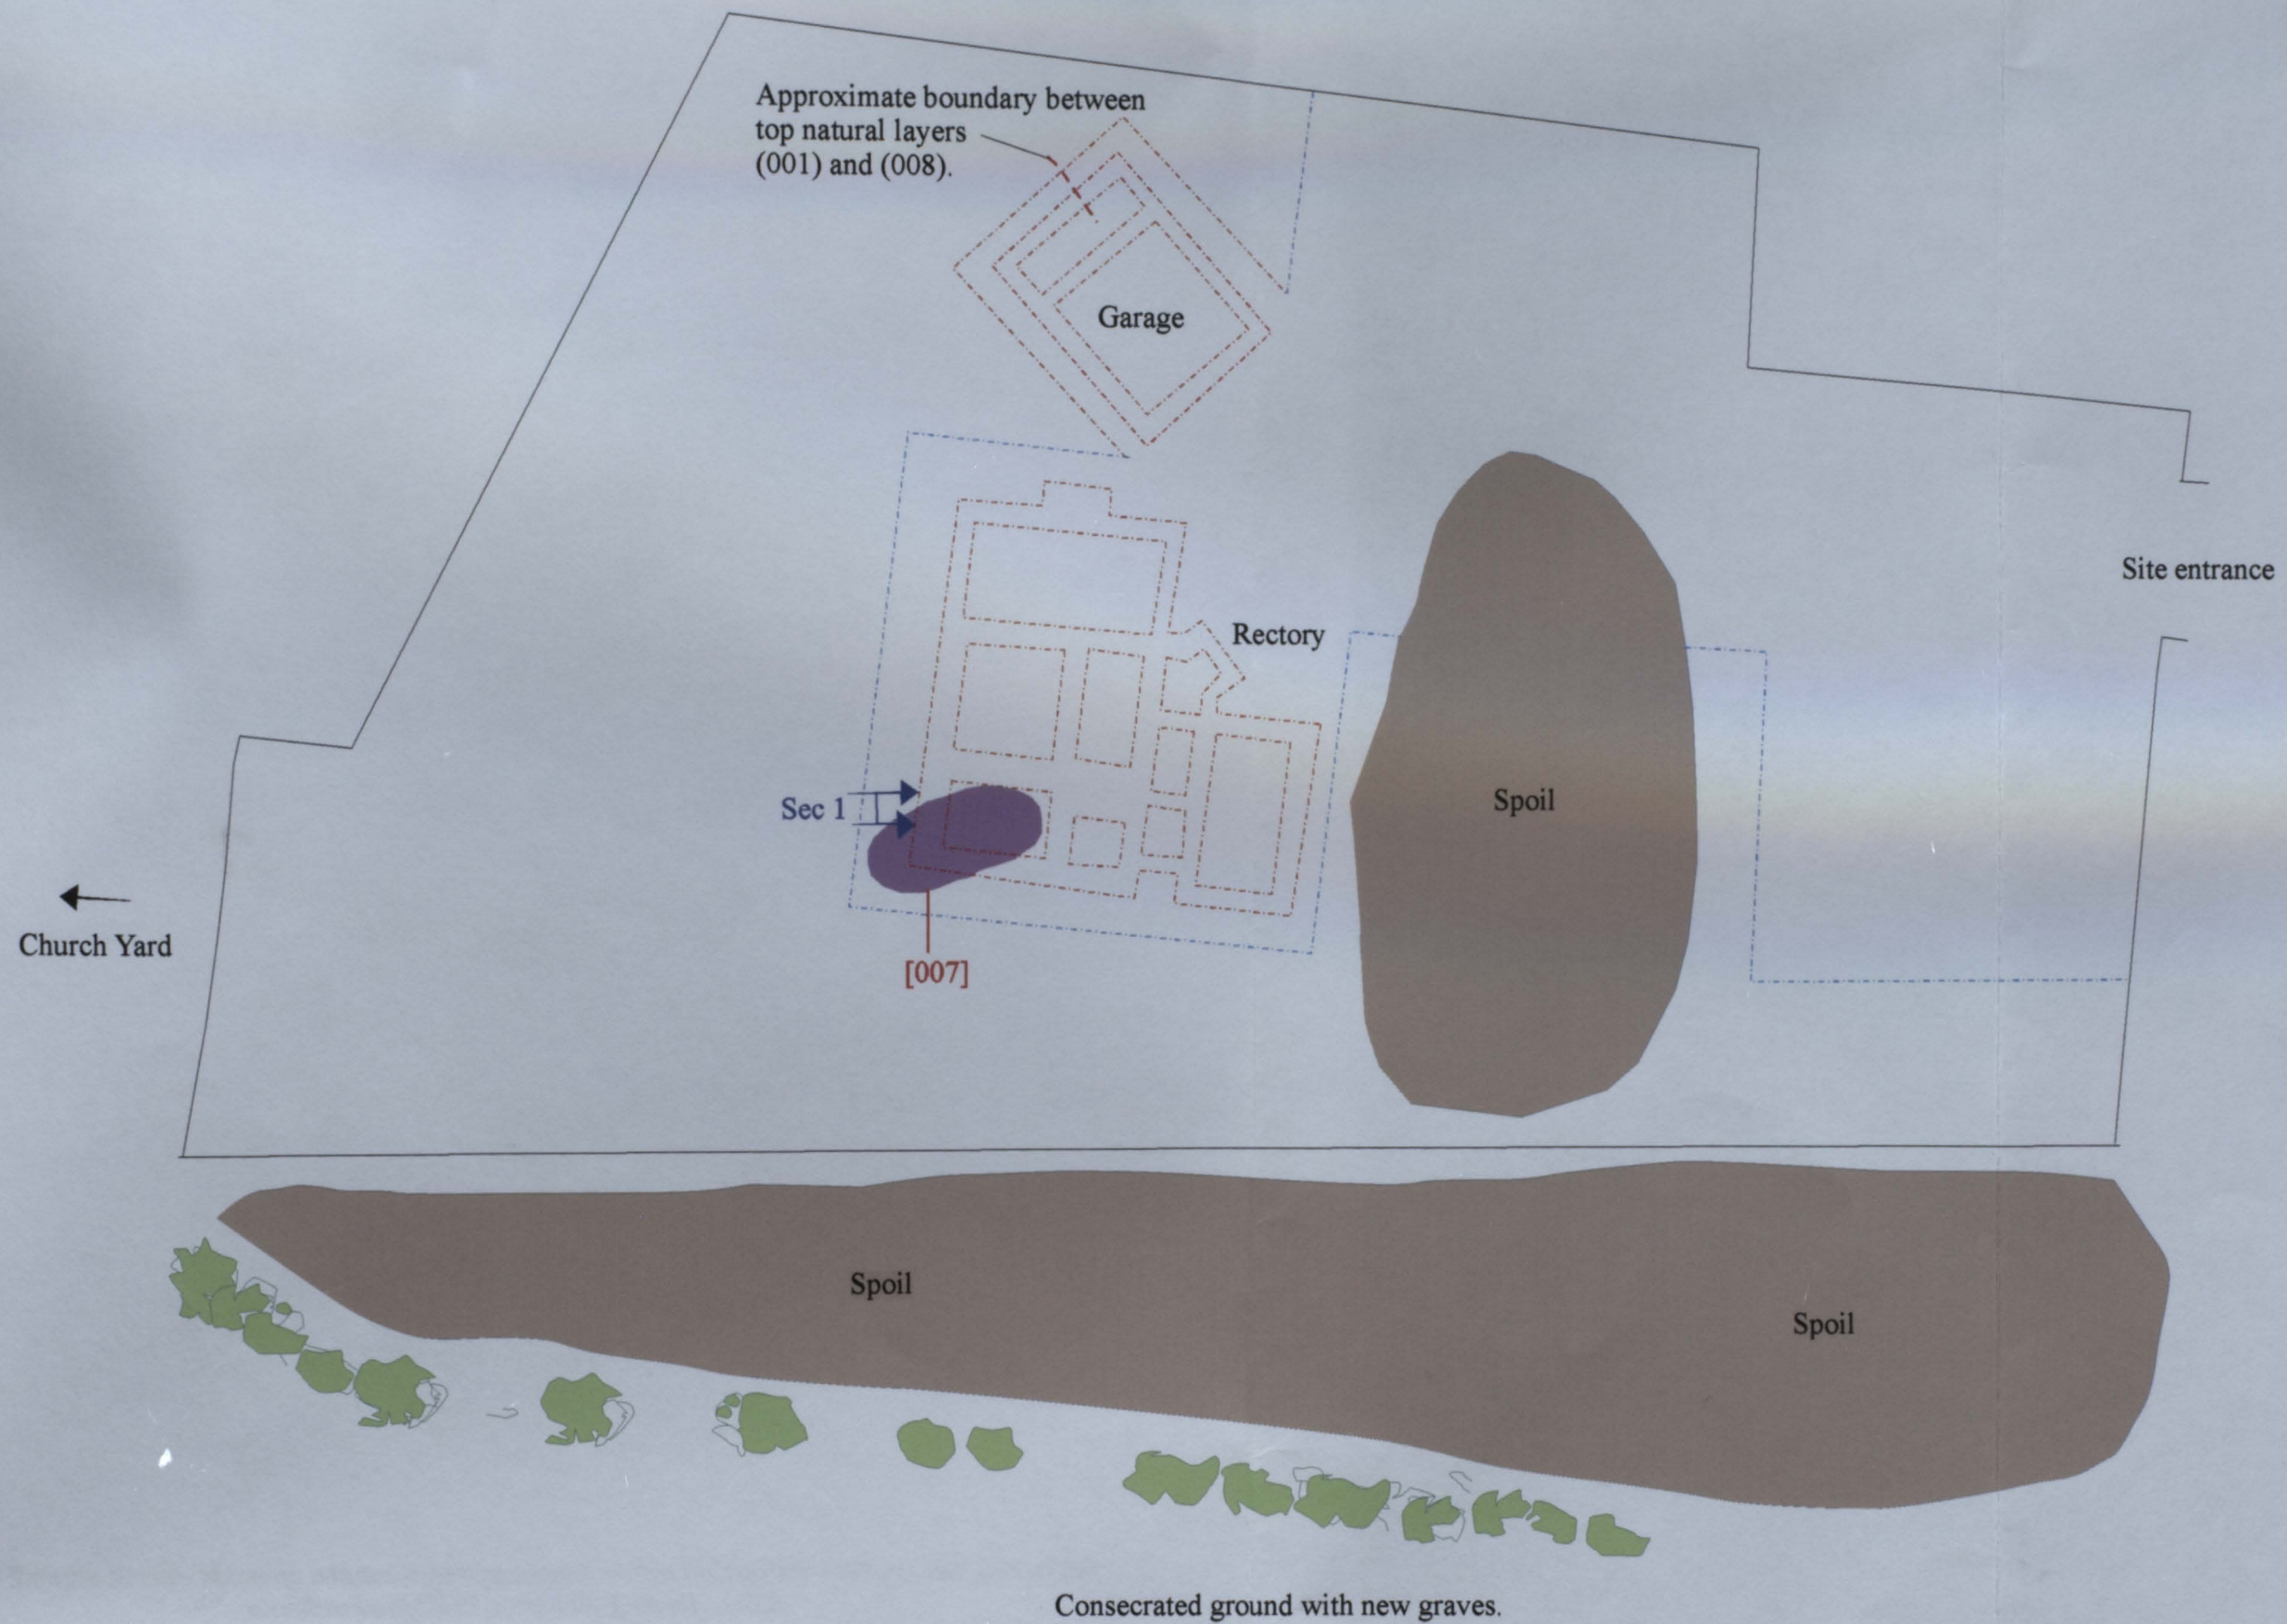
Fig. 2 Site map showing groundworks monitored during the watching brief in brown, the position of the modern filled pond in purple and the area stripped prior to archaeological monitoring in blue. (Scale 1:250)

The development site lies along the north edge of the settlement, immediately to the south-west of the parish church of St Andrew. The groundworks monitored during this watching brief included the stripping of topsoil from areas of the site and the excavation of two sets of foundation trenches for the rectory and its detached double garage. The extent of these are illustrated in figure 2.

No significant archaeological deposits were observed during this watching brief. Before monitoring commenced, an area of the site to the south and east had been stripped of topsoil and covered with type one structural fill material. The extent of this area is illustrated on figure 2. The area of the site where the rectory footings were to be excavated had also been stripped prior to the arrival of the author on the 19th of February 2004. Here, remnants of the topsoil were observed overlying a thick layer of naturally structured limestone. In the north east corner of this area, an oval pit, [007], approximately 6m long and 2.5m wide was observed. Modern finds protruded from its dark brown, friable, topsoil like fill, (006). Excavation of the rectory footings revealed that [007] was approximately 0.50m deep with moderately sloping sides and a flat base as is illustrated in Section 1 (Fig 3). The site contractors mentioned that a pond had existed here shortly before development work commenced on the site.

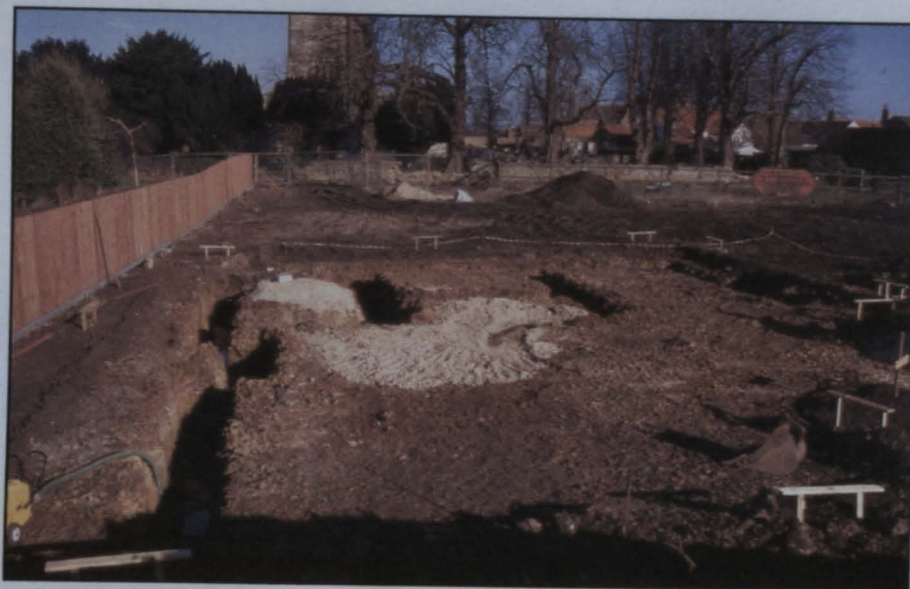
Pl. 1. Overview of the rectory footings in progress within which pit [007] was observed, looking east.

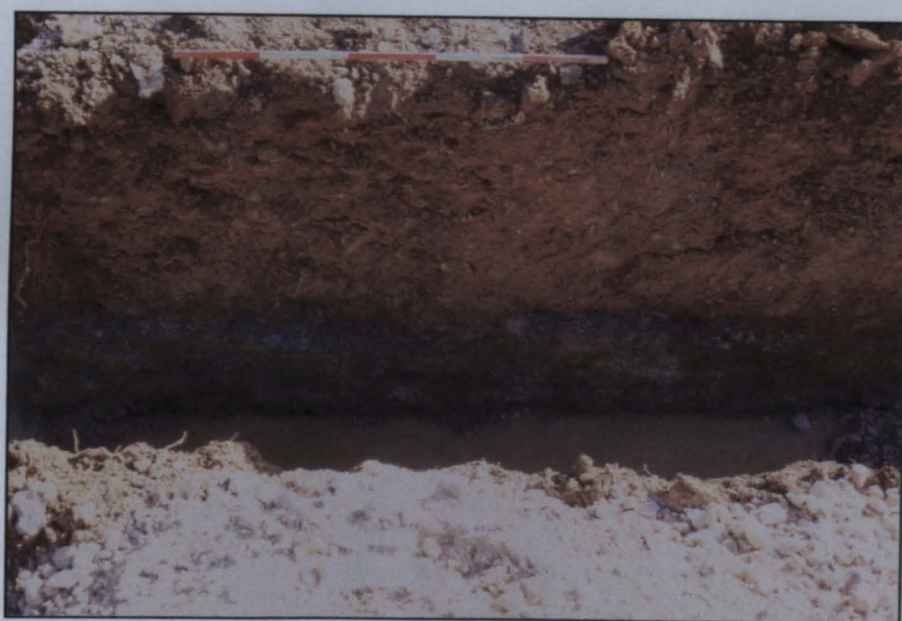
Pl. 2. Sample section showing the natural layers observed within the excavated footings. Looking south.

The natural layers exposed by the excavation of the rectory footings rested upon a seam of concrete-like dark grey weathered clay, (005), which had occasional rounded gravel inclusions. Above this were two layers of more pliable light grey brown and mid orange brown clay, (002) and (004), which sandwiched a contrasting layer of light grey gravel with a pale clay infill, (003). The majority of the area monitored was capped by the aforementioned layer of naturally deposited beige limestone, (001), which proved to be approximately 0.40m thick. Towards the southern side of the area covered by the garage footings this gradually gave way to (008), a layer of mid dark brown silty subsoil of a similar depth. Two sherds of pottery of probable late medieval date were recovered whilst the area of the garage footings was being stripped of topsoil.
