**Clapgate Farm, Greetham with Somersby, Lincs.
Reservoir Development
An Archaeological Watching Brief**

**NGR: TF 3225 7263
Site Code: SCFR03
LCNCC Museum Accn Code: 2004.48
ELDC Planning Application No. S/066/1638/02**

**LAS Report No.731
March 2004**

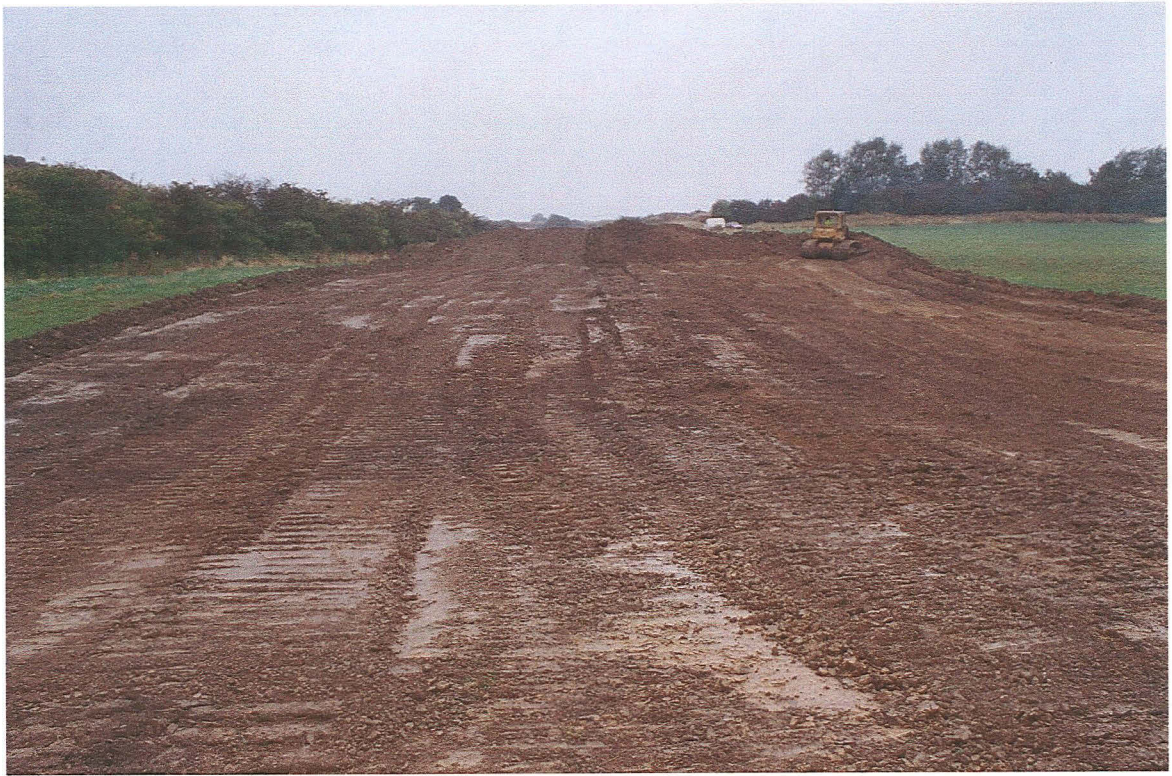
Pl. 1 Bulldozer stripping showing 100 and faint traces of the former stream channel 102 (looking SW).

A layer of dark brown silt sand topsoil 0.30m thick (**100, PI. 1**) was removed by the tracked bulldozer revealing natural mid brown sand with some clay (**101, PI. 2**). Remnants of the stream channel visible on the aerial photograph were encountered but yielded no finds (**102, PI. 1**). No archaeological features were observed.

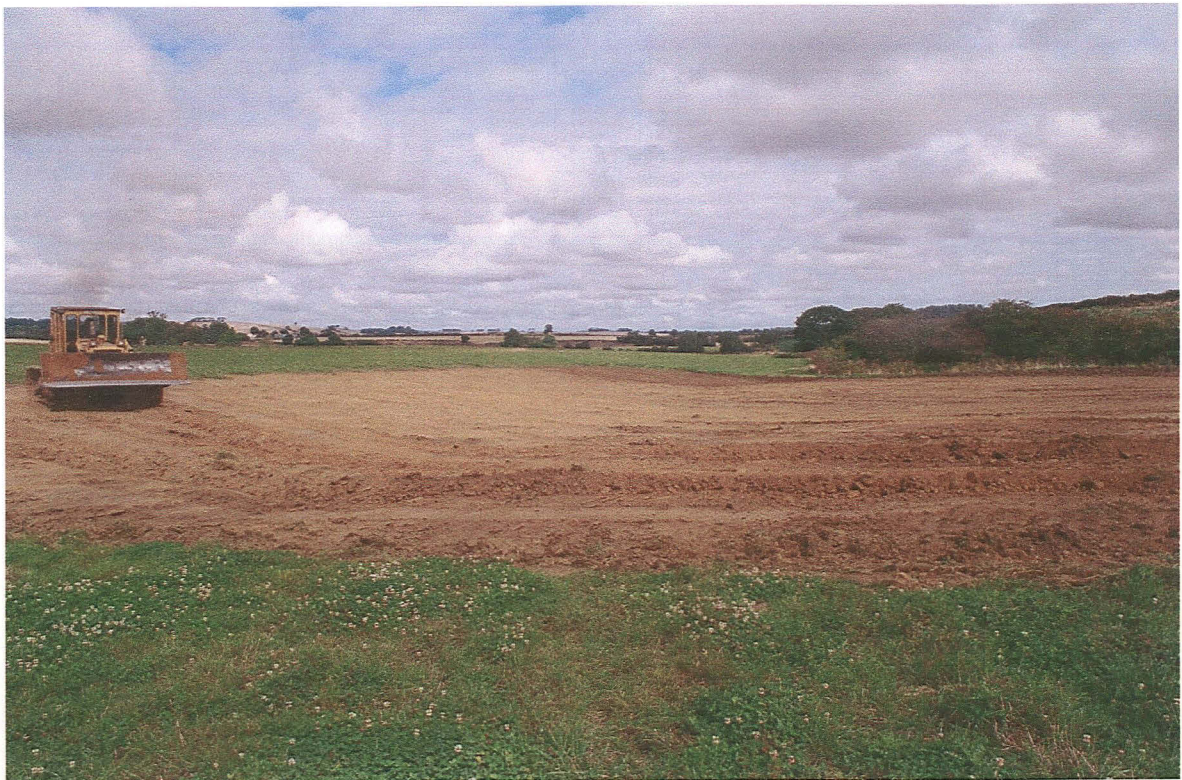
Pl. 2 Natural sands 101 exposed by bulldozer (looking NE).
