**Lincolnshire Section 101A Schemes: The Carltons, Gayton le  
Marsh and South Reston  
Sewer Pipelines and Pumping Station  
(Manby, Great Carlton, South Reston and Gayton le Marsh  
Parishes)**

**Archaeological Watching Brief**

**Report prepared for  
Anglian Water Services Ltd**

**LAS Report No. 707**

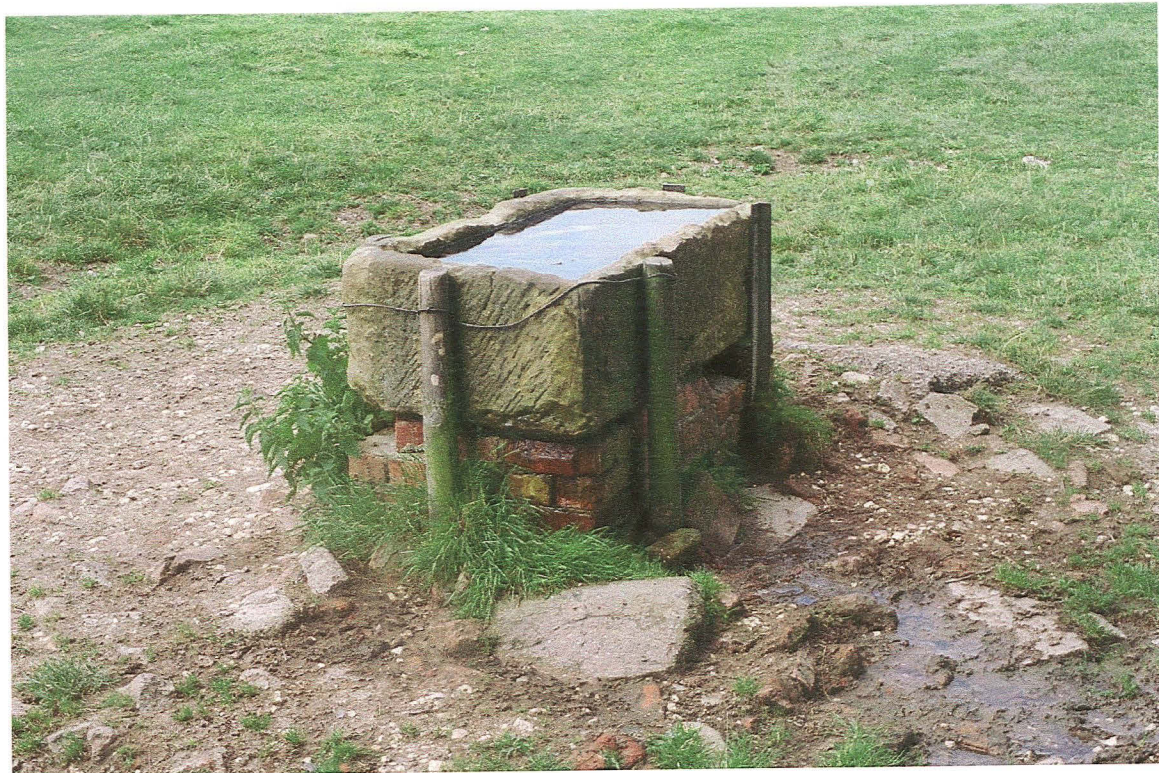
**Pl.1** Stone sink in use as cattle water trough, 25, Glebe Farm, Great Carlton.

The new sewer pipe was directionally drilled below a field with ridge and furrow earthworks west of Glebe Farm, with no disturbance of the field surface (**24**). A record photograph was taken of a stone sink in the SE corner of this field (**25**), used as a cattle water trough (Pl. 1). A reception pit (**26**) excavated in the northern verge of the lane east of Hall Farm revealed chalky boulder-clay at a depth of 0.5m below ground level.

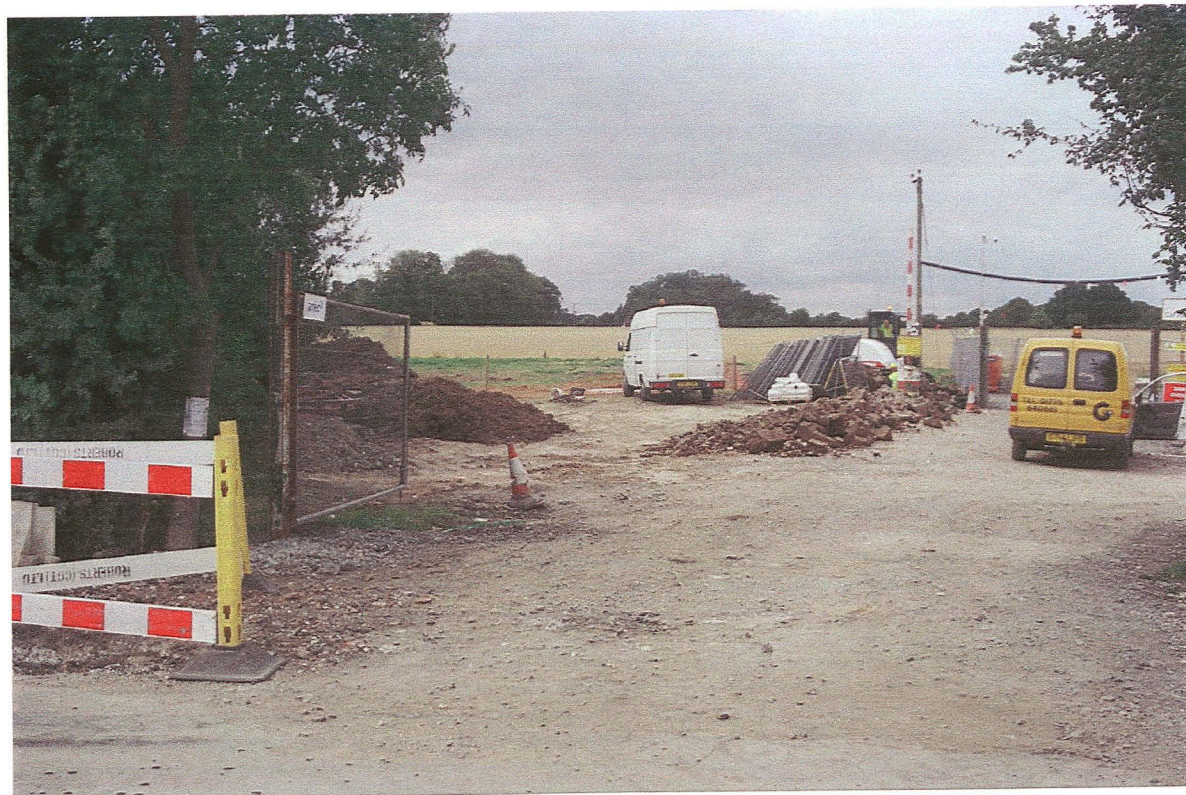
**Pl. 2** Trench (27) for electricity cable, Sturdy Hill Vacuum Pumping Station site, Great Carlton (looking north).

Further works on the Vacuum Pumping Station site were monitored. A shallow trench for an electricity cable (**27**) was excavated along the line of a former track, shown on early Ordnance Survey maps as leading to a bridge across the stream, and serving a house to the north of the

stream (now removed). The trench exposed track metalling material, but no evidence of medieval occupation other than flecks of fired clay (possibly remains of daub) below the topsoil (Pls. 2 and 3). More extensive groundworks to the SW of the former track also contained no indications of medieval occupation. Here, the underlying material was flood silt, with chalky boulder-clay at 1m below present ground level. The boulder-clay surface was not associated with any evidence of prehistoric or Roman activity.

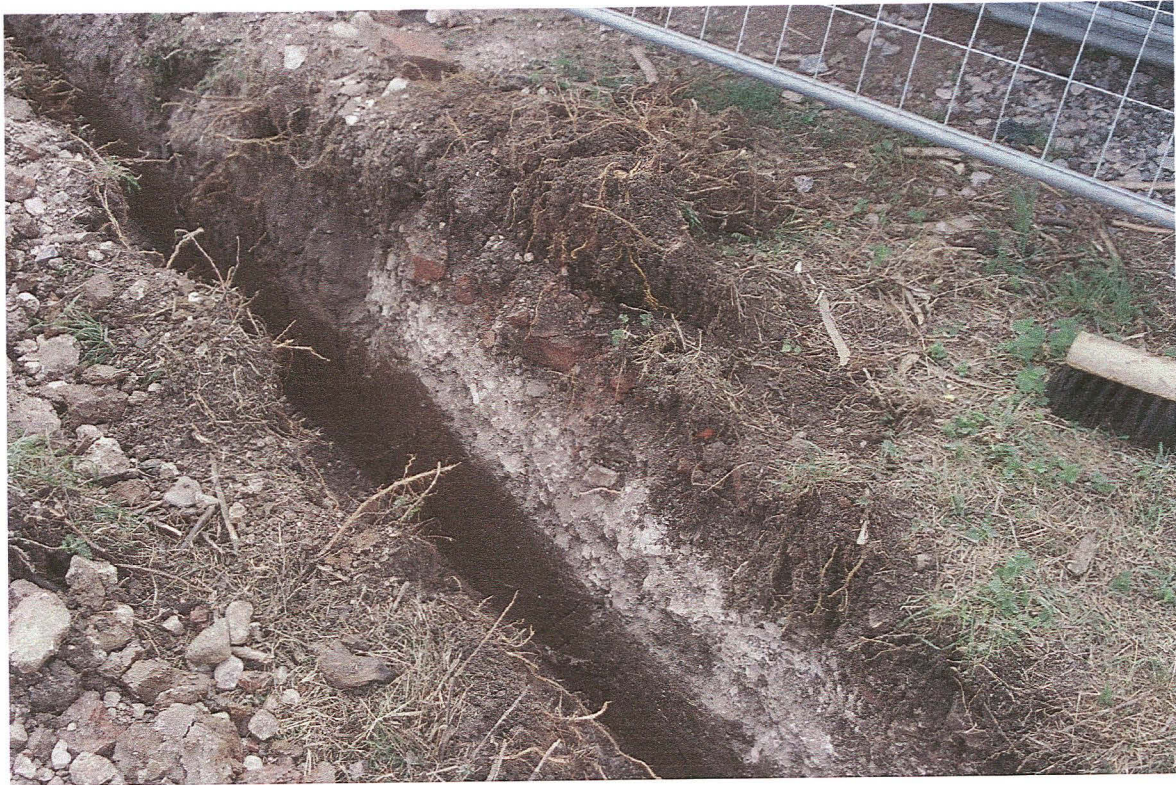
**Pl. 3** Brick demolition rubble and track make-up material in trench for electricity cable, Vacuum Pumping Station site, Great Carlton (looking NE).

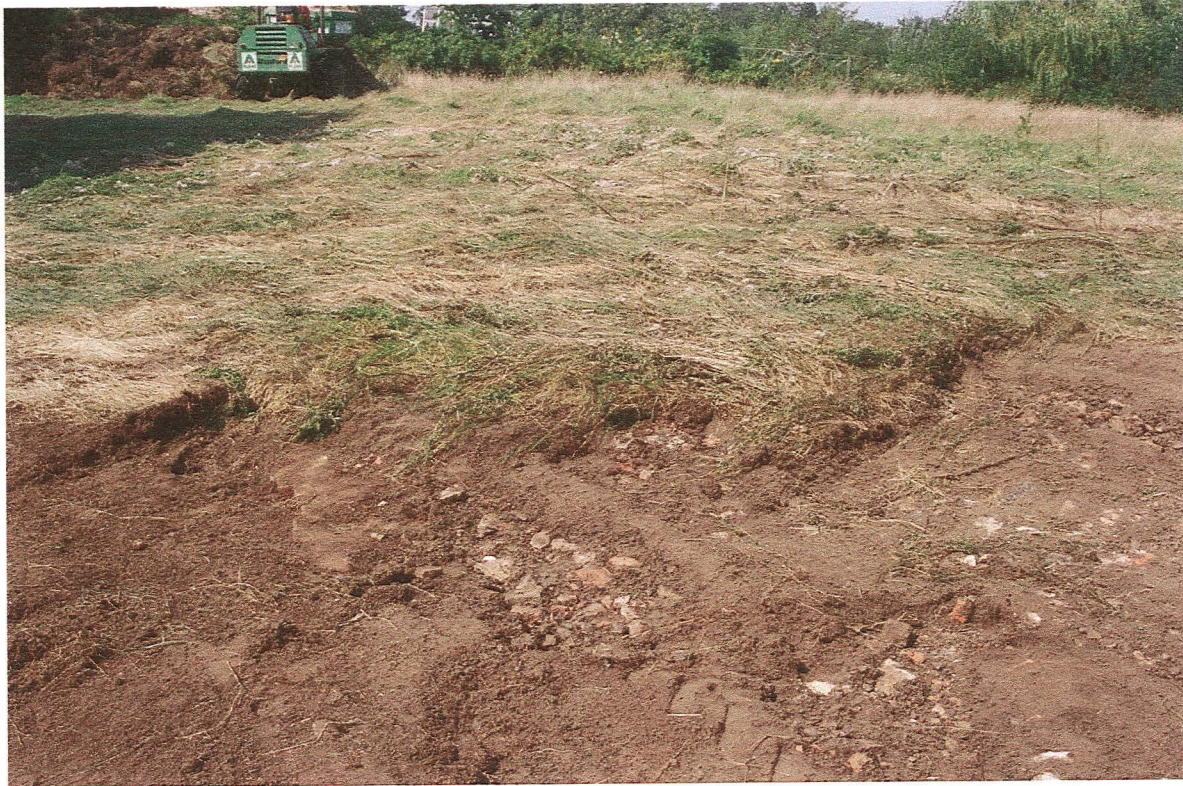
**Pl.8** Gravel and brick demolition rubble over the site of a demolished brick structure on the contractors' compound, South Reston (looking NE). The brick wall foundation is in the left foreground.

A small pasture field between Haven House and South Reston Methodist Church was stripped of topsoil for a contractors' compound (32). The field is separated from the road through the village by another plot, which contains fruit trees and may have been an orchard or land beside a dwelling which has been removed (Pls. 5-7). The rear field shares a common northern field boundary with plots to the NW, apparently the divisions between the developed crofts and tofts, and farmland beyond. Although the site of this compound was uneven, there was no obvious sign of archaeological features. A watching brief was maintained during topsoil stripping of this site, and the brick foundations of a wall along the SW side of a building were exposed (Pl. 8). The brick dimensions were 220mm x 110mm x 70mm. The topsoil removal was partial, and most of the feature remained covered, with a spread of gravel below the demolition rubble to the SE. The foundation was interpreted as the remains of a barn.
