LOWER WITHAM ENVIRONMENT SCHEME PHASE II WORKS:

**FISKERTON BORROW PIT AND EIGHT SECTIONS
OF RIVER DEFENCE IMPROVEMENTS,
RIVER WITHAM, LINCOLNSHIRE**

**ARCHAEOLOGICAL WATCHING BRIEF
REPORT**

Site code LWES 02
LCCM Acc No: 2002.199
Planning ref. Fiskerton Borrow Pit: W30/0178/01
Planning ref. river defence works: N/A

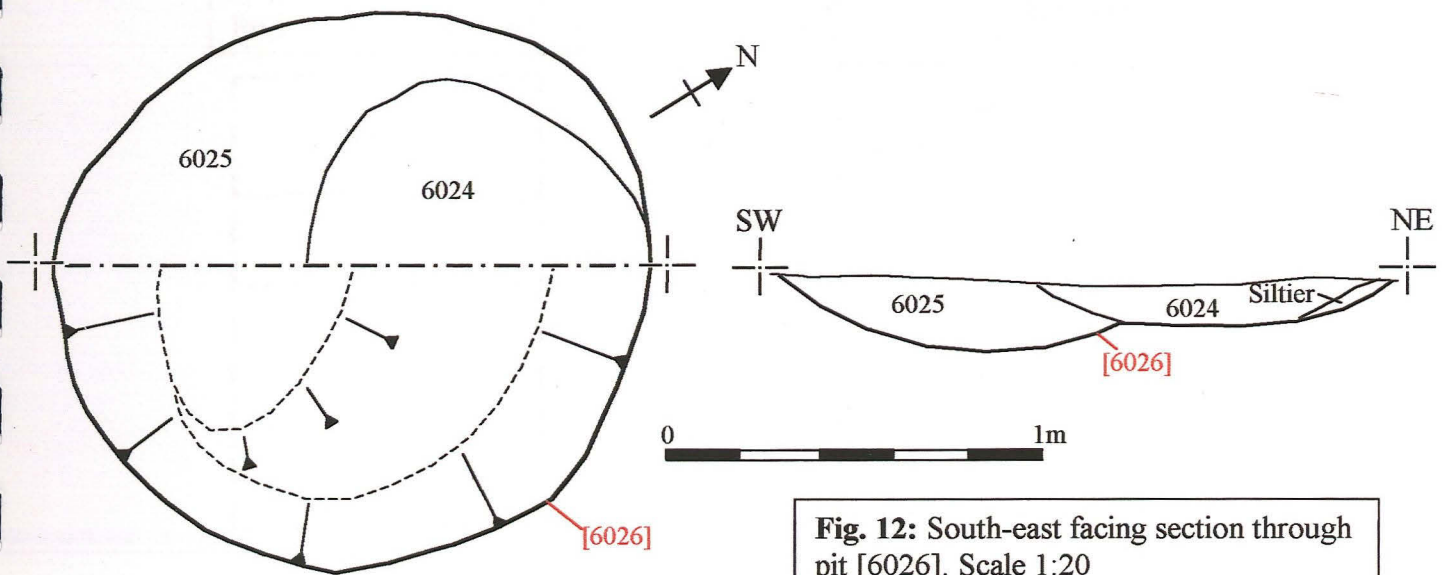
Fig. 12: South-east facing section through pit [6026]. Scale 1:20

Close to the SW edge of the area was a circular shallow-sided pit, approximately 1.6m in diameter and 0.2m deep [6026]. This had two fills, the primary one (6025) was a mottled mid/ dark brown silty clay containing occasional flints (pebbles and chips), also very occasional charcoal flecks and peat mottling. This material appears to have washed in before the bulk fill (6024) of very dark, slightly reddish-brown peat was deposited (fig. 12). The primary fill, 6025, yielded two chunks of burnt flint, although the possibility remains that these are the product of frost damage (see Appendix 2).

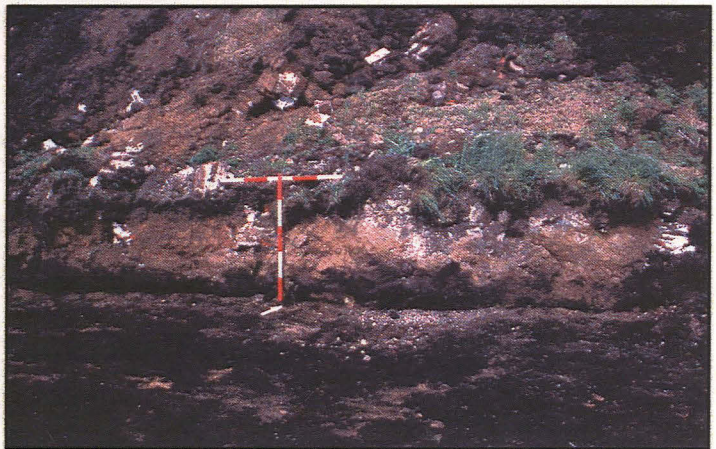
Plate 4: the remains of Tale's Cottage seen in the SW facing section at ch.40124, looking NW.

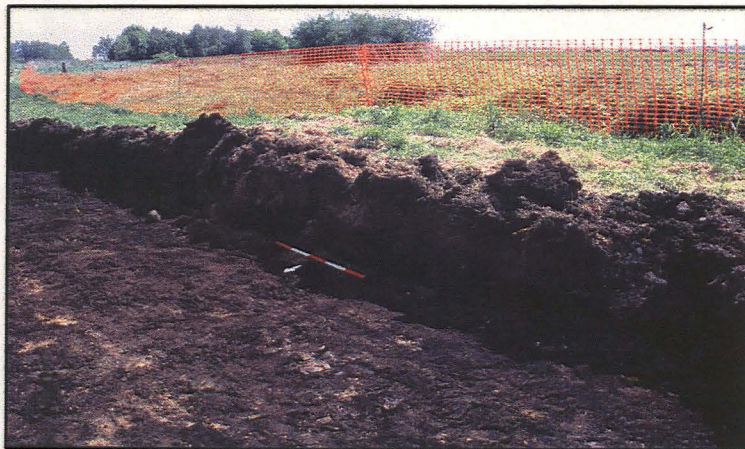
Plate 5: the remains of Tale's Cottage seen in the NE facing section at ch.40124, looking SW.

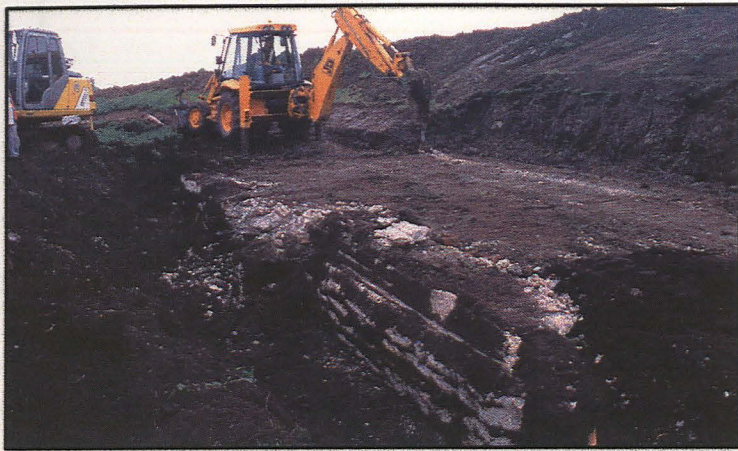
Plate 7: A rockbreaker removing the concrete and brick foundation at ch.41821, looking NW.

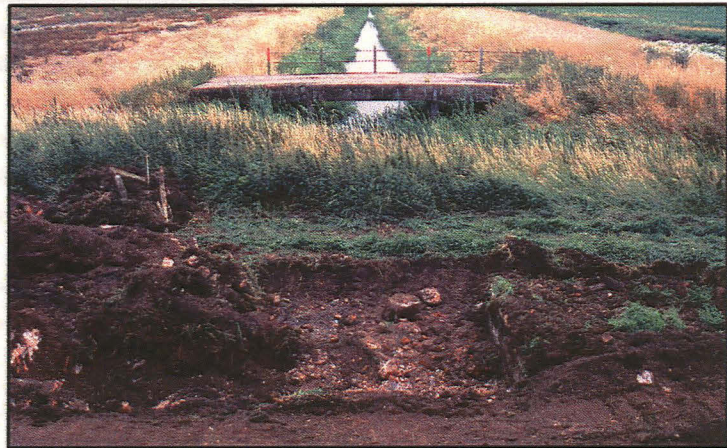
Plate 8: The remains of the pumping station at ch.41850, looking S.

More concrete and brick footings, [204], were encountered at ch.41850 and these appear to represent the remains of the building identified as a '*Pumping Engine*' on the second edition OS map of 1906. Several large concrete footings were exposed, including the headwall and retaining walls of the inlet to the pump (reinforced by steel piles, and still retaining the impressions of the inlet pipes), along with the concrete and brick footings of the pumping house immediately to the north (fig. 18). According to the drainage board, the reinforced concrete foundations at ch.41821 are the remains of a bungalow built after 1906 (as these do not appear on the second edition OS map) to house the 'engineer' (M Tupholme *pers comm.*)

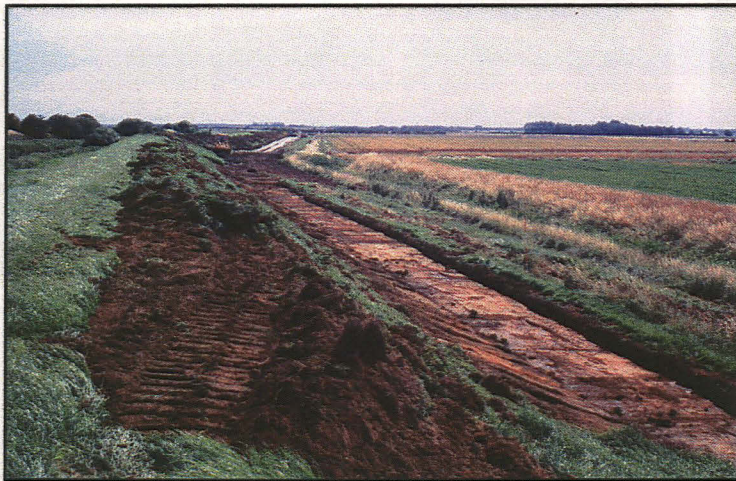
Plate 9: general view of section 3, from ch.42125, looking E. Sandbank (303) can clearly be seen in the stripped area

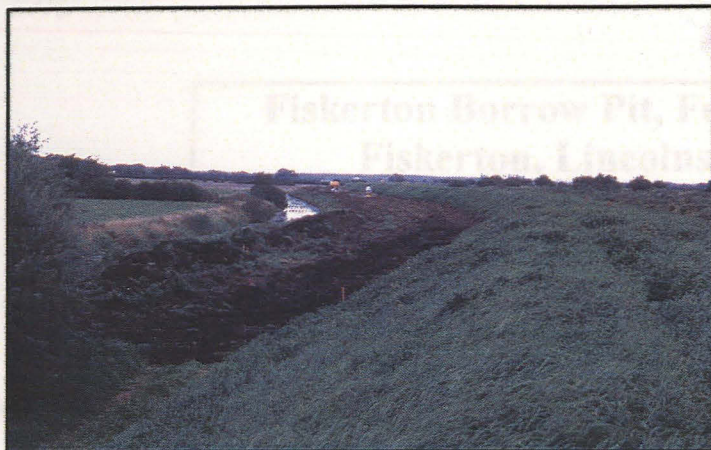
Plate 11: view of the West end of section 21, from ch.42175, looking E. The wood-rich organic peat (2111) can be seen in the foreground
