**ARCHAEOLOGICAL WATCHING BRIEF,
GREESTONE PLACE TO BISHOP'S PALACE,
LINCOLN**

NGR: SK ~~9743-7137~~ 497830 371730
SITE CODE: BIPL03
ACC. NO.: 2004.64

Report prepared for British Telecommunications plc,

March 2004

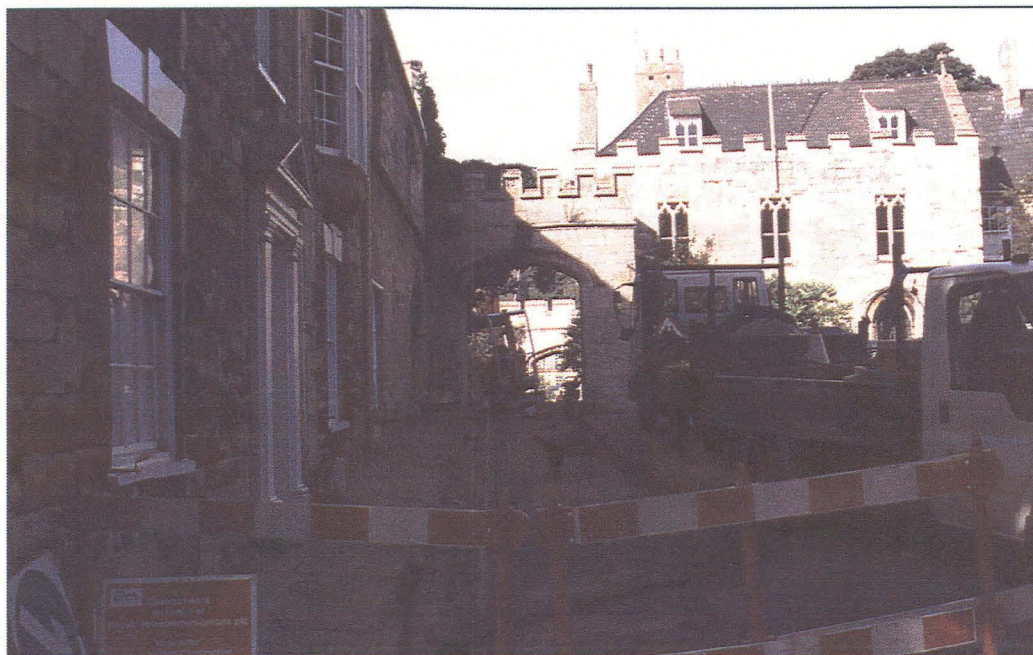
Pl. 1: View along the line of the cable trench, looking west from the east end of the trench.
