Enterprise Road, Caistor, Lincs

Archaeological Watching Brief

**LAS Report No.: 730
March 2004**

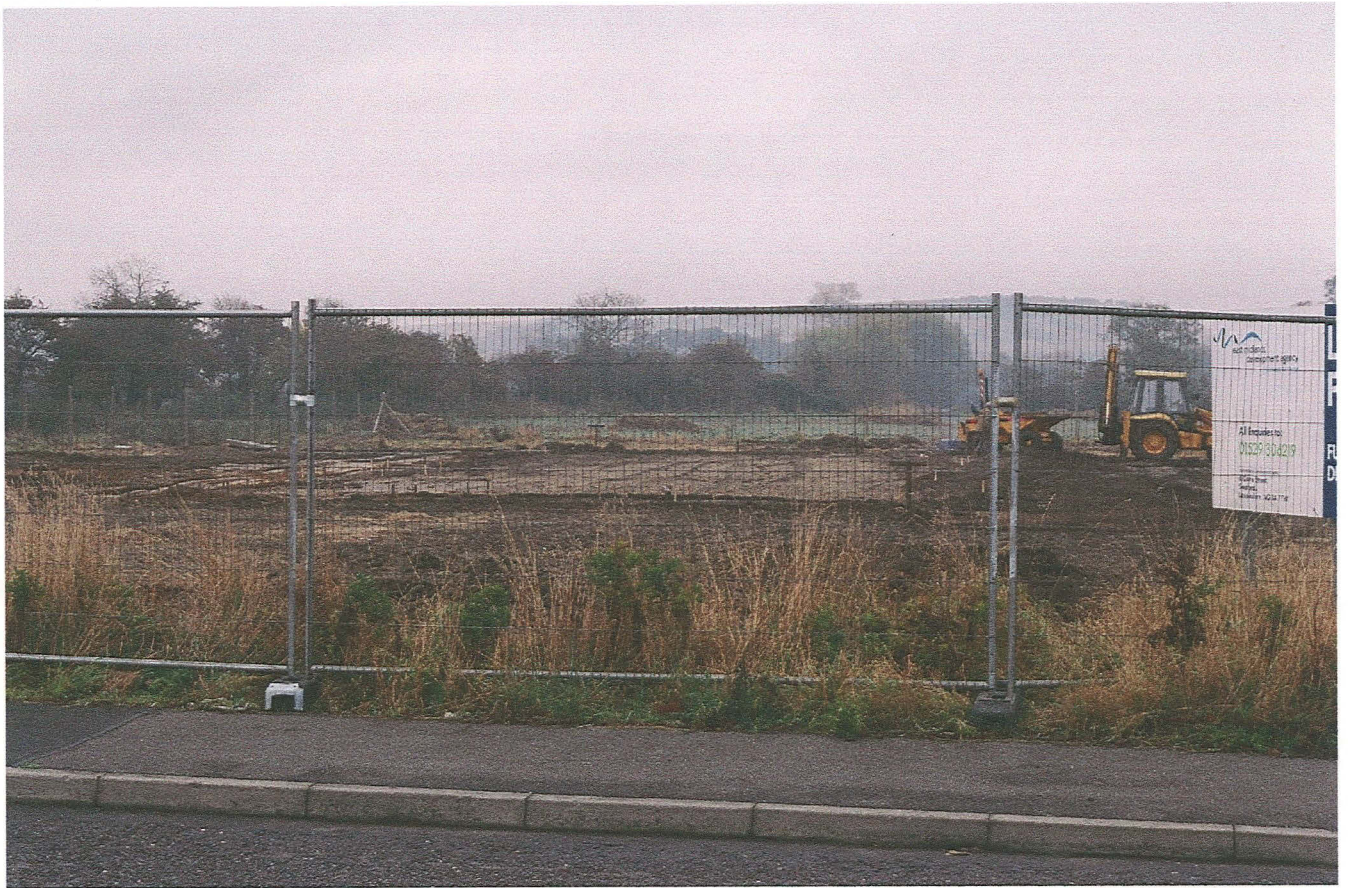
Caistor is a small town situated in the Lincolnshire Wolds 13 km north of Market Rasen. The site is located on the south side of Enterprise Road, to the south of North Kelsey Road (Figs.1 & 2). The site was previously agricultural in use, and had a downward slope from east to west (Pl.1). Development proposals included the excavation of 18 foundation pads, each measuring 1.5m x 1.5m x 1m deep (Fig.3).

PI.1 General view of the site from, facing south

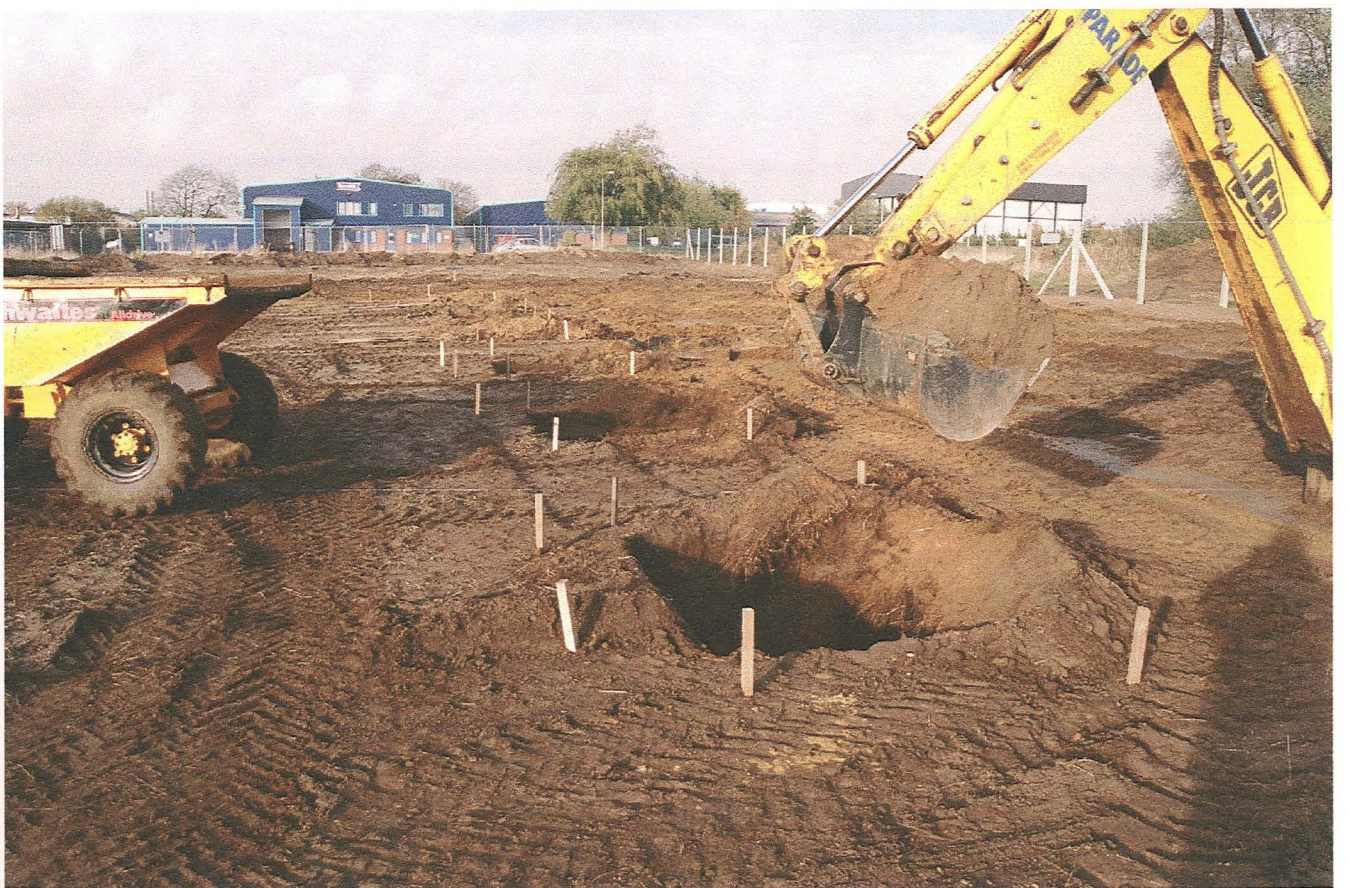
PI.2 Excavation and layout of the eastern alignment of pad foundations, facing north.

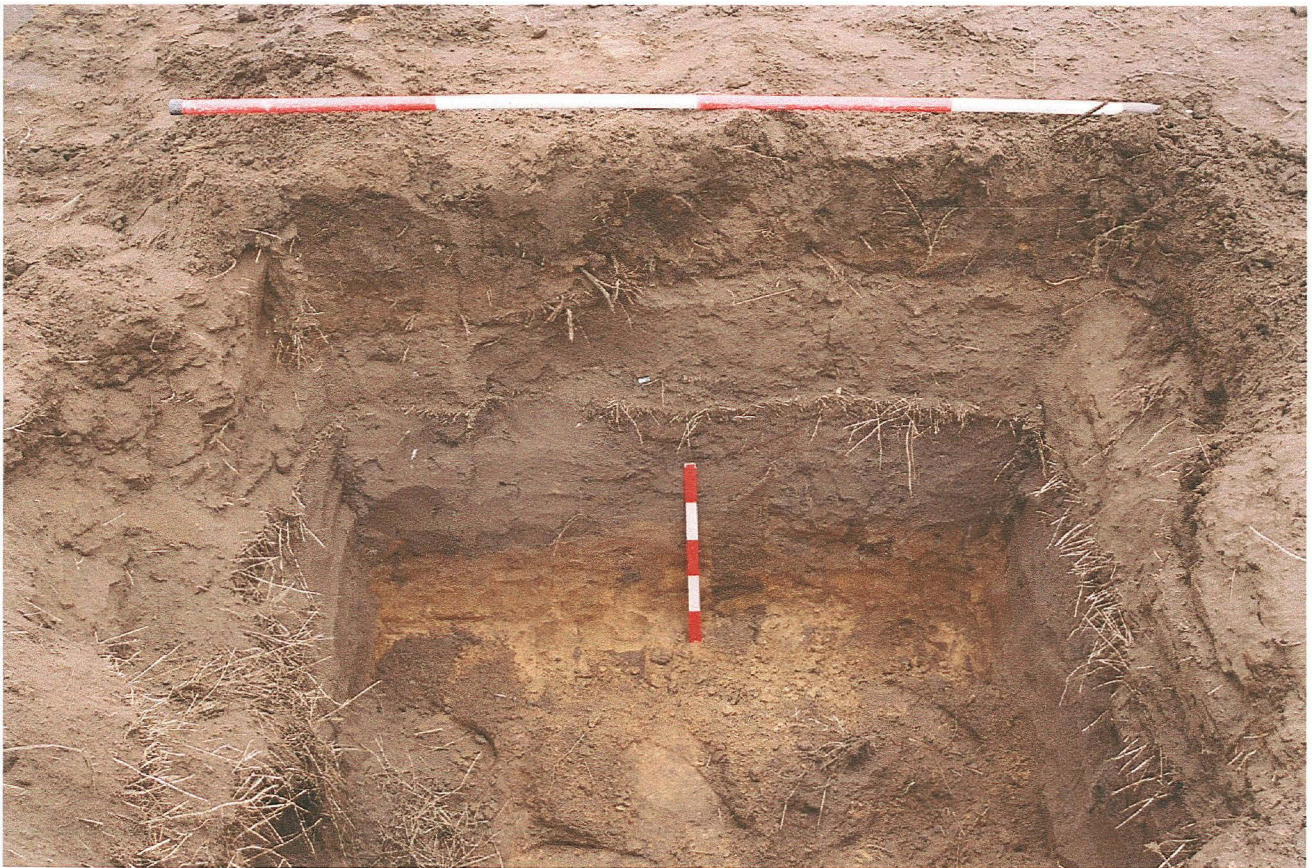
The examination of the development area revealed no finds of any kind, although the excavation of many of the foundation pads, particularly those on the western side, clearly showed that the area had undergone at least two phases of build up in recent years. This was evident from visible turf lines separating the upper topsoil (1), from the lower build up layer (2), which sealed the former topsoil (3). The remainder of the site comprised the afore mentioned topsoil (3), overlying natural sands (4) and clays (5). The presence of these redeposited layers hampered both excavation and monitoring, making vertical sections unstable in some cases.

Following the removal of the recent redeposited material, *i.e.* layers (1) & (2), the former topsoil (3) was removed. This layer consisted of relatively fine light brown sand which covered the yellow/orange sand natural (4). The pits within the northern and eastern extents of the site also contained a dense brown/blue clay natural at approximately 0.6m below ground level.

PI.3 Representative view of a single pad foundation along the western extent of the building, facing south. Notice the redeposited layers (1) & (2), overlying the former plough soil (3). The yellow/orange sand natural (4) is visible below (3)
