**Agricultural Barn at Manor Farm, Wickenby,
Lincolnshire
LN3 5AB**

Report on the Archaeological Watching Brief

Sitecode: MFWK02

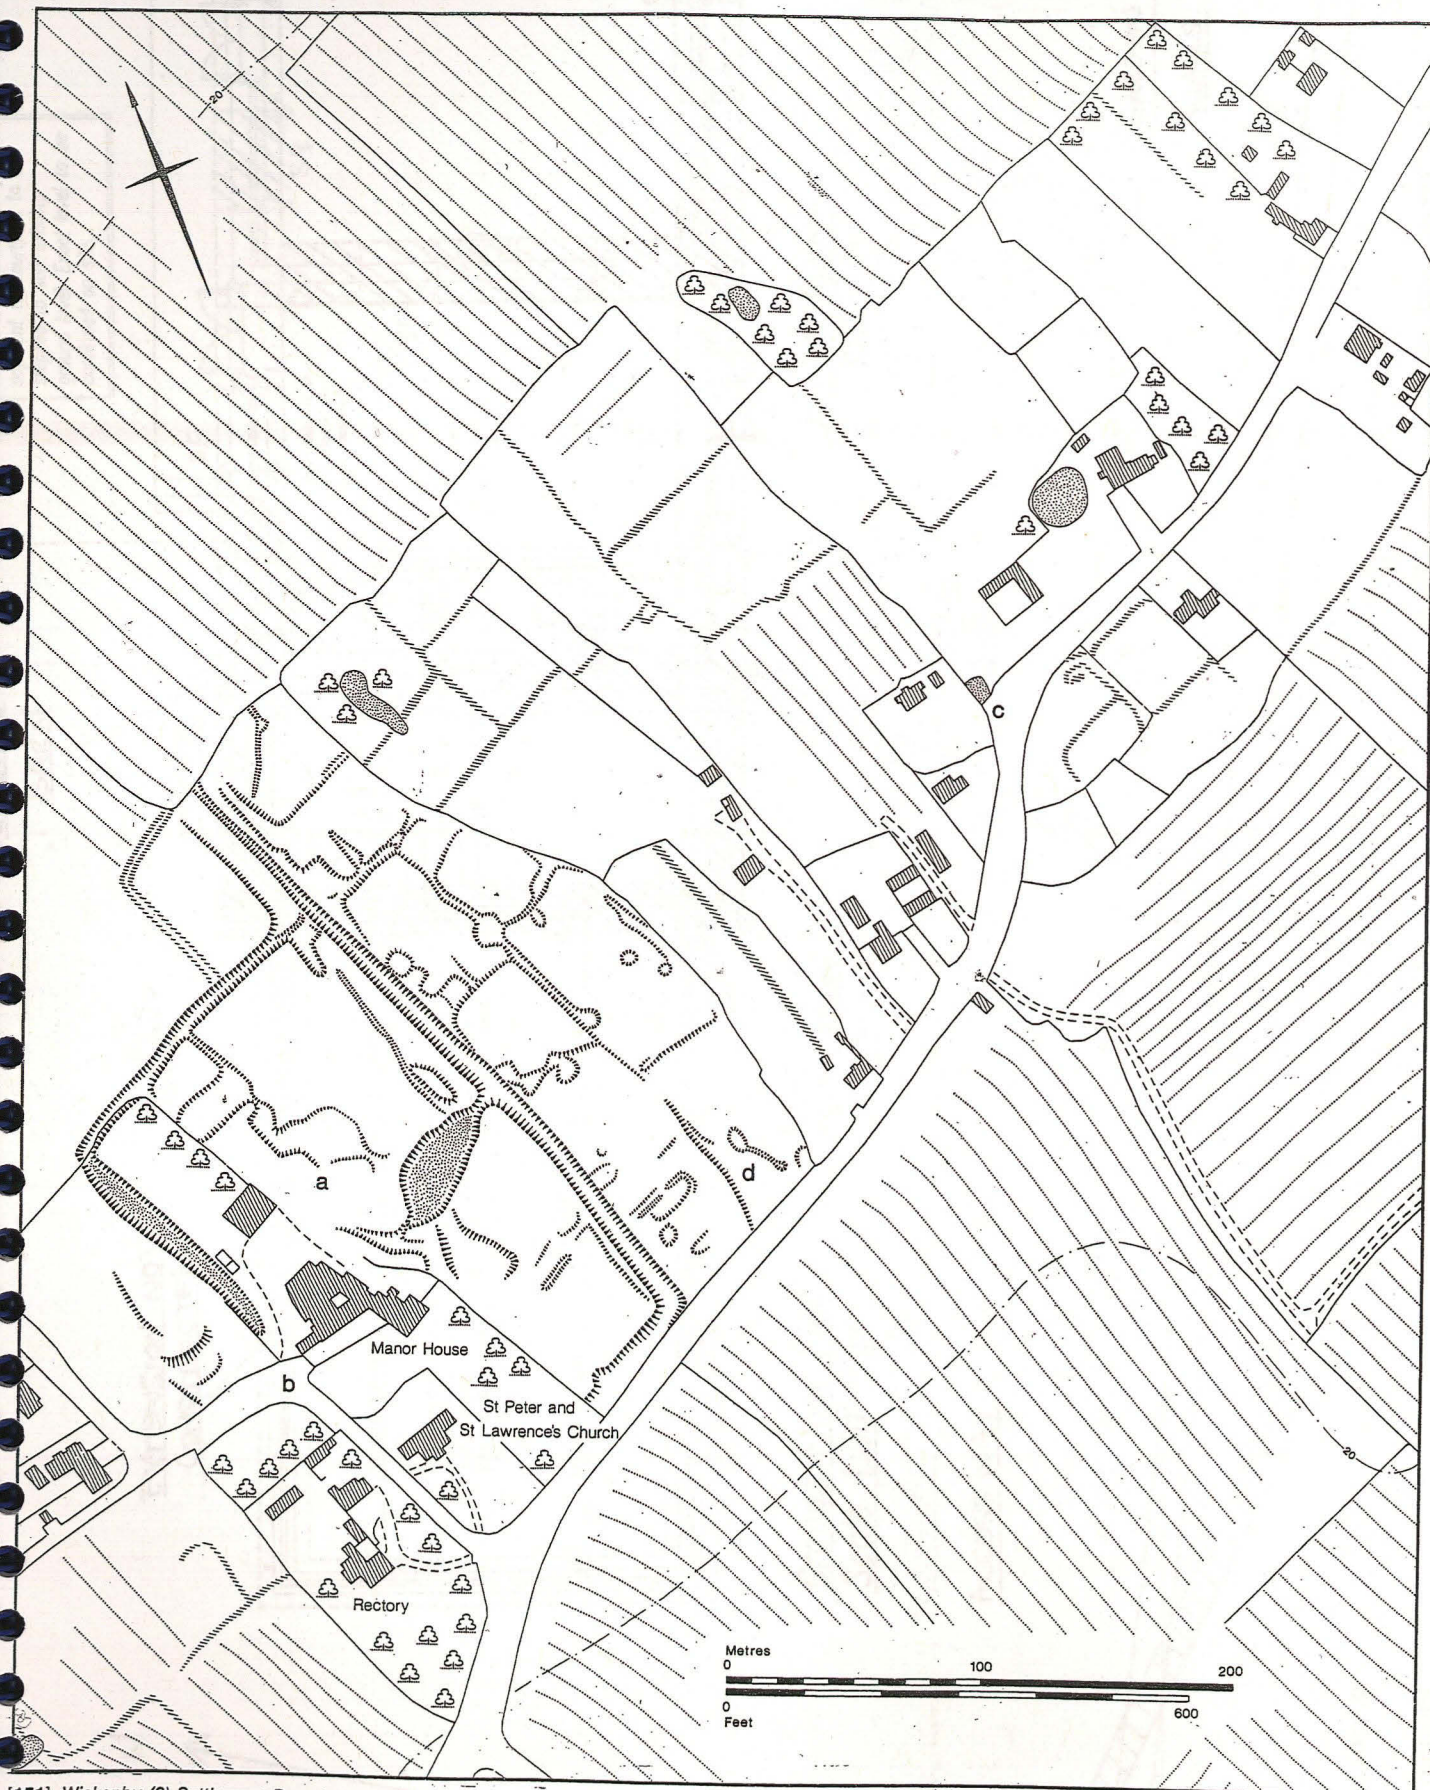
Figure 3 Archaeological survey of the moated manor carried out in 1976

The site of the barn at Wickenby lies within a medieval moated site surveyed in 1976 by RCHME and published in Everson and Taylor 1991 (see Fig 3). The platform at Wickenby was some 210m x 120m, surrounded by the moat. The manor was held by William de Percy at Domesday and had passed to the Chamberlain family by the mid-13th century and remained in their possession until at least the mid-15th century.

Earthworks were noted during the 1976 survey, both in the field to the east of the current house and in the field beyond the moat (Fig 3). These may have been building platforms. The moat also has a low internal bank.

The large pond to the east may have been the remnants of medieval fishponds connected to the moat by a channel (see Fig 3). The pond is situated on the site of a spring which presumably would once have also fed the moat. A chain of fishponds were noted also on the survey. There was another sunken area, possibly a channel off the moat or a fishpond, along the northern side of the churchyard found by the previous occupants of the manor.

The manorial block has disrupted the road alignment. Snarford Road may once have linked up to Lissington Road at the east of the village. This east-west route (noted on Fig 3 between b and c) may originally have crossed beneath the present site access road but has now rerouted around the moat to the south.

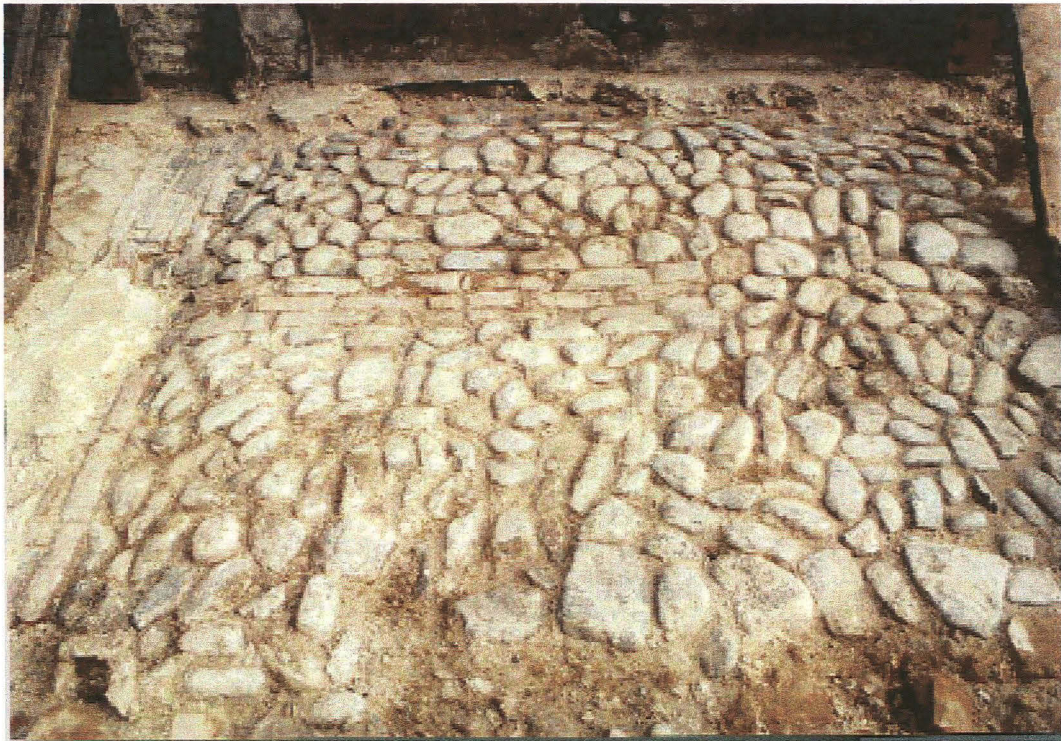
Very little general ground reduction took place as the finished floor level for the new building is to be the same as the old one. However, the cobble floor of the old barn was cleaned and photographed and then removed to make way for makeup for the new concrete floor.

The original floor of the barn was made of cobblestones. Pottery from under the floor dated to the late 17th–18th century could not help to refine the date of the barn's construction.

The cobbled floor of the barn

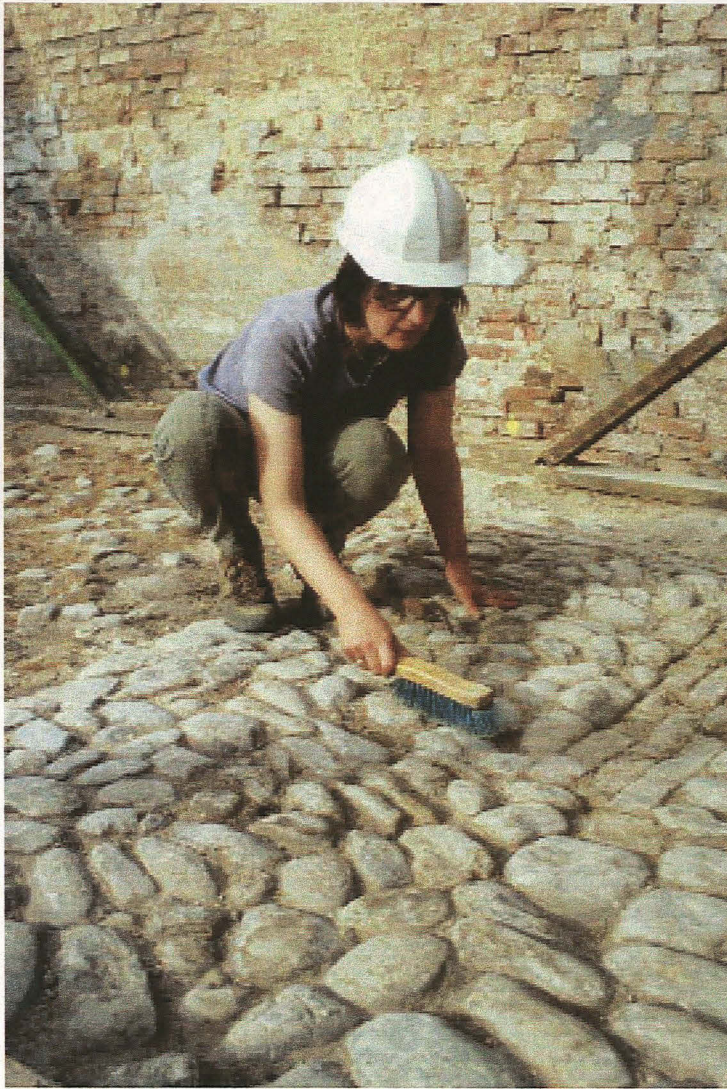
Cleaning the barn floor
